Marina El-Alamein: Conservation Work 1995

Polish Archaeology in the Mediterranean 7, 42-52

MARINA EL-ALAMEIN

CONSERVATION WORK 1995

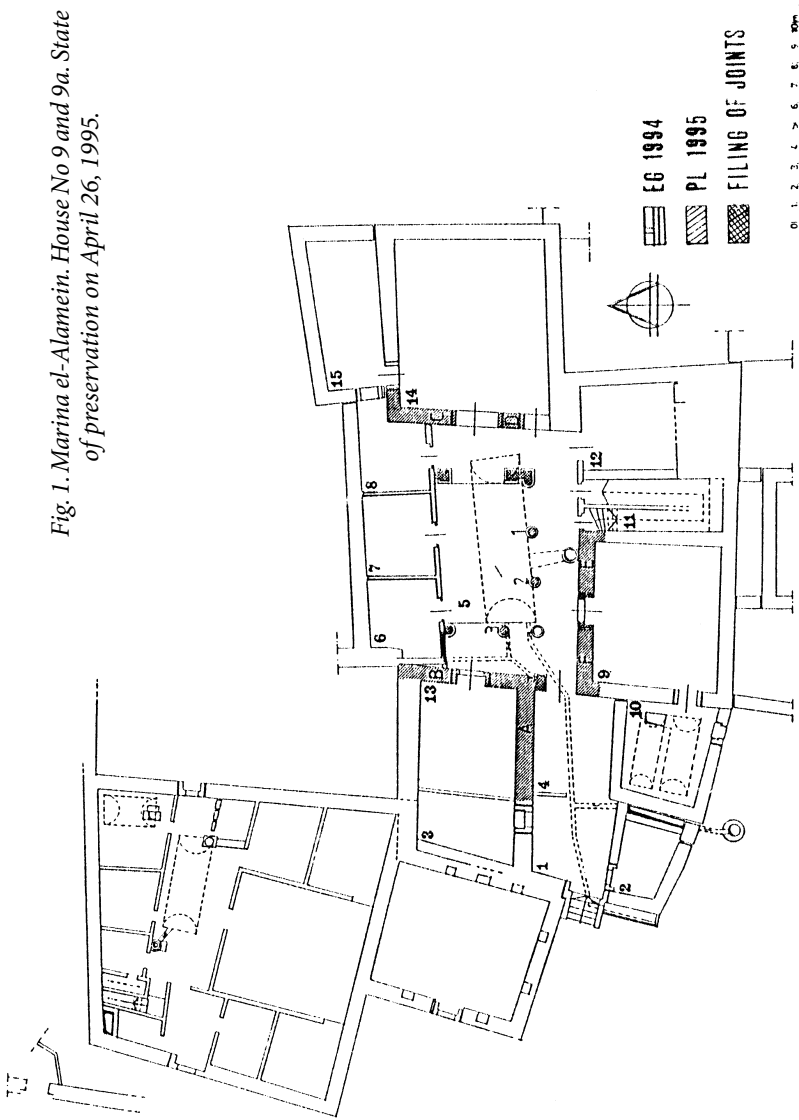
Fig. 1. Marina el-Alamein. House No 9 and 9a. State of preservation on April 26, 1995.
