Marina El-Alamein: Conservation Work, 1999

MARINA EL-ALAMEIN

CONSERVATION WORK, 1999

Stanisław Medeksza

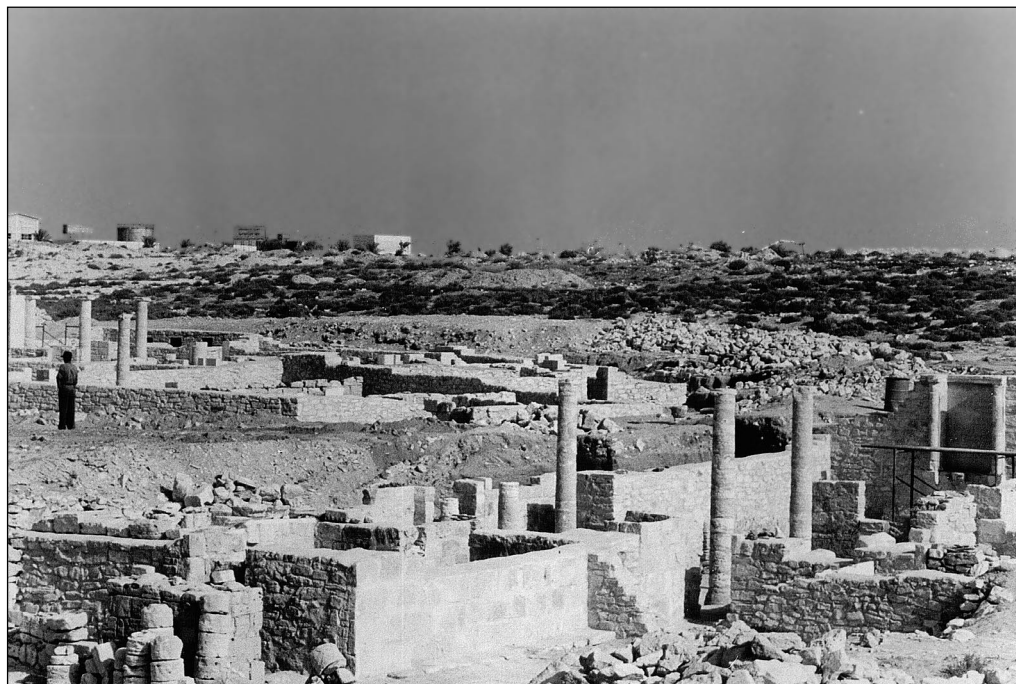
Fig. 2. General view from the northwest of houses H 10 (foreground) and H 9 and H 9a, at the close of the 1999 season (Photo S. Medeksza)

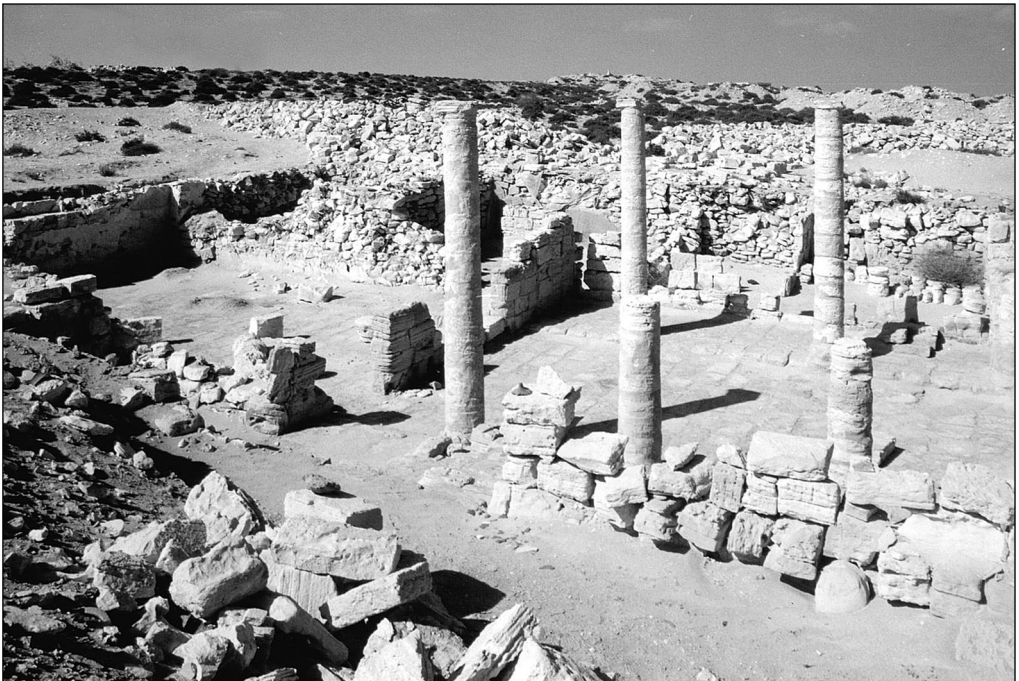
Fig. 3. House H 10. Portico courtyard and room 2 with relics of niche before restoration. View from the northeast (Photo R. Czerner)

The niche discovered last year in room 2 (Fig. 3) was now restored (Fig. 4), the mural removed to be displayed in the future on-site museum. The only step taken was to insert the two blocks directly supporting the columns of the niche. No effort was made to recreate in detail the ornamental profile of the parapet, eroded beyond recognition, but about 90% of the original decoration of the niche has been preserved (Fig. 5). Nevertheless, the structure was found unsound, the blocks of the engaged columns being only shallowly inserted into the original wall structure. Every second element of the columns was reinforced, using steel rods and epoxy resins, to bond the niche to the wall behind it. The inside of the niche, once decorated with paintings, has been finished in plaster.

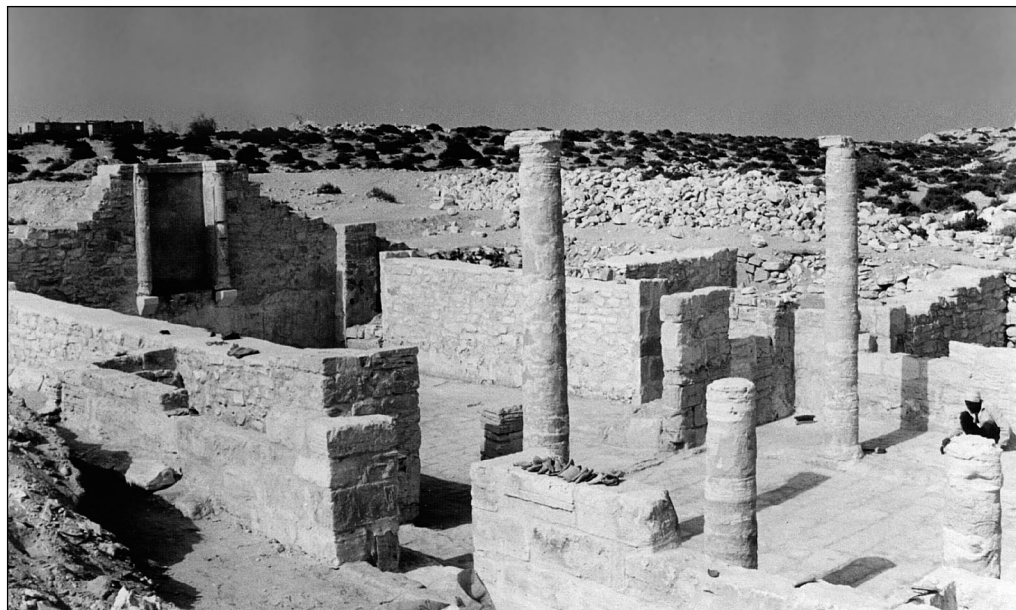
Fig. 4. House H 10. Portico courtyard and room 2 with relics of niche after restoration. View from the northeast (Photo S. Medeksza)

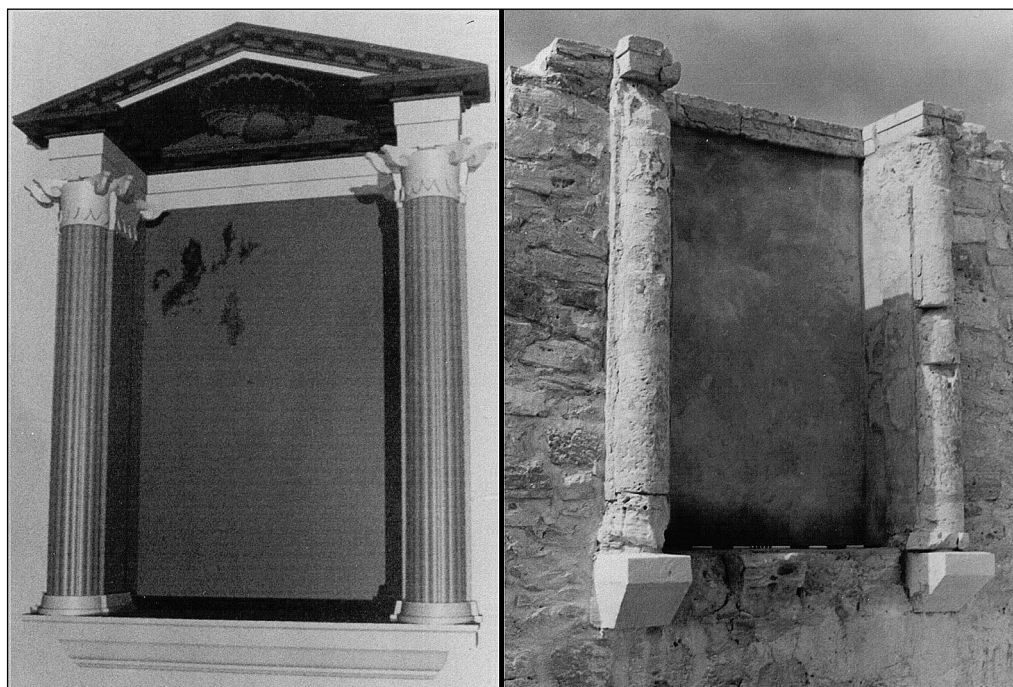
Fig. 6. House H 10, room 2. Niche viewed from the north. Computer reconstruction on the left (Rendering R. Czerner). The niche after anastylosis in 1999 on the right (Photo P. Zambrzycki)

The cornices and conch, preserved in 70%, will be restored in the coming season, when it will be possible to recreate most of the missing stucco elements (*Fig. 6*).

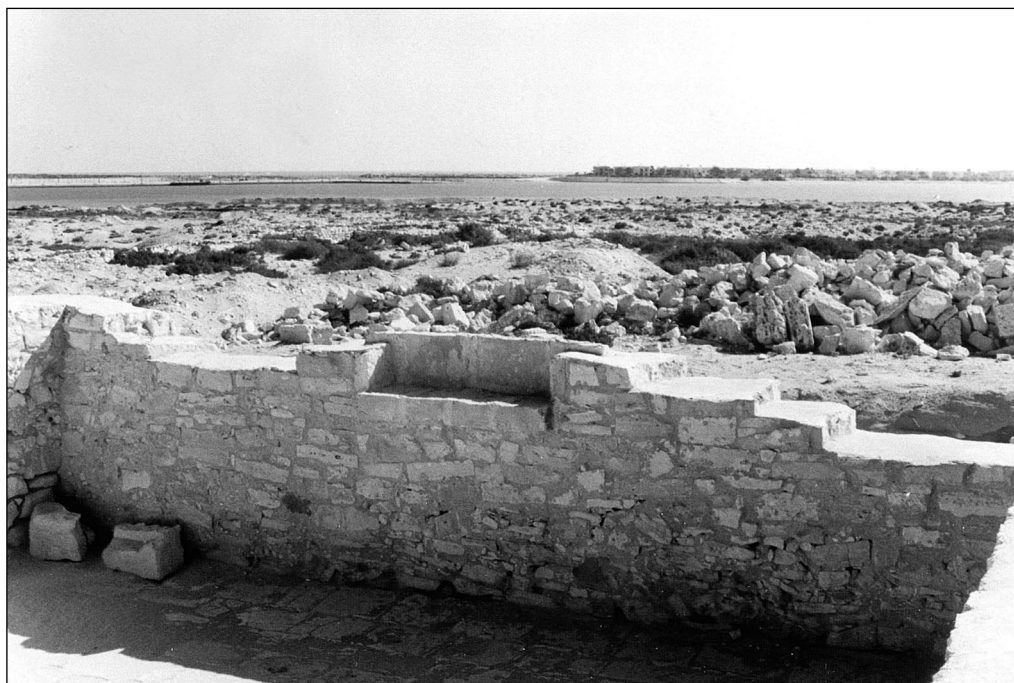
in room 14, made possible by last year's fortuitous discovery of the niche in House H 10. The niche, which had been excavated several years ago (*Fig. 10*),³⁾ had suffered considerably from lying out in the open. It now proved impossible to use all the original elements; the northern column had to be reconstructed entirely, and there is little chance for saving the conch (*Fig. 11*).

Fig. 9. House H 9, room 14. Wall with the setting of the niche before restoration (Photo R. Czerner)

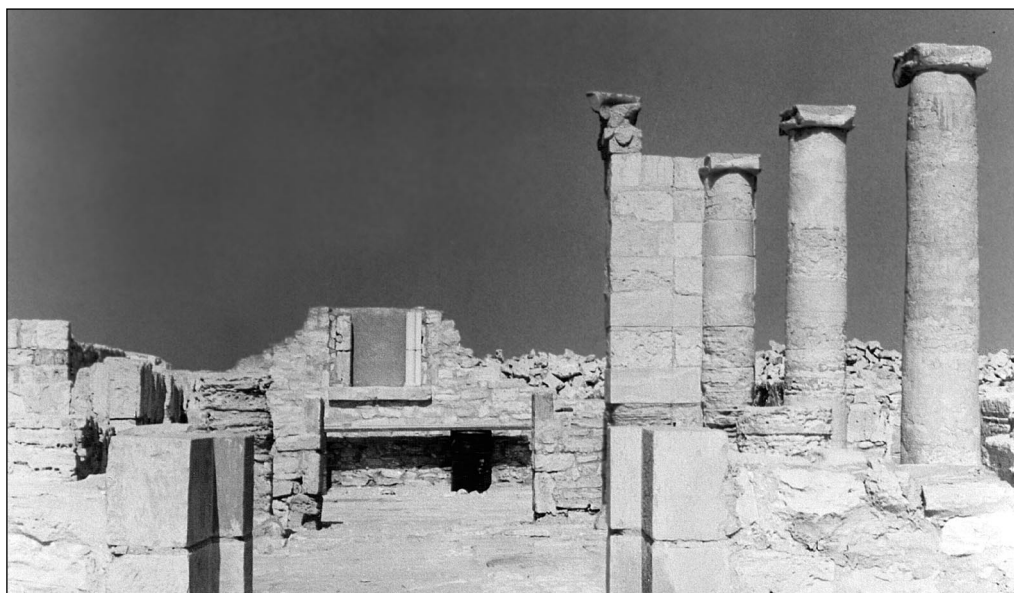
Fig. 10. House H 9. View of the reconstructed niche from the west, in line with the principal axis of the complex (Photo S. Medeksza)
