## West Saqqara: Conservation Work in the funerary chapel of Meref-nebef

Polish Archaeology in the Mediterranean 11, 97-100

# CONSERVATION WORK

## in the funerary chapel of Meref-nebef

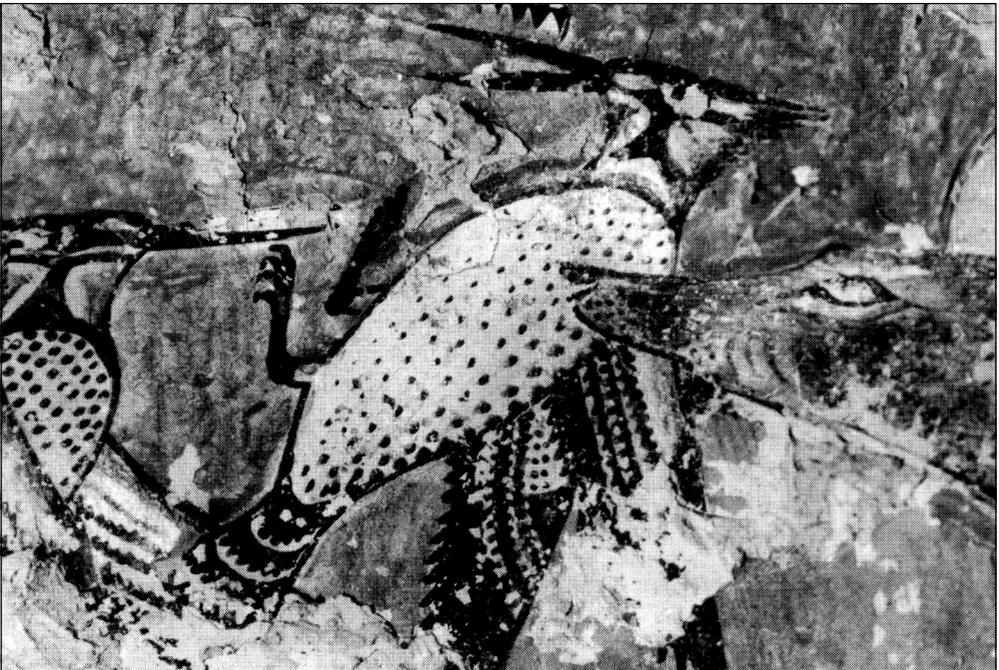
Fig. 1. Detail of hunting scene on the eastern wall of the chapel, after conservation (Photo Z. Kości)
