Conservation Work at Marea in 2006

Polish Archaeology in the Mediterranean 18, 62-67

CONSERVATION WORK AT MAREA IN 2006¹

Barbara Wrońska Kucy

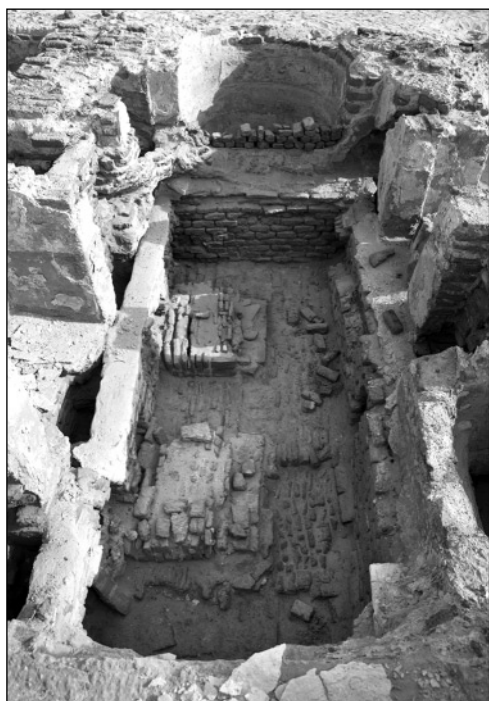
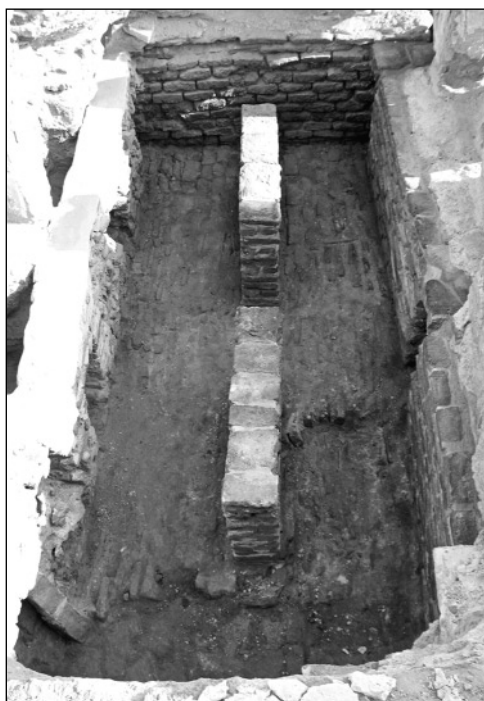
Fig. 1. Byzantine baths. Hypocaust F: before conservation (left) and after (Photo J. Kucy)

Emergency repairs were required in several areas. Work in the hypocaust (F) included reconstruction of the brick pillars (supporting the floors) and adjacent arched openings and sections of the hypocaust walls [Fig. 1].

All reconstructions within the bath were done using the original brick, set in a lime-sand mortar mixed with small amounts of crushed red brick (as per original mortar), and a small amount of white cement for structural strength where required.

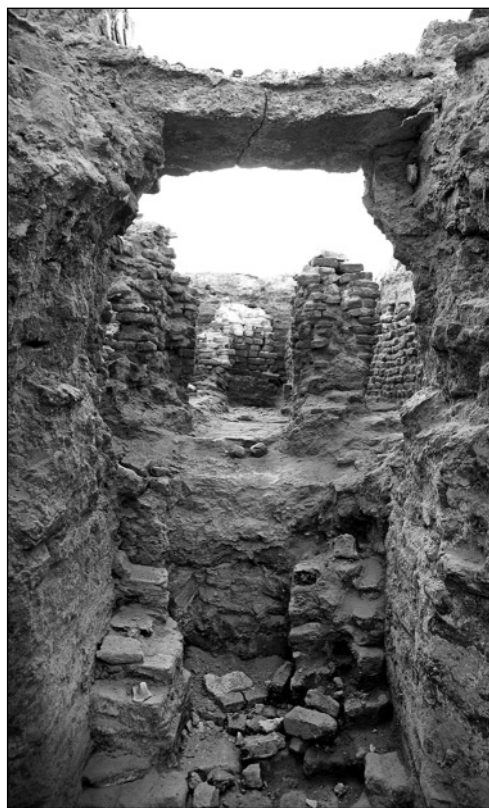
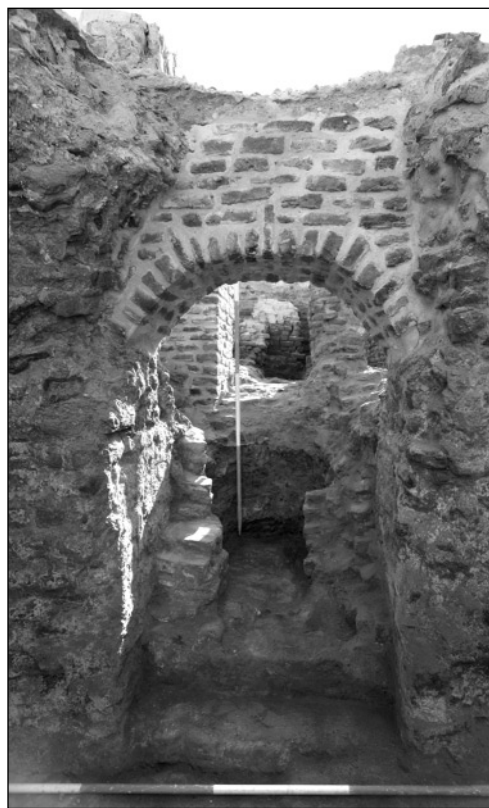
Fig. 2. Byzantine baths. Furnace O4: before conservation (left) and after (Photo J. Kucy)

An arched opening leading to the furnace (O4) between the cellar area (A2)

and (A1), and the adjacent hypocaust brick pillar and arched opening were partially reconstructed [Fig. 2].

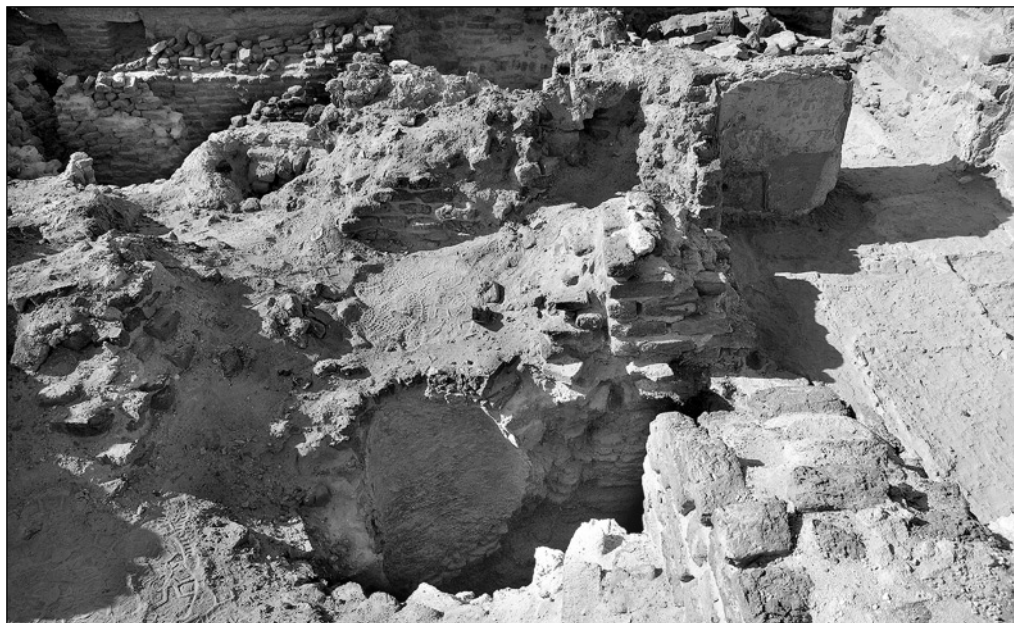
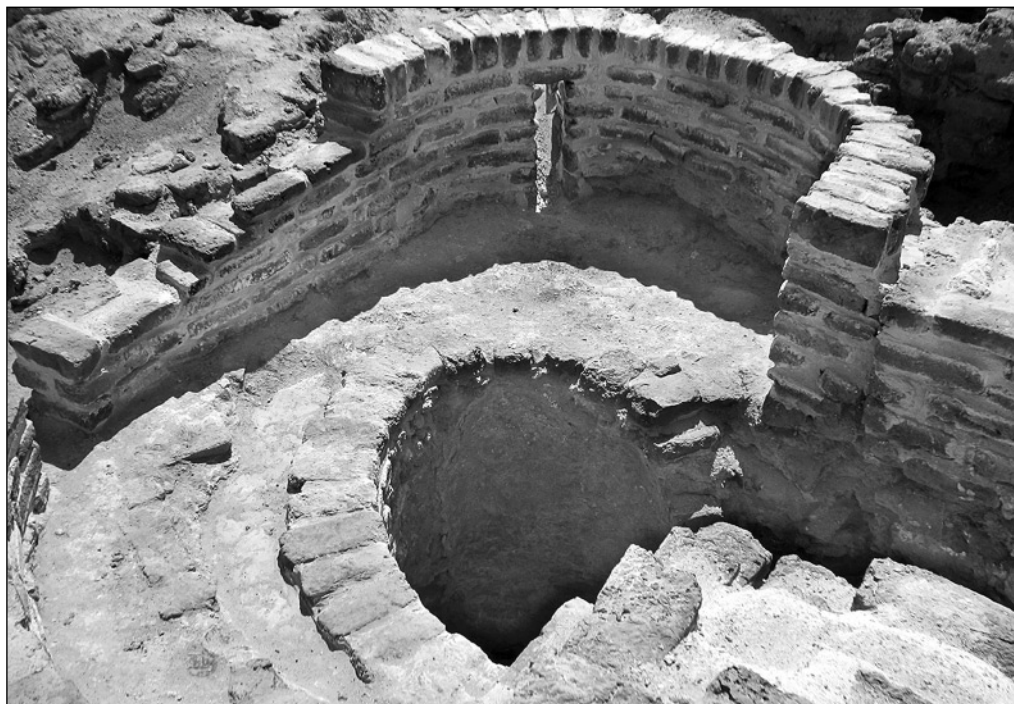
*Fig. 3. Byzantine baths. Furnace O: before conservation (top) and after
(Photo J. Kucy)*

Work around the furnace area (O) included reconstruction of the crown of the outer wall surrounding the furnace, and repairs to the brickwork of the furnace lining [Fig. 3].

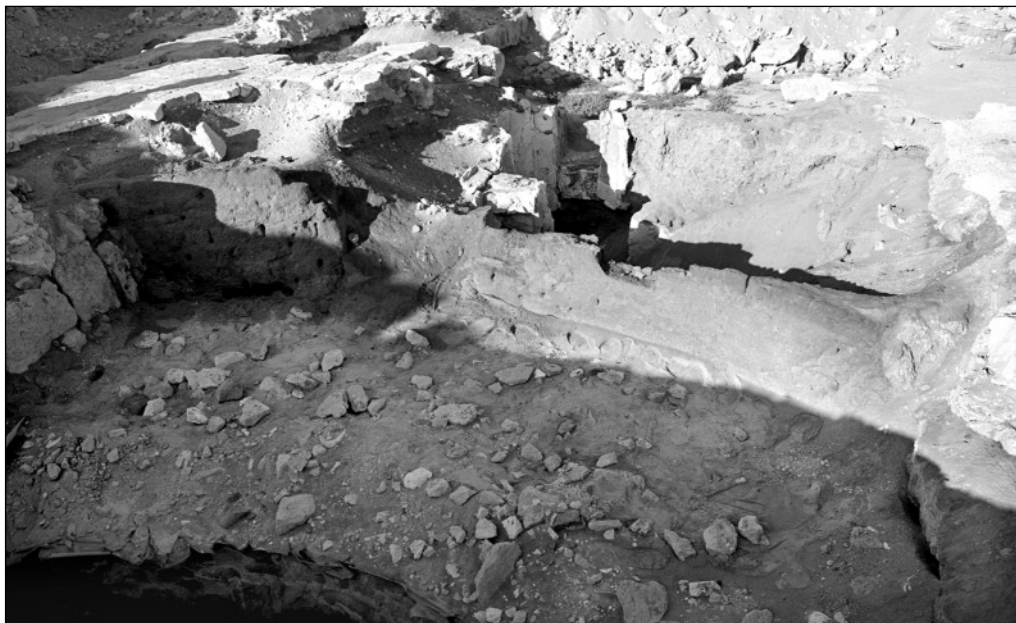
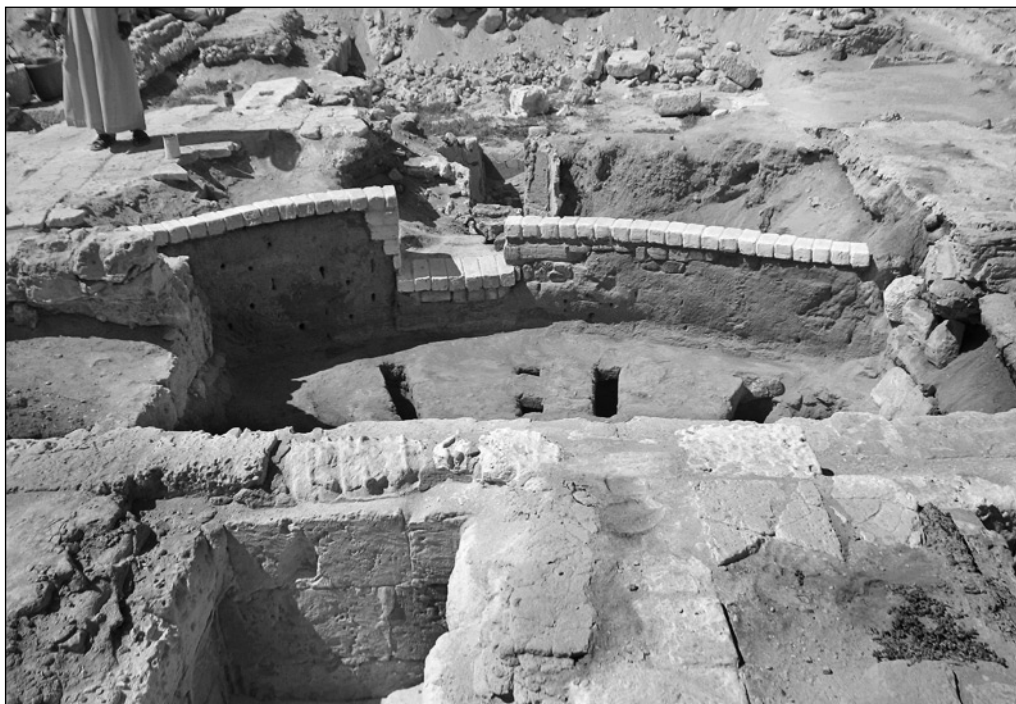
*Fig. 4. Wall of the kiln for firing amphorae: before conservation (top) and after
(Photo J. Kucy)*

The outer wall of the kiln surrounding the grate was constructed of mud brick; it shows evidence of burning due to heat generated inside of the kiln. This burned surface was suitable for treatment with an impregnating breathable solution (30 l) of FUNCOSIL SNL (by Remmers).

The crown and outer face of the wall are severely deteriorated and have soft, powdered surfaces [*Fig. 4*]. In order to prevent further deterioration of this wall, a temporary mud-brick coping was installed, manufactured on site, using locally available clay, sand, and chopped

straw, and very small addition of cement, to increase the water resistance of the brick. This coping with pronounced drip edges, was set in a mud mortar bed (no cement added). Small sections of the wall were patched with original brick found on site, and with new mud brick. It should be emphasized that the new coping is not an attempt at reconstruction; it has been installed merely as a preventive measure against the elements. The mud coping can be removed in the future, if required for the following conservation seasons.

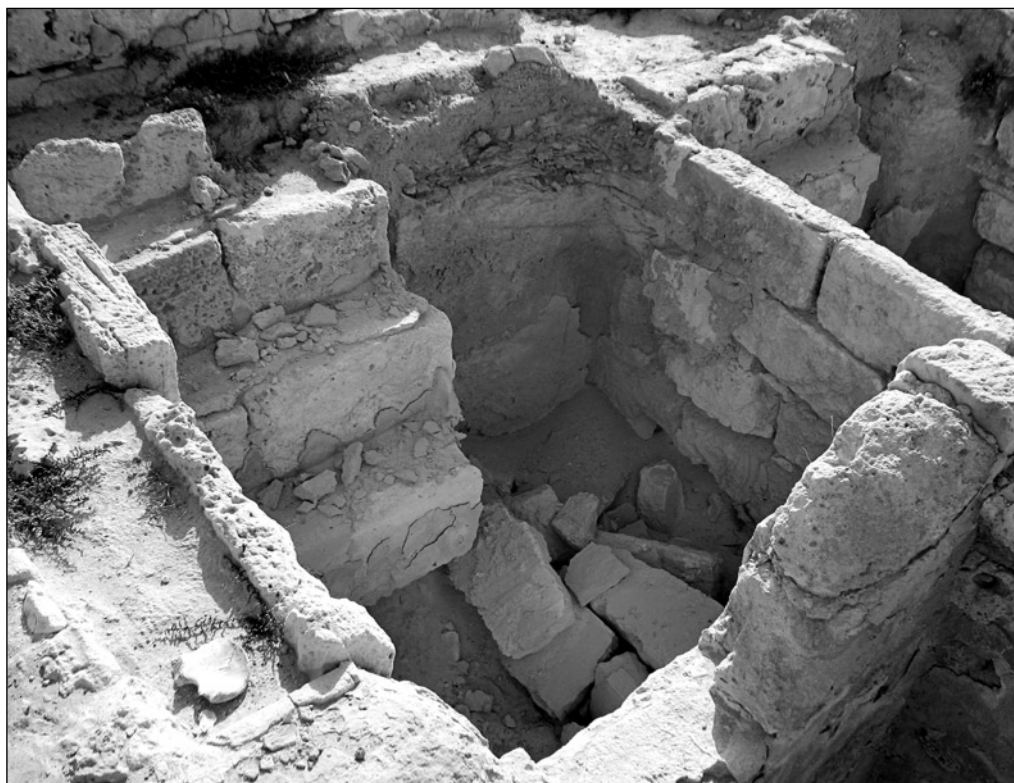
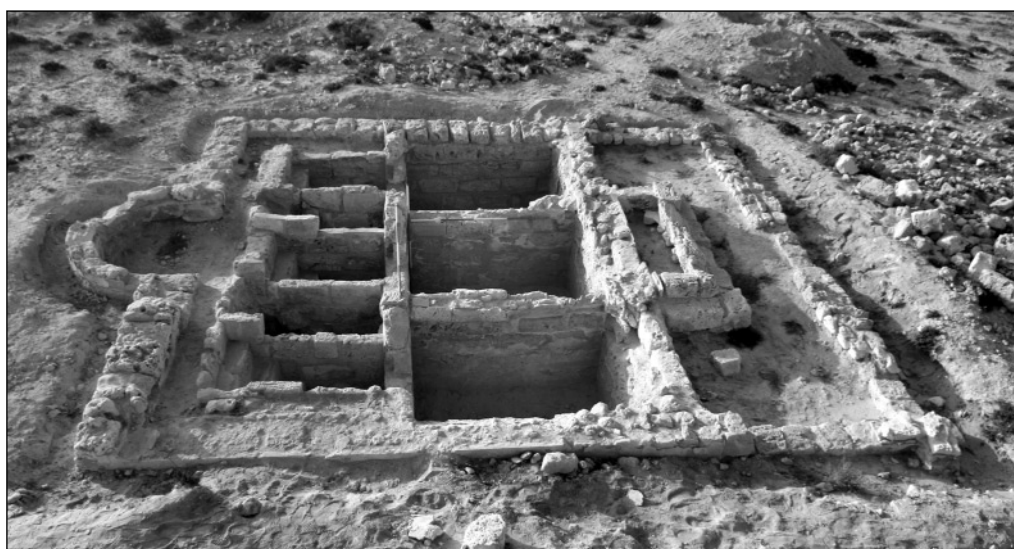
Fig. 5. Funerary chapel: before conservation, detail (top) and after (general view)
(Photo J. Kucy)

The vault walls of the chapel and a footprint of the structure are preserved to approximately half a meter below the chapel floor (not existing). The interior walls of the chambers are exposed to the level of the wall footing. Due to deep excavation and loose stone bond, some partitions adjacent to the

stairs have collapsed [*Fig. 5*, top]. The reconstructive work in the chapel included reconstruction of these walls, and supporting of the stairs [*Fig. 5*, bottom]. All the chambers were backfilled with compacted dirt (post-excavation fill) in order to stabilize the wall foundations.
