Polish Archaeology in the Mediterranean 19, 224-228

2010

SAQQARA 2007: CONSERVATION WORK

Zbigniew Godziejewski

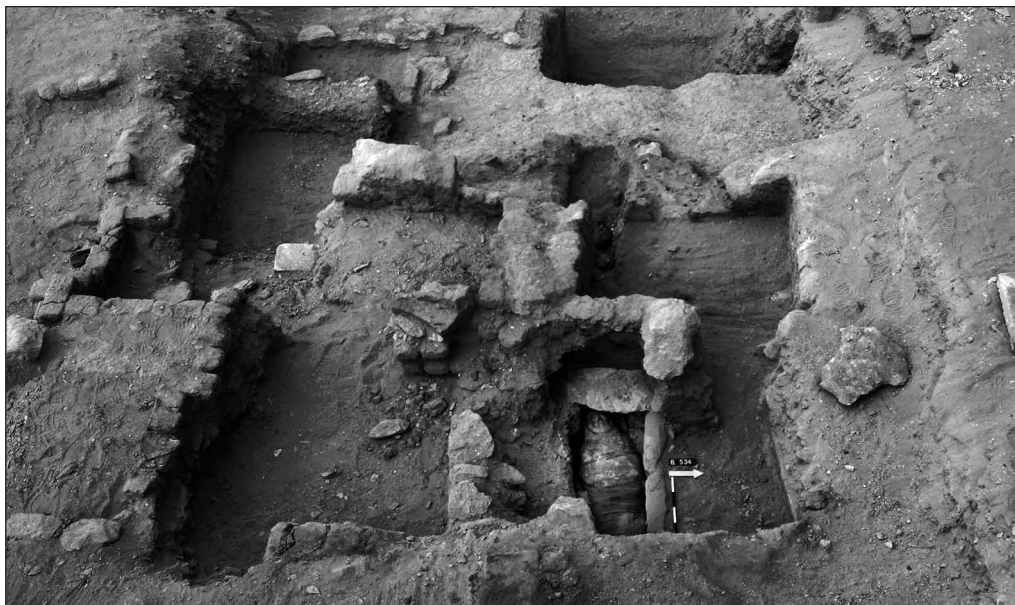
*Fig. 1. Section of the Upper Necropolis with Burial 534 in a pit made partly in the fill of the upper part of a burial shaft and partly excavated in rock (squares 1804/1805, view from the east)
(Photo J. Dąbrowski, PCMA)*

Burial 534 contained a mummy with cartonnage composed of two elements: a gilded mask and a necklace [Figs 1–2]. The gilded foil on the face tended to become detached from the matrix. The necklace, folded and bent, had completely lost its original convex shape. The polychromy layer was covered with a network of cracks and the binder in both the painting and the mortar layer had become degraded, causing disintegration of these technological layers.

Repeated surface sprinkling with a solution of PARALOID B72 in acetone (c. 5%) strengthened the layers and secured their mutual cohesion. Further consolidation was achieved with PARALOID (as above) and a solution of KLUCEL GF in ethyl alcohol. Falling flakes were mounted with PRIMAL

AC33 in water solution (8–10%), after which the head-cover and the necklace were transferred from the mummy to a provisional support made of styrofoam and small sacks filled with rice. The process of mounting flakes and smoothing out bent parts of the lappets was continued on the mask, after which dirt particles were removed from the surface using cotton wool damped in acetone. Damping the necklace with a solution of KLUCEL GF in alcohol helped to elasticize the object, permitting the conservators to shape it until the original form was reconstructed. Work on these objects will have to be continued in the next campaign.

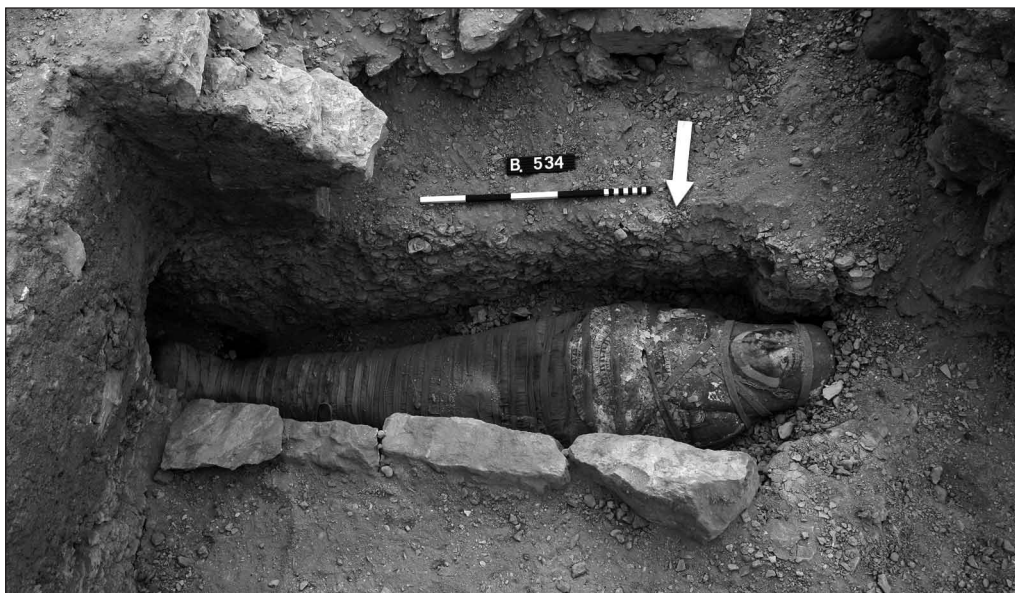
*Fig. 2. Close-up of Burial 534 in situ
(Photo J. Dąbrowski, PCMA)*
