**Marina El-Alamein: Conservation
Work in the 2009 Season**

MARINA EL-ALAMEIN: CONSERVATION WORK IN THE 2009 SEASON

Abstract: In 2009 the Polish–Egyptian Restoration Mission to Marina el-Alamein proceeded with another season of conservation work in heavily constrained circumstances. Architectural studies preceding building conservation work were carried out in House H1, where the Mission has been active over the past few seasons. It was established that the house had an inner peristyle consisting of two tiers corresponding to building floors: pseudo-Corinthian of the Marina type on the ground floor and pseudo-Corinthian or pseudo-Ionic of the Marina type on the upper floor. A similar tiered architectural decoration was noted in the incomplete peristyle (unit 4) of the Southern Baths just off the presumed Main Town Square. Work continued on clearing the chambers of the baths and accomplishing preservation, conservation and subsequently building restoration works. A marble plaque with an inscription, found previously, was subjected to conservation treatment once standard condition monitoring demonstrated progressive deterioration of the state of this object.

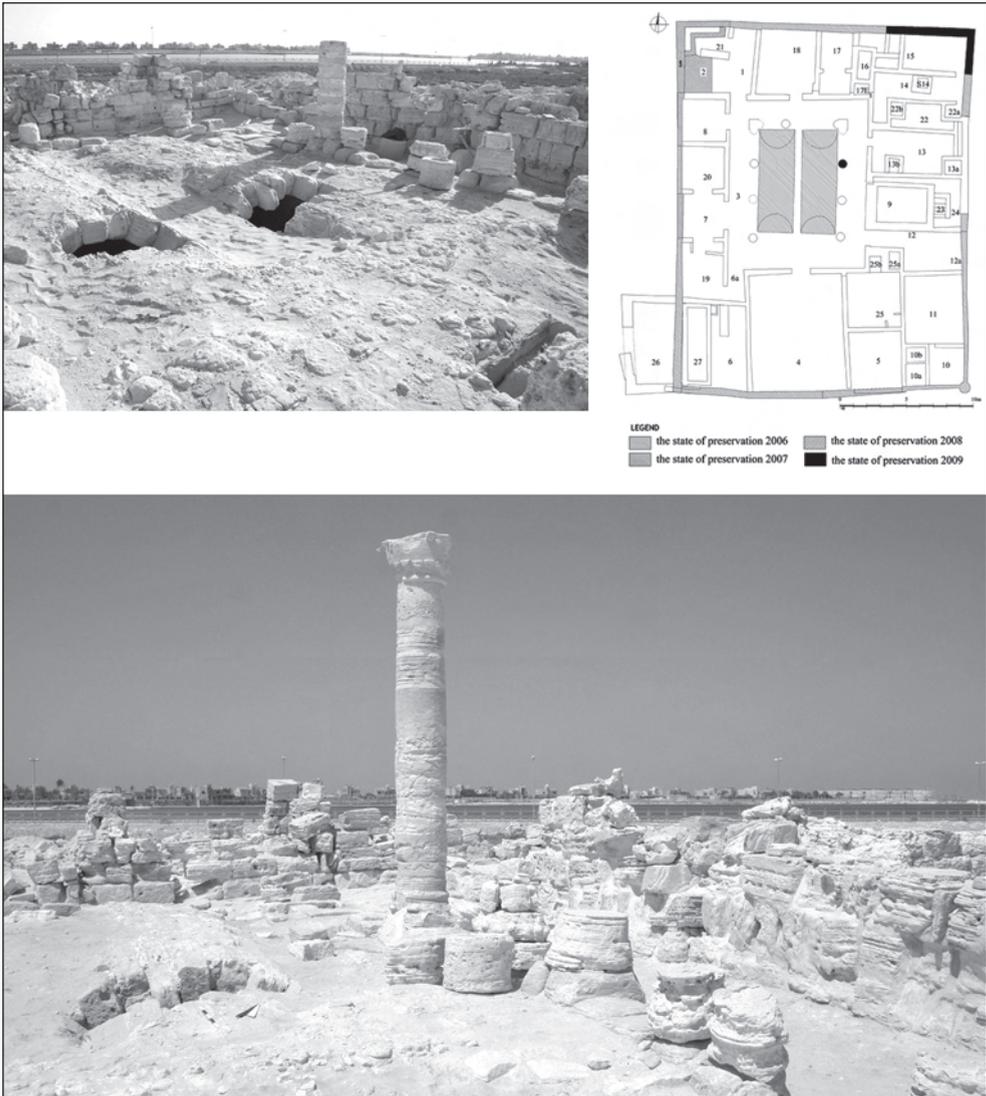
The house poses a considerable challenge for detailed architectural phasing and consequently for building-restoration works that have to take this factor into account. The difficulty lies in having to avoid deforming the extant record of architectural changes, especially as it is impossible to display all phases in architecturally unquestioned form. Consequently, walls can be supplemented either in the vertical or the horizontal. The most important research document in this situation is a very precise architectural inventory of remains of the original architecture.

Fig. 2. House H1, central peristyle before (top left) and after conservation; top right, amended plan (Photos R. Czerner; plan A. Brzozowska)

The foundations and upper parts of the outer walls were completed this season. Another course was added to the foundation in the northwestern corner of the building. One column was raised to its full height following architectural studies on the proportions of the portico columns [Fig. 2]. The parts done in 2005 and 2006 were now raised with four more drums and topped with a capital, achieving a height of 3.45 m which is close to the theoretically reconstructed one. One of the drums had to be made anew, while more extensive

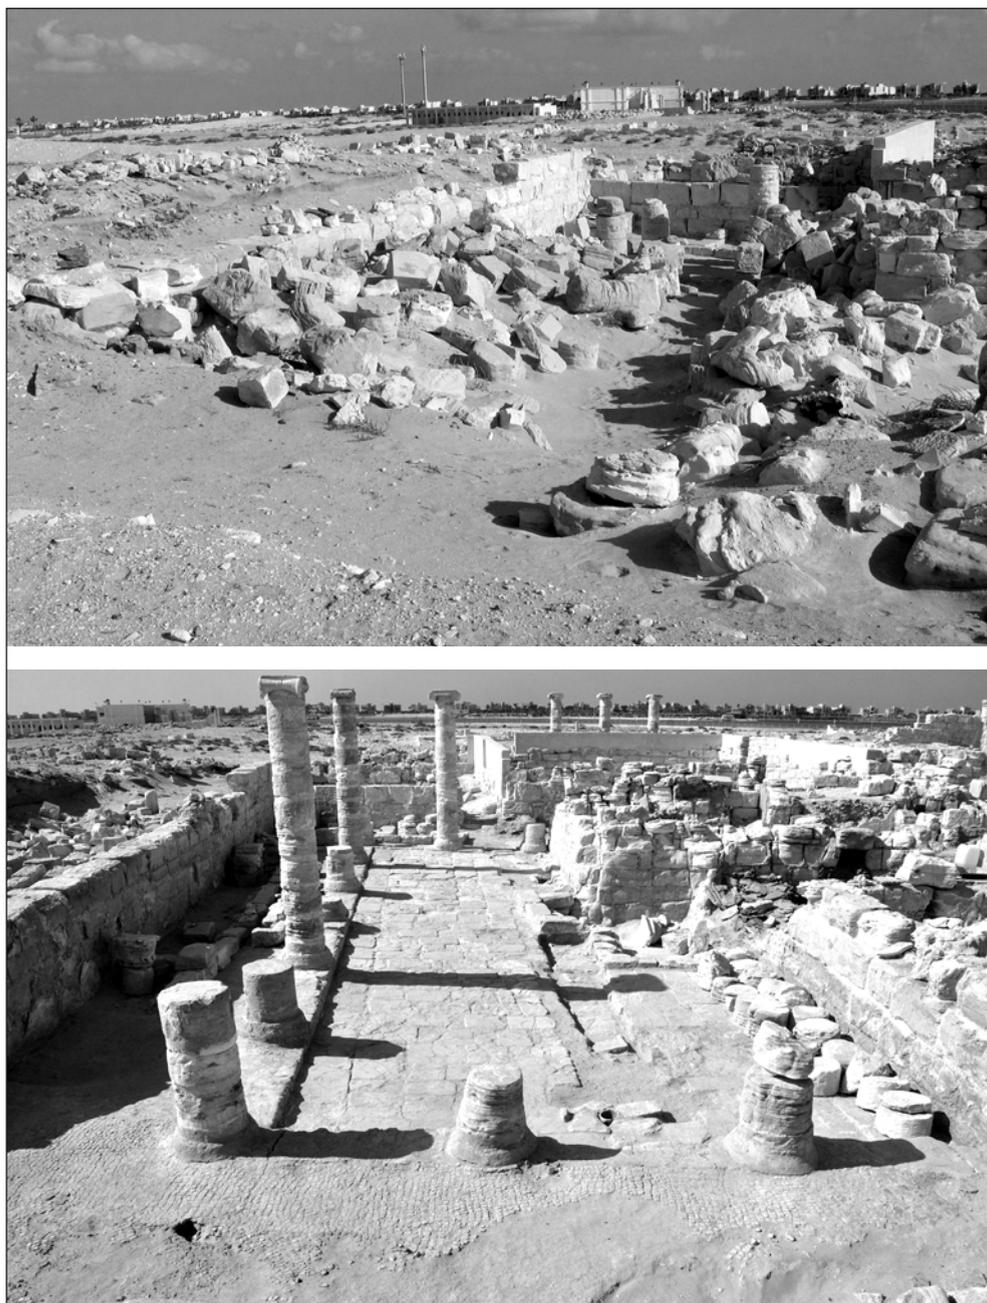
Fig. 4. Unit 4 of the Southern Baths, before (top) and after clearing and conservation, view from the south (Photos G. Bąkowska-Czerner, P. Zambrzycki)

The preserved parts of columns in the Western Portico of unit 4 had small losses of the substance in the form of old lime joints and fragments of bases and drums. After clearing of the feature parts of the hypocaust structure in unit 6 of the Southern Baths were also found to be detached and powdering.

Lime mortar in proportions as above mentioned was used at a minimum in filling in the joints of columns in the Western Portico.

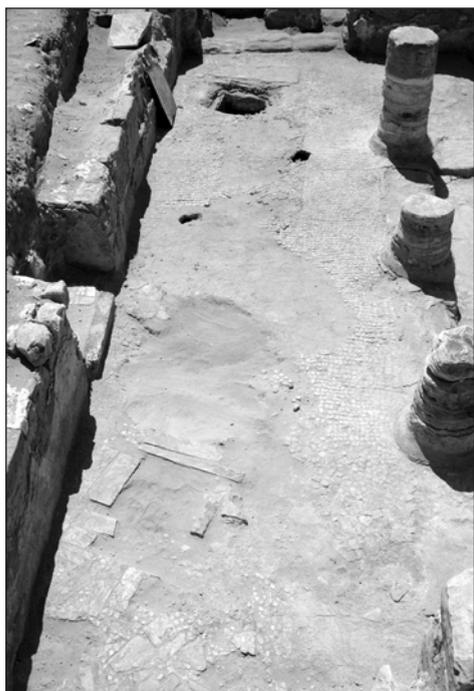
The southern portico featured a mosaic floor made of small irregular cubic stones. The material used was a local oolithic limestone. Most of the floor was made up of cubes made of creamy-colored limestone with brown patina; cubes of a darker color were obtained by burning a high temperature process of burning through blocks of limestone in charcoal. Separate light tesserae were made of milky micritic limestone. The floor was repaired in antiquity with fragmented marble tiles, both unshaped and original elements [Fig. 9].

Fig. 9. Mosaic floor preserved in the southern portico in unit 4, view from the east (Photo R. Czerner)

In the eastern end of the southern portico, the floor had been damaged by a falling column drum, which broke through it. Tumbled architectural elements and

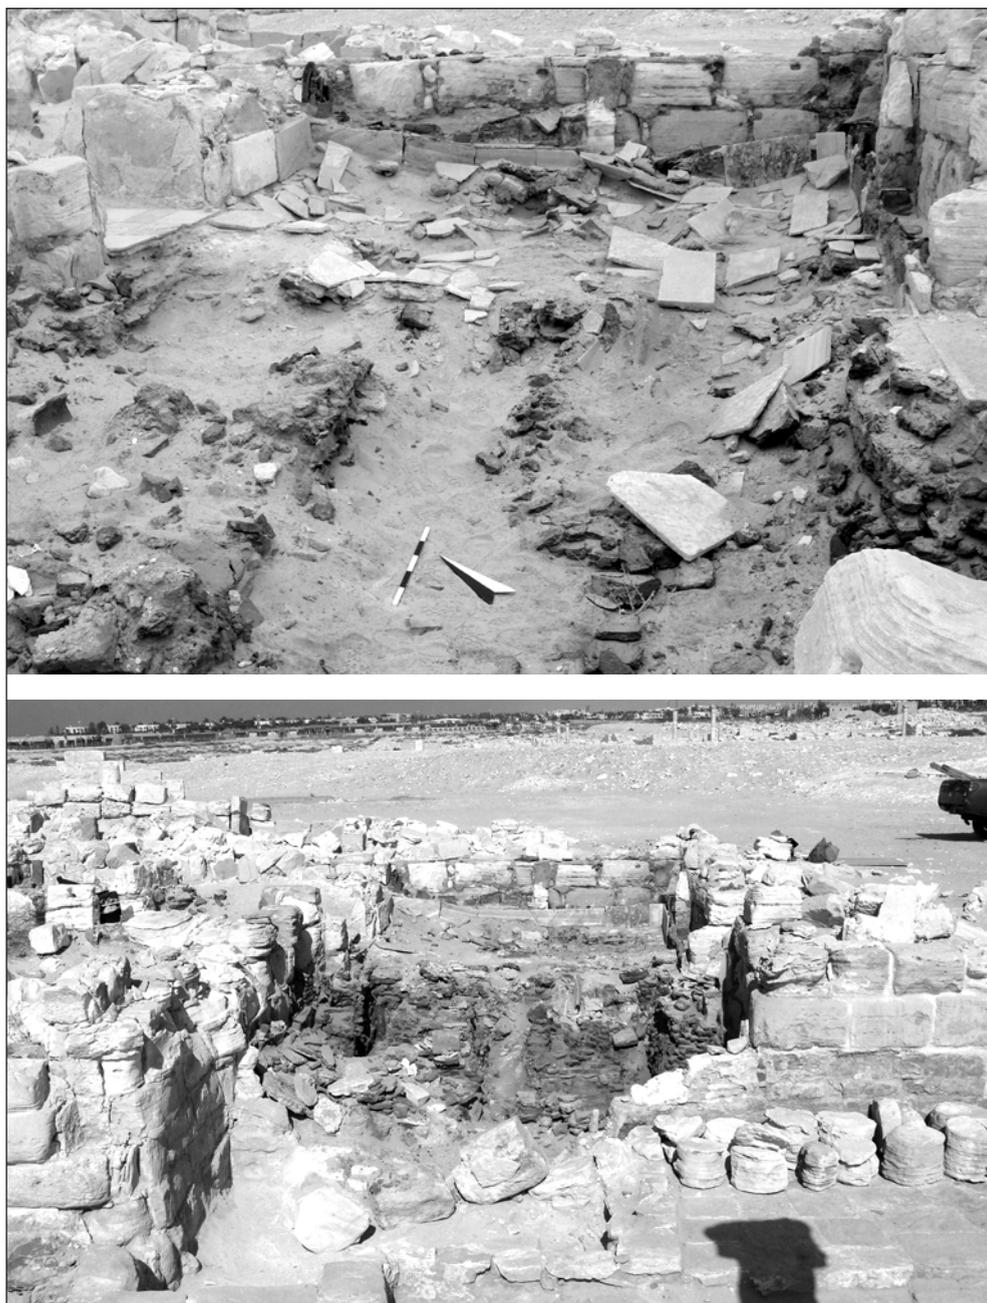
an apparent inner recreational courtyard, and reconstruction of the porticos [Fig. 3]. Emergency measures were needed in unit 6, where the hypocaust and tubuli heating installation relics were rapidly deteriorating — the ceramic tiles powdering, the tubuli shattered and hypocaust cellar vaults collapsed — and the marble floor slabs and wall revetment were in no better shape.

Fig. 11. General view of unit 6 of the Southern Baths at the beginning of the season (2009) and after emergency conservation of the remains (Photos M. Mrozek-Wysocka)

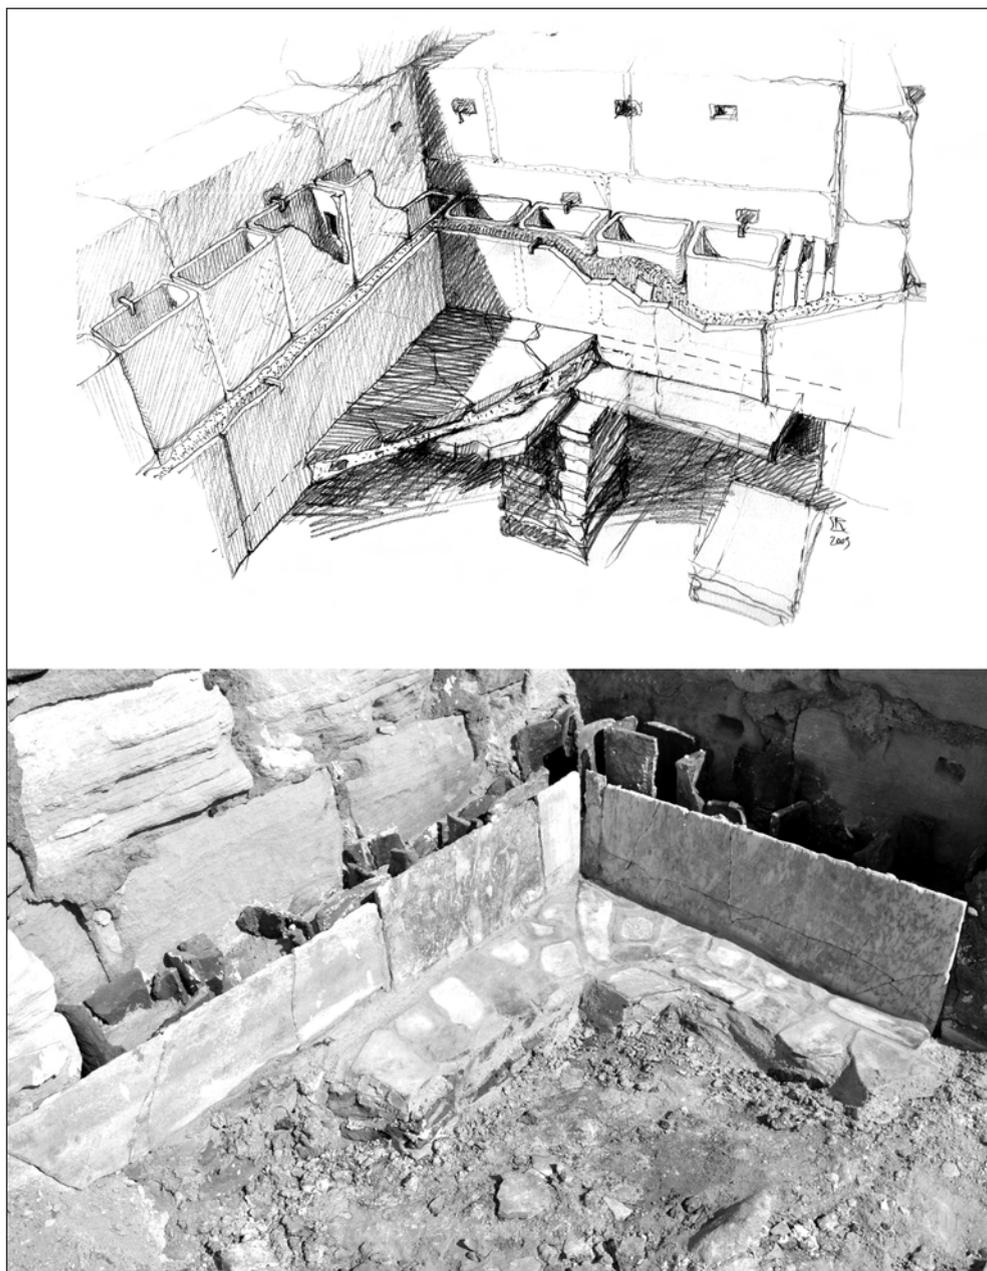
Fig. 13. The tubuli system in the southeastern corner of unit 6 of the Southern Baths: theoretical reconstruction (top) and state after conservation (Reconstruction drawing R. Czerner; photo P. Zambrzycki)

a reconstruction of the *tubuli* system preserved in the southeastern corner of the room. This led to a theoretical reconstruction prior to the actual restoration [Fig. 13].

The condition of the revetment and tubuli was assessed and steps were undertaken toward a partial anastylosis of this installation [see Fig. 10]. Cracked fragments of the revetment were removed for consolidation and reassembly before remounting. Excavated elements of ceramic tubuli were cleaned and partly reinforced

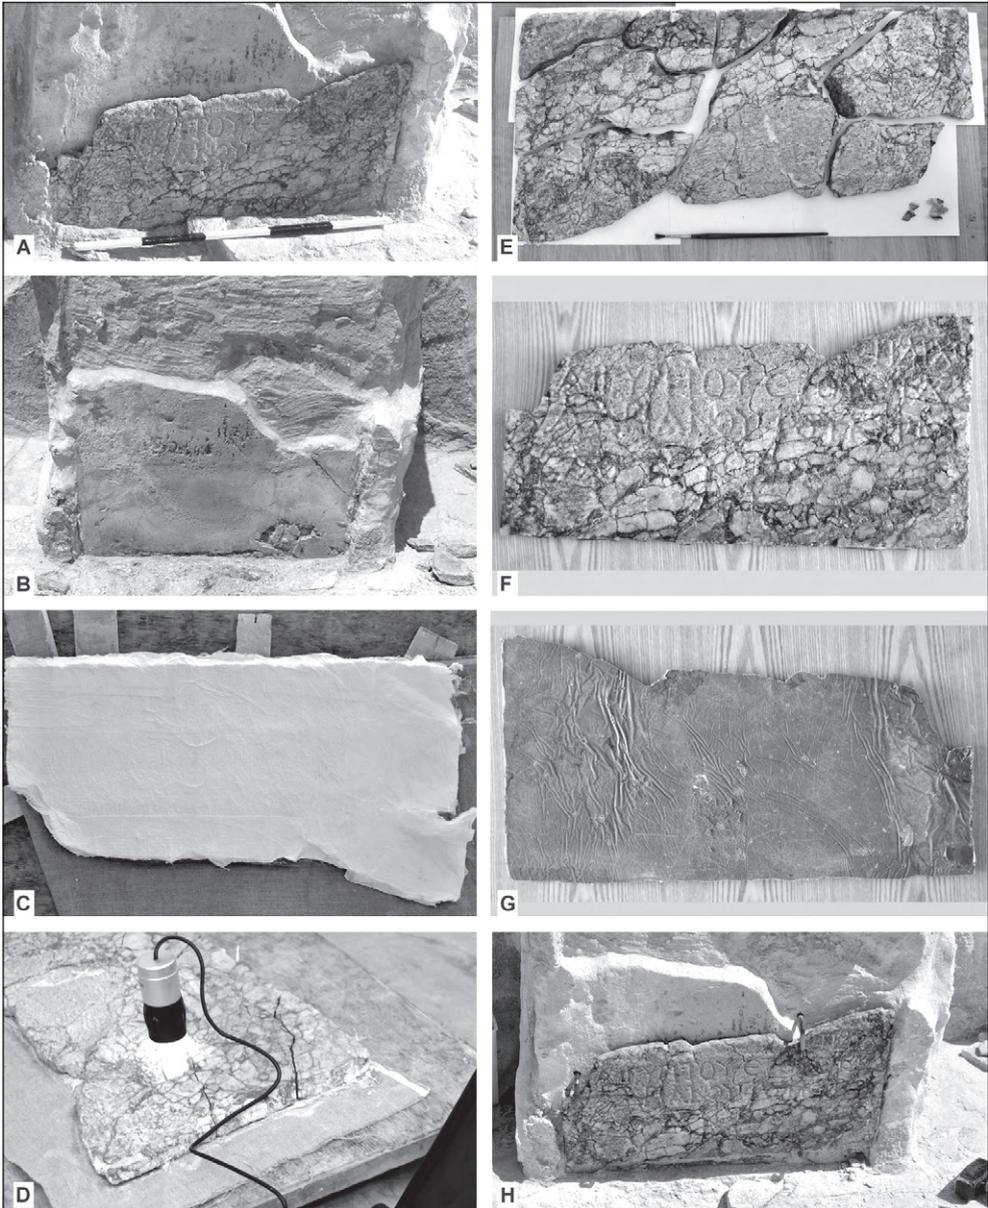
of peeling and detached plaster were filled with loose accumulations, parts of the plaster sticking as much as 2 cm away from the wall face. The marble inscription plaque, which had been protected after its original discovery, had come away from the pedestal; its deformation created a deep pocket filled with loose saline sand. The preserved fragment of the plaque was cracked heavily, the cracks radiating along the veining of the marble. Conservation in situ was no longer possible, hence it was dismantled and transferred to the field lab for further treatment.

Fig. 14. Conservation of a marble inscription plaque: a – current state before conservation; b – the pedestal during conservation after the plaque had been dismantled; c – desalination of the plaque with compresses; d – recording of damages; e – after removing of the “facing”; f – gluing of pieces; g – consolidation of the back side of the plaque; h – after reassembly (Photos G. Bąkowska-Czerner, M. Mrozek-Wysocka, P. Zambrzycki)

Annual monitoring of the condition of a marble inscription plaque discovered in 2005 in the passage by the basilica (for the archaeological context of this object, see Daszewski 2007: 83) [location marked with a dot on the inset plan of the Southern Baths in *Fig. 3*], preserved out in the open on the site, recorded extensive damages to the structure of the stone of this plaque, caused by unfavorable exposition and natural erosion processes.

First the plaque was cleaned of loose deposits and delicately washed with water. The pocket behind the plaque was cleaned. Joints around the plaque were also cleaned, uncovering the bronze anchors used to mount the plaque. The piece was documented and then dismounted by the transfer method. Two layers of cotton gauze were fastened to the surface of the plaque with polyvinyl alcohol (water solution). The same adhesive was used to attach linen cloth to the gauze. Once this was done, the plaque was detached mechanically with trowels onto a convenient support in the

Conservation procedures started with a desalination of the plaque using cellulose compresses [*Fig. 14*]. The protective “facing” on the face of the plaque was removed temporarily for this purpose. The state of the stone was examined and assessed, and a program of conservation treatment was developed. The complete deterioration of the stone around the cracks called for these areas to be cleaned and reinforced. Particular fragments were first separated, cleaned and protected with a 5% solution of PARALOID B-72 in toluene. The pieces were reassembled using an epoxy mass with marble filler.

The back was reinforced with a fiberglass laminate with binder KEMAPOXY 150 produced by CMB. The stone was subsequently reinforced with a silico-organic agent SILEX OH produced by Keim. The last stage was mounting the plaque back in its original position using stainless steel anchoring. Air isolation 20 mm above the floor will reduce the negative effects of ground humidity. In preparing the remounting of the plaque an effort was made to minimize the detrimental effect of climatic conditions in its surroundings, hence the anchors which do not transfer pressure and which maintain horizontal and vertical air isolation.

Should erosion processes continue, the plaque will have to be replaced with a copy and the original prepared for museum display.
