Alexandria: Polish-Egyptian Preservation Mission at Kom El-Dikka, 1993

Polish Archaeology in the Mediterranean 6, 5-10

ALEXANDRIA
POLISH-EGYPTIAN PRESERVATION MISSION
AT KOM EL-DIKKA, 1993/94

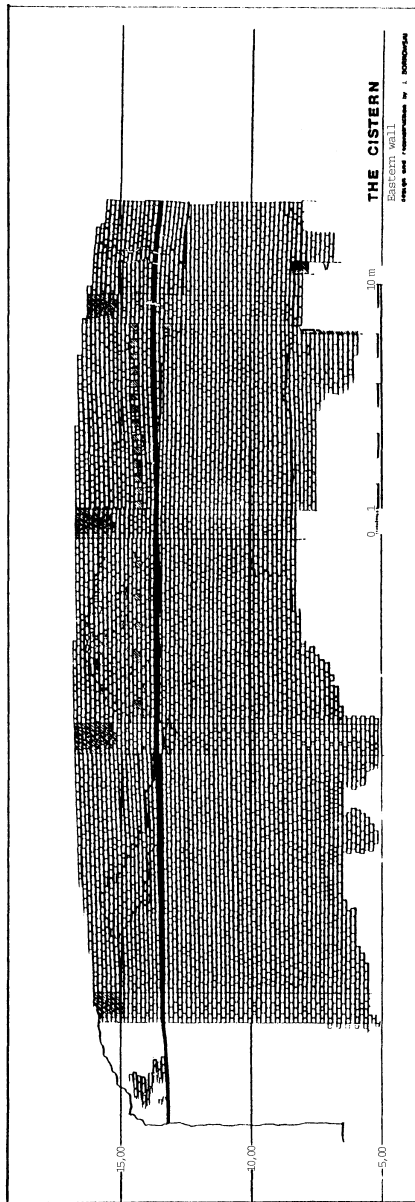
Fig. 2. Cistern, east wall. Design and reconstruction J. Borkowski.

Restoration of the eastern facade of the monument was completed (Fig. 2). Two additional sections of wall facing between buttresses nos II and III (c. 23 m²) as well as between buttresses nos III and IV (c. 40 m²) underwent complex restoration. A large amount of earth (c. 1000 m²) deposited in the area between the Cisterns and the Bath was removed using heavy machinery.

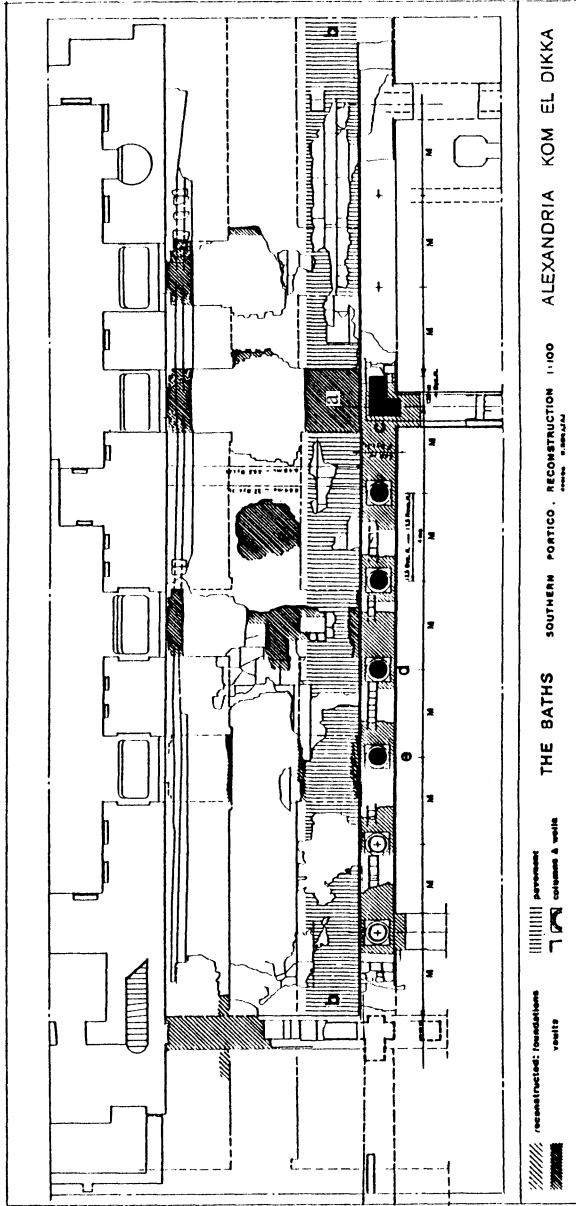
Fig. 3. Baths, southern portico. Reconstruction W. Kolář.

A stone vault over a fuel store located in front of hypocaust furnace no. IV was reconstructed (Fig. 3:a). This store, located under the pavement of the Bath's southern porticoed passage, formed part of a large underground structure serving maintenance purposes. This reconstruction permitted work to proceed on the preparation of visitors paths in the area between the Bath and the Cisterns (Fig. 3:b-b).

A large pillar supporting the northeastern corner of the palestra was prepared for reconstruction. A large block containing sockets for wooden architraves was properly exhibited (Fig. 3:c).

Two more columns of the portico were re-erected (Fig. 3:d,e). A steel tripod used for lifting columns was then relocated and reassembled in a new location in order to re-erect yet another column in the coming season. One of the partly destroyed marble bases was restored and another one was reconstructed using artificial stone according to a formula already described in the previous report.
