West Saqqara: Conservation Work, 2000

CONSERVATION WORK, 2000

FUNERARY CHAPEL OF MEREF-NEBEF

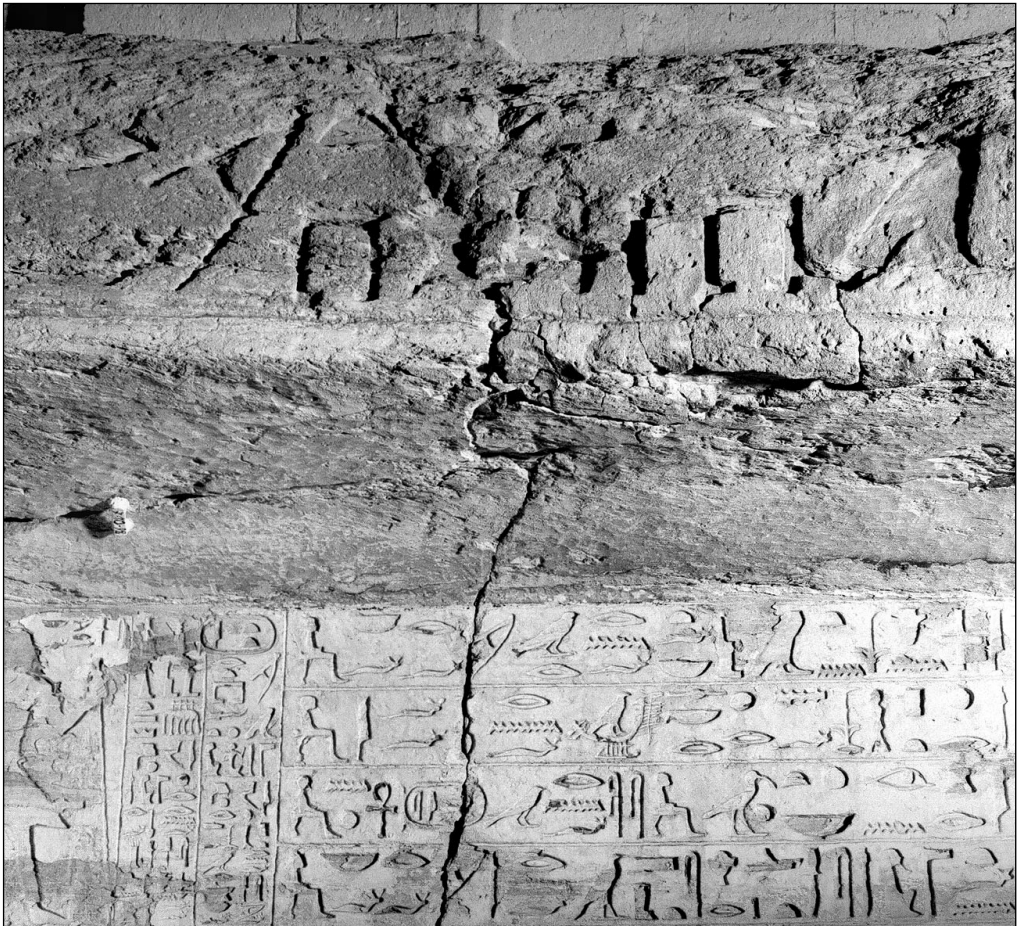
Fig. 1. Façade of the funerary chapel of vizier Meref-nebef. Re-inserted fragments of the "outer architrave" (Photo J. Śliwa)

Once the falling rock fragments of this part of the architrave were removed, the inside of the rock structure was found to be completely disintegrated. Cleaning resulted in an empty space directly above the place where the fragments of rock were to be reintroduced. The "ceiling" of this empty space has been reinforced with strips of stainless metal netting overlaid

Another ten fragments of plaster found on the chapel floor in 1997 were now re-attached to the matrix in original position. One of the main objectives of the present campaign was the conservation of the "outer architrave" in the chapel of Merefnebef. Falling fragments of the rock and three inscribed fragments made of artificial stone had to be put back in place (*Fig. 1*). The overall surface of this part of the architrave is c. 45 by 20 cm. The artificial stone turned out to be a gypsum mortar, the gypsum being no more than a filler and binder. It also contained quartz and dispersed vegetal black and loamy matter. The latter, probably originating from ground local limestone, was also used as filler. This mortar, porous and very friable, has been consolidated by means of repeated dripping with a solution of Paraloid B 72 in toluene (2-3%).

Leaving an empty space above the inserted fragments relieved the architrave at the reconstructed spot. Two of the three decorated fragments made of mortar were first stuck together, and then attached to the reinserted stone fragment of the architrave (using UHU Epoxy Quick). Given the limited adhesion surface, a kind of security hanger made of the same epoxy-covered metal netting had to be prepared

in order to prevent the fairly heavy pieces from falling. The third mortar element with a broader adhesion surface was fixed with UHU Hart. The void between the rock and the mortar elements, visible from below, has been veiled with cardboard of appropriate shape, reinforced with epoxy-covered metal netting. Joints and epoxy-covered surfaces were masked with a thin layer of putty produced on the base of Paraloid B 72 with chalk, calcareous carbonate, sand and pigment added, designed to adapt to the color of the context.

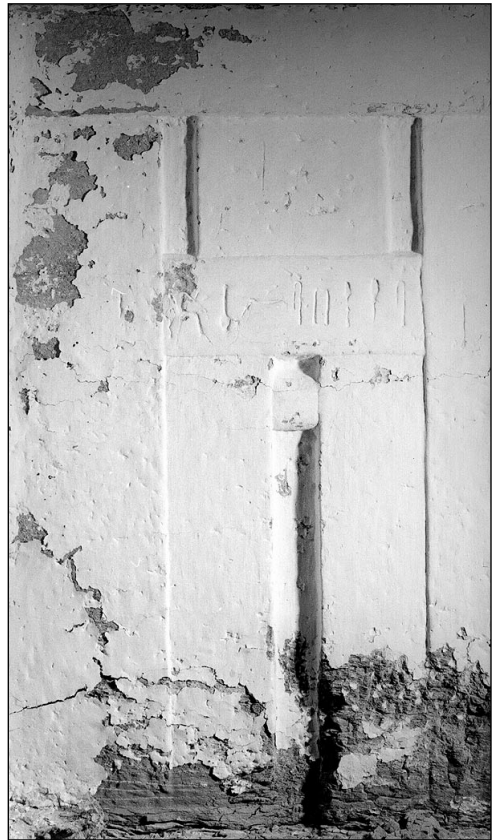
Fig. 2. False door inside the funerary chapel of Sesbennef (Photo J. Śliwa)

The friable limestone lintel with sparse remains of a hieroglyphic inscription above the entrance to the chapel of Seshemnefer was reinforced with a solution of 2-3% Paraloid B 72 in toluene. Inside the chapel, there is a false door covered with at least three layers of lime(?) whitewash (*Fig. 2*). The latter is powdering and very rifted. A large part is detached from the bedding, which is also partly disintegrated and extremely fragile,

falling at the slightest touch. In order to make possible a facsimile of the false door without affecting the whitewash, the latter had to be reinforced and made to adhere to its background. A series of injections was made at the weakest places. Primal AC 33 in 8% water solution was used as the binder. Also in this case, a small quantity of ethyl alcohol with water (1:1) was introduced prior to the action of gluing.

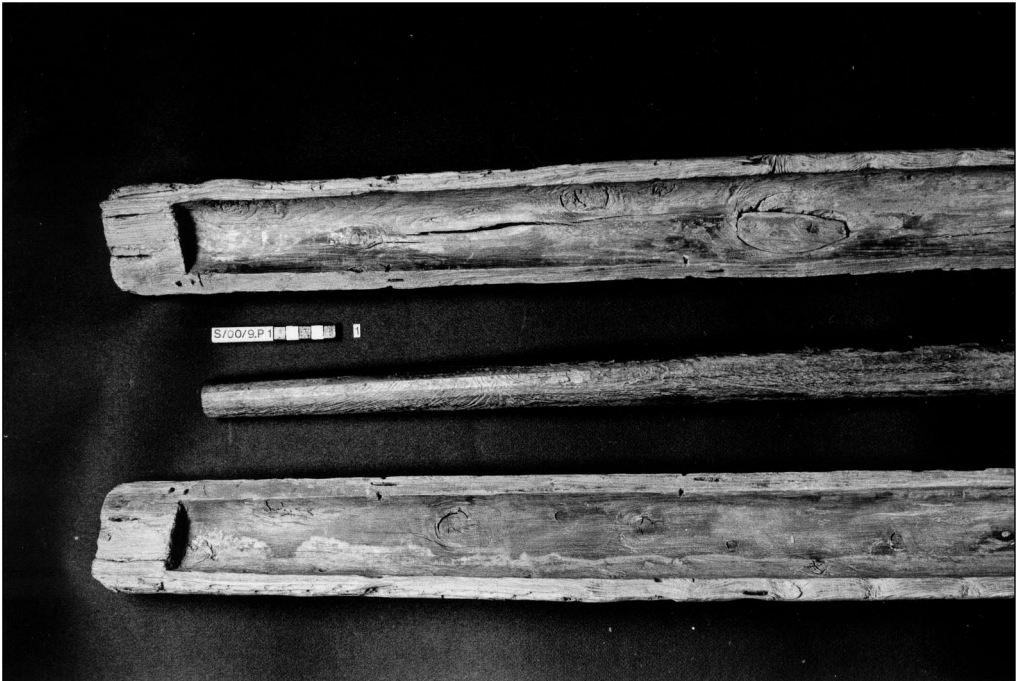
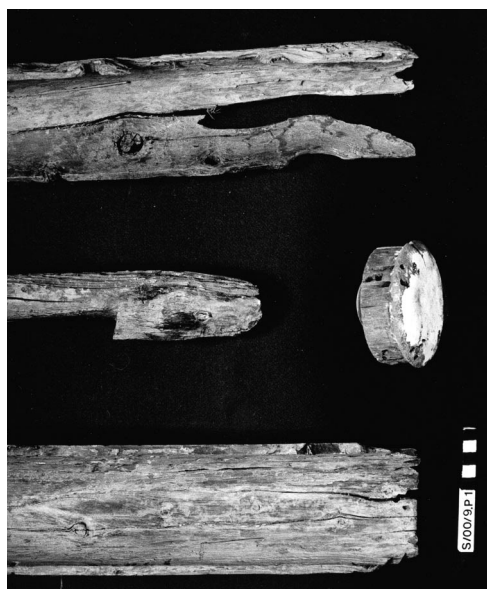
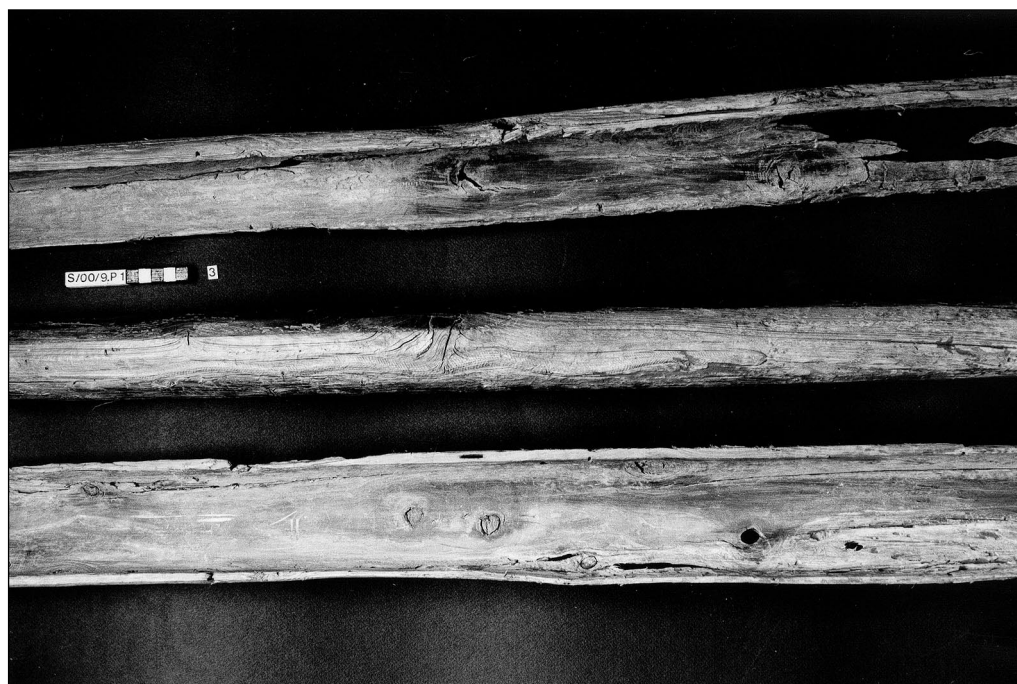
The cedar(?) wood harpoon is 2.60 m long and appears to be in excellent condition (Figs. 3 a, b and c). The insignificant deformation is due to humidity and the weight of overlying strata, including stone implements. Slight damages that are observable to the spearhead seem to be purely mechanical.

The cylindrical casing it was found in has suffered more extensive damage. The walls are very thin (8-16 mm) and the wood with its many knots is in considerably worse shape than the harpoon. The casing consists of two long, hollowed out semi-cylindrical elements, each with many taps. The top

part is considerably split and cracked. The fragments, which are partly detached from the main body, are deformed. The damages to the outside of the casing were caused by damp, as well as insects. The wooden plug at the top of the casing has concentric rifts. Its outer surface preserves a layer of whitewash (gypsum?) that is powdering.

All cracks and disconnected fragments were stuck together with the Cola Blanca wood glue. The process of gluing was followed by dripping the whole object with a solution of paraloid B-72 in toluene (5%). The aim of this procedure was to reinforce the object and protect it against changing climatic conditions. The casing and particularly its weakened parts were subjected to impregnation with a mixture of Paraloid B-72 in acetone and ethyl polyglycol in alcohol (see above).
