BANGANARTI 2004: CONSERVATION REPORT

The main task of the season was the transfer of two paintings (from Chapels 5 and 6 of the Upper Church) and uncovering of earlier paintings on the underlying plaster.

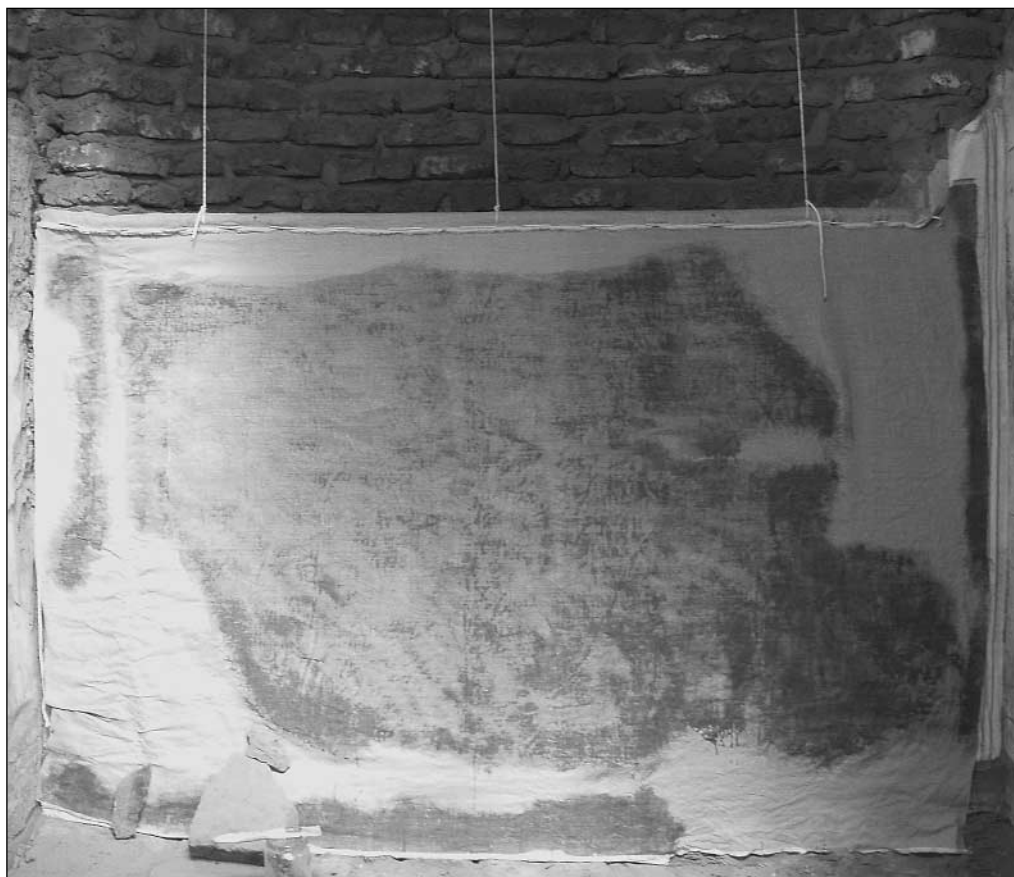
*Fig. 1. Chapel 5. Later painting with complete facing, suspended from the ceiling
(Photo C. Calaforra-Rzepka)*

The facing (two layers of Japanese tissue, two layers of cotton gauze and a layer of linen canvas) was attached with a 20% solution of MOWILITH 30/60 in ethanol. It was provided with a wooden frame support and suspended from the metal bars of the ceiling [Fig. 1]. The bricks of the supporting walls were dismantled to provide access [Fig. 6].

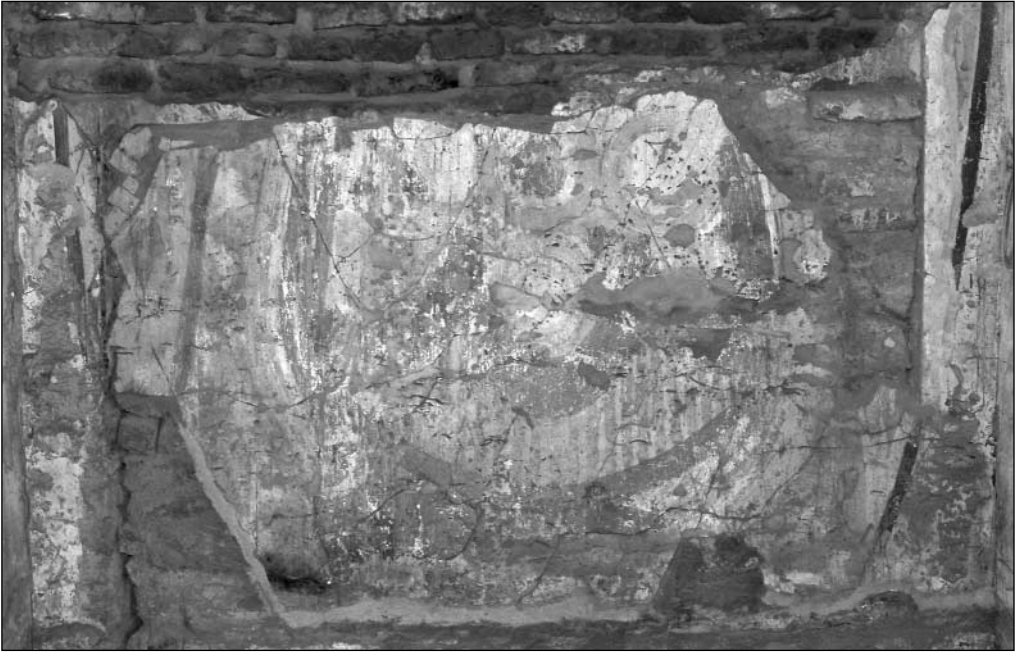
Fig. 2. Chapel 5. Later painting in situ (Photo C. Calaforra-Rzepka)

The two transferred paintings were first cleaned carefully with soft brushes, scalpels and cotton swabs with acetone. The surface was consolidated with a 2% gum arabic solution in water with a small addition of ethanol for better penetration of the consolidator. Flaking parts of the paint layer were consolidated with PRIMAL AC 33 solution (1:3 in water) [Figs. 2,7].

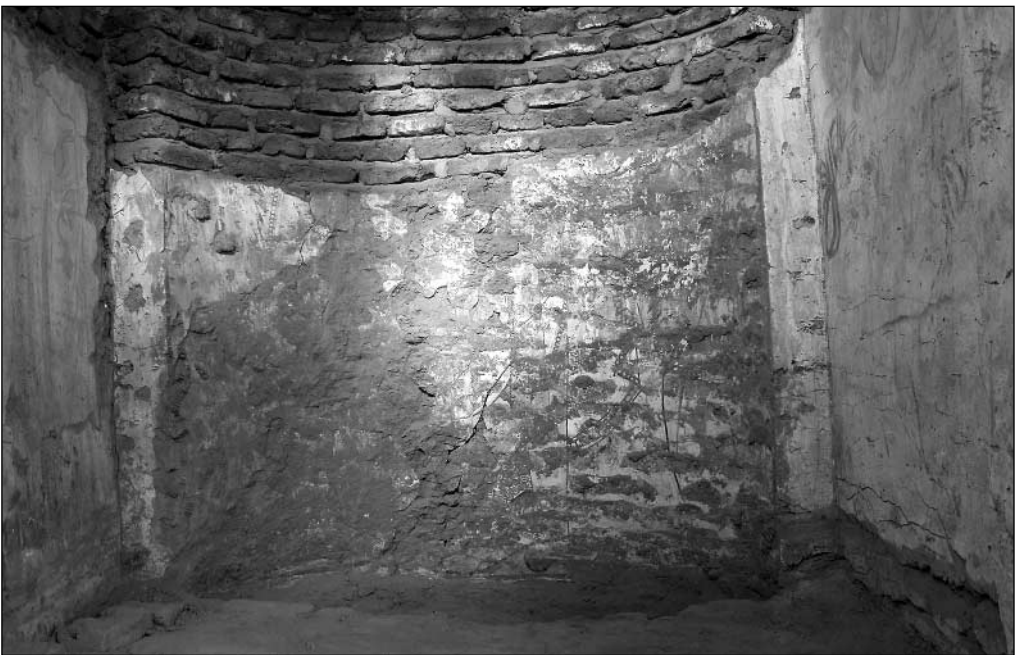
After the murals were transferred, the walls that once supported the paintings were dismantled down to the ground, exposing the earlier paintings in the niche

Fig. 3. Chapel 5. Earlier painting after uncovering (Photo C. Calaforra-Rzepka)

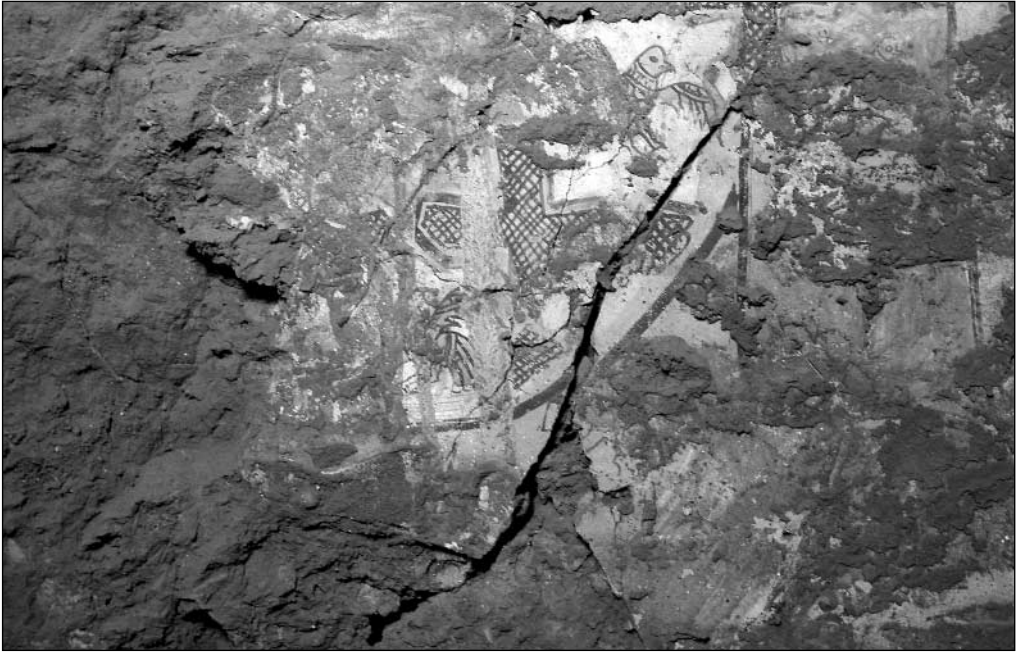
behind them [Fig. 3]. Unfortunately both layers of paintings were poorly preserved. The mud mortar joining the bricks was attached to the paint layer and it had even dissolved it in some parts. Its firm attachment to the original mud plaster made it impossible to rescue the original paint layer [Fig. 4].

Fig. 4. Chapel 5. Earlier painting after uncovering detail (Photo C. Calaforra-Rzepka)

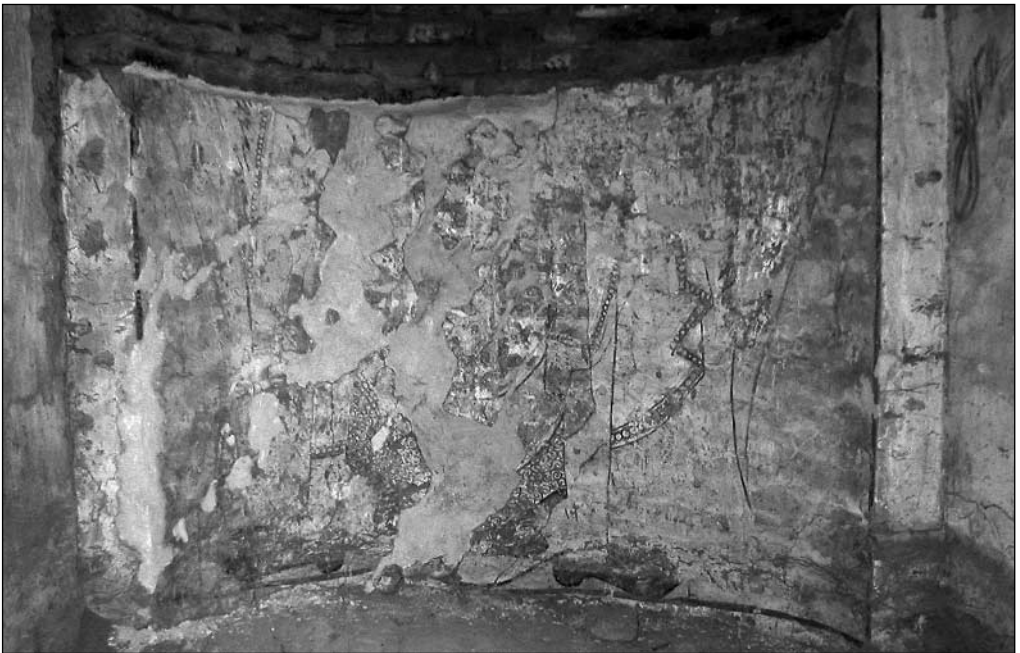
Fig. 5. Chapel 5. Earlier painting after cleaning and infilling of the gaps (Photo C. Calaforra-Rzepka)

The surfaces of both paintings were cleaned carefully with soft brushes, Wishab sponges, scalpels and cotton swabs soaked in acetone and consolidated with a 2% gum arabic solution in water with a small addition of ethanol for better penetration of the consolidator. The gum arabic solution consolidated the powdered fragments well, but increased the flaking of the delaminated paint layer. Consequently, the flaking parts were consolidated with a PRIMAL AC 33 solution (1:3 in water) with better result. To fill in the pockets in the plaster, kaolin-sand mortar was used with a small addition of gum arabic for better adhesion to the original support [Figs. 5, 8-9]. The new paintings that had been unearthed on the walls of the Lower Church were first cleaned carefully with soft brushes, Wishab sponges, scalpels and cotton swabs with acetone and consolidated with a 2%

PARALOID B72 solution in toluene. Flaking parts of the paint layer were consolidated with PRIMAL AC 33 solution (1:3 in water). For infillings, kaolin-sand mortar was used with a small addition of gum arabic for

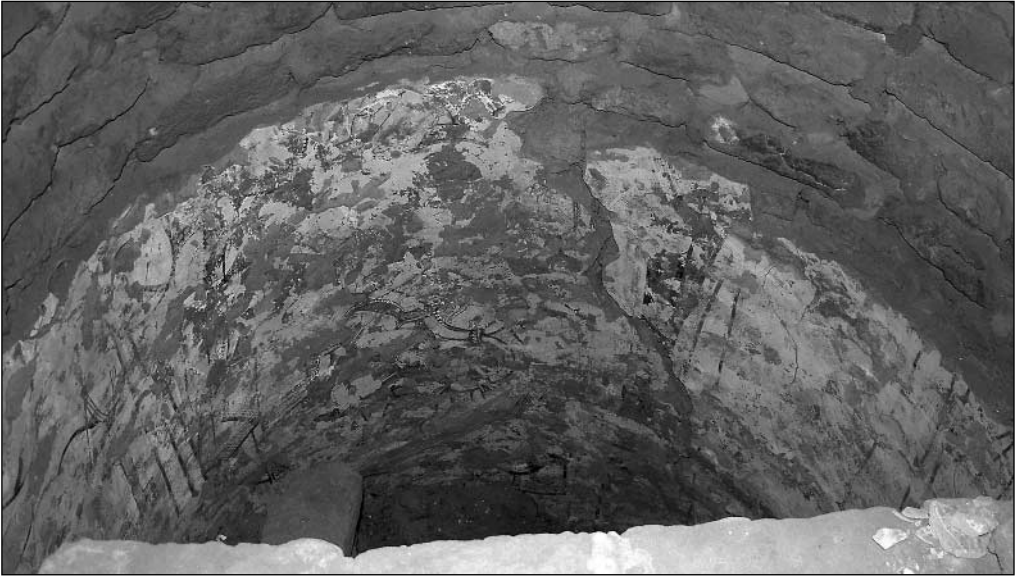
Fig. 6. Chapel 6. During the dismantling of the blocking wall: later painting with partial facing and the earlier painting uncovered (Photo C. Calaforra-Rzepka)

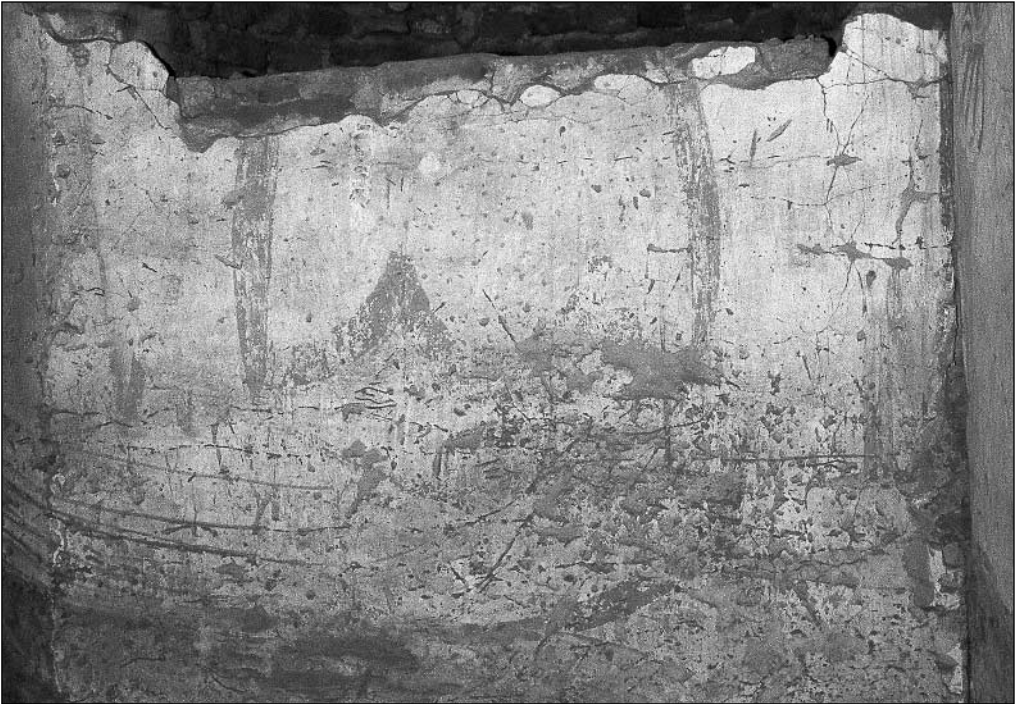
Fig. 7. Chapel 6. Later painting in situ (Photo C. Calaforra-Rzepka)

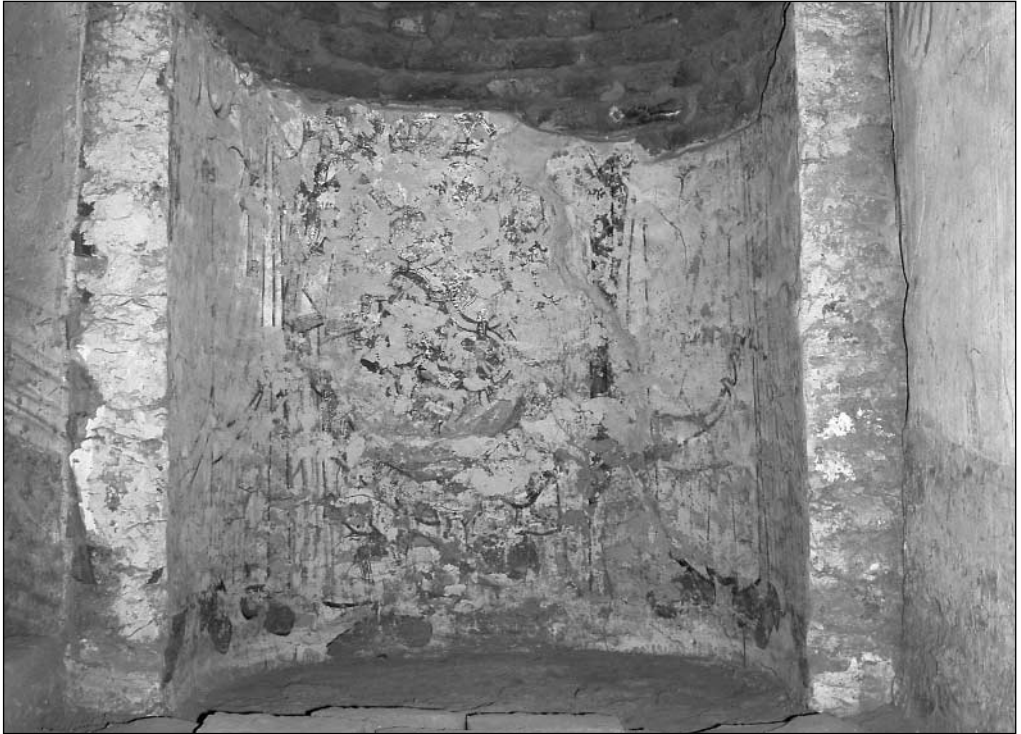
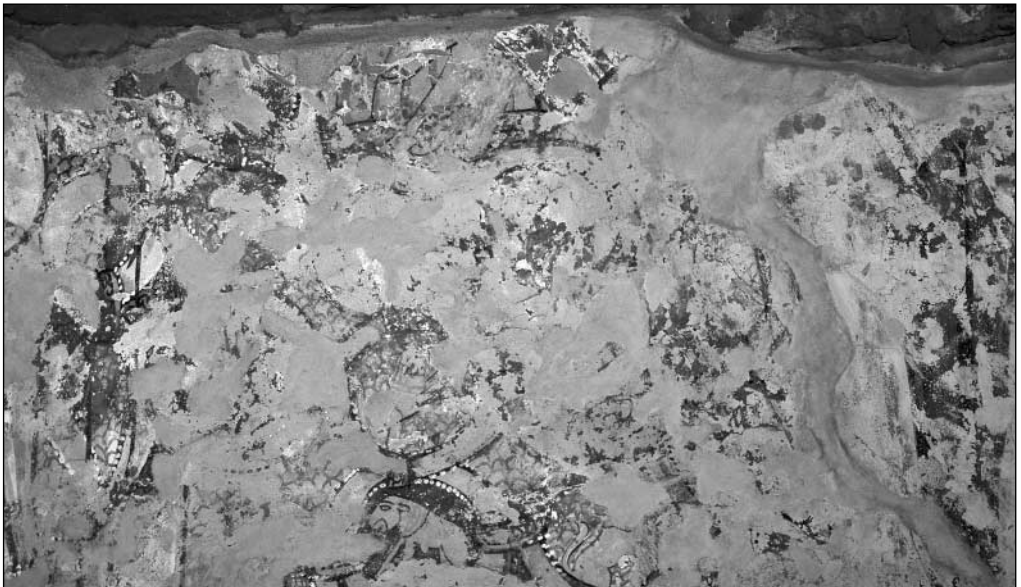
*Fig. 8-9. Chapel 6. Earlier painting after cleaning and infilling of the gaps and detail (below)
(Photo C. Calaforra-Rzepka)*

better adhesion to the original support. Salt crystals were dry cleaned from the surface without desalinization compresses, as the risk of damage from water use is very high in this part of the Lower Church.
