Marea 2005 : Masonry Conservation Report

MAREA 2005 MASONRY CONSERVATION REPORT

Barbara Wronska Kucy*

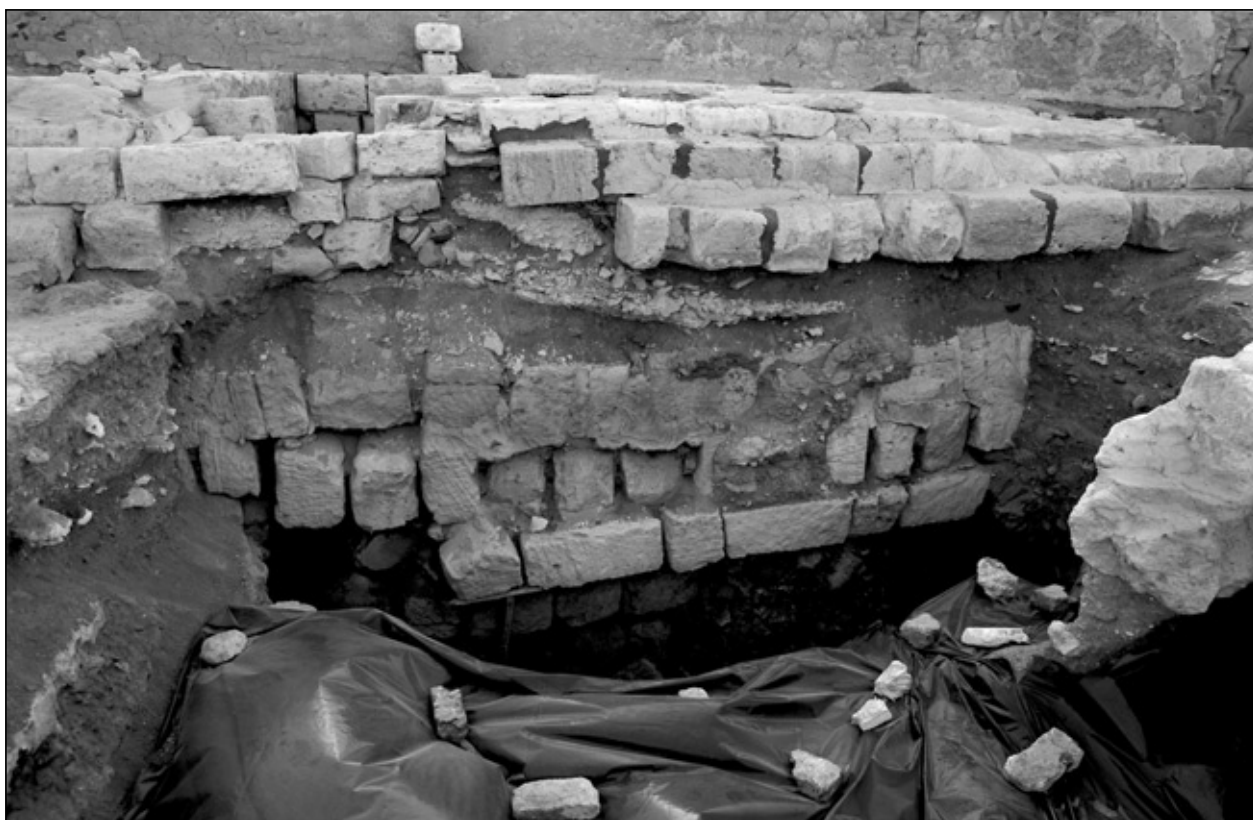
A limestone wall supporting the floor of the apse was set inside the pottery kiln and partly over the kiln grate; it extended into the kiln on both ends. This wall was constructed of randomly-laid, large limestone blocks, the irregular bond indicating its infill character. The excavated

height of this wall was approximately 2.50 m. A layer of approximately 0.40 to 0.60 m sand, clay and limestone infill separated the top of this wall from the stairs of the apse. All of the interlocking structures (wall, kiln, and apse stairs) were unstable and in danger of collapse [*Fig. 1, top*].

The first stage of the work required temporary wood shoring to be installed to support the random-block wall and the stairs above to create conditions allowing for the structural stabilization of the wall and associated structures. A wood platform was erected to provide access to all wall areas.

The masonry joints between the stone blocks were cleaned and repointed for structural stability of the wall. Missing sections of the wall were restored with limestone blocks to support still further the wall above.

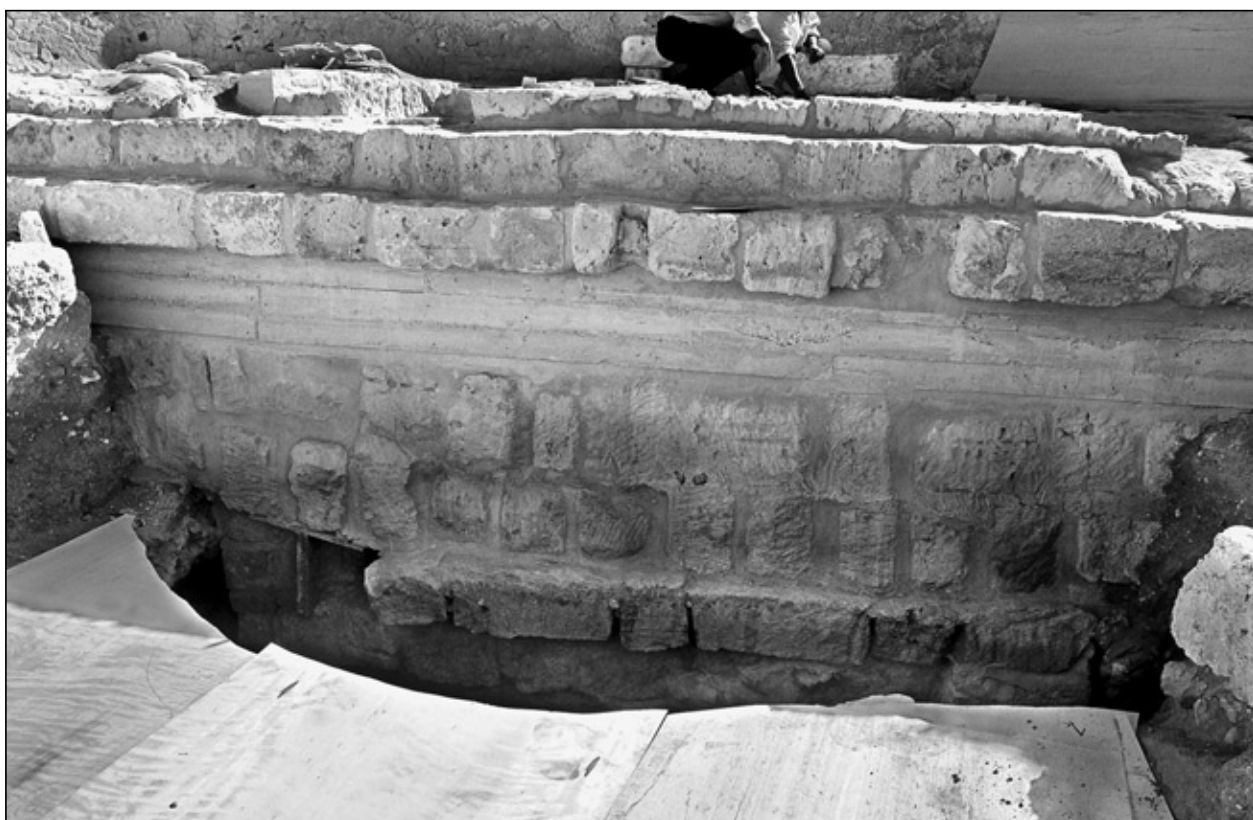
*Fig. 1. The apse of the Basilica before (top) and after conservation in 2005
(Photo J. Kucy)*

For the same purpose, a reinforced concrete beam was installed in place of the sand-and-clay infill above the wall. It was supposed to brace the wall, relieve the kiln walls at the stairs area, and create adequate substructure for future reconstructions, as well as to allow for exploration of the kiln bottom during the season of 2006 [*Fig. 1, bottom*].
