Polish Archaeology in the Mediterranean 18, 426-431

# CONSERVATION WORK IN BANGANARTI IN 2006

Dorota Moryto-Naumiuk

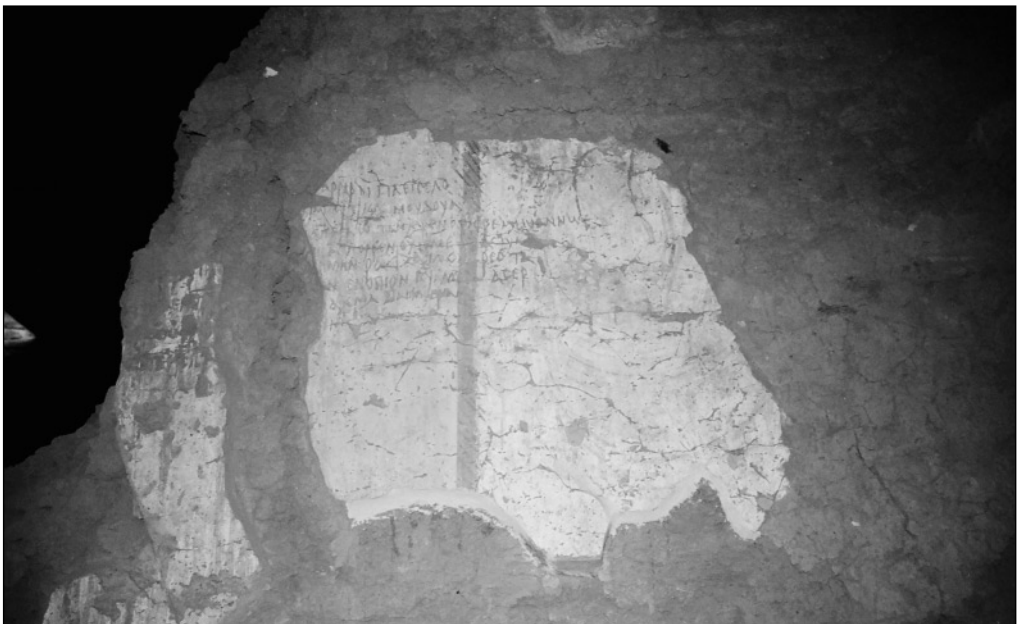
The first case is a mural with scratched inscription from Chapel 9 in the Upper Church [*Fig. 1*]. It was executed on a lime-sand plaster with clay added, the painting layer applied to presumably kaolin white-wash. The painting layer was whitish and ochery with a red stripe running vertically on the surviving fragment. The wall on which this inscription was found was a later partition made of mud brick that had to be dismantled in order for the excavations in the lower church to proceed. Before this could be done, the inscription had to be transferred safely and the place chosen for it was the southeastern Room 18 of the Upper Church, which had been reconstructed in previous seasons.

Fig. 1. Chapel 9. Fragment of mural with scratched inscriptions before the transfer (Photo D. Moryto-Naumiuk)

Mechanical cleaning of surface dirt and grime from the mural was the first stage. Next, a 10% dispersion of PRIMAL AC33

and polyvinyl acetate (1:1) was injected for structural reinforcement of the plaster ground. The painting layer was impregnated with PARALOID B72 in toluene (c. 3%). Cracks and losses of plaster were filled with a mixture of lime, sand and clay (coming from powdered mud brick) in proportions 1:3:2, adding a few percent polyvinyl acetate for adhesion. On-site conservation practice has shown this mortar composition to be the most effective and suitable for filling losses in murals under the Banganarti conditions.

Once the reinforcing procedures were completed, a facing of two layers of Japanese tissue paper, a layer of thin, loosely woven cotton and a layer of linen cloth, was applied using as adhesive KLUCEL G (c. 5 cm<sup>3</sup> per 500 ml of water). The mural was subsequently cut from the wall with a saw, together with the plaster ground. The back of this layer was thinned mechanically and smoothed, after which it was consolidated with a water dispersion of PRIMAL E330 with polyvinyl acetate (c. 15%), having first lowered the surface tension with a mixture of water and ethanol. The treatment was repeated a number of times. Hollows and losses of plaster in the back were filled with putties of the same composition as those used on the face of the mural; these were sprayed repeatedly with water in order to induce lime-carbonization processes. Additional reinforcement consisted of a fine

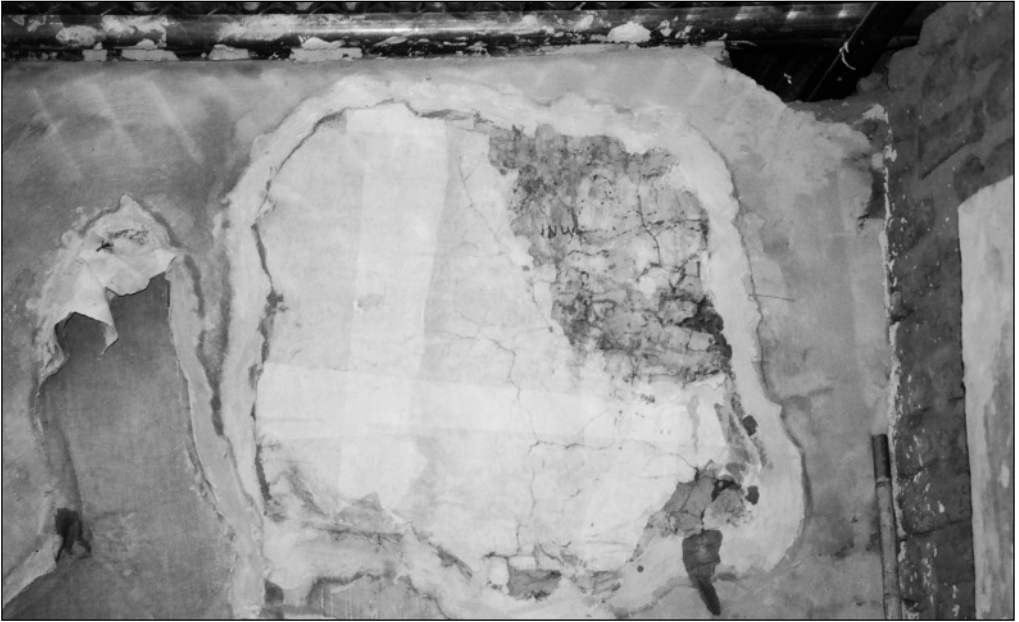
*Fig. 2. The mural after transfer to Room 18, in the course of removing the facing  
(Photo D. Moryto-Naumiuk)*

The last step was removal of the facing with water compresses [Figs 2, 3]. Additional injections were made in the cracks. Ongoing conservation monitoring has shown this method to be effective.

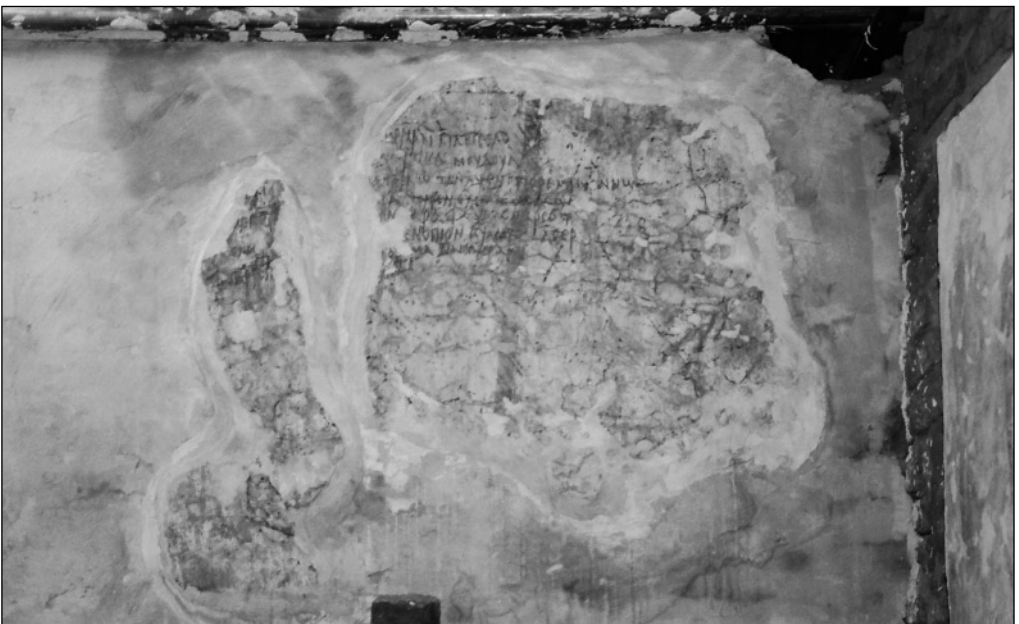
*Fig. 3. The mural after the transfer  
(Photo D. Moryto-Naumiuk)*

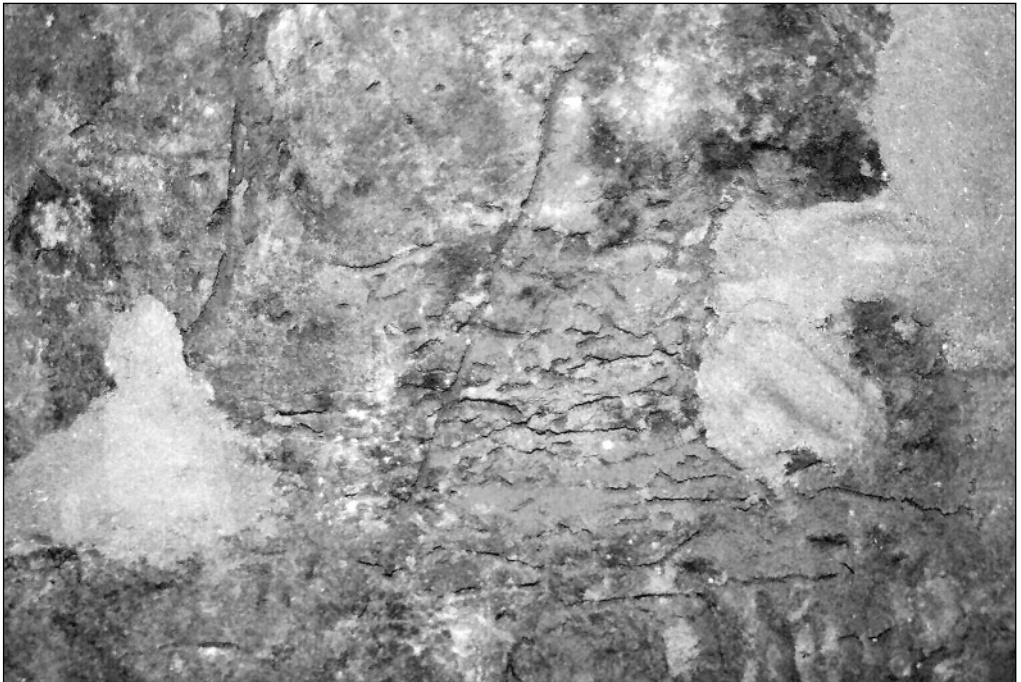
The second case is a mural from the Lower Church, which, like all the wall paintings from this structure, are severely threatened from the structural point of view. This is due to the disintegration of binders in both the plaster ground and the painting layer, a weakening of the plaster and numerous losses of painting layer caused by termite tunneling, intensive salt crystallization between the plaster ground and whitewash coating or painting layer. The presence of numerous fungi colonies on the face of wall paintings and whitewashed walls is an additional problem to deal with. The mural was discovered in a trench dug in the place of the dismantled wall with scratched inscription discussed above.

and vertical insulation on the walls of the Lower Church (for fear of disturbing building equilibrium). Consequently, since water evaporating through the face of the paintings will be a source of constant salt efflorescence, drawing away the whitewash often with the painting layer, a transfer of selected wall paintings from this part of the Lower Church has been recommended.

Fig. 4. Face of mural from the Lower Church (after application of putties and preliminary reinforcing of the plaster structure), demonstrating a full gamut of damages: termite tunnels, white spots of salt crystallization – chiefly gypsum, black fungi (?) colonies (Photo D. Moryto-Naumiuk)

In an effort to preserve in situ the painting, which demonstrated a full gamut of possible damages [Fig. 4], a treatment aimed at structural reinforcement of the plaster ground was undertaken. Injections and drips of the same composition as used for the previously discussed mural were applied. The painting layer was impregnated with PARALOID B72 and alcohol-dissolved PARALOID B82. The surface of the mural was disinfected with a 1% solution of LICHENICIDE. This treatment concerned the heavily powdering mural depicting the Anastasis, paintings from the baptistery and the representation of St Mercurios and the *Maria Orans* icon.

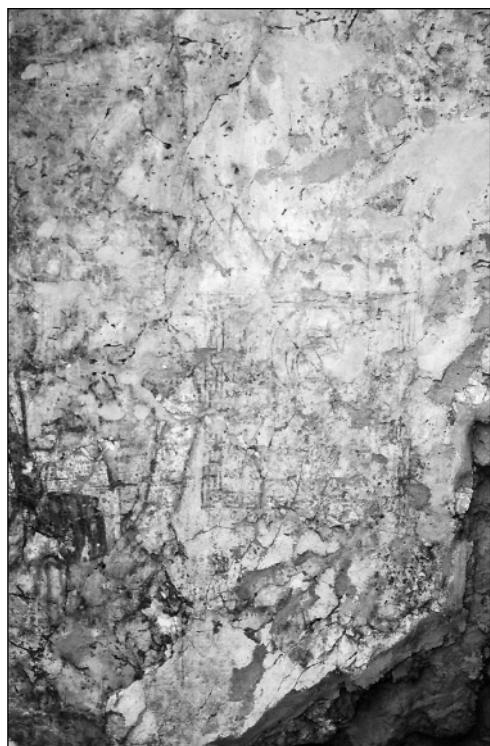
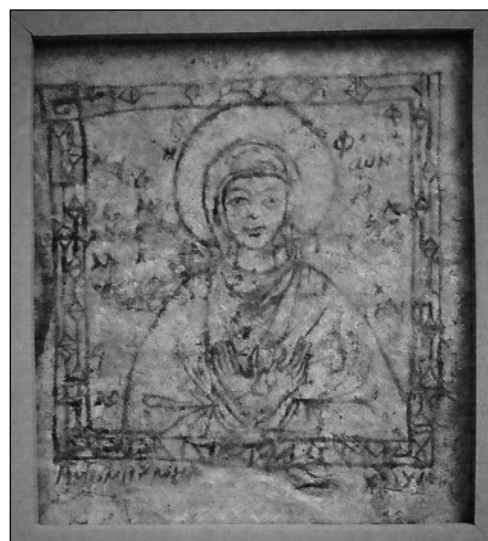
disintegrated lime-sand binder, silt compounds, pottery grits; no organic filler was determined, which, if it had been there, would have explained the concentrated activity of termites. The painting is monochromatic, the outlines rendered in black (presumably lampblack, but pigment analyses were foregone in view of the fact that the painting had been impregnated already for two years, thus falsifying the picture of the binders) drawn on a white-washed ground.

*Fig. 5. The Maria Orans icon before (left) and after conservation in 2006 (Photo D. Moryto-Naumiuk)*

In Poland, the facing was removed with water compresses. A large rift in the face of the figure was cut and glued. The openings of the termite tunnels were injected with PRIMAL AC33 mixed 1:8 with water and precipitated lime carbonate as filler. The surface was cleaned of discolorations and

grime with ethanol, taking care not to disturb the delicate painting layer which showed extreme sensitivity to solvents. Next, surface putties were applied, the putty in this case being acryl stuccolini colored with dry pigments.

Watercolors were used for unification of the painting layer. They are easily removed,
