Polish-Egyptian Restoration Mission at Kom El-Dikka, Alexandria, 1992-93

Polish Archaeology in the Mediterranean 5, 5-10

POLISH-EGYPTIAN RESTORATION MISSION AT KOM EL-DIKKA, ALEXANDRIA, 1992-93

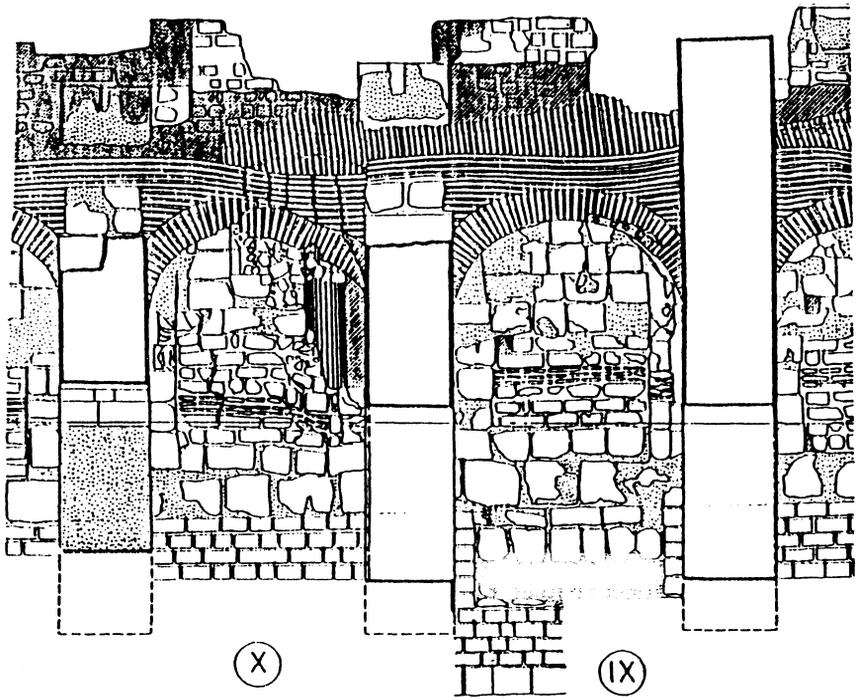
Following the consolidation of the unit X arcade in the theater corridor, that is, ambulatory, the central segment was explored, removing the fill deposited after the edifice had been abandoned in the 7th century. The adjacent section of the outer wall, which also sustained heavy damage during modern construction works in 1964 before the theater was discovered, also called for immediate consolidation (Fig. 1). An inventory was made of the wall facing before the entire section was dismantled; the wall was then reassembled preserving as much of the ancient substance as could be retrieved; in many cases the original mortar in the joints was preserved, although several seriously damaged or crushed blocks had to be replaced with new ones (Fig. 2). The newly applied mortar was similar to the ancient one and composed of sand, lime, and powdered bricks with a 5% addition of white Portland cement. In the upper part of the wall, a com-

*Fig. 1. Theater. Inner face of the corridor prior to restoration.
Drawing by the author.*

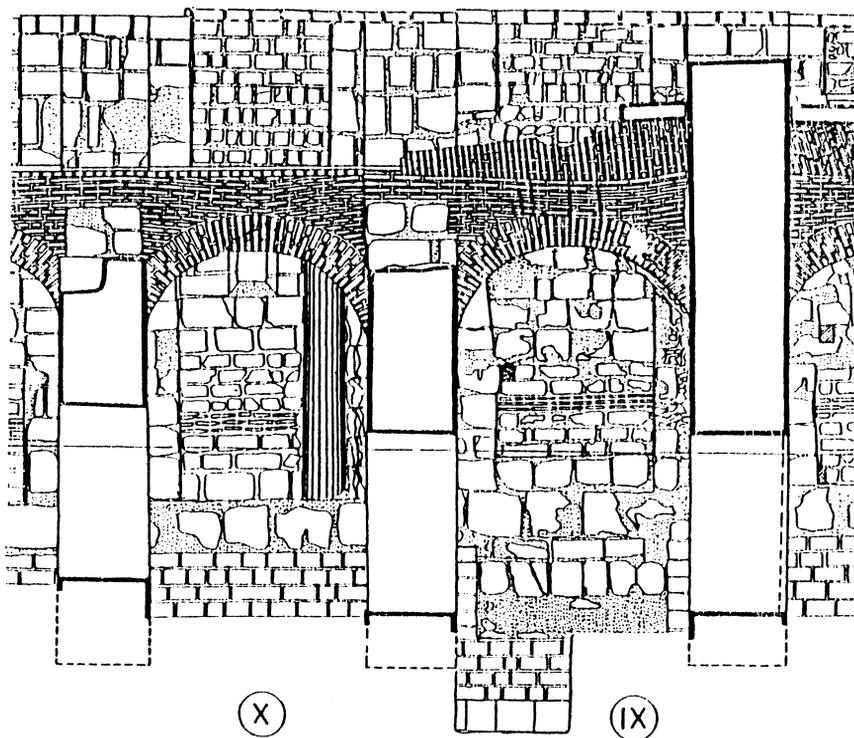
*Fig. 2. Theater. Inner face of the corridor after restoration.
Drawing by the author.*

pletely destroyed window frame was thoroughly restored to its original shape.

A modern concrete pillar set into the wall was left in place for structural reasons as much as educational purposes

(removing the pillar could have caused serious damage to the wall, while it has already become part of the monument's history).
