Cairo: Funerary Complex of Amir Kebir Qurqumas from January 1 to April 31, 1995

CAIRO

FUNERARY COMPLEX OF AMIR KEBIR QURQUMAS FROM JANUARY 1 TO APRIL 31, 1995

Jarosław Dobrowolski

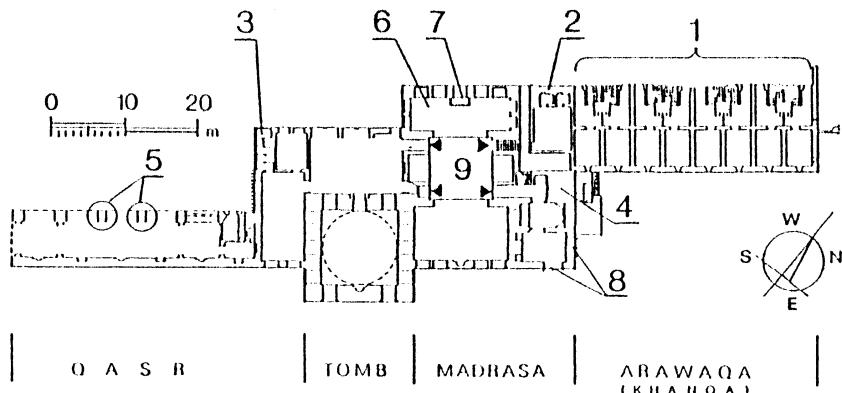
Fig. 1. Funerary complex of Amir Kebir Qurqumas in Cairo: key plan (consult the text for descriptions).

The work, which is a continuation of previous season's tasks, aimed at rendering the ruined building structurally sound and safe for visitors (Fig. 1:1). A partial reconstruction of the western outer wall was necessary to restore the collapsed parts of the walls and vaulted ceilings, so that in future the structure can be properly protected from rain. Approximately 35% of the wall was reconstructed, including two decorated doorways which were patterned on the remnants surviving in the southern and northern ends of the wall (none of the original doorways had been preserved in full).

Original lintels, reused as doorsteps, were recovered and reinstalled. The only surviving original section of the much-rebuilt wall was in disintegrated condition and dangerously inclined outwards. Its facing was dismantled and the original stone blocks were reassembled in their proper positions (Fig. 1:2).

Six out of ten of the minaret's marble columns (Fig. 1:4), which had been broken in the October 1992 earthquake, were braced with 15 cm-wide brass rings made of 6 mm sheet and bound with brass bolts. A new marble column shaft was installed to replace the one that was destroyed completely in the earthquake. The original capital was retrieved and reinstalled. With these operations completed, the provisional wooden propping installed in 1992 was removed.

Reinforcement of the pillar foundations in the ground floor arcade of the *qasr* was started in April 1995, following designs prepared by Dr. G. Bogobowicz in 1993 (Fig. 1:5). The work proceeded under the supervision of Eng. Nazmi Daoud. Reinforced concrete banks were introduced around the pillars to widen the foundations. Steel anchors remain to be added in the upper storey walls and the defective roof cover still needs to be replaced.

By the end of April 1995, the walls and vaults of the ground floor were completed. Work began on building up the modest remnants of the upper storey walls (only two stone courses preserved) to enable proper protection from water.

er. An identical vault was reconstructed over an adjoining room (Fig. 1:3).

To protect the *muqarnas* friezes under the minaret's galleries from damage caused by rainwater, the galleries were covered with a layer of waterproof mortar and provided with a water draining system.

Small-scale structural repairs continued in various parts of the complex: eroded stone blocks were replaced in walls, lintels and vaults; plastered surfaces were repaired; loose masonry in the minaret's stairwell was fixed, etc.

In the *madrasa* (Quranic school and mosque), decorated wooden ceiling panels from the western area, which had been taken down for conservation in 1992 (cf *PAM VI*, p. 23), were reinstalled in their original positions (Fig. 1:6).
