## ALEXANDRIA

### KOM EL-DIKKA PRESERVATION WORK 1996/97

#### Wojciech Kołataj

The Polish-Egyptian conservation work was carried out from 1 November 1996 until 30 May 1997.<sup>1</sup>

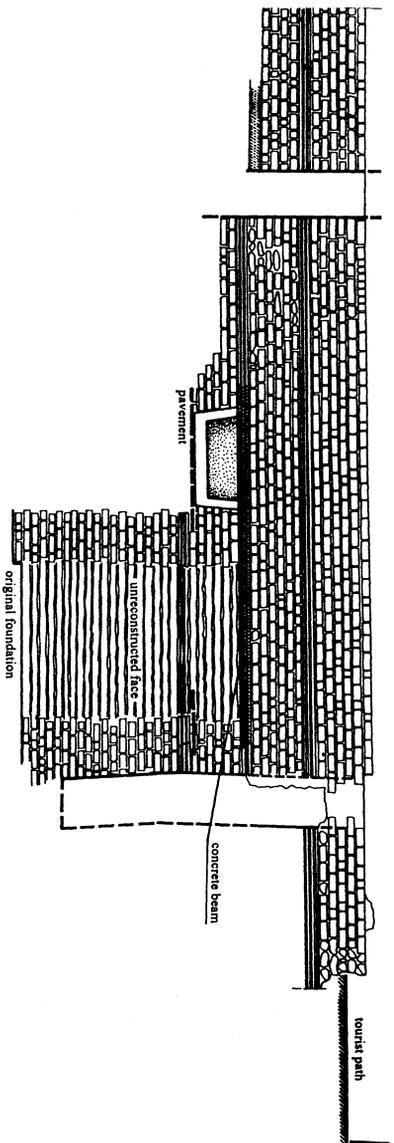
Work was completed on the final landscaping of the southern end of the eastern wall of the corridor. A large part of the face of the upper wall was completed and the top of the wall was insulated. Test trenches dug along the southern end of the wall (western face) that separated the cistern from street R4 revealed that the structure was preserved to a depth of c. 5 m above sea level. A partial reconstruction of the western face of this wall was begun in accordance with the original work program, resulting in a total of 9 m<sup>2</sup> being reconstructed over the season (fig. 1).

*Fig. 1. South end of the wall (western face) separating the cisterns from street R4.  
Drawing W. Kotqtaj.*

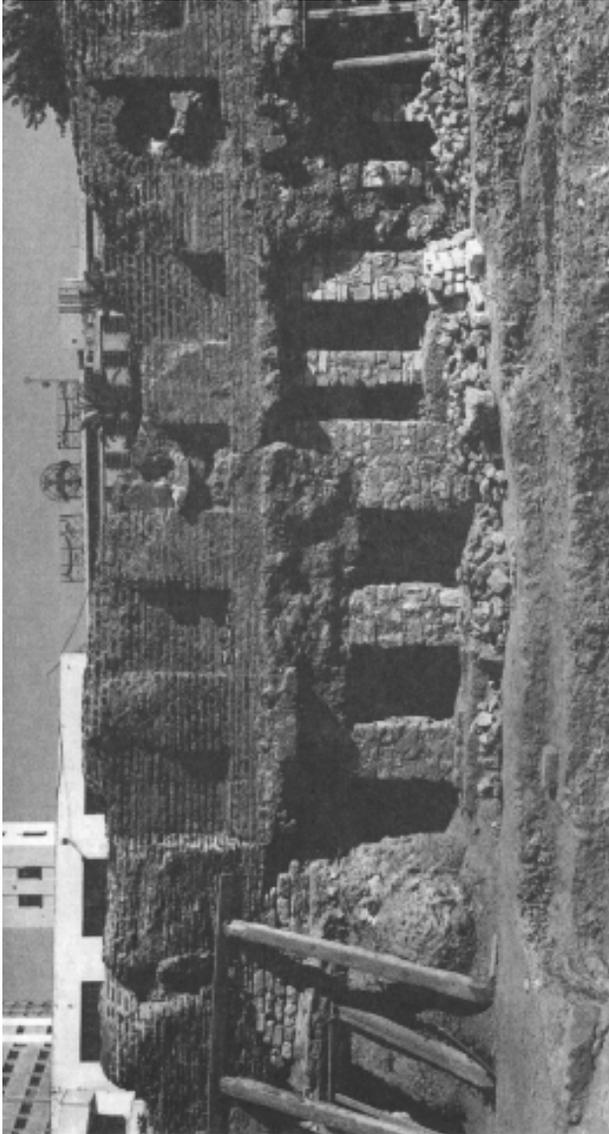
*Fig. 2. Northern facade of the cistern.  
Photo W. Jerke.*

Clearing of the northern facade of the cistern in 1995/96 had revealed a dangerous overhanging of the upper parts of this elevation. Almost the entire length of this facade (c. 50 m<sup>2</sup>) was cleared this year, providing visible proof of the fact that practically the entire cistern complex stands on top of

a number of extensive voids created by the caving in of the structures that had lain underneath. The work was extremely dangerous, requiring the most endangered fragments to be cleared and protected on a step-by-step basis. Since protection in this case does not concern a historic building (cistern) and in any case it is only a structural reinforcement of fragments threatening to collapse, the supporting walls and pillars, of which a total of 17 m<sup>2</sup> was constructed, were made using a semi-cement mortar (fig. 2).

Investigations of the northern cistern facade proved that it had been robbed out in the Middle Ages in a section 20 m long and 2.50 m or more high. The reconstruction of this wall facing will be completed next year.

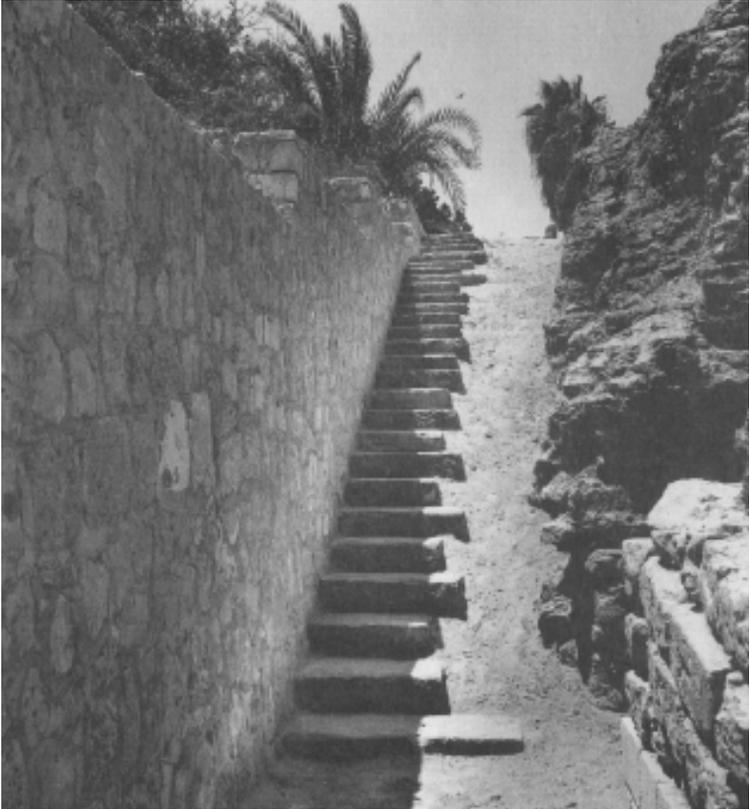
*Fig. 3. New stairs and revetment wall at the southern edge of the cistern.  
Photo W. Jerke.*

With respect to the *Zona Monumentale* landscaping project, it should be noted that 2,000 m<sup>3</sup> of excavated soil were removed from the area of the bath's *frigidarium*, as well as modern deposits from the surface layers in the area between the theater and the bath complex. Besides, a total of 25 m of pavement and steps was laid along the southern perimeter of the site, using basalt slabs and basalt and granite cobblestones recovered from the debris accumulated in the modern layers (fig. 3).
