**The Mosque Building in Old Dongola
: Conservation and Revitalization
Project**

Polish Archaeology in the Mediterranean 22, 248-272

THE MOSQUE BUILDING IN DONGOLA

CONSERVATION AND REVITALIZATION PROJECT

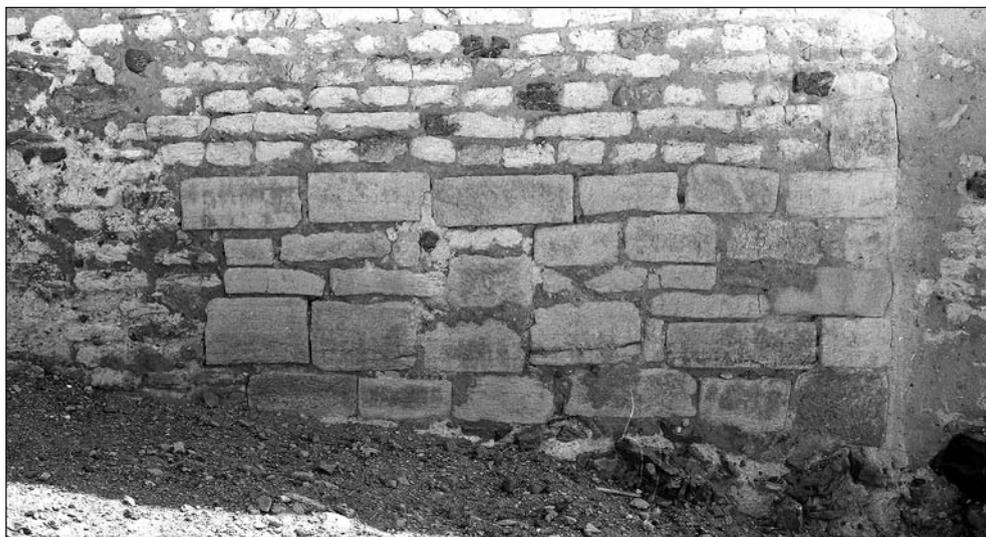
Fig. 9. Stone blocks reinforcing the northwestern corner of the Mosque Building (Photo W. Jerke)

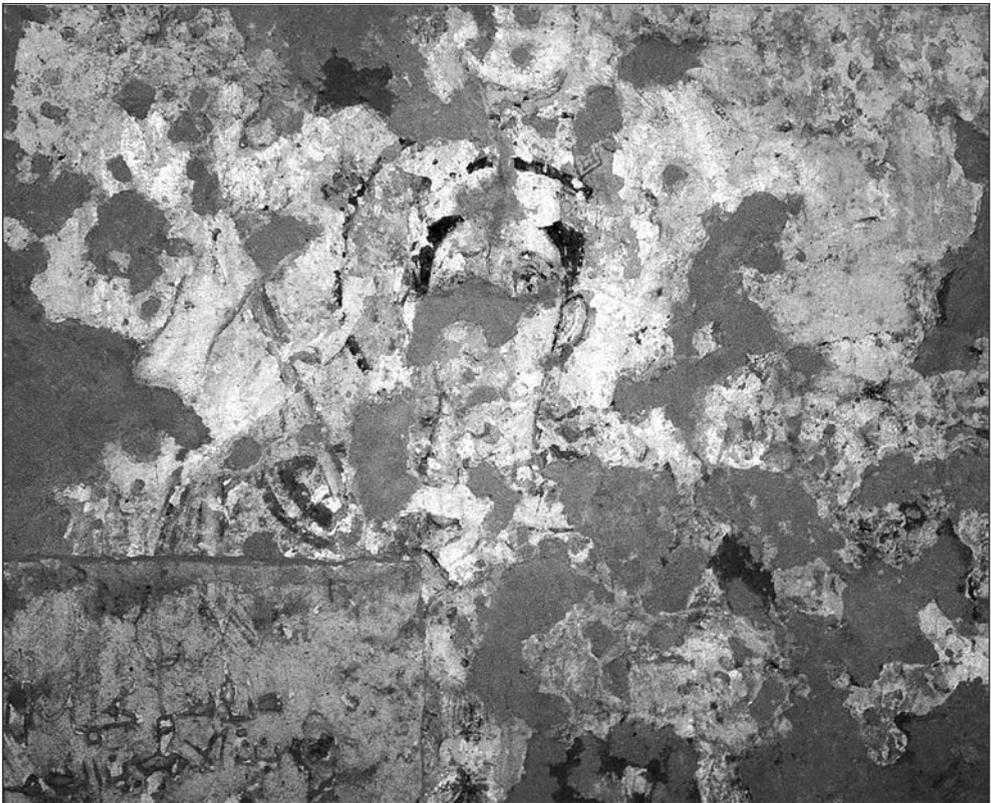
on a small-scale on the second and third landing of the staircase permitted the nature of these murals to be identified. In both cases, the frescoes on the second coating of plaster featured warrior saints. The one on the second landing of the staircase was a standing saint holding a spear in his raised right hand. Traces of yellow wings with red peacock feathers on both sides of the head suggested an identification with the Archangel Michael. Assuming the interpretation is correct, these painting traces should be linked rather with the first layer of plaster on this wall and treated as older than the standing figure, which is

dated to the 11th–12th centuries. Earlier representations of standing figures were positioned higher up on the walls, about 0.60 m above the head of the later warrior saint. Identifying the older representation is not possible because of the condition of the painting and the limited extent of the conservation work done at the time. The mural observed on the second landing featured a warrior saint on horseback. It, too, was painted over an older painting of a warrior saint, depicted most probably in standing position. Again, the condition of the earlier painting precludes its full interpretation.

*Fig. 10. Mural of a warrior saint on the south wall of the staircase
(Photo W. Godlewski)*

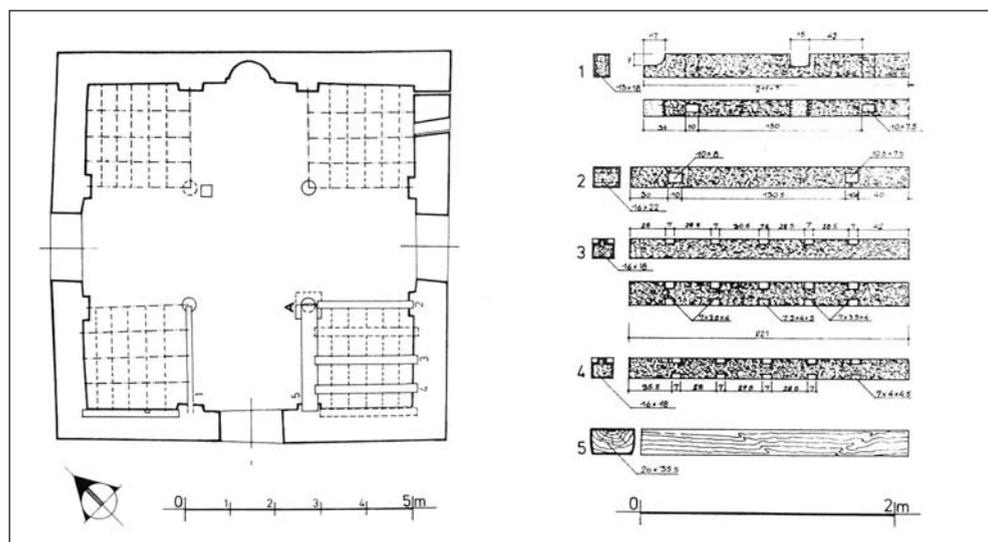
Fig. 11. Ceiling of the central room on the first floor
(Archival documentation S. Medeksza)

It is indispensable to replace various elements of the ceiling above the central room; however, a guiding conservation principle is to preserve historically justified ceiling elements wherever possible. Replacement shall be considered solely in case of elements which undoubtedly were not introduced in the 20th century reconstructions or as protective means. At least a fragment of the coffer ceiling (in the southwestern corner) will have to be reconstructed. Construction of a flat ceiling is posited, independent of the ceiling, above the central room, thus achieving independent operation of the ceiling and roof structure and proper natural ventilation.

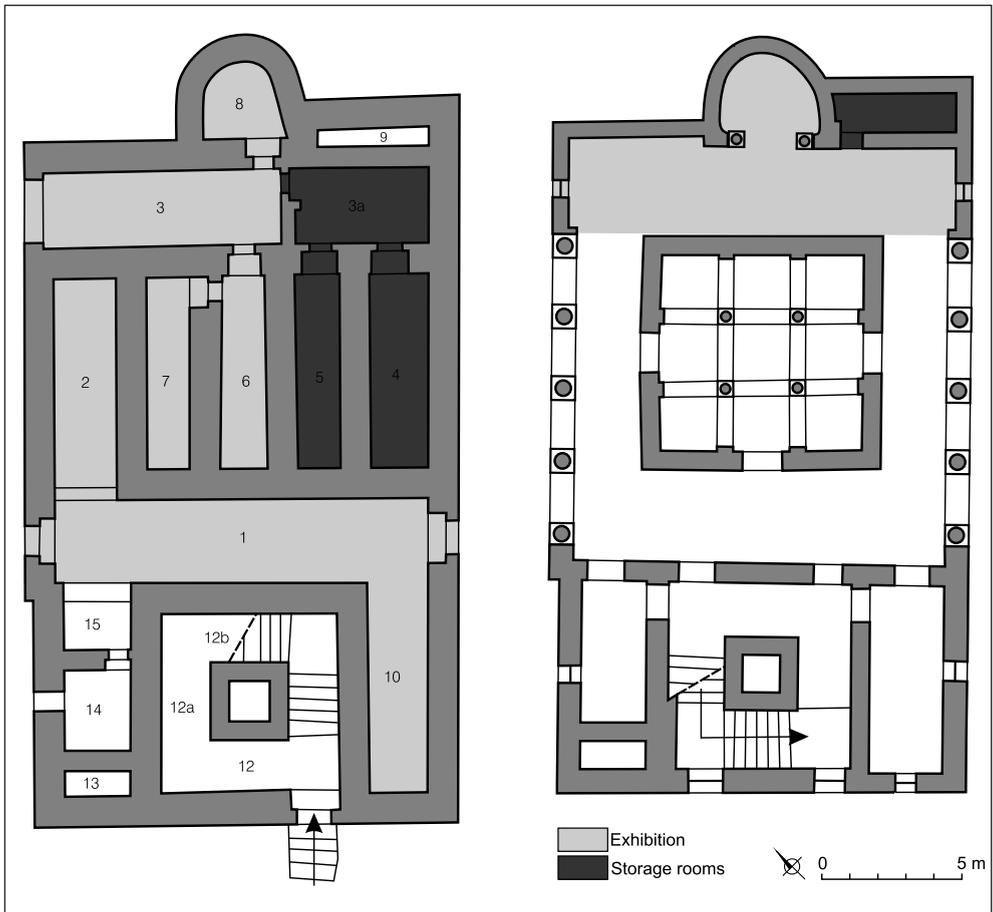
Fig. 15. *The Mosque, concept of interior adaptation, ground floor and first floor*
(Design W. Kolątaj, S. Medeksza)

The current project is intended to prepare the grounds for an adaptation of the building that will meet all the requirements of conservation of historical heritage, while making the structure significant again for the local Dongolan community. Growing tourist interest in the site of Dongola and a rising local pride in the town's and region's history have created the proper circumstances for a meaningful restoration and adaptation of the structure [Fig. 15].
