**Marina El-Alamein: Preservation and
Conservation in 2005**

Polish Archaeology in the Mediterranean 17, 99-115

MARINA EL-ALAMEIN

PRESERVATION AND CONSERVATION IN 2005

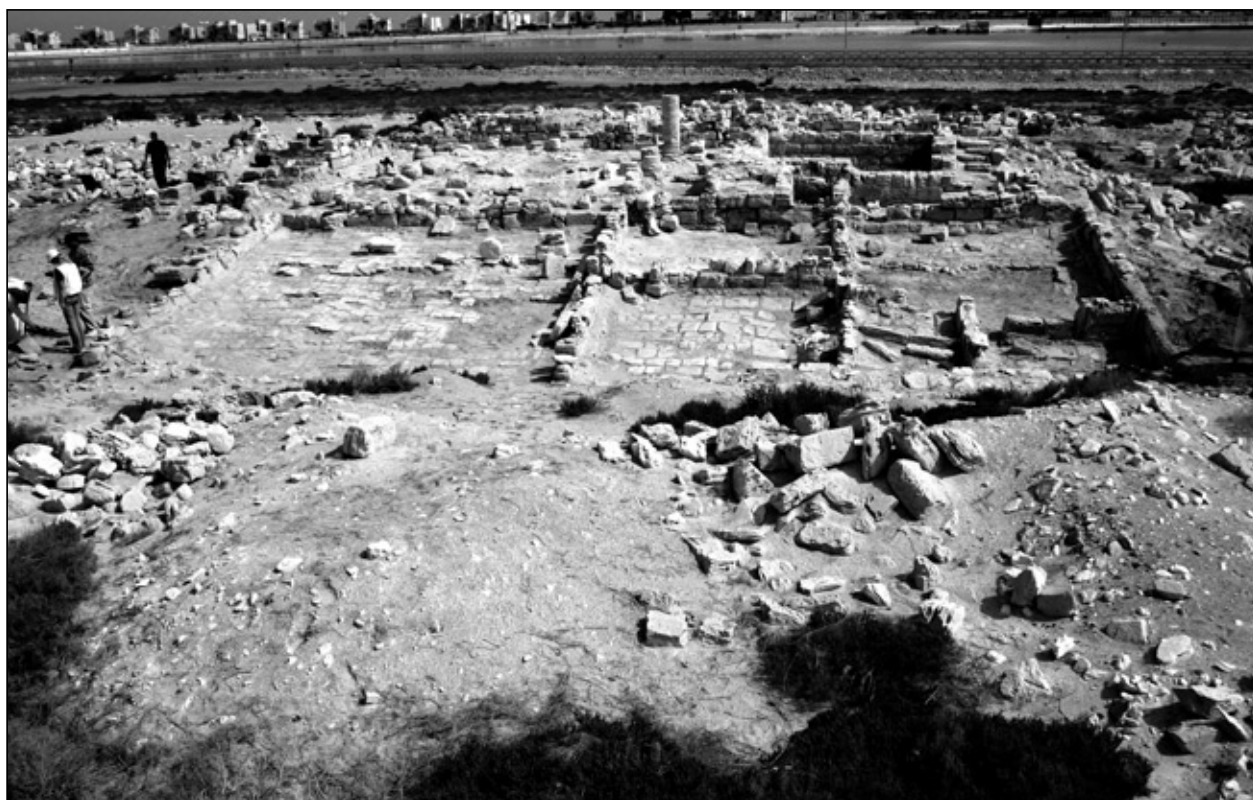
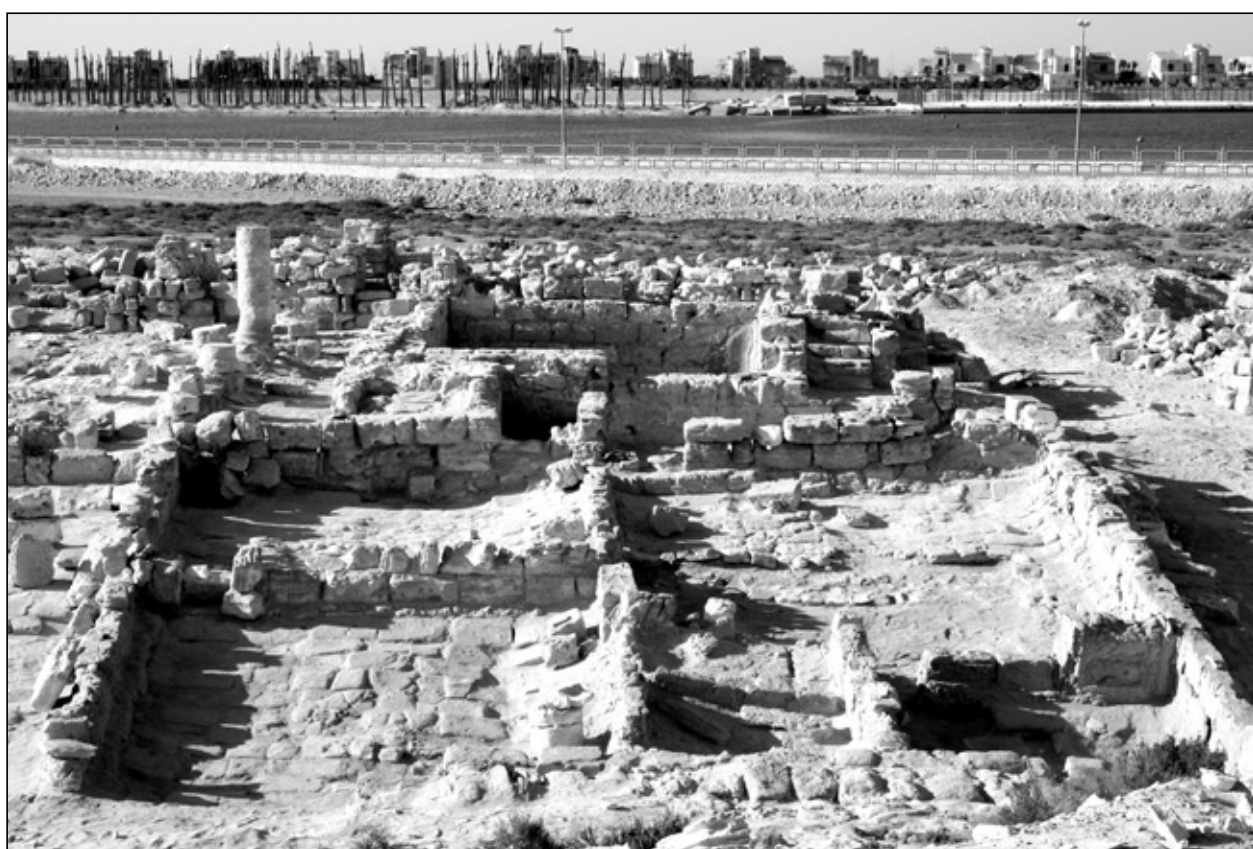
The building has suffered evidently from earthquakes and ground movement caused by other geological factors, resulting in a considerable distortion of the architectural appearance. Much subsidence of the original stone pavements is in evidence, especially in the courtyard (north portico of the peristyle) and in the area of rooms 4, 5, and 10 [*Fig. 3*]. Only the vaulting of the cistern under the floor in room 3 seems to be at the original level, but it has a deep E-W fissure that is pushing apart room 13 and basin 9. The perimeter wall also proved to be very poorly preserved, even missing entirely in places (especially in the eastern part of the house, in the vicinity of rooms 15, 14, 22, 13, 24). Room 6 appears to have been a projection, extending west, beyond the rectangular body of the house.

Fig. 3. House H1. View from the south, before (top) and after the season (Photo S. Medeksza)

The ruins of House H1 have been prepared for conservation and partial reconstruction

for the past two seasons. Rubble and secondary deposits, including vegetation, have been removed, and the vaulting of the cisterns under the courtyard protected. Architectural documentation work, in preparation for the building works to start next year, was completed this season, including fundamental revisions of the earlier documentation [*Fig. 2*]³ (indeed, more research needs to be done in order to understand the internal chronological stratification of the building).

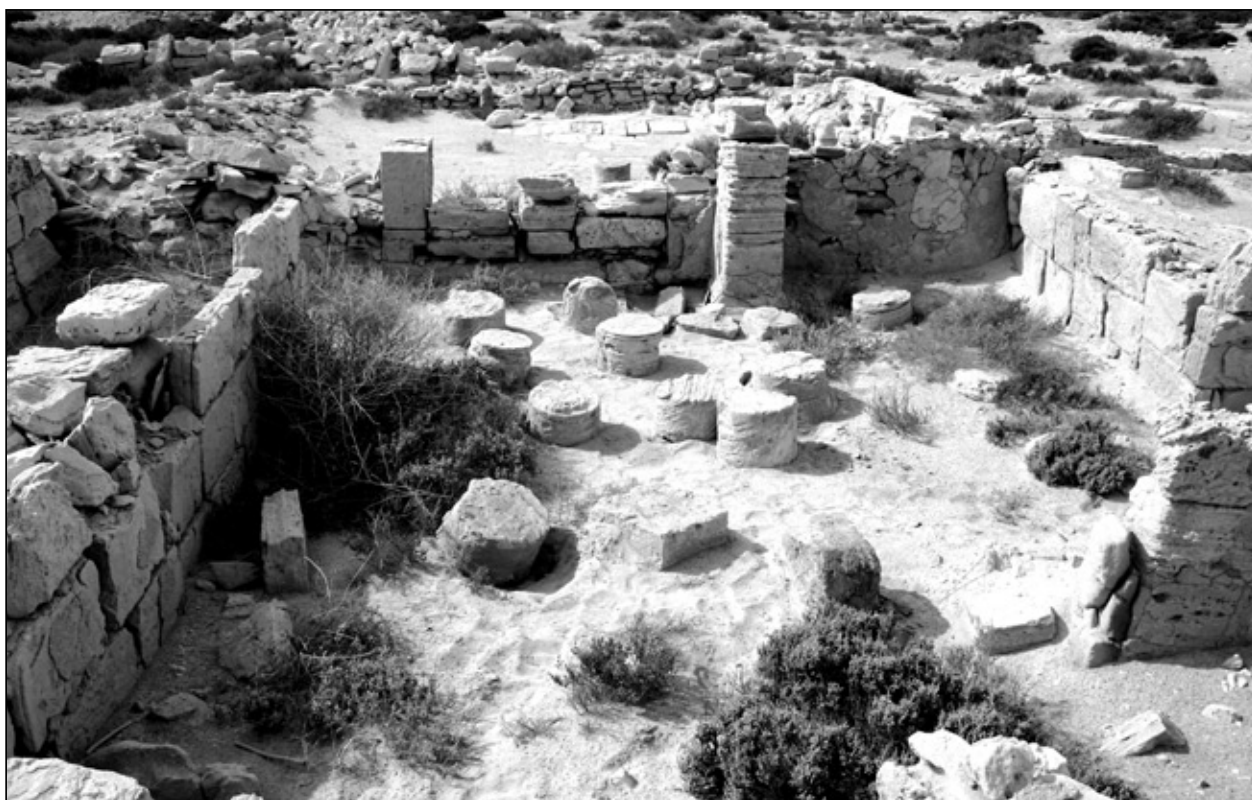
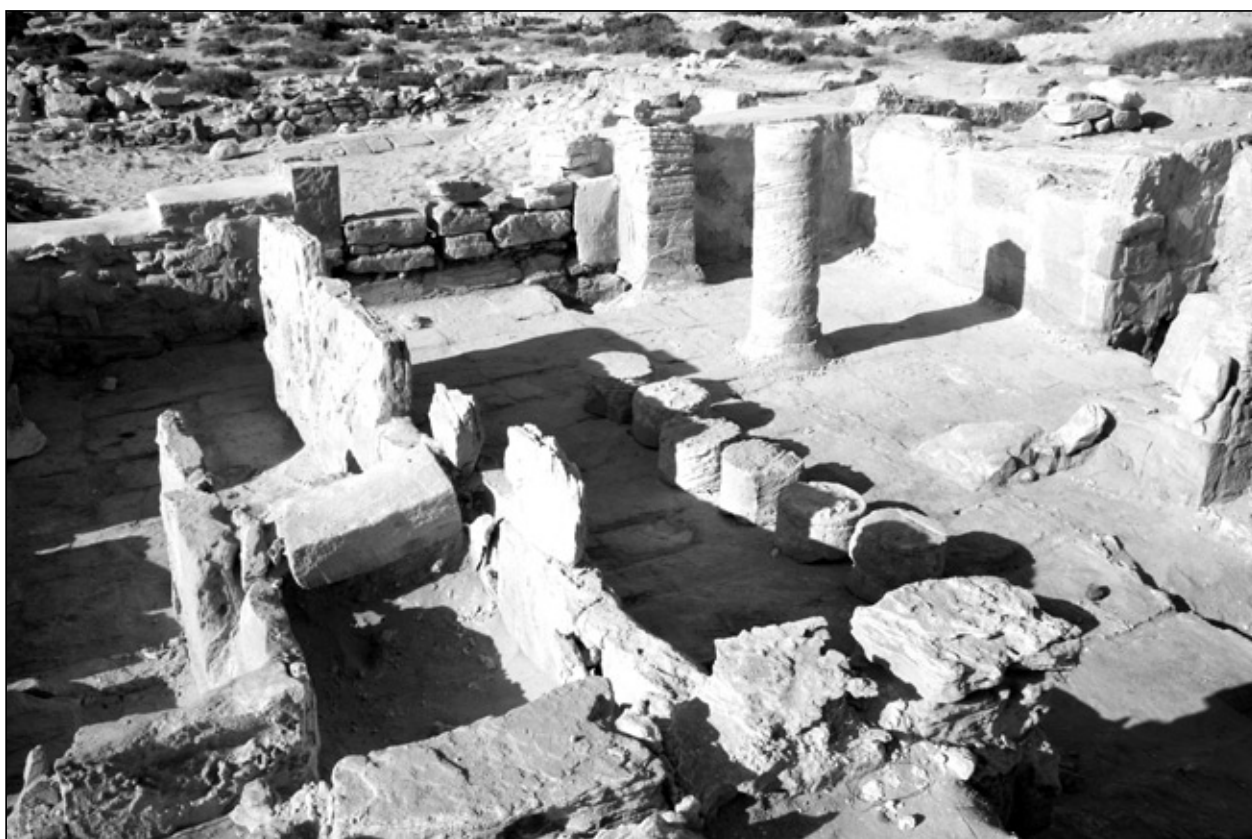
*Fig. 5. House H2. View from the south, before (top) and after the season
(Photo S. Medeksza)*

In 2005, all the walls surrounding the courtyard were consolidated [Fig. 5]. New jointing was carried out and the missing plaster completed. The broken-stone walls had the tops protected with the regular lime-cement mortar used by the mission.

The column was raised to a height of 1.20 m and will be completed next year.

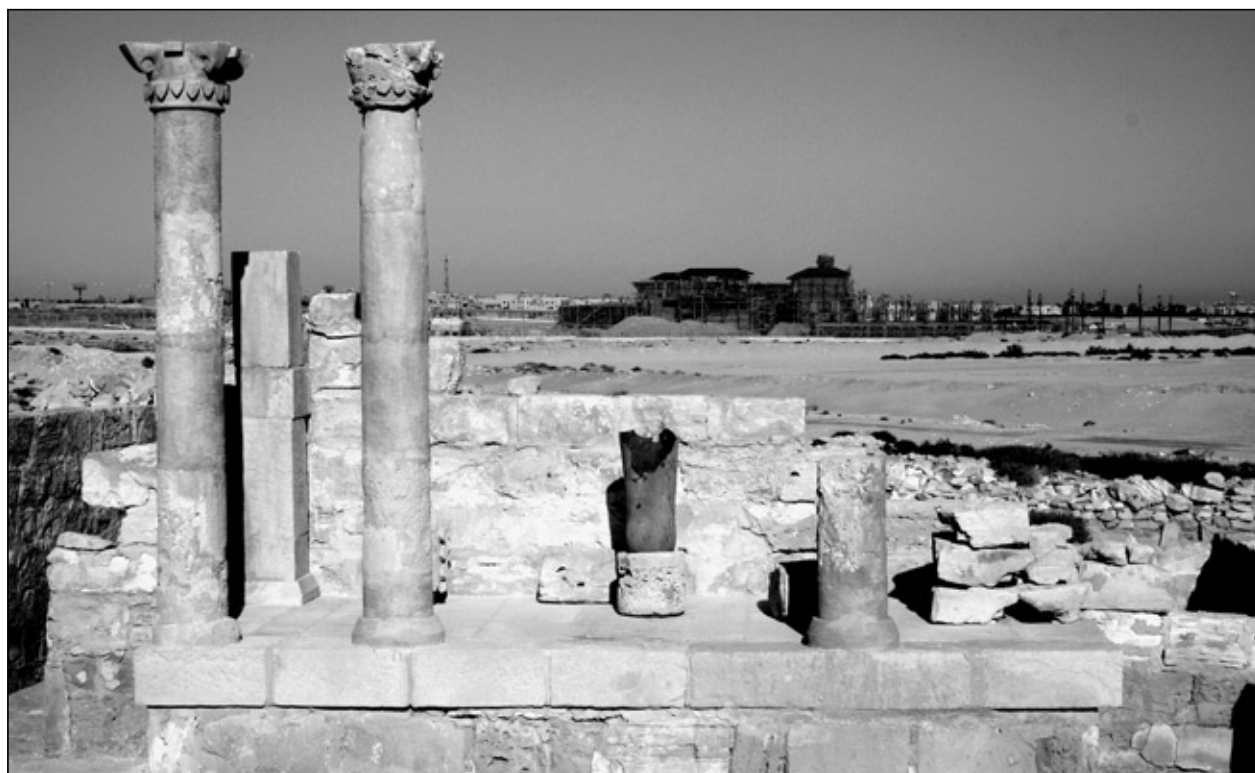
Fig. 6. Commemorative monument from House 21, after restoration work in 2005 (Photo S. Medeksza)

The commemorative monument in room 2, which had been restored to the top of the parapet walls in previous seasons, now underwent an anastylosis of the upper, decorative parts. Three of the four small columns, which together with the engaged pilasters had formed the portico, were re-erected on the platform measuring 4.00 by 2.20 m. Originally, each of the columns had consisted of four drums, the three bottom ones being 0.53 m high, the last one on top 0.45 m high; the diameter of these drums ran from 0.31 m at the bottom to 0.29 m at the top. One of the drums with preserved polychromy composed of a floral ornament, which underwent conservation in the 2000 and 2001 seasons, is intended for display in the local site museum. The other surviving

elements – five drums, a base and a capital, both 0.28 m – high were strengthened and completed with limestone of similar properties as the original.⁵ The small columns were raised using some new stone elements (four drums, three blocks from the pilaster, three bases and column capital⁶), the two columns on the south were raised to their full height, the third to the height of one drum above the base. A sizable section of the back wall of this commemorative portico and one of the engaged pilasters, 0.30 m to the side, was also reconstructed, but the surviving capital still waits to be put into place [Fig. 6]. The full height of the restored columns is 2.56 m. Further work on the back wall and pilasters, using surviving elements of the cornice, is planned for the coming season.

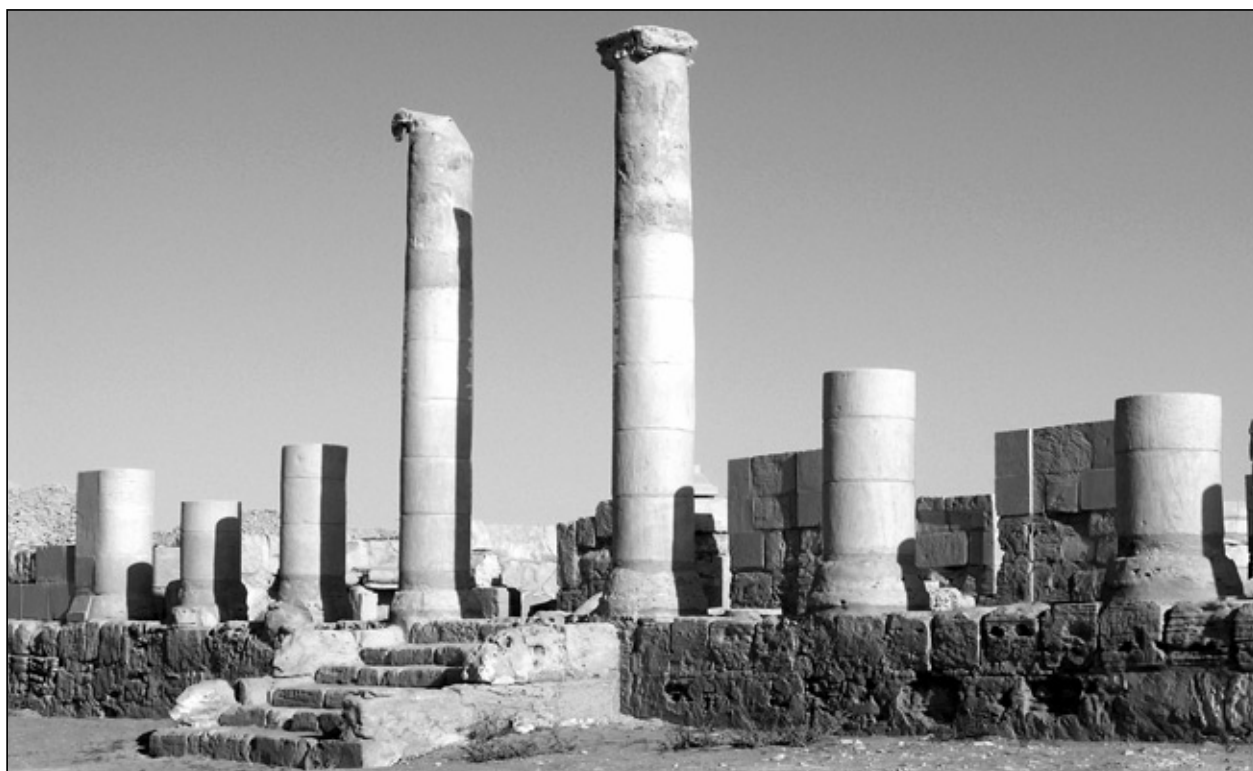
Fig. 7. *Hypogeum-Mausoleum T6, façade of the mausoleum after restoration work in 2005*
(Photo S. Medeksza)

Restoration work on the mausoleum of Hypogeum Tomb T6, discovered by the Polish Archaeological Mission in 1988-1998, continued with a further reconstruction of the columns of the front portico. In previous seasons these columns had been raised and restored to no more than 135 cm in height. Having some shaft drums from the upper parts of these columns (as suggested by the smaller diameter) and remains of a capital, it was possible this year to reconstruct the two columns framing the entrance to their full height of 3.25 m [Fig. 7].⁷ The lateral pillars with engaged columns were also raised by two blocks in the case of the eastern one and a single block in the case of the western one. Both the height and span of the portico are now clearly visible.

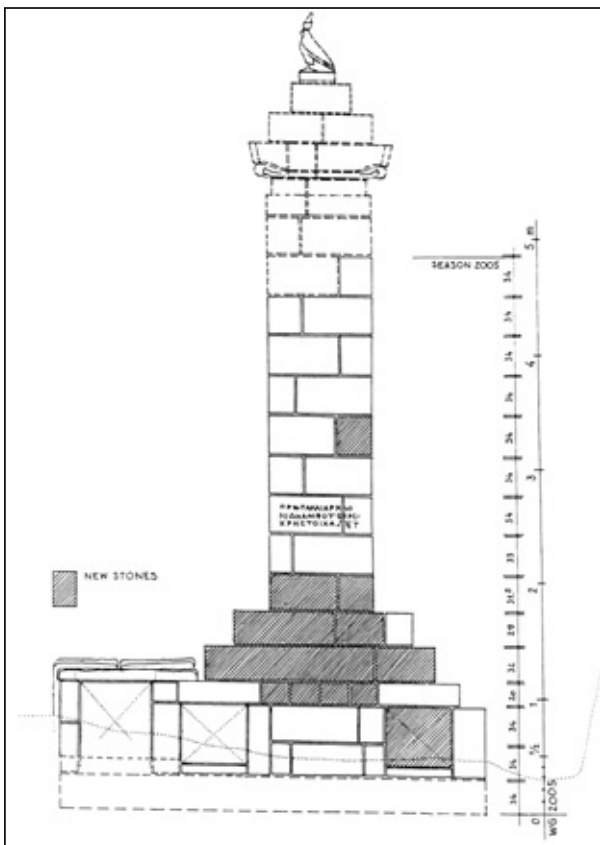
Fig. 8. Building-conservation work on tomb T12 in 2005 (Design W. Grzegorek, original drawing J. Dobrowolski)

During this work, an inscription was discovered on the blocks of the third course on the eastern face of the pillar, which had so far not been lifted (cf. *Fig. 8*). The text, read by Adam Łajtar of Warsaw University, is a typical funerary inscription for a married couple buried together in this tomb: “*Prota and Archonides, both good ones, farewell*”.¹⁰

The tomb, which was discovered in 1994 by the Polish Archaeological Mission,⁹ was cleared again in 2004 in preparation for the restoration project. This season, the eroded stone blocks in the three upper courses of the base on the west and south were replaced with new blocks. The original fill consisting of small rocks mixed with clay and sand was removed from the core of the substructure and in its place larger stone blocks in lime-cement mortar were introduced. Four of the limestone slabs (52x26x20 cm each) covering the loculi comprised within the base were replaced. Also, the lowermost course of the pillar was reconstructed in new

stone. A trial mounting of particular layers based on a project design prepared originally by J. Dobrowolski and updated by W. Grzegorek, permitted missing elements to be replaced with new ones made in old and new stone. The pillar was verified as measuring 0.91 by 0.91 m, with each course being 0.34 m high [Fig. 8].

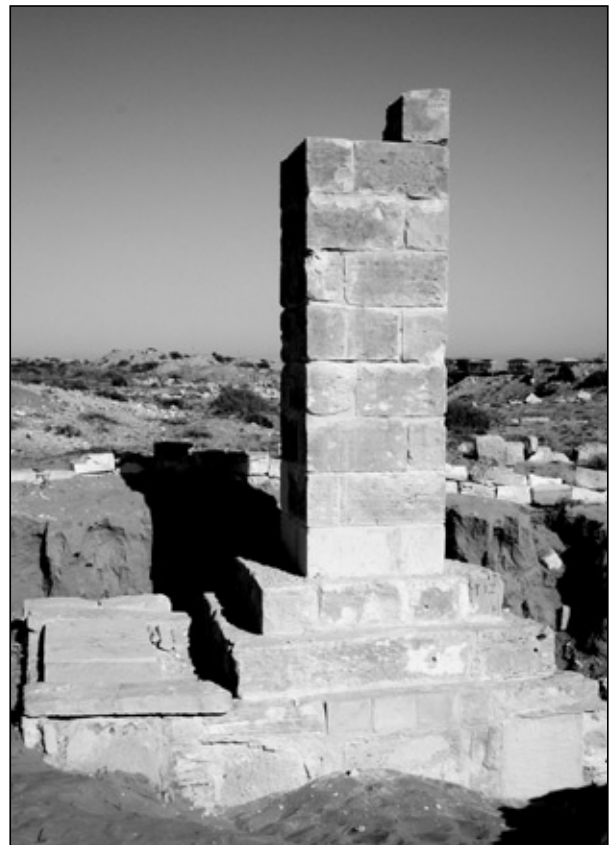
Fig. 9. Pillar tomb T12, state after reconstruction in the 2005 season (Photo S. Medeksza)

Eight courses of the pillar shaft were raised [Fig. 9]. Next year, the remaining three courses will be erected, plus the two-course capital and the course on top of the capital, which is the base under a limestone sculpture of Horus in falcon form, discovered during the earlier excavations, restored and kept in storage at the site.

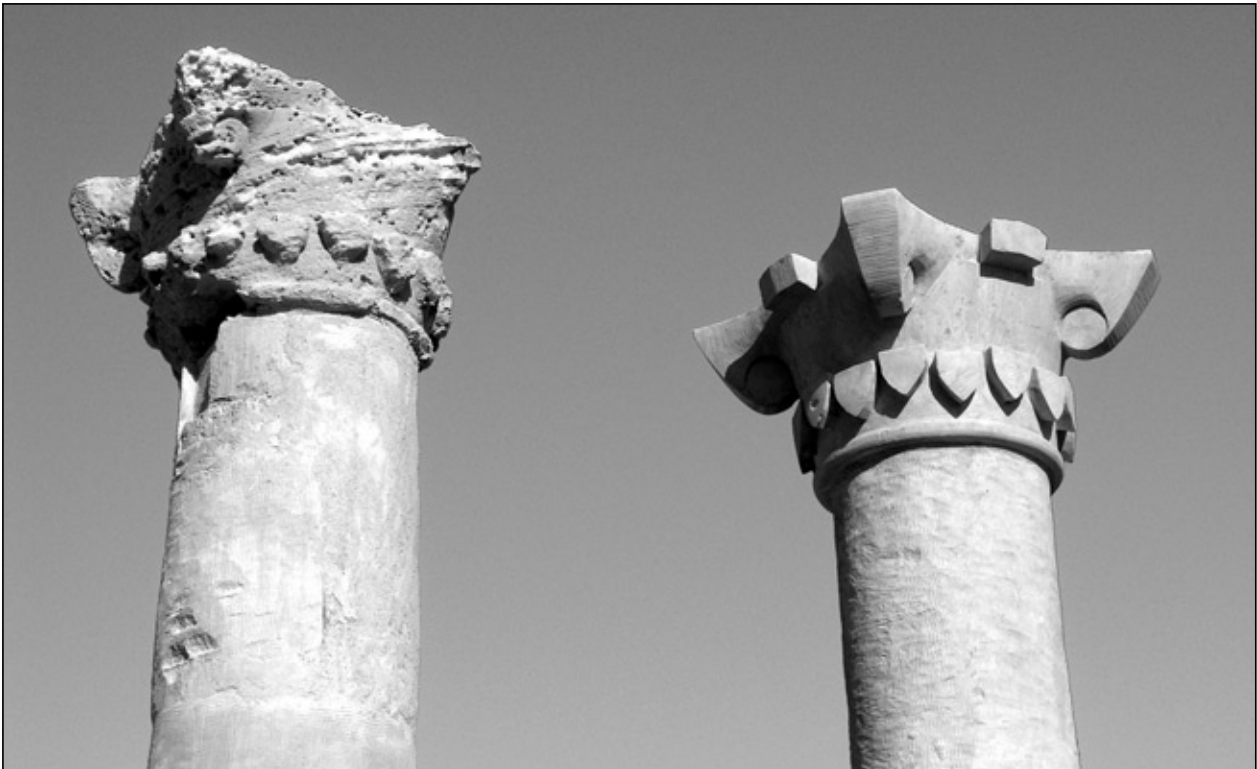
Fig. 10. Capitals from the commemorative monument in H21, after treatment (left) and reconstruction (right) in 2005 (Photo S. Medeksza)

The program calls for protection of the ancient substance, reconstruction of the original form of selected elements (determined by the needs of future display) and testing of specialist materials for use in the future. Objects for treatment were chosen from structures both in the town and the necropolis, including some which were a continuation of earlier activities, e.g. the base of a pilaster and capital in pseudo-Corinthian style typical of Marina, from the commemorative monument in H21, which were replicated in Heluan limestone, based on comparative analysis of surviving fragments and executed using traditional techniques [*Fig. 10*].

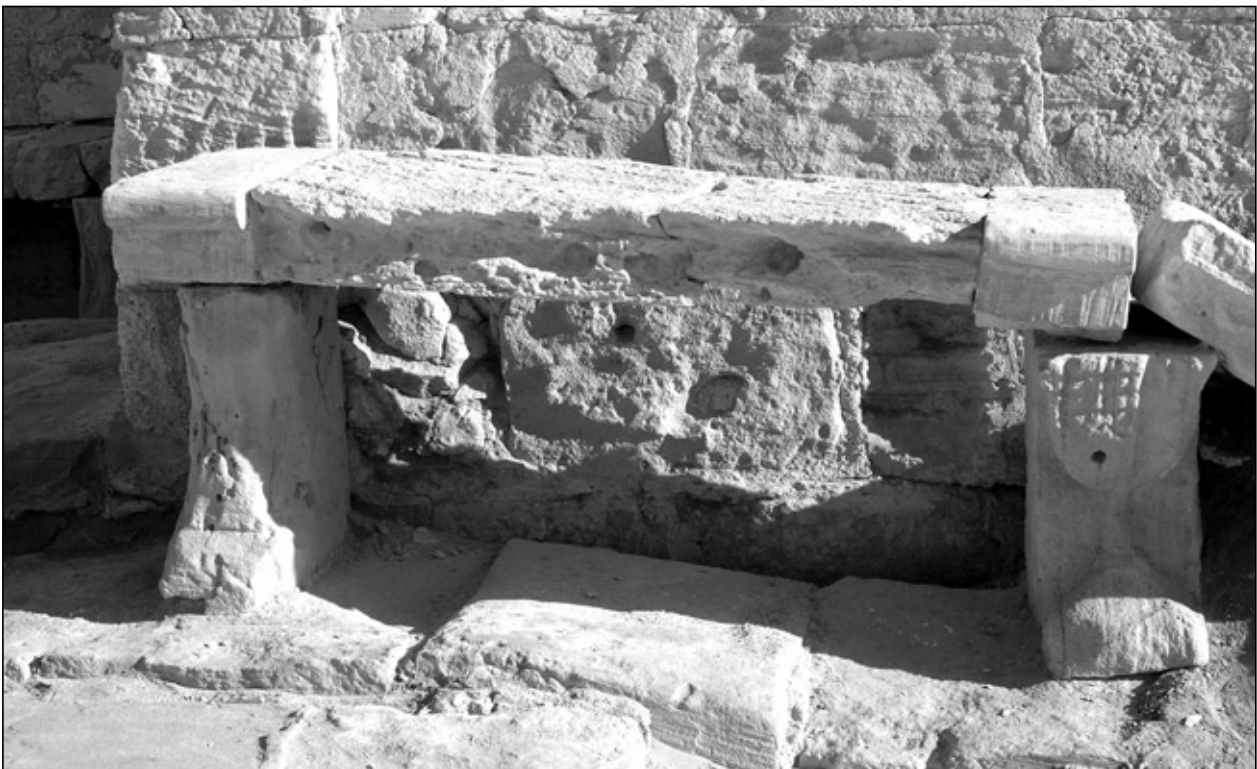
Fig. 11. Stone seat in the South Stoa of the main square, after conservation work in 2005 (Photo P. Zambrzycki)

Similar treatment was applied to the seats of benches in the South Portico of the Town Square. Surviving fragments were consolidated and the original appearance reconstructed in part. Stone replacements for missing elements were introduced based on a comparative analysis of surviving parts [*Fig. 11*]. The work will be continued in the coming season, once the remaining deposits under the benches are excavated.

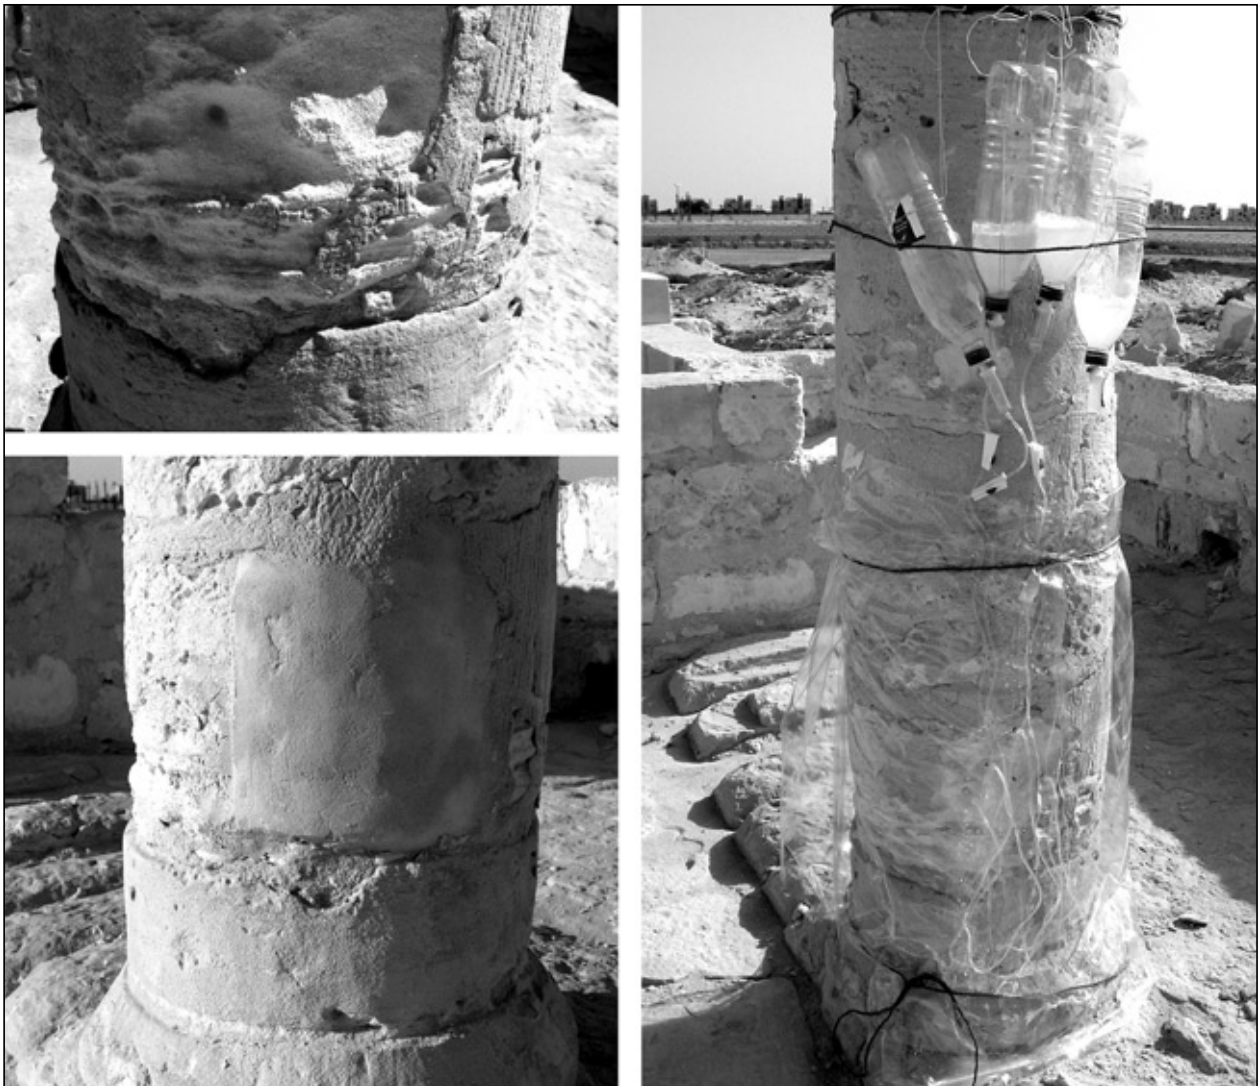
based on new materials was initiated in 2005. A major cause of on-site damage is the impact of an erosive seaside climate on faulty stone material of local origin. Substantial daily and seasonal variations in humidity and temperature levels result in granular disintegration, intensified at the absorption line. The process could have been escalated by the considerable salinity of the cement binder used so far, hence attempts to replace it with slaked lime. In chemical terms, slaked lime is also the better material because it corresponds to the stone used for the building blocks.

Fig. 12. Drum of a limestone column from H21, before (top left), during (right) and after trial conservation in 2005 (Photo P. Zambrzycki)

The object chosen for the research program was the lower drum of a column from room 1 in H21; tests included reinforcing and protecting the surface of the stone through a re-profiling with appropriate mineral mortars. The structure was reinforced with a solution of dispersive lime, which was introduced by drop injection. Upon seasoning in stable conditions, the surface was covered with lime plaster containing quartz sand filler (1 part lime to 1.5 parts sand) [Fig. 12]. The material used was dispersed lime KALKINIEKTION by Kalk-Kontor-Germany. Actual conservation

work was preceded by tests under controlled conditions. Should the need arise, the porosity of the said mortar can be increased,

in an effort to achieve WTA-system plaster (that is, renovation plaster highly resistant to ground salinity).
