**Marina El-Alamein: Conservation
Work in the 2007 Season**

Polish Archaeology in the Mediterranean 19, 81-97

CONSERVATION WORK IN THE 2007 SEASON

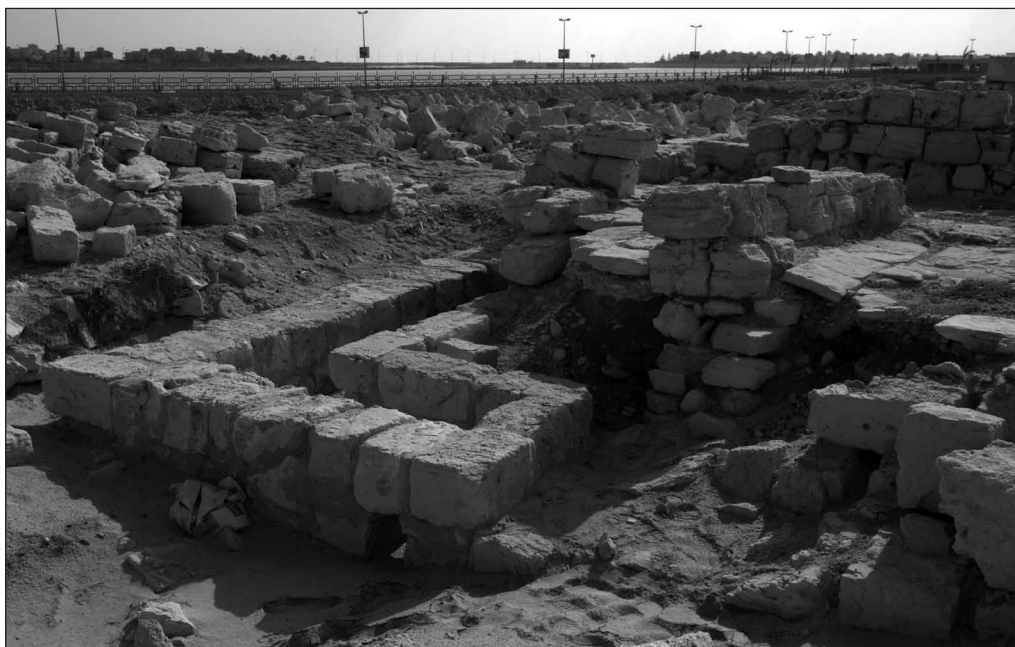
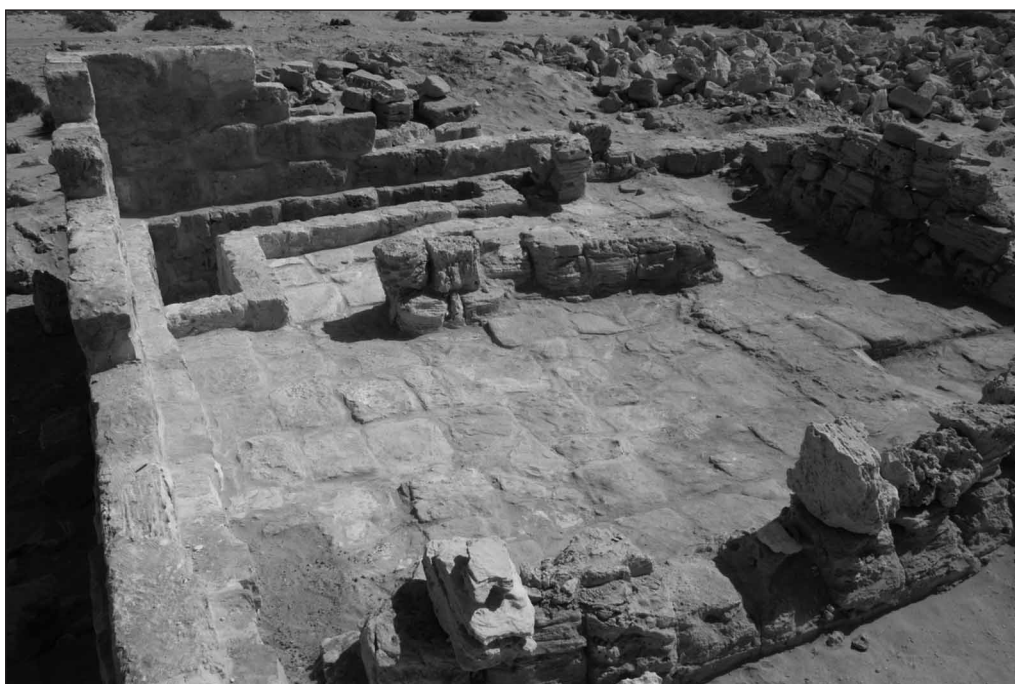
The restoration of the perimeter wall on the northwest and west sides of the house was completed in 2007, continuing the work begun in the previous season. The reconstruction of the latrine (units 1, 2, 21) in the northwestern corner of the house proceeded, encompassing the small colonnaded courtyard that was presumably connected with it. The entire bottom of the latrine was reconstructed, thus restoring the northwestern corner of the house as well [Fig. 3].

Fig. 3. The latrine in the northwestern corner of House H1: before (top) and after restoration in 2007 (Photo S. Medeksza)

New parts raising the original walls were distinguished from the ancient wall substance by evidently thicker jointing and the leveling of particular courses of stone blocks. The original courses and walls

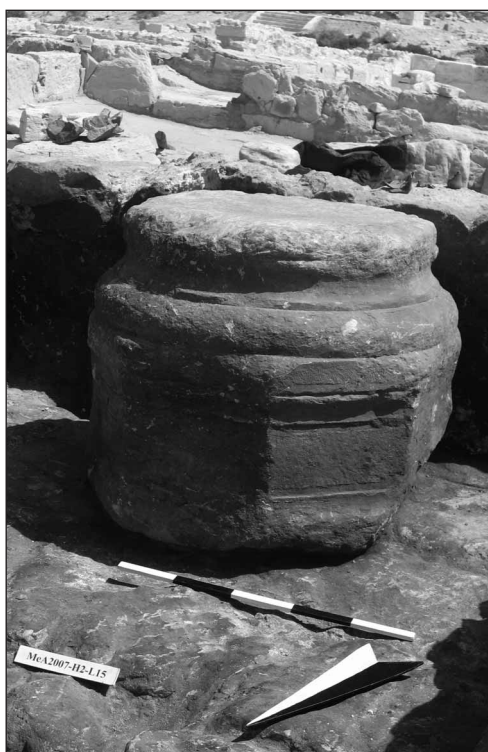
Fig. 5. Marble Attic base with octagonal pedestal found in House H2 (Photo S. Medeksza)

Rooms 15 (1.80 x 1.70 m), 16 (1.80 x 5.35 m) and 17 (7.30 x 3.20 m) were traced in the northern part of the house. A curious find from Room 15 is an Attic base (Dia. 0.55 m, H. 0.52 m) [cf. *Fig. 5*], obviously reused here seeing that it stood in an accumulation layer of dark burned soil 0.35 m deep, separated from the flagstone pavement by a 0.03 m thick layer of sand. The base had been set up against the south

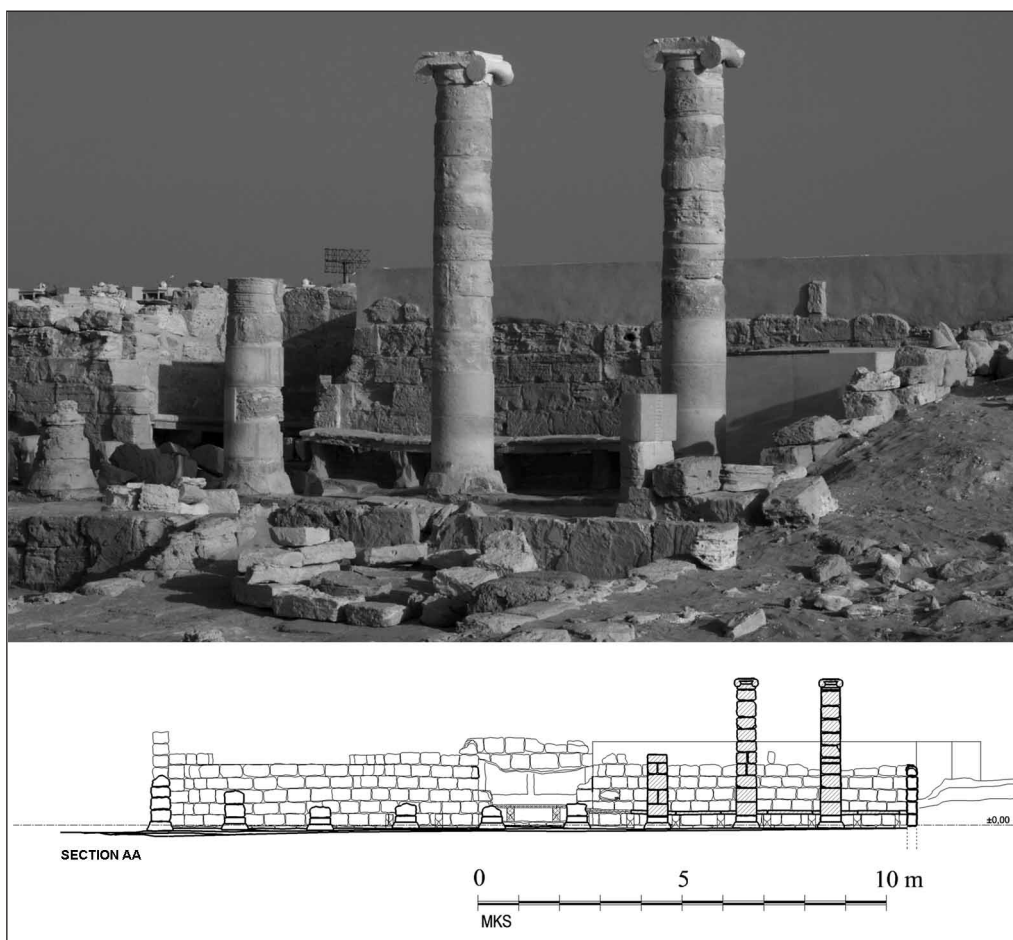
Fig. 7. South Portico with restored columns and bench in the background (top); section (AA in Fig. 6), state after the 2007 season (Photo S. Medeksza, drawing M. Krawczyk-Szczerbińska)

The columns had the bases preserved *in situ*, including in some cases the lowermost drums, which were the most damaged and eroded at the point where they had broken and collapsed. For this reason these drums, although partly preserved, were replaced in the reconstruction with replicas. The original pieces were structurally too weak to carry the upper parts of the columns. The reconstructed drums were cut from single blocks of stone unless only one half of the drum had to be replaced. They were set up on the original bases, which were in satisfactory condition and required only minor consolidation and reinforcement of the substructure.

Column first from the west: The four lower drums are from this column, the upper ones come from the sixth column from the west, part of which was very poorly preserved. The original top of this column, which is the

Column second from the west: Set up from original elements found near its base during excavations. Only the lowermost two were replaced with drums of identical size but better preserved, coming from elsewhere in the portico, but without exact provenience.

Column third from the west: Reconstructed to a height of 1.82 m, replacing with replicas half of each of the two lowermost drums and the entire third drum. Mounted on this were two more original drums composed of halves.

Standard mortar was used for bonding all the restored elements (3 parts sand to 2 parts lime to 1 part white cement). The halves of two-part drums were clamped with stainless steel rods (\varnothing 8 mm) on top.

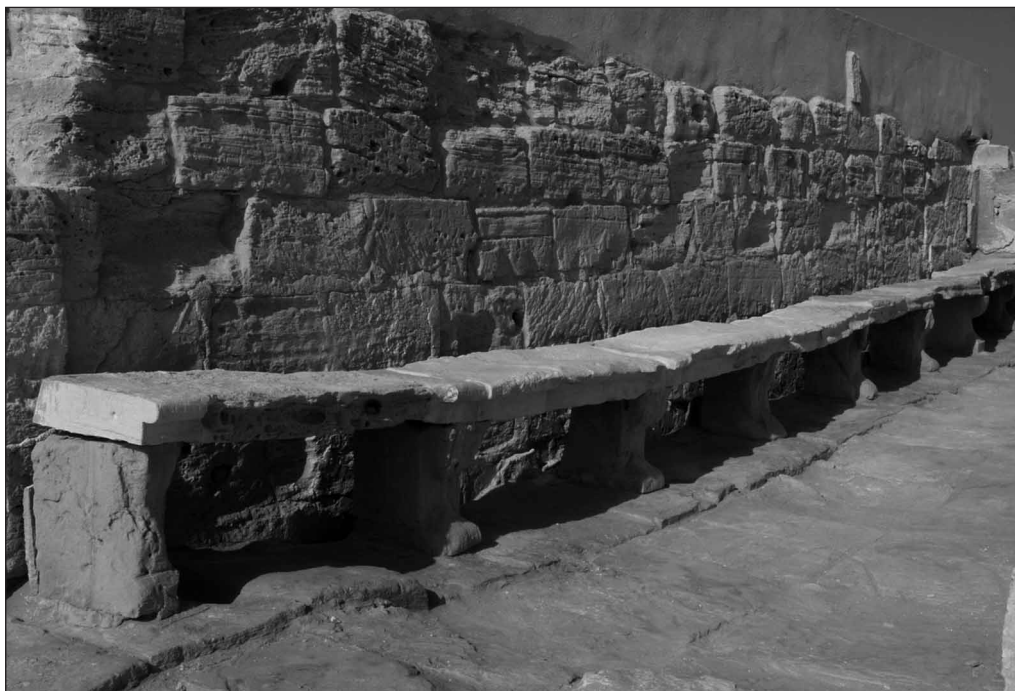
In 2006, the state of preservation of the elements in question was recorded in preparation for planned restoration in 2007. All of the seats were found to be broken as a result of mechanical impact. Since the collapsed fragments were supported on undisturbed ancient fill, it should be assumed that the damage occurred in antiquity. Documentation in April 2007 revealed new damages, presumably connected with the building works being carried out on the south wall of the South Portico, which is the back wall of the benches. The cracked seating slabs had been dismantled and the bench legs were used as provisional supports for scaffolding needed in the building works. Fragments of the benches were displaced with regard to their original position, preventing the restoration of fragments in their original position.

Fig. 8. Benches in the South Portico, state after full restoration in 2007 (Photo S. Medeksza)

The bench legs displaced by the movement of the substructure were mounted on the floor in their original position. The natural dilatation at the joining with the south wall was not refilled intentionally in order to reduce the amount of rainfall flowing from the high wall onto the surface of the bench. (A historical joint was left in place by the extreme leg as proof of its existence).

Small losses and cracks were filled with lime-cement putty with lime filler. The seating slabs were mounted on the legs, and the joints were only partly filled [*Fig. 8*] (in anticipation of the need to dismantle the benches for conducting further building work on the back walls).
