# Marina El-Alamein: Conservation Work in the 2003 Season

Polish Archaeology in the Mediterranean 15, 91-100

# MARINA EL-ALAMEIN CONSERVATION WORK IN THE 2003 SEASON

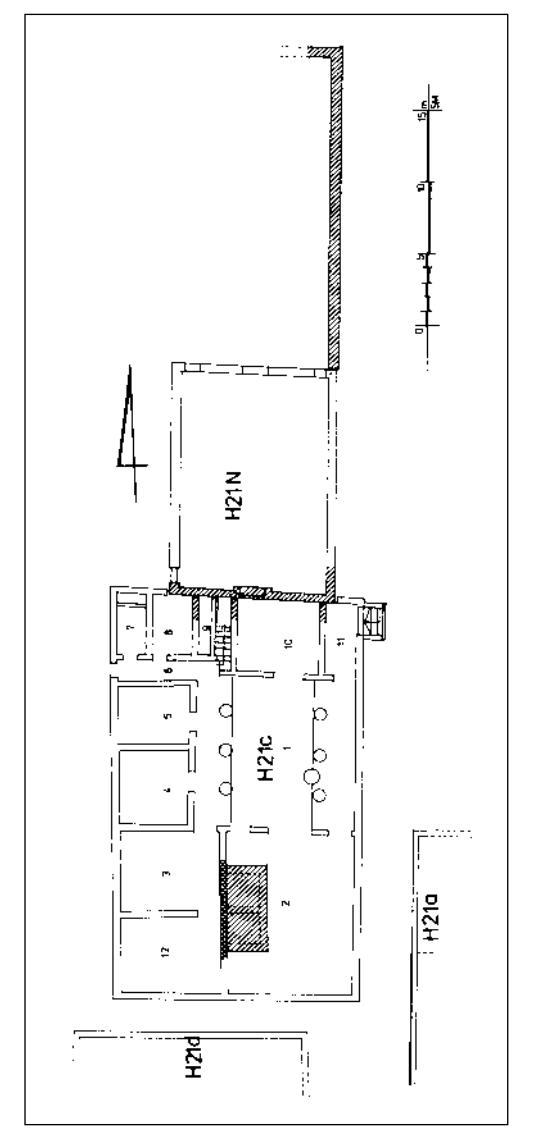
Fig. 3. House H 21c and hall H 21N. Plan showing work completed in 2003 (hatched) Drawing S. Medeksza)

The commemorative memorial to Commodus in room 2 of House H 21c was given a limestone parapet and was covered with stone slabs (*Fig.* 3).<sup>5)</sup> The bases of small columns were erected on this parapet; one whole column and a piece of another will be restored in the future. The bases are 0.30 m high; the six surviving parts of column shafts measure 0.29-0.30 m in diameter and are 0.52 m high. A single preserved column capital measures 0.30 m in height.

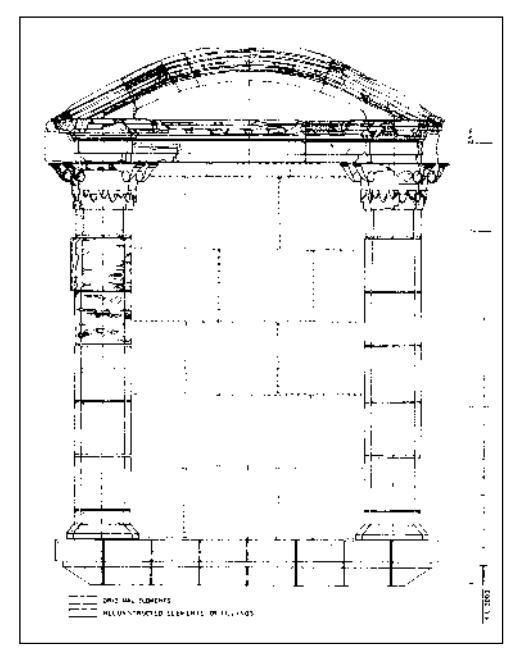
Fig. 4a. Wall niche from hall H 21N. Theoretical reconstruction (Drawing R. Czerner)

As reported previously,<sup>6)</sup> the niche in the south wall of Hall 21"N" had been reconstructed to the height of the imposts. In 2003, the work was completed based on reconstruction drawings prepared by R. Czerner (*Fig.* 4a).<sup>7)</sup> New fillings were inserted, glued and fixed with stainless steel dowels. Areas around the joints were strengthened with ethyl silicate stone strengthener FUNCOSIL STEINFESTIGER OH (Remmers). The adhesive used for both stone and steel was an epoxy resin ARALDITE AW 1360 (CIBA-GEIGY) with powdered limestone added. The missing sections of the ornamental cornice were carved using traditional tools. Small fillings were made on the base of a silicon resin ADHESIL K1 with powdered limestone. The reconstructed impost blocks were then reinserted in place and fixed with mortar. The missing part of the niche tympanum was reconstructed in the same way as the impost blocks. The original elements, which had been impregnated in 2002 with FUNCOSIL STEINFESTIGER 300 (Remmers), were reassembled and the recreated piece fitted into place, thus completing the reconstruction (*Fig. 4b*).

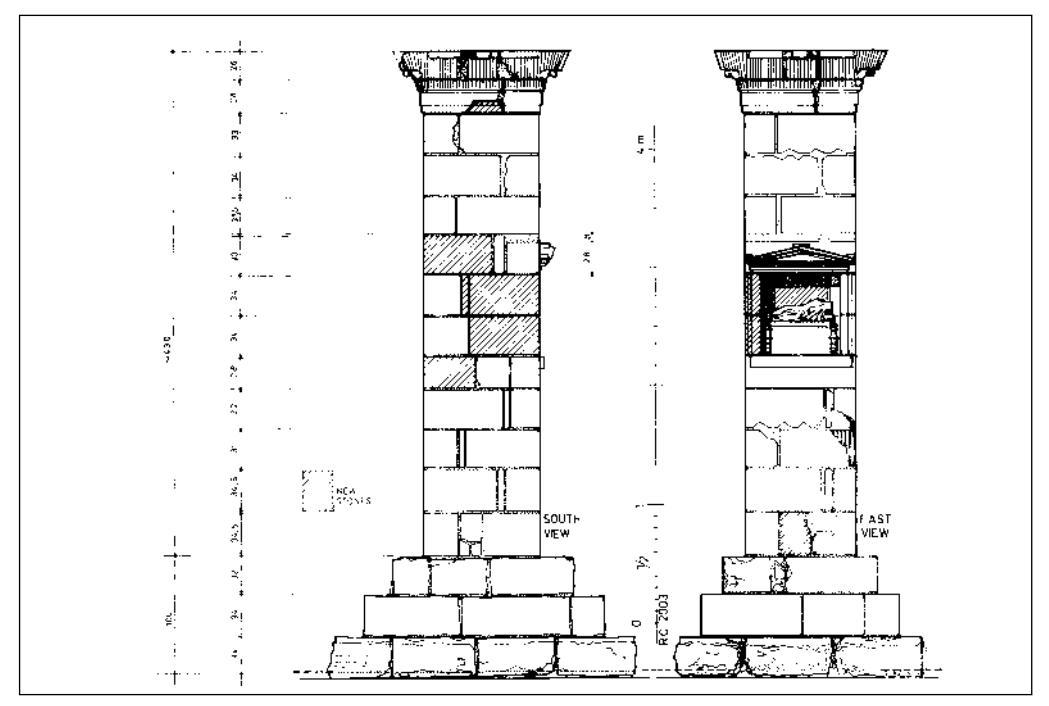
Fig. 5. Tomb T 1K after partial anastylosis in 2003 (Drawing R. Czerner, based in part on J. Dobrowolski, 1994)

surviving elements of this pillar-shaped monument were put back in the position in which they were found and carefully protected for future restoration.<sup>10)</sup> Several blocks of similar dimensions were lying in the vicinity and it turned out in consequence that few new blocks had to be prepared for the reconstruction. Sadly enough, one of the missing pieces was the southern jamb of a small niche located in the middle height of the pillar. With some modifications resulting from the need to include the results of recent research, it was possible to raise the pillar to a height of 5.30 m, (*Figs. 5, 6*), leaving the remaining

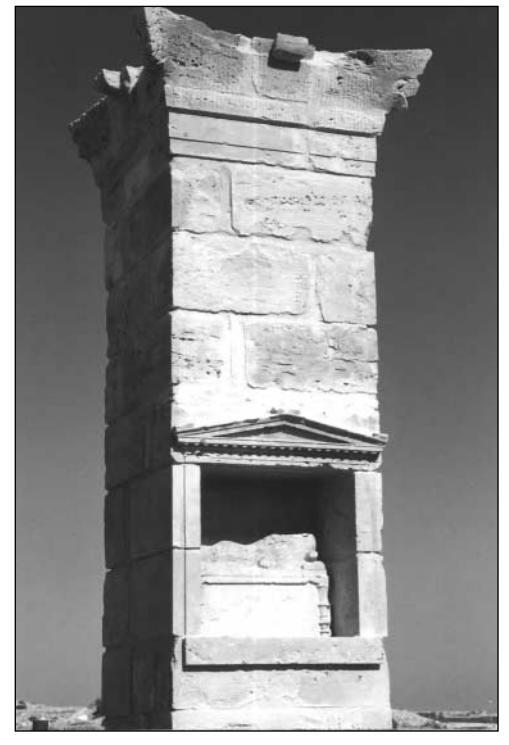
Fig. 6. View of the front of pillar tomb T 1K with reconstructed niche (Photo S. Medeksza)

parts of the cornice for the coming season. The carved representation of a man lying on a banquet couch was reintroduced into the reconstructed niche (*Fig. 6*). The stone was first desalinated and impregnated with FUNCOSIL STEINFESTIGER 300 (Remmers).
