Polish Archaeology in the Mediterranean 10, 153-166

DEIR EL-BAHARI

THE TEMPLE OF QUEEN HATSHEPSUT, 1998/1999

Franciszek Pawlicki

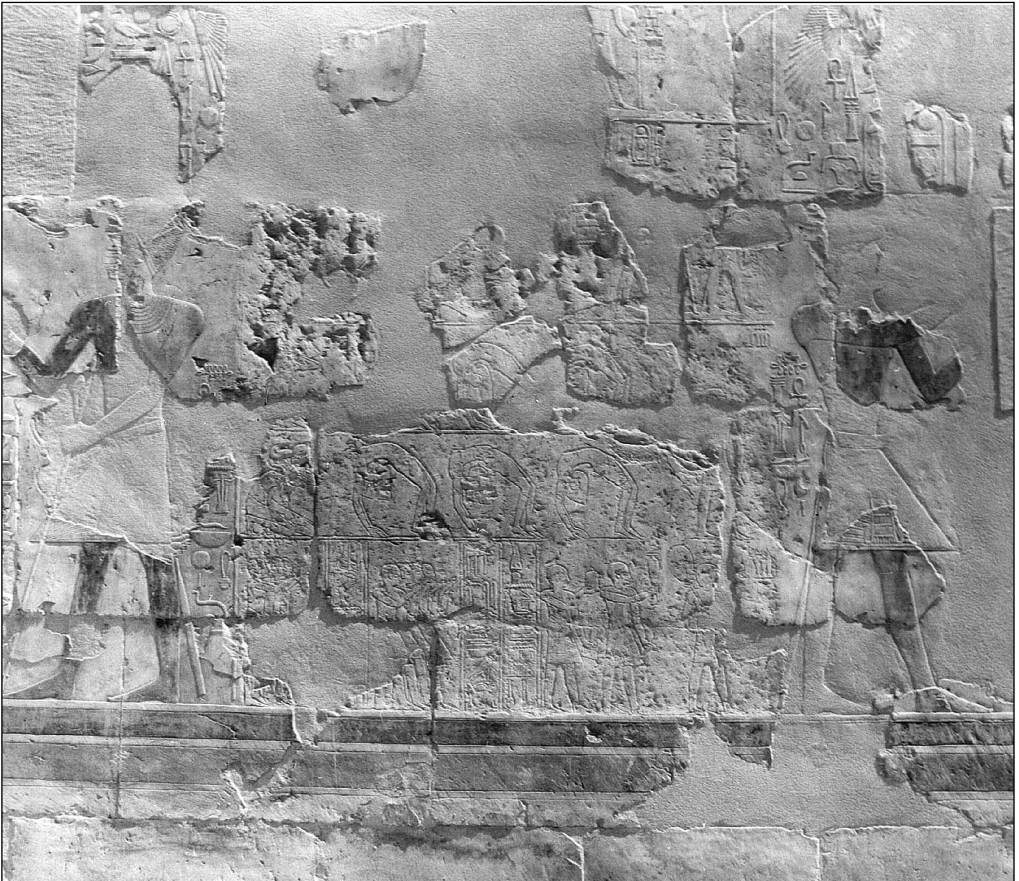
Fig. 3. Tuthmosis III with incense in front of the sacred bark. Representation of royal statues, dancers and priests during the Beautiful Feast of the Valley. Northern wall of the Upper Court after final conservation (Photo W. Jerke)

Some minor reconstruction of the outlines of the missing representations of king Tuthmosis III and of sacred bark of Amun was attempted in modern plaster to make the decoration clearer for visitors (*Fig. 3*).

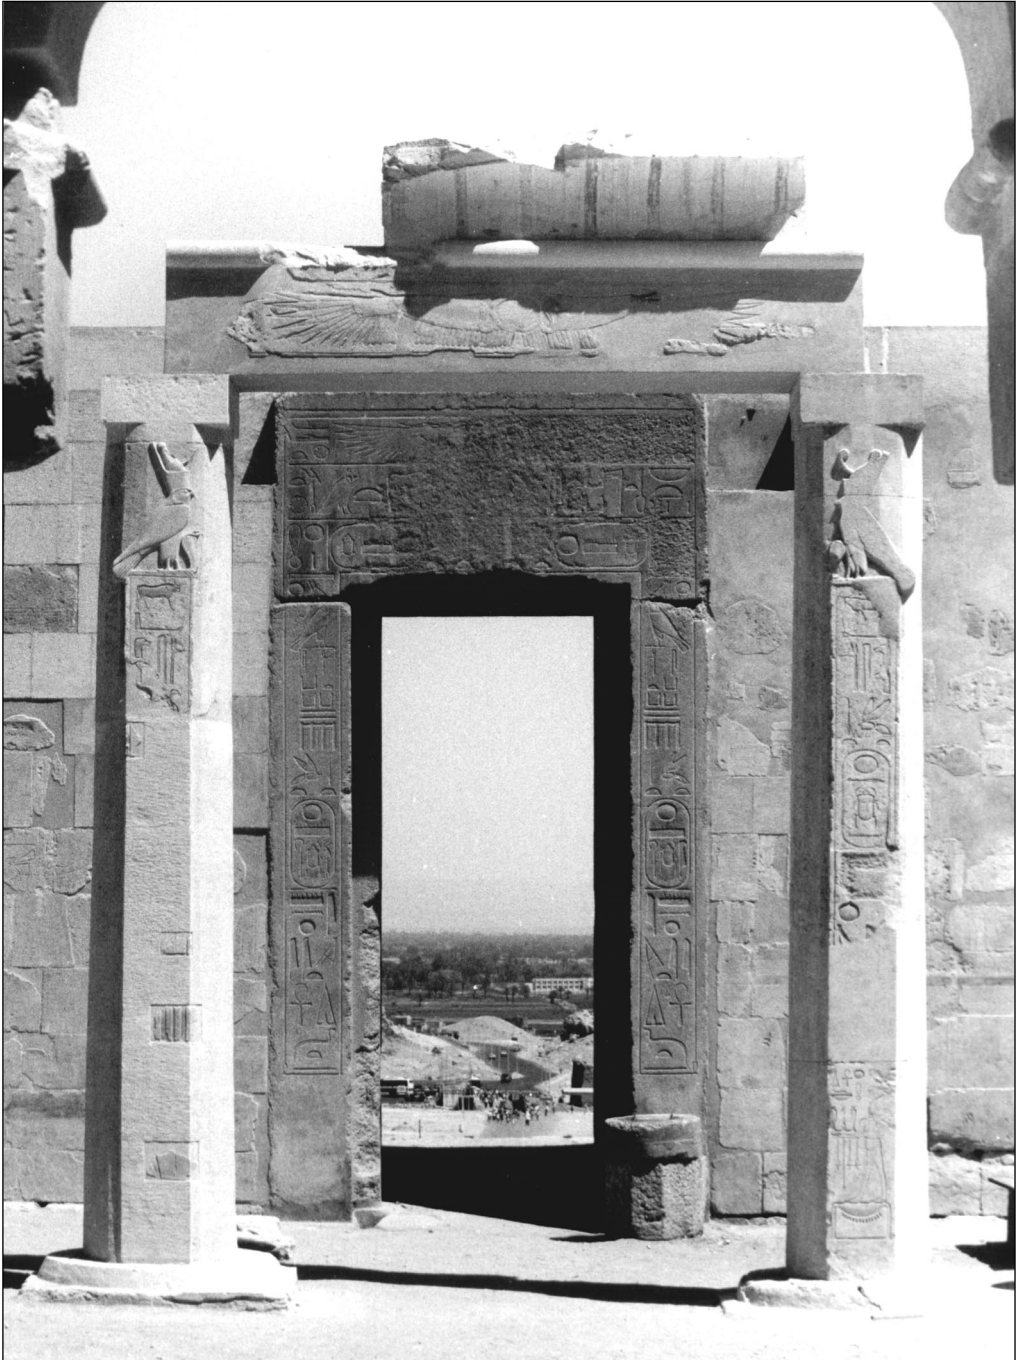
*Fig. 4. Architrave restored on the main axis of the Upper Court
(Photo W. Jerke)*

The goal of the current restoration of the inner colonnade was to make this plan evident. Two columns with the architrave were restored on the main court axis. The latter, leading to the Main Sanctuary of Amun, was emphasized by the image of a winged solar disc on the inner face of the architrave (*Fig. 4*). Another architrave bearing the inscription: "Life [for] the mighty bull, powerful of strength, king of Upper and Lower Egypt, *3-hpr-n-Rc*, Two Ladies, Divine of the crowns, Horus of gold:

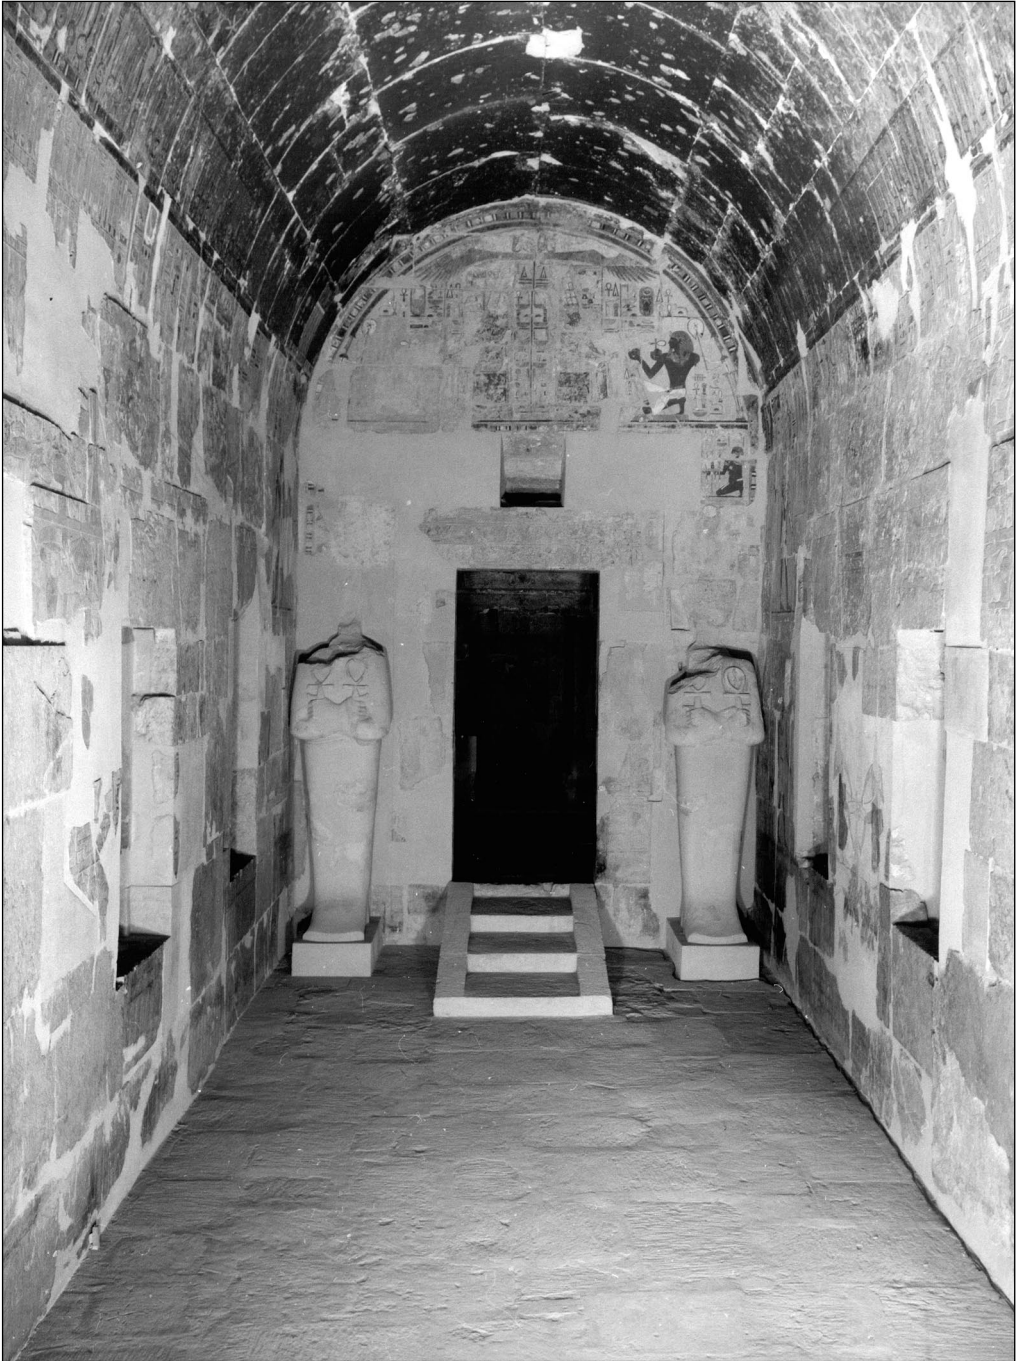
Fig. 6. Western wall of the Hall of the Bark in the Main Sanctuary of Amun-Re, after final conservation with the restored statues of Queen Hatshepsut (Photo W. Jerke)

H. Winlock first ascertained that there were four statues of Queen Hatshepsut standing in each corner of the Hall of the Bark.¹⁰⁾ The shoulder and crown outlines are still visible on the original blocks preserved in the eastern wall of the room. Two of these figures have now been restored. The missing elements (but not the heads)

were sculpted in mortar made of powdered limestone, sand and white cement and covered with a final coat similar in color to the original fragments (*Fig. 6*).
