## Tell Amarna: Restoration and Excavation, 2000

Polish Archaeology in the Mediterranean 12, 347-356

# TELL AMARNA

## RESTORATION AND EXCAVATION, 2000

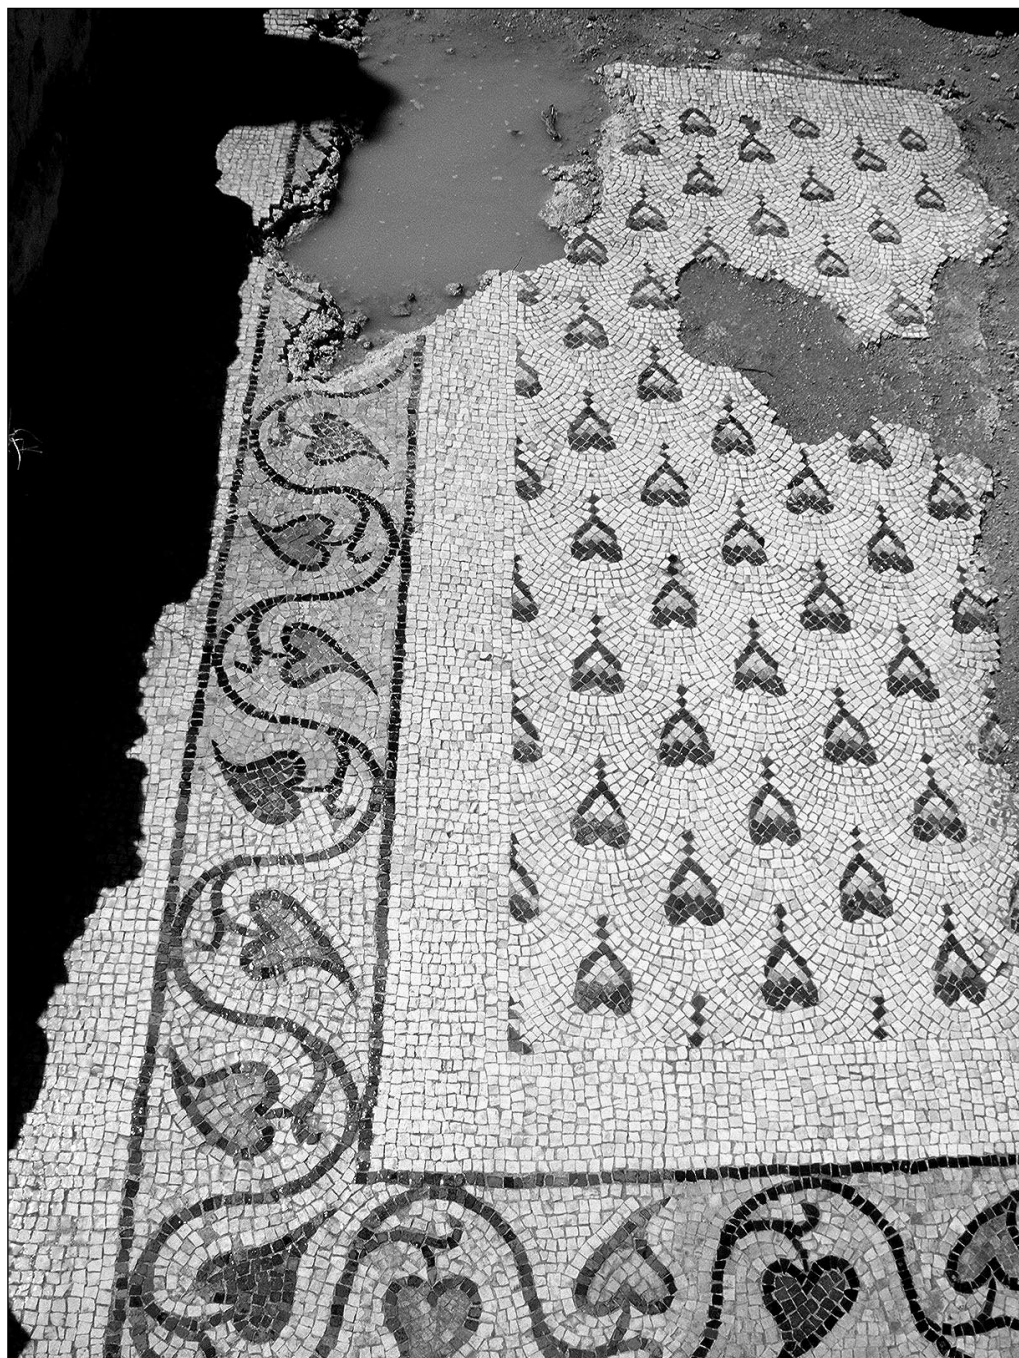
*Fig. 3. Tell Amarna. Mosaic floor in the northern pastophorium  
(Photo T. Waliszewski)*

The mosaics in the nave and aisles were made in *opus tessellatum* technique, using cubes 1 cm square (*Fig. 3*). Geometric designs formed rectangular panels that emphasized the interior division of the church. Some of the motifs used in the decoration are considered unique in the region.

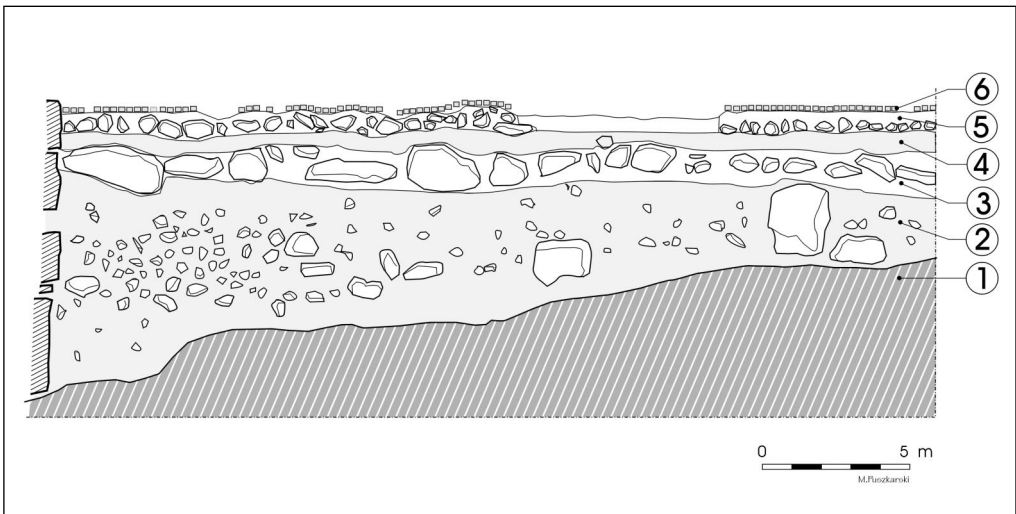
Fig. 4. Cross-section through layers excavated in the northern aisle of the church (Drawing M. Puzskarski)

A probe was dug in the northern aisle, about even with the side doors of the church and the second pillar. It measured 3 by 1.50 m and provided the following stratigraphic information (*Fig. 4*):

- on the very surface a mosaic floor of the 5th century, covering the northern aisle;

- lime substructure under it, some 3-4 cm thick;
- limestone floor, hard, decorated with haphazardly introduced mosaic cubes; it corresponds to the floor found under the mosaics in other parts of the church;
- floor substructure (ca. 15 cm thick) made of small stones in a loose brown soil matrix;
- light-brown soil constituting a layer 50 cm thick on the average, accumulated over the bedrock which drops slightly to the north; it yielded several mosaic cubes of different colors and roof tiles, suggesting that another older mosaic floor must have existed inside a building that may have been dismantled and reused in the construction of the basilica.

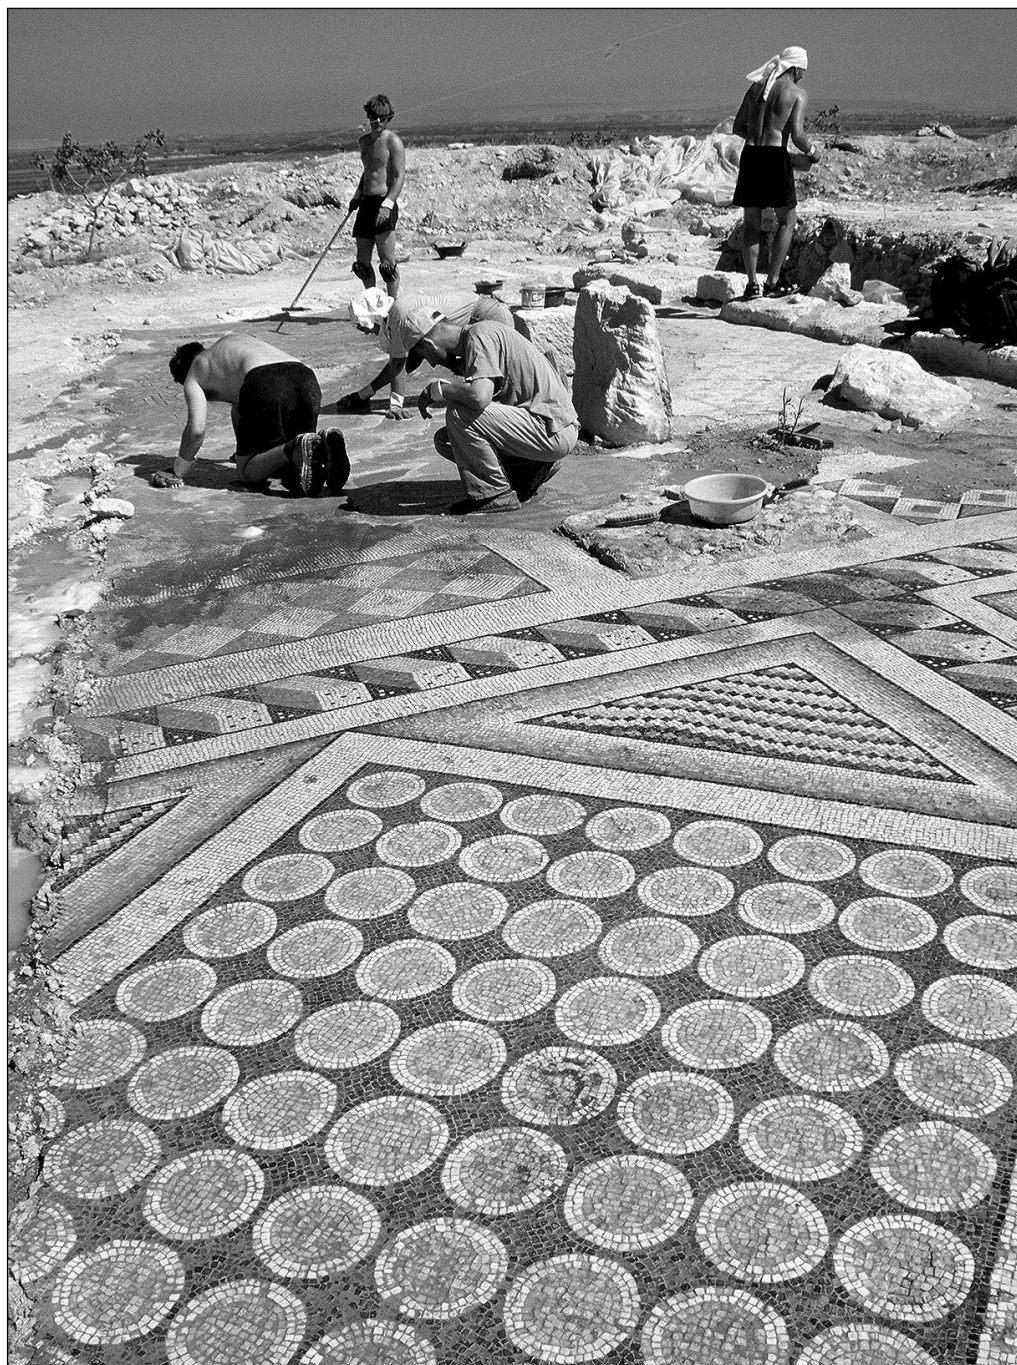
*Fig. 5. Mosaic floors in the nave and southern aisle  
(Photo T. Waliszewski)*

The mosaic floors surviving in the basilica cover a total area of c. 120 m<sup>2</sup> (Fig. 5). Each floor comprises four technological layers. An uneven layer of stones of differing size is laid directly upon the ground and fixed with the first layer of a lime-and-sand mortar. A second, white lime-and-sand mortar, a few centimeters thick, was poured over this first one, and it is in this layer that the different-color cubes of natural stone (c. 1 cm to the side) were set.

The floors have suffered considerable damage and extensive, irregular losses of

mosaic surface, frequently making it difficult to reconstruct the original geometric composition. The overall level, however, is fairly even with only occasional insignificant depressions. In the aisles there is an overall westerly sloping tendency, presumably due to the ground subsiding in a generally downslope direction. A narrow regular strip of lost cubes several meters long must be the outcome of plowing.

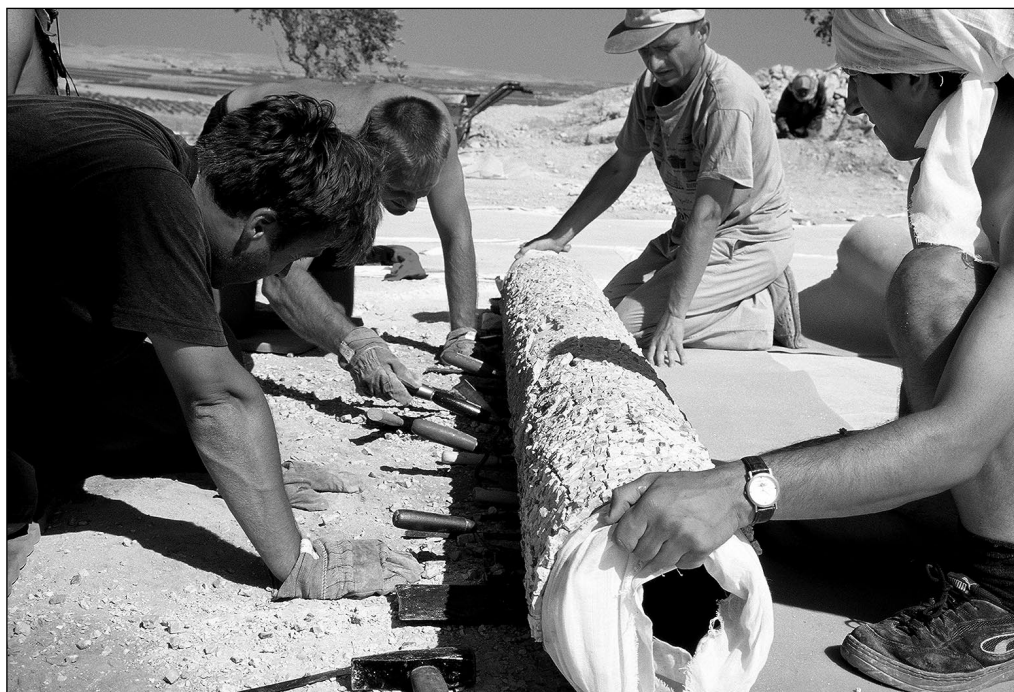
*Fig. 6. Conservators roll up the mosaic floor from the nave  
(Photo T. Wąliszewski)*

During the 2000 season all the surviving mosaic floors were removed and stored after appropriate protective measures had been taken. The mosaics were first photographed and drawn, then divided into over forty bigger and smaller

fragments, to be removed successively (*Fig. 6*). The borders of particular pieces were determined both by the arbitrary edges of the missing parts and by the original geometric decoration, this coupled with the technical possibilities.

After cleaning the surface, two layers of gauze and a thin linen fabric were glued to the mosaics with vinyl polyalcohol. Then the floors were divided into fragments removing the cubes found at the junctions. Once the fragments were cut away from their substratum, the pieces were transferred to wooden boards and turned over in order for the underside to be cleaned of mortar. This was done in order to lessen the weight of particular fragments and to increase their cohesiveness. This done, the mosaic fragments were packed in layers of foam and moved to a storeroom.
