Naglun 2001 : Wall Painting Transfer and Conservation

Polish Archaeology in the Mediterranean 13, 171-177

NAQLUN 2001: WALL-PAINTING TRANSFER AND CONSERVATION

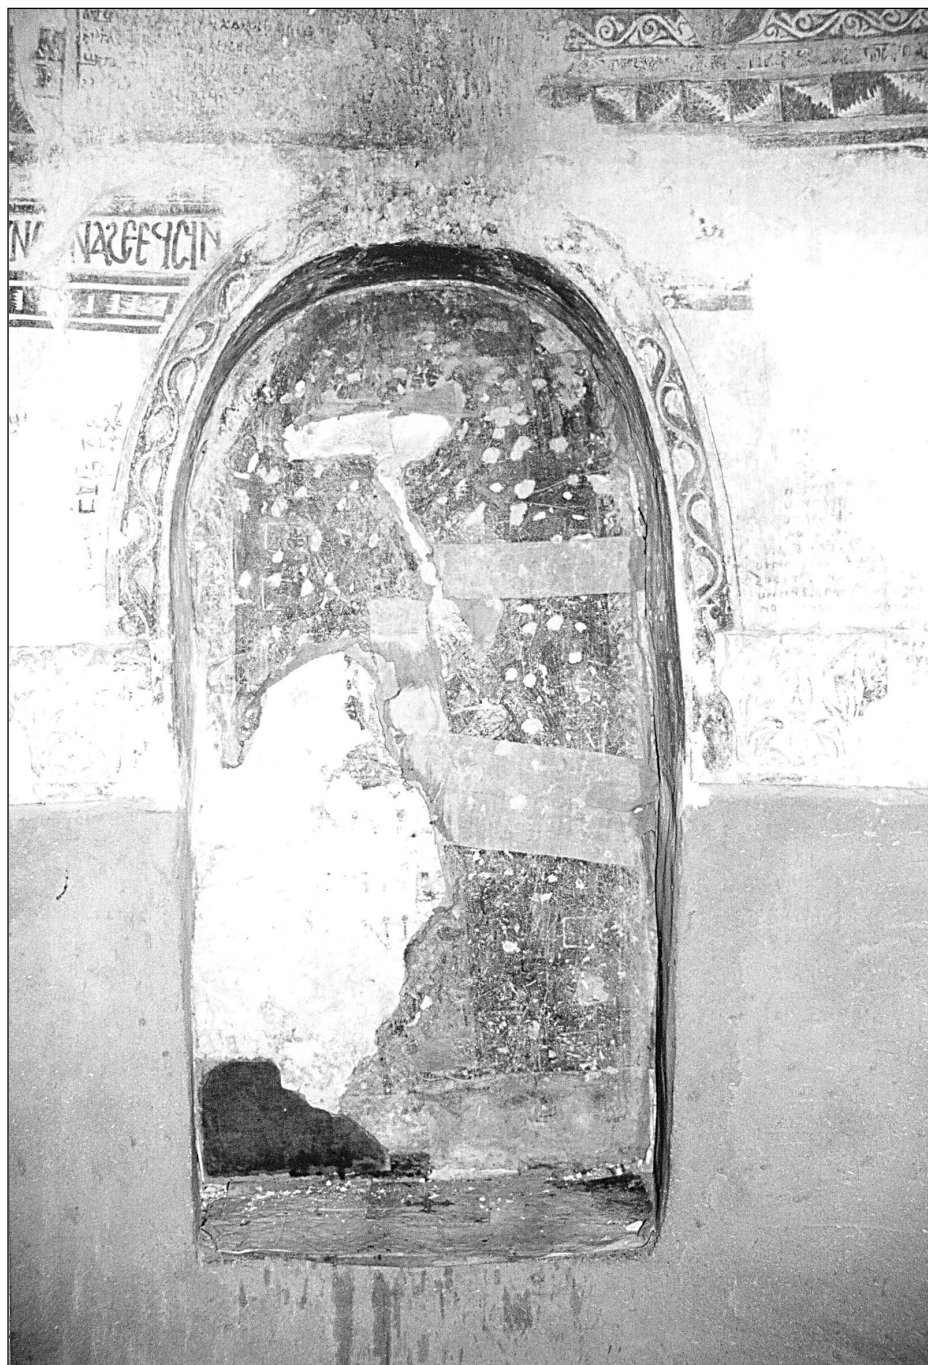
The painting, discovered in 1995 under layers of undecorated plaster, was in a very bad condition, having suffered considerable damages during the various stages of the church's building history. The original plaster was cracked in several places and detached from the painting underneath, practically hanging only at the edges. A larger crack had divided it into two major pieces and several smaller ones. A big part of the composition was missing (40%), including fragments of the Virgin's head. Intentional hammering in preparation for re-plastering was in evidence. The paint layer was covered with a thick layer of soot and grease from candle smoke, incense and chrisim, which are common agents of deterioration for wall paintings, especially near the main altar, making lines and colors illegible. Several scratches were observed,

including an Arabic graffito. The green color was very flaky. Red and black were powdered. The upper part of the framed niche was partially washed, as a consequence of water seeping in from the window (which is no longer the case after the blocking of the window).

Fig. 1. Wall-paintings in the central niche of the church apse, before conservation
(Photo C. Calaforra-Rzepka)

Consolidation *in situ* was unacceptable from the beginning. Injections of glue between the two layers would have certainly caused irreversible damage to the earlier mural, the consolidating agent penetrating through all the inner layers and ruining them in the process. It was

therefore decided to transfer the upper paint layer.

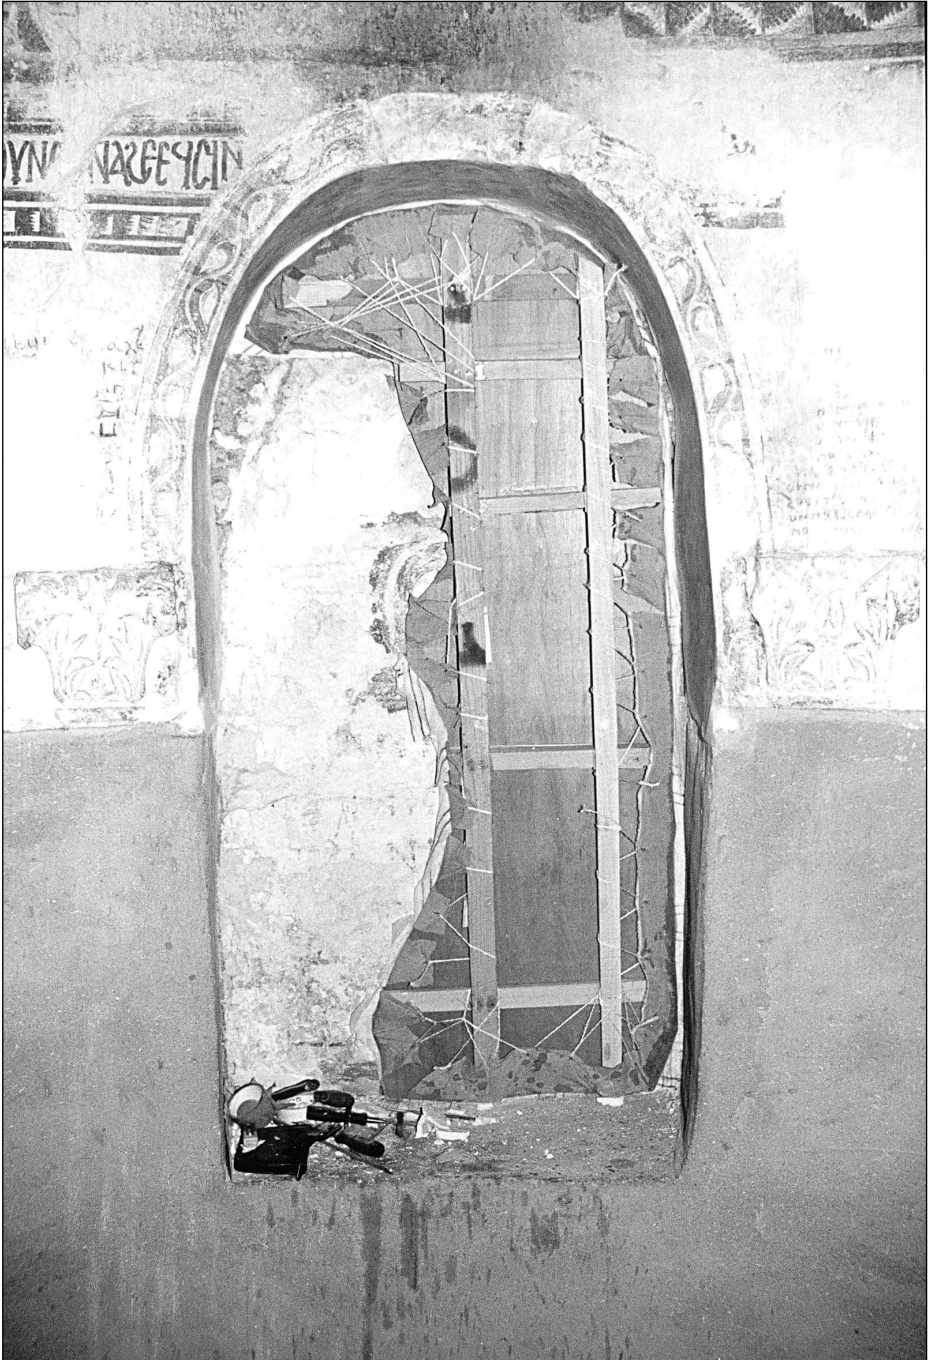
separate the original plaster from the wall, especially in the upper part, where the earlier paint layer was not preserved (*Fig. 2*).

*Fig. 2. The painting of the enthroned Virgin in the process of being transferred
(Photo C. Calaforra-Rzepka)*

The chosen method was "*stacco*", a technique that requires the mural painting to be transferred together with the original plaster. The facing canvas was bigger than usual and extended about 5 cm beyond the original layer, covering the borders of the wooden frame and firmly attached to it. Then one fragment of the painting was separated from the rest without any problems (it just hung there by the edges), but in the second case, long chisels and a hammer had to be used to

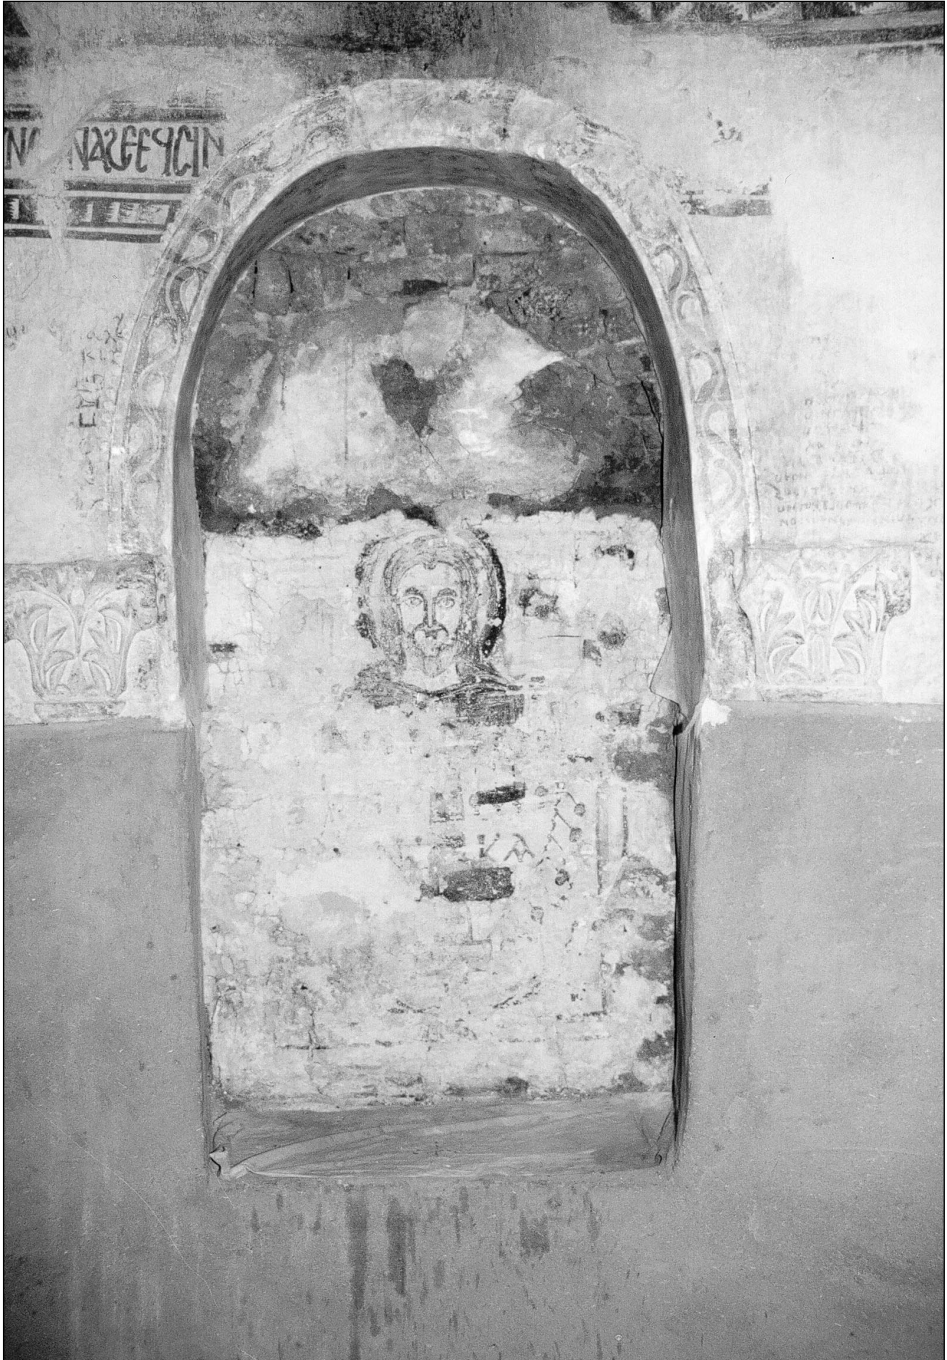
The painting underneath, which was visible through the gaps, bore testimony to an earlier decoration not found in other parts of the church. The colors were clean and bright and it seemed that a cross had been represented in the niche before.

*Fig. 3. The earlier wall-painting representing Christ on the cross
(Photo C. Calaforra-Rzepka)*

After completing the stripping, the earlier paint layer (representing Christ on the cross, *Fig. 3*) (was dry-cleaned with natural and fiber-glass brushes, soft gums and wihsab sponges. Tampons of acetone and alcohol solutions were used for chemical cleaning of the paint layer. Then the surface was fixed with a 2% paraloid B-72 (Rohm and Haas) solution in toluene. The plaster was consolidated with injections of Primal E330 (1:3 water solution) and Primal AC-33 (1:3 to 1:1 water solutions) for larger voids and cracks. The glue injections were preceded by alcohol injections (40%) for better penetration of the consolidant.

Once the painting was consolidated, the cracks and empty spaces were filled with new plaster. The composition of the mortar was 1 part of lime to 4 of sand, with a small addition of Primal E330 for more elasticity. The smaller gaps and cracks were filled with Italstucco (prod. Ditta F. Follador-Milano). The retouching and final aesthetic arrangement was postponed to the next season, once it will have been made certain that nothing is happening with the representation of Christ.
