Marina El-Alamein: Conservation Work, 2001

MARINA EL-ALAMEIN CONSERVATION WORK, 2001

Stanisław Medeksza

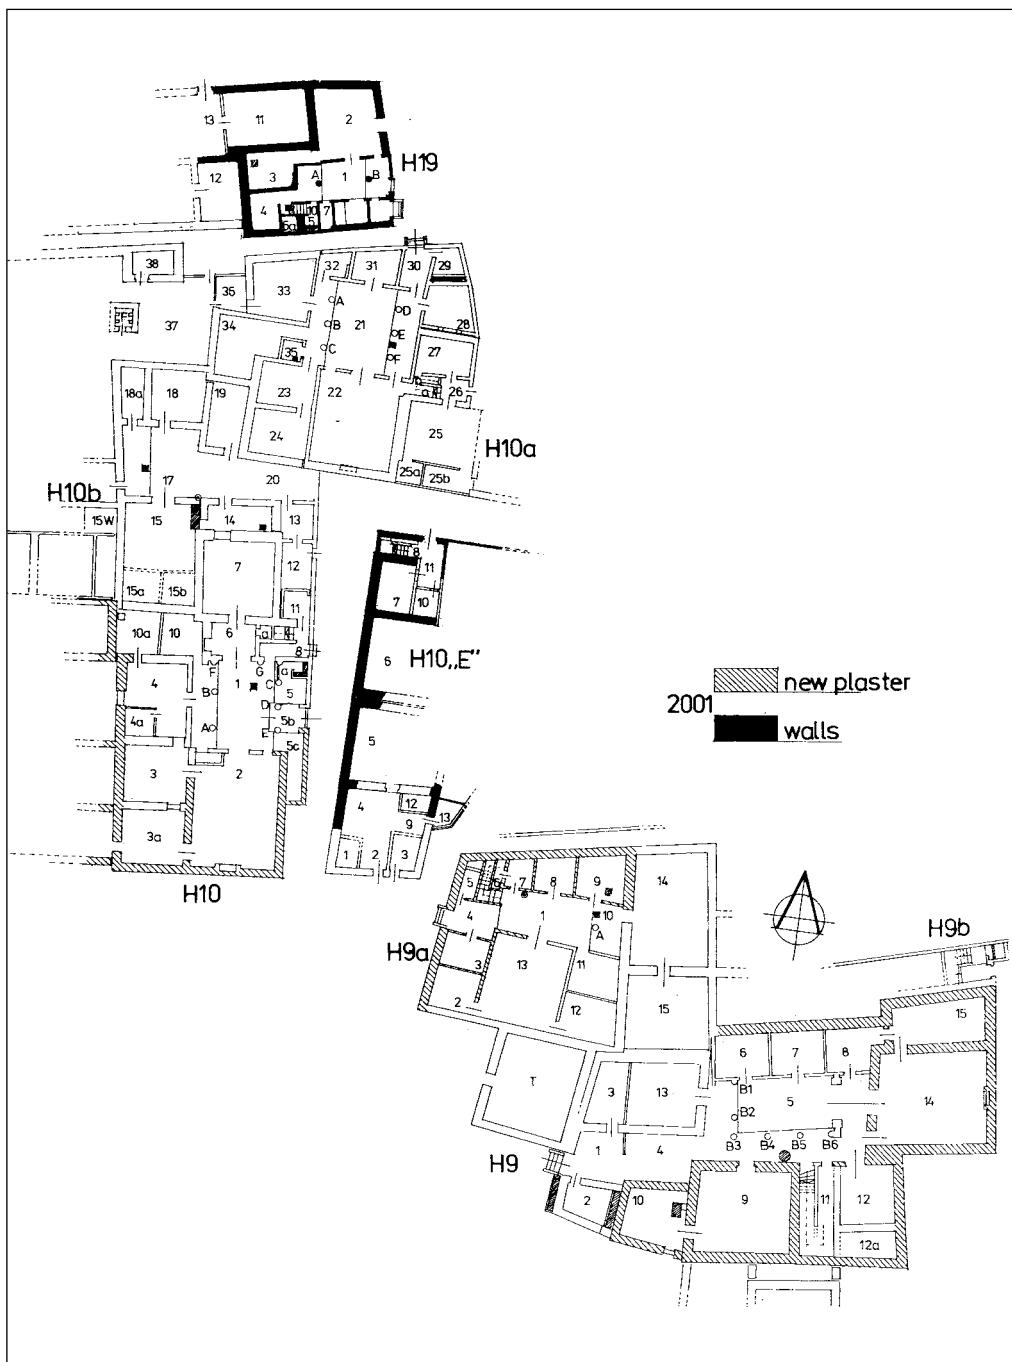
Fig. 2. Houses H 9 and H 10 with H 19 and H 10"E". Plan showing extent of work in 2001 (Drawing S. Medeksza)

undertaking conservation in the coming season (*Fig. 2*).

2. House H 10“E”. The house lies opposite the H 10 complex, separated from it by a N-S street (cf. *Fig. 2*). Only the eastern side, some thirteen units, has been recognized so far, even so there is ample evidence for agglutination as the principle of architectural development here. Blocks

1. House H 10b. Work focused on the northwestern part of the house and the alley separating it from neighboring house H 19. Room 38 (3.30 by 1.86 m, cf. *Fig. 2*) was cleared and a probe dug to a depth of 1.80 m. The stratigraphy here proved undisturbed, facilitating the study of successive occupational levels. The small finds from these layers – oil lamps, bone pins, cooking ware (pans), tableware, amphorae, bronze objects and coins – reflect a chronological horizon from the last thirty years of the 1st century through the 2nd century AD. Previous results with regard to the multiphase character of the private residential building in Marina have been confirmed, revealing yet again the presence of an occupational level dating to the second quarter of the 2nd century AD. Below this level, at a depth of 0.70–0.75 m, there appears an occupational level dated to the last quarter of the 1st century AD.

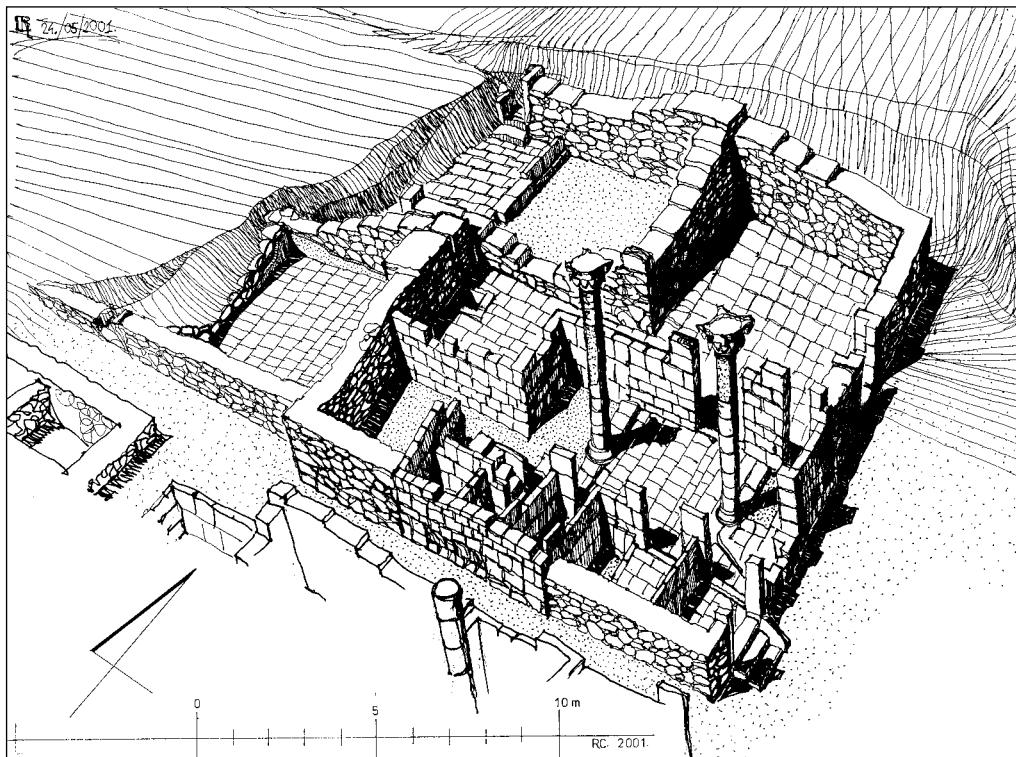
*Fig. 3. House H 19. Axonometry after the 2001 season
(Drawing R. Czerner)*

1. House H 19. While the western end of the building still escapes study, its northward extent has been traced (*Fig. 3*). Room 2 turned out to be a corner space, adjoined on the west by room 11 (6.65 by 4.15 m). The northern wall of these rooms was at the same time the outer wall of the structure, and running westward along it was another alley, parallel to the one separating the house from neighboring house H 10a to the south. A doorway with stone jambs interrupted this wall just beyond room 11; through it one enters room 13. Only a thin partition wall (built of stone slabs measuring 0.50 x 0.35 x 0.16 m)

separated the two rooms, which were connected by means of a doorway, 10.5 m wide, situated in the middle of this wall. The last of the newly discovered chambers, room 12 (4.76 by 3.40 m) was entered from the part of the house, which as yet escapes recognition, through a doorway 1.06 m wide.

Practically, all the walls in the newly uncovered part of the house were built of broken stone bonded in a lime-clay mortar. Only the walls between rooms 3 and 4, and 12 were of mud brick in a clay mortar and on a stone underpinning. All were covered with lime plaster.

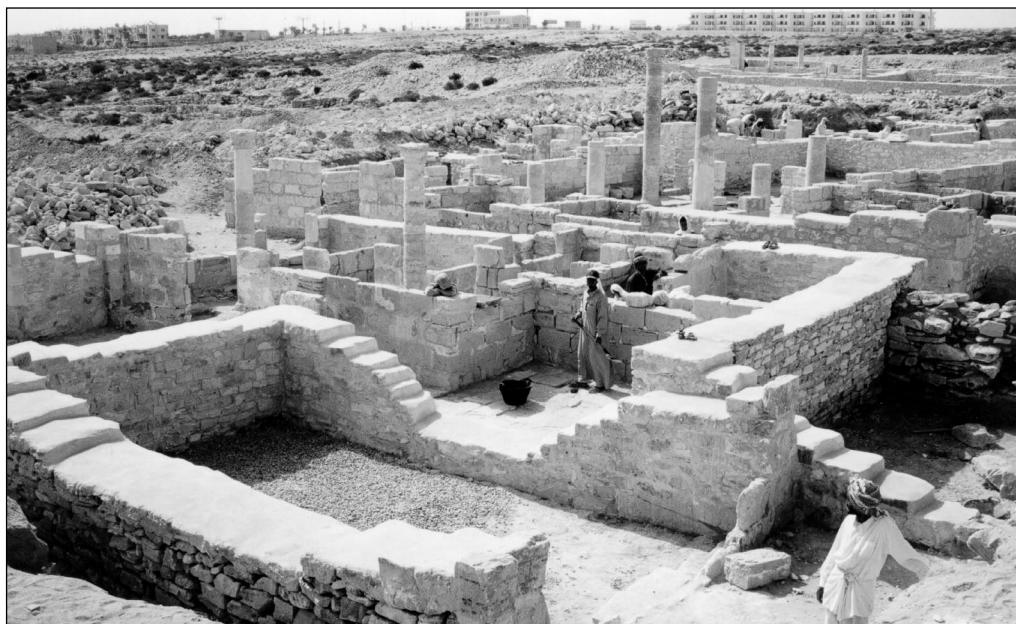
Fig. 4. House H 19. View from the northwest, state after the 2001 season
(Photo S. Medeksza)

3. House H 19. The main thrust of building conservation activities this season, beside H 21c, was focused on this house (*Fig. 4*). Two columns with Nabatean-style capitals⁴⁾ were raised in the courtyard. All the walls around rooms 1, 2, 3, 4, 5, 6, 6a, 7, 8, 9 and 10 were either re-laid or raised. In room 11, all the walls except for the west one were raised, while in room 12 only the east wall and part of the north wall could be raised. In room 13, the northern outer wall of the house was extended to reach the eastern jamb of the street entrance.

The wall between rooms 3 and 4 and the west wall of room 12 were originally made of mud brick in a mud mortar bonding. Without expensive chemicals there is no way to preserve such construction. Thus, for the sake of momentary preservation – until the necessary funds will have been raised – these walls have been encased in a stone facing and capped with closely fitting slabs, using lime mortar for bonding and introducing appropriate draining facilities.

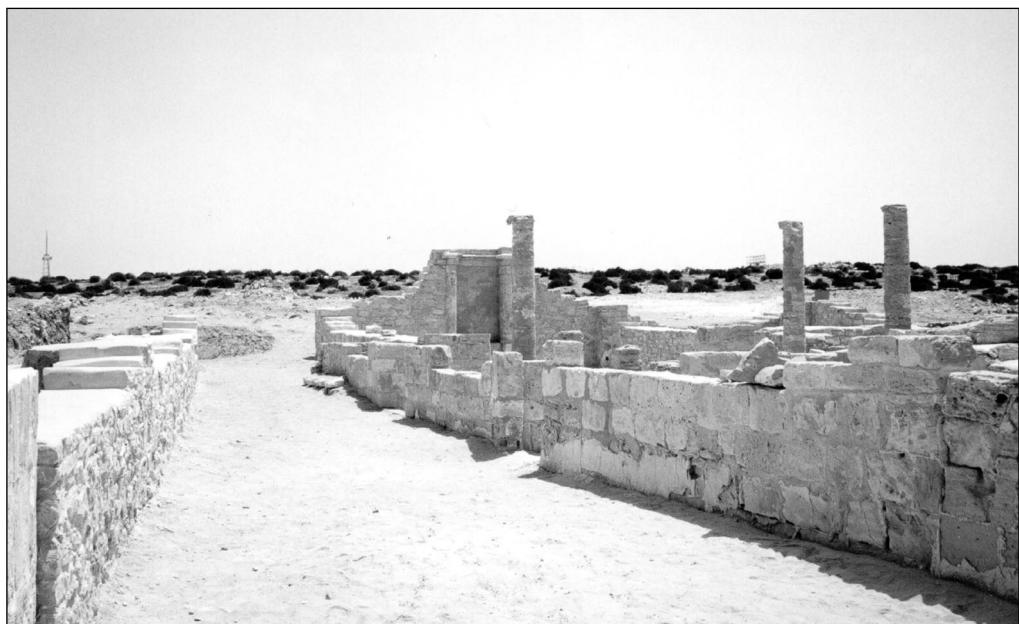
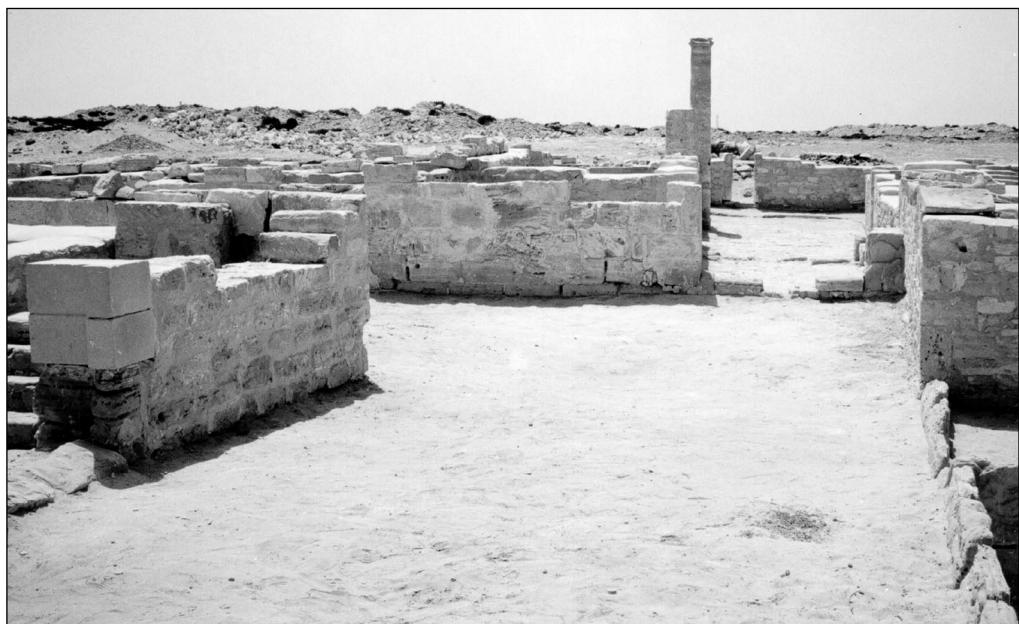
Fig. 5. Street running N-S between houses H 10 and H 10"E", view from the north, from the corner of the E-W street in Fig. 6 (Photo S. Medeksza)

Fig. 6. Street running E-W between houses H 10a and H 10"E", view from the east toward the corner of the N-S street in Fig. 5 (Photo S. Medeksza)

2. House H 10"E". Some building conservation work was carried out on the outer northern and western walls, and the entrance to room 11 on the north, as well as the partition walls in order to clarify their course and raise them in height to an average 1.20 m. The partial restoration of

the western outer wall of house H 10“E”, which helped to set off the street running in front of the entrance to house H 10, enriched the display of the ancient residential quarter in Marina (*Figs. 5, 6*).

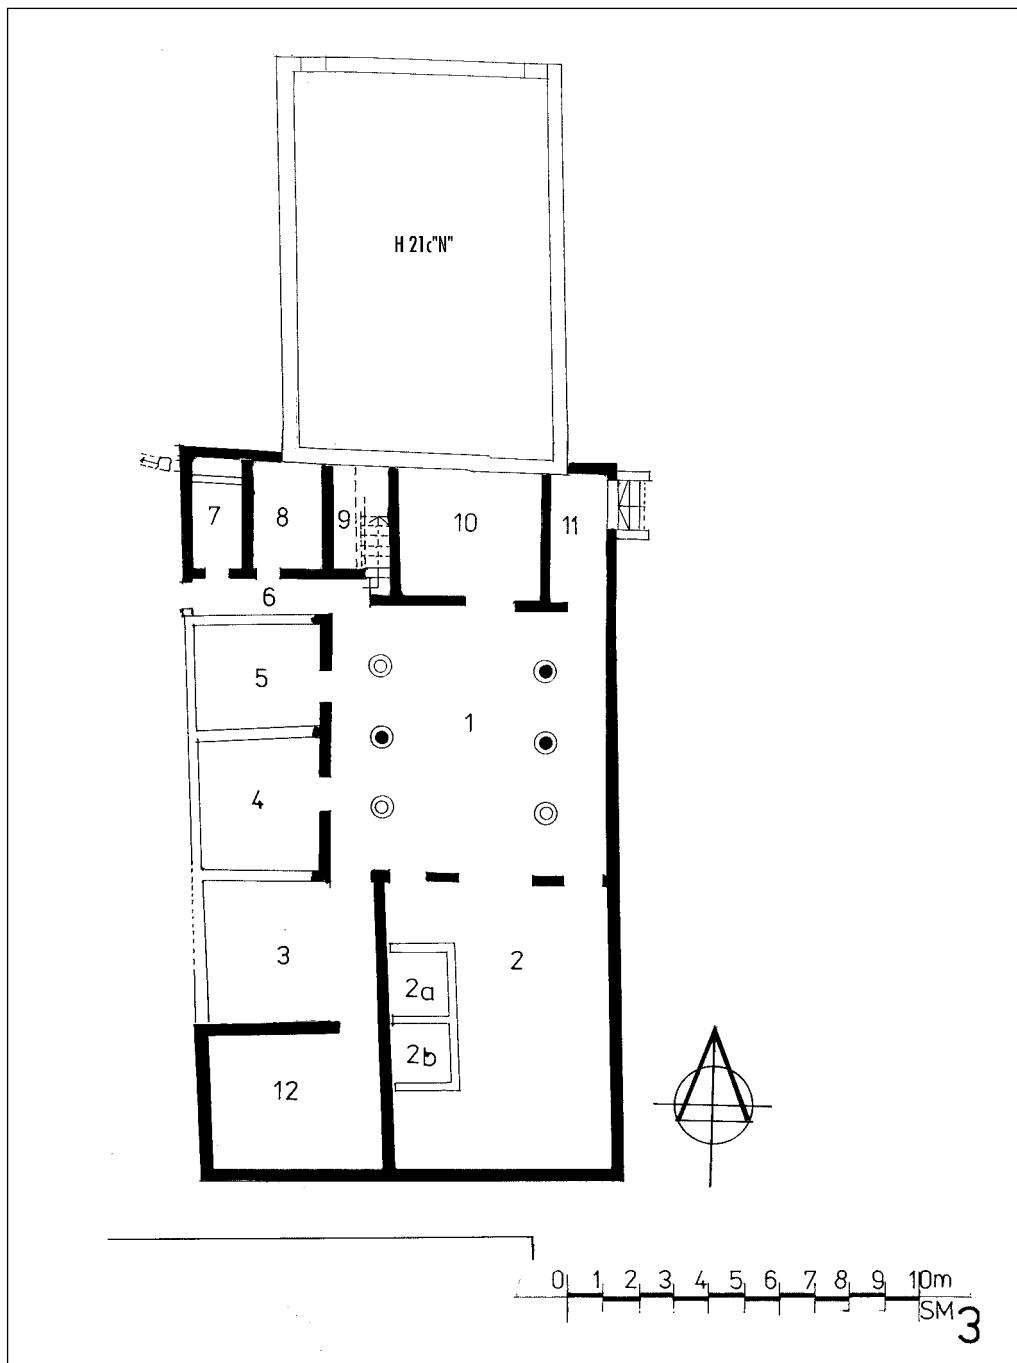
Fig. 7. House H 21c. Plan showing work completed in 2001
(Drawing S. Medeksza)

the structure is now quite clear. The house is not connected with any other building in the quarter except for the hall to the north of it and even with it there is no direct connection. This hall (H 21c "N") lies on a level 1.30 m lower than H 21c; it measures 10.45 by 7.50 m (cf. Figs. 7, 9). Like the house, it, too, must have served some other than residential purposes. Visually, the hall does not interfere with the architectural homogeneity of the complex; hence, it will be included in the restoration program.

4. House H 21c. A complete anastylosis of two columns in the eastern portico of the courtyard was carried out (*Figs. 7, 8, 9*). The remaining columns were raised as much as the preserved stone elements permitted it. Furthermore, the outer and partition walls were both easily

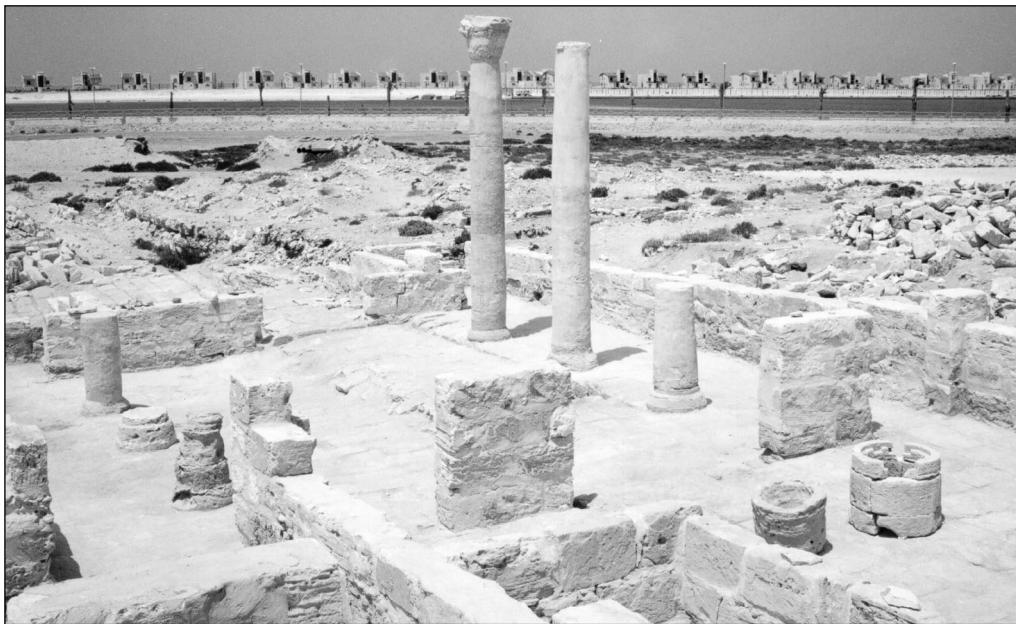
*Fig. 8. House H 21c. State after the 2001 season, view from the southwest
(Photo S. Medeksza)*

reconstructed from fallen blocks, lying obviously undisturbed from the time of the cataclysmic earthquake that had toppled the building. The lime mortar used in the restoration had a small proportion of white cement mixed in for the sake of durability.

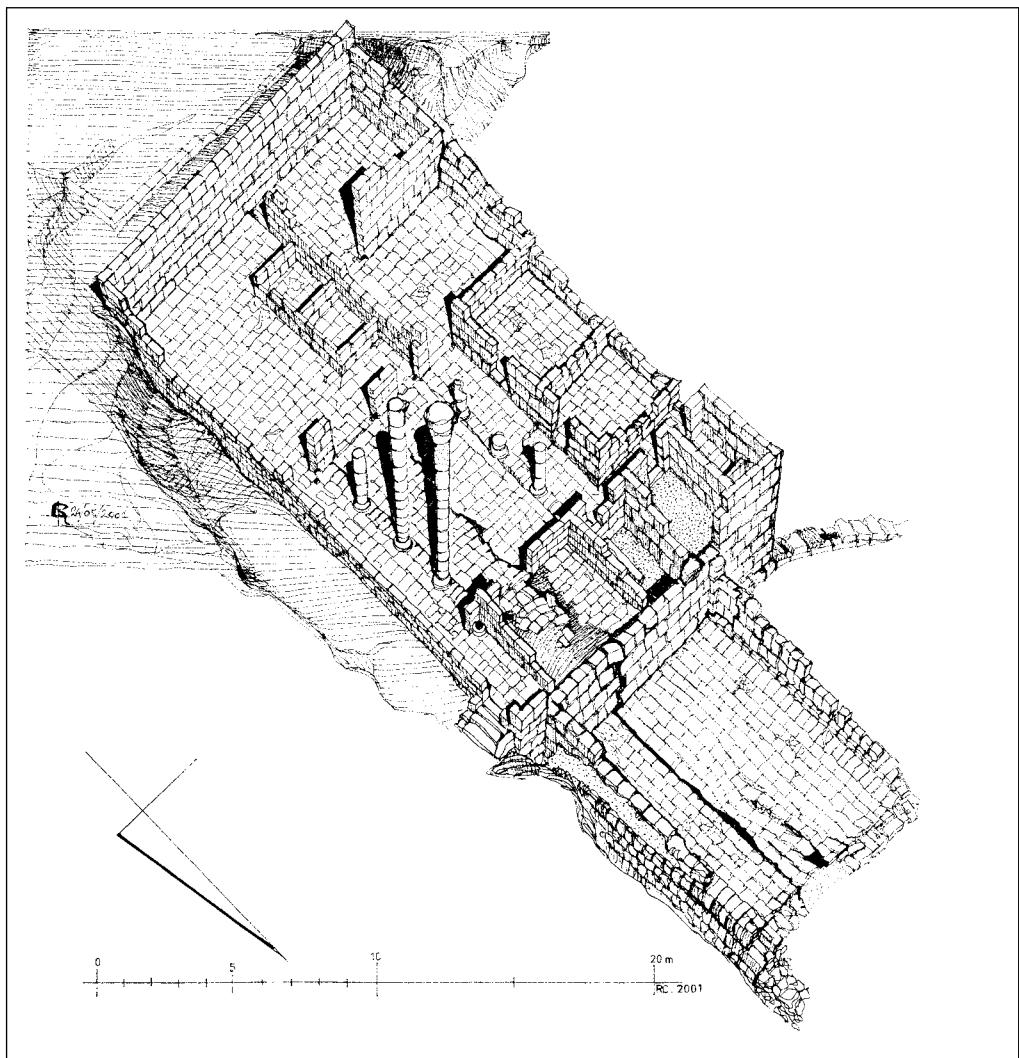
*Fig. 9. House H 21c. Axonometry after the 2001 season
(Drawing R. Czerner)*

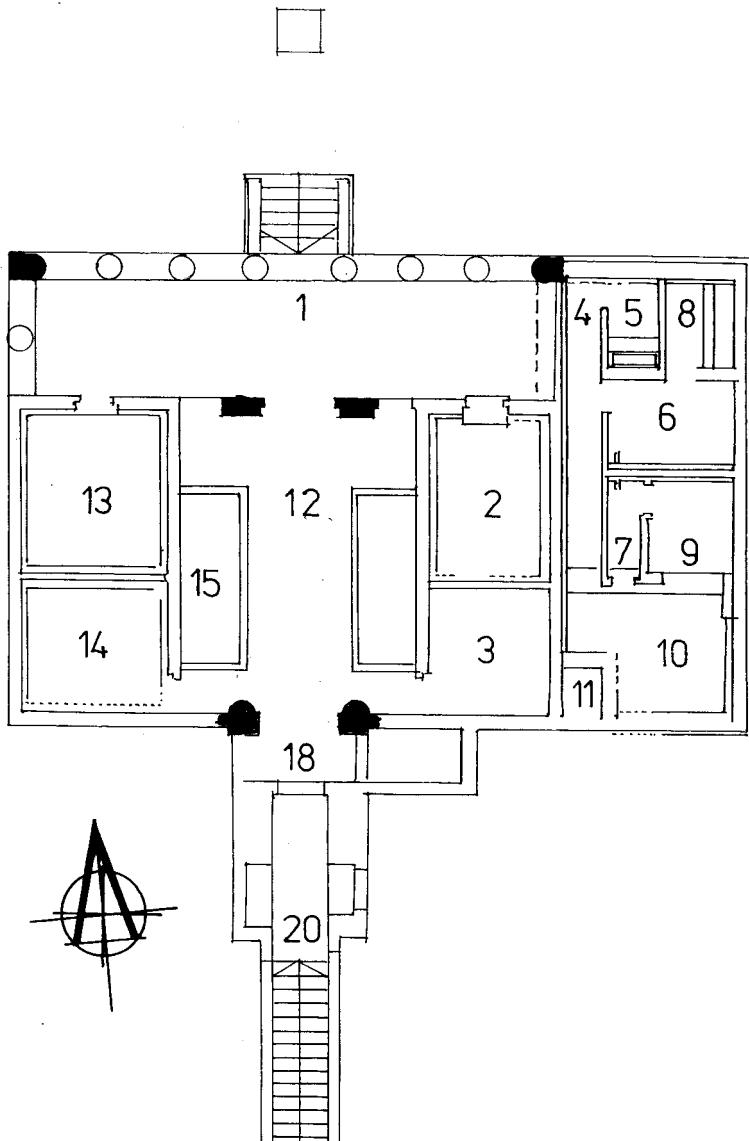
Fig. 10. Tomb-hypogeum T 6. Plan of aboveground mausoleum. Elements introduced in 2001 are marked in black (Drawing S. Medeksza, after K. Kamiński et al., PAM X, Reports 1998 (1999), 44)

5. Tomb T 6. Specialist stonecutting complemented last year's building restora-

tions, helping to emphasize the main line of symmetry that runs through the mausoleum (*Fig. 10*). Helwan limestone was used for the drums of engaged columns, reveals and profiled niche framing (*Fig. 11*). The only exception, with regard to the stone material used, is a block belonging to a monolithic pillar with

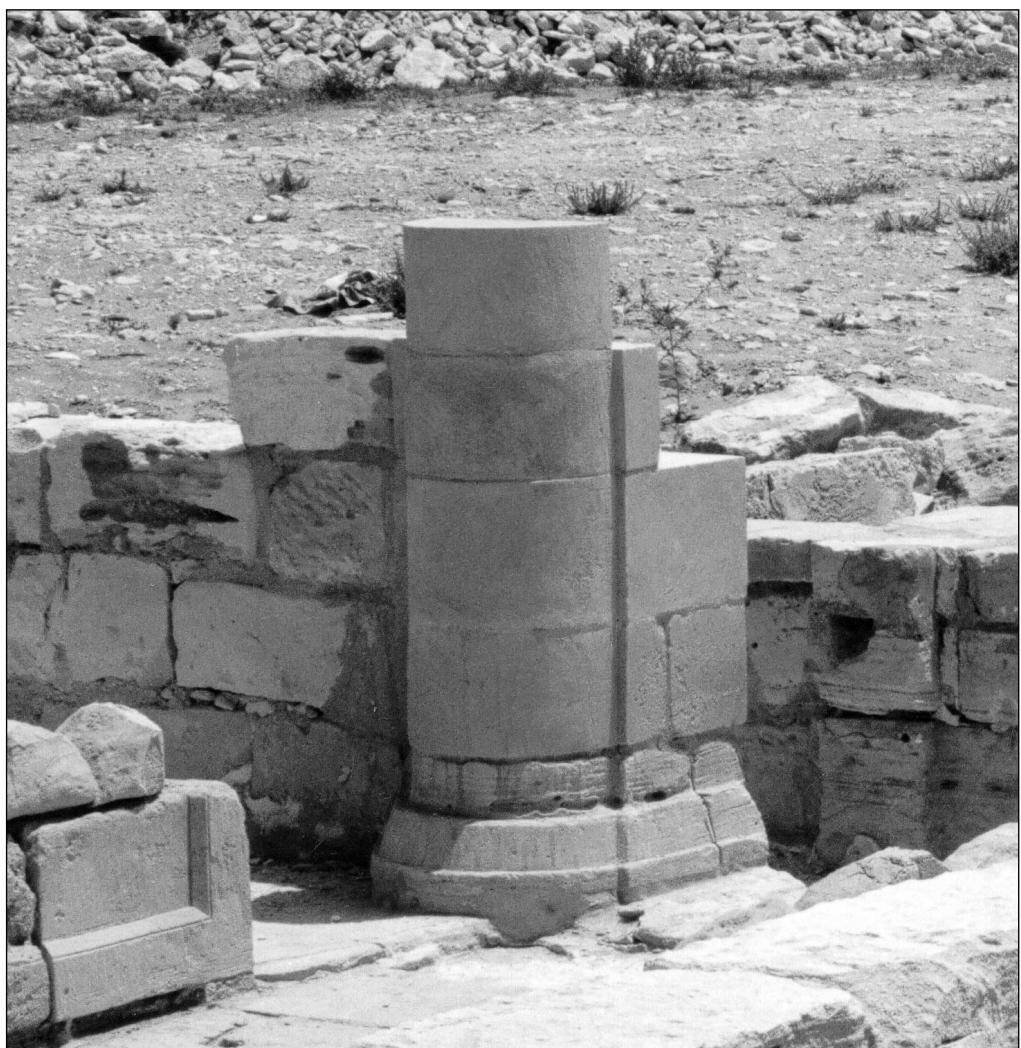
Fig. 11. Tomb-hypogea T 6. A newly cut stone element in the aboveground mausoleum (Photo S. Medeksza)

engaged column that flanked the main entrance to the portico on the west; owing to the size of this element, it had to be cut in a single block of Tura limestone.

All the blocks were fitted and dry-laid, leaving a joint 1-3 mm thick. *Anathyrosis* of the surface helped to achieve a better fit. Four engaged column drums were mounted

using for bonding lime mortar with some white cement for the sake of durability. An epoxy binder was used to join elements made of the much harder Helwan limestone. The new material will thus be tested at the site to see how it reacts to varying atmospheric conditions existing there.

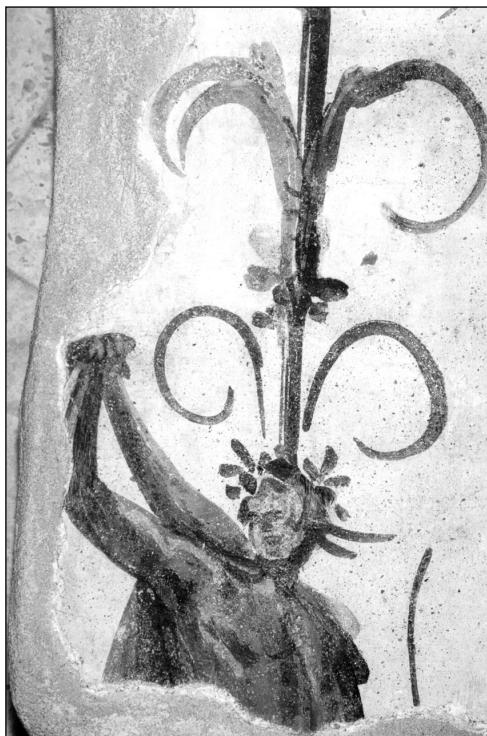
Fig. 12. Fragment of a grotesque painting from H 10a, after conservation (Photo S. Medeksza)

Work proceeded as planned on a fragment of grotesque mural discovered last year.⁵⁾ It will be displayed on the original stone ground, hence the need to fill in the structurally weak parts of the stone block around the broken plaster edges (*Fig. 12*). Conservation of a piece of mural depicting a female head crowned with the prow of a ship⁶⁾ was completed. The eight fragments were joined together with epoxy resin and the surface treated comprehensively to prepare the piece for museum display (*Fig. 13*).

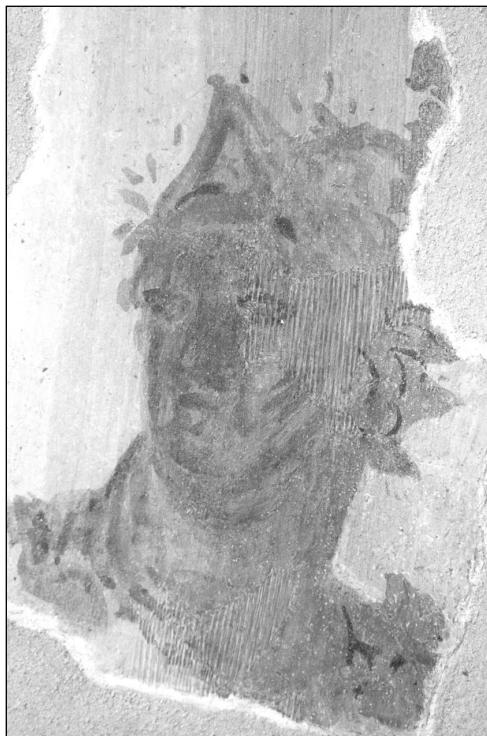
Fig. 13. Female head crowned with the prow of a ship from H 10“E”, after conservation (Photo S. Medeksza)

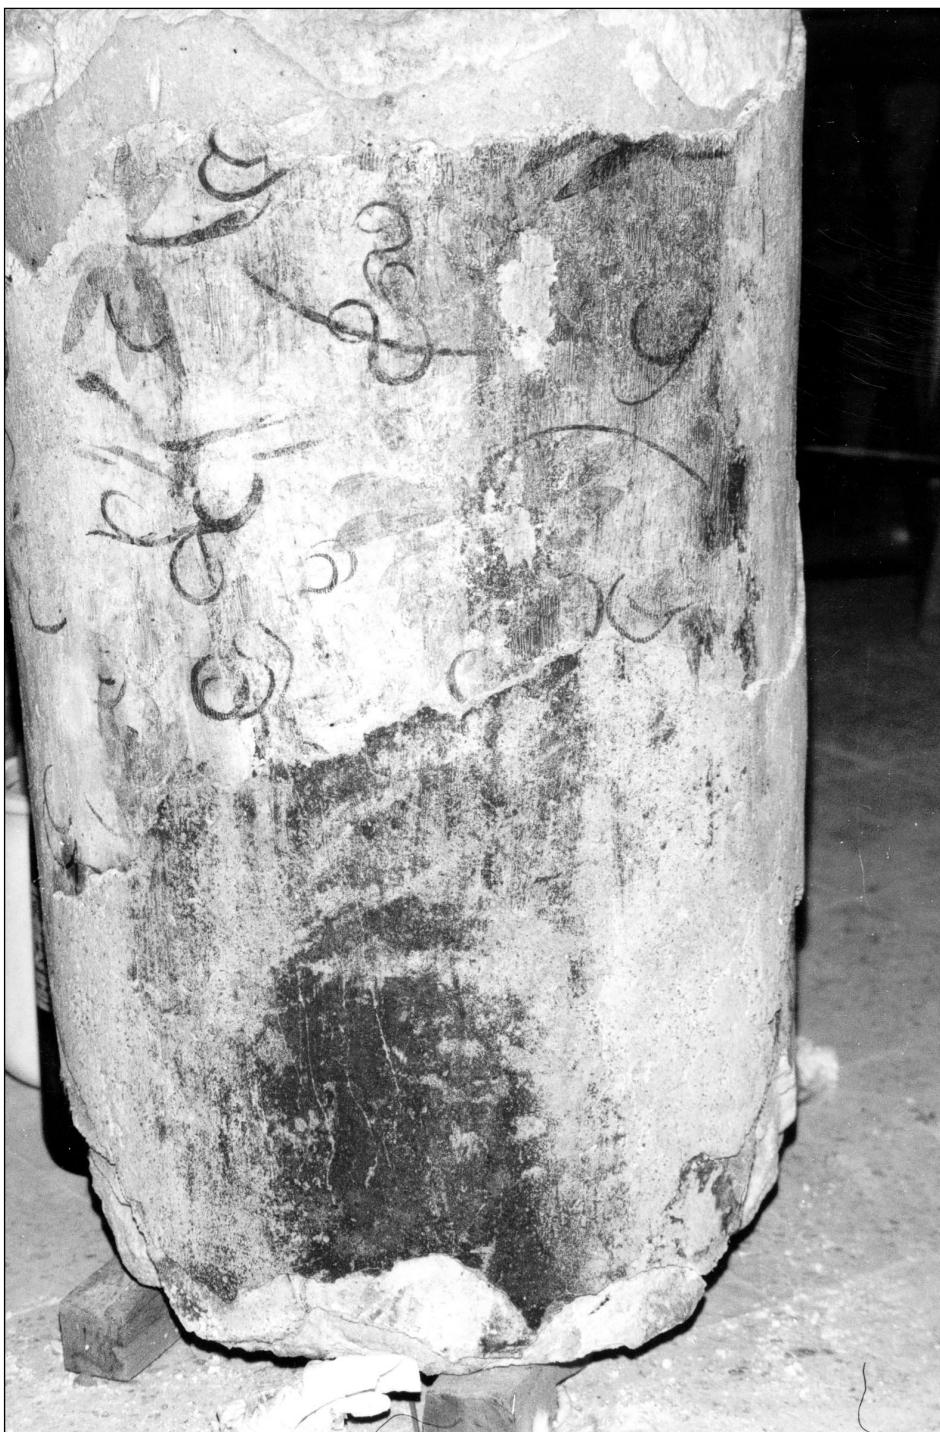
Fig. 14. House H 21c, room 12: Column shaft with two layers of painted plaster, under conservation
(Photo S. Medekszai)

A piece of decoration of importance for understanding the phasing of painted decoration in house H 21c was uncovered in the center of the newly cleared room 12. It is a plastered and painted column shaft, 0.343 m in diameter, 0.55 m high. Of the two layers of plaster, the initial one survives over a greater expanse of the shaft (*Fig. 14*). Originally, the decoration consisted of a scrolling vegetal ornament. The second layer seems to have been a monochromatic red. The stone shaft is in good condition; the conservator's chief goal in this case was to halt deterioration processes.
