Wall-Painting Transfer and Conservation at Naqlun : Part 2

Polish Archaeology in the Mediterranean 14, 185-187

WALL-PAINTING TRANSFER AND CONSERVATION AT NAQLUN

PART 2

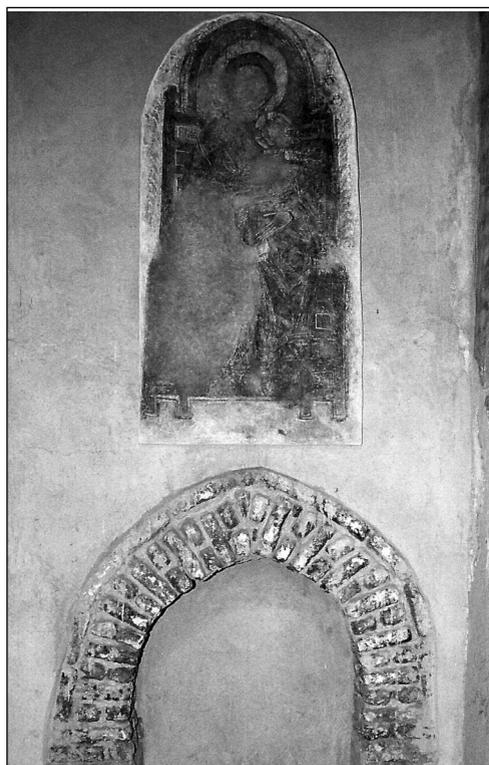
Fig. 1. *The Virgin-and-Child painting reinstalled in the church narthex (Photo C. Calaforra-Rzepka)*

As a final step, the transferred picture was screwed onto the south wall of the narthex, beside other paintings from the

same period (*Fig. 1*). This will prevent any further damage due to accidental transport of the object, while putting the painting

high enough to be out of reach of visitors. The mounting holes were then filled with plaster and retouched.

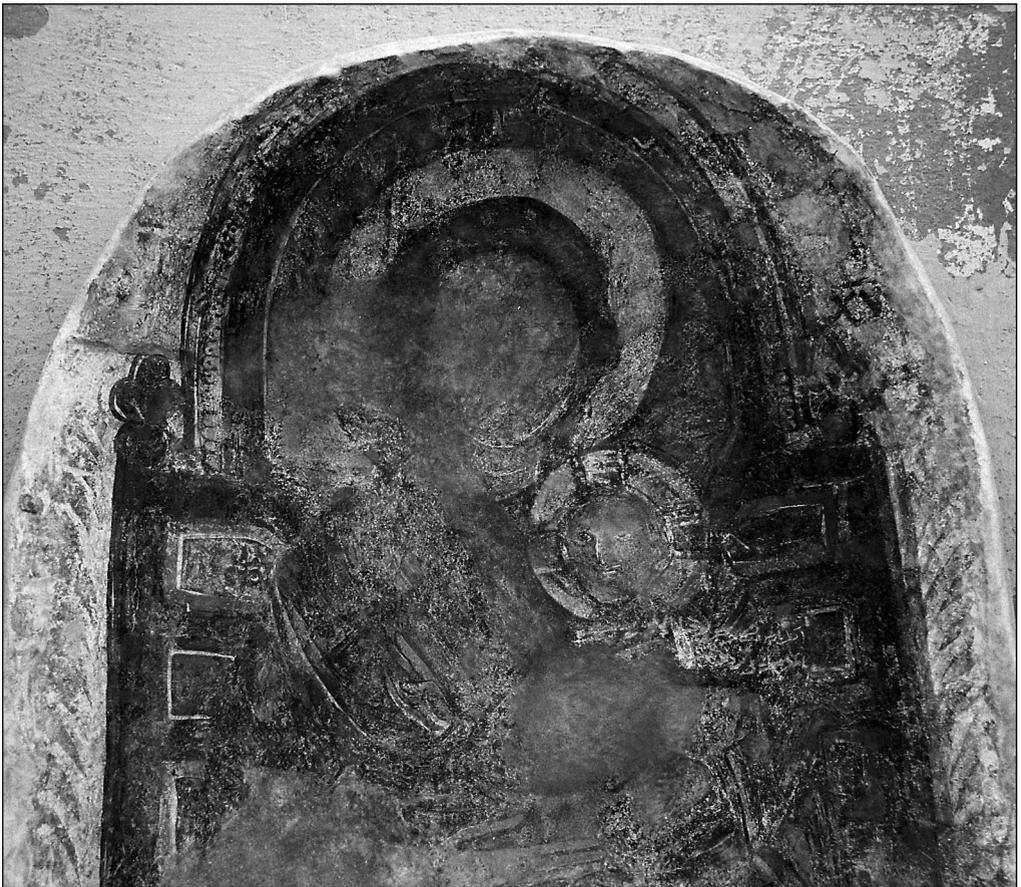
Fig. 2. The upper part of the composition of the Virgin and Child from the central niche of the church apse, after retouching (Photo C. Calaforra-Rzepka)

The final aesthetical arrangement of the transferred representation of the Virgin and Child, which had been postponed from the last season, was now the chief objective. The procedure of retouching was done in the same watercolor technique as in the case of the earlier layer of painting. In view of the fact that the church continues to be in use and is heavily visited by pilgrims, not to mention scholars, it was deemed appropriate to reconstruct parts of the missing composition in order to make the whole entirely more legible.

The smaller gaps were first filled with local color lighter than the original, tracing lines and shapes that had not been legible at the beginning of the work. This was followed by a partial reconstruction of the basic shapes, such as ovals of heads and haloes, hands, and the outline of the throne. The reconstructed lines were blurred to suggest the shape, but without any details, which can be discerned only on the original parts (Fig. 2).
