Deir El-Bahari: The Temple of Queen Hatshepsut : Season 2001

THE TEMPLE OF QUEEN HATSHEPSUT

SEASON 2001/2002

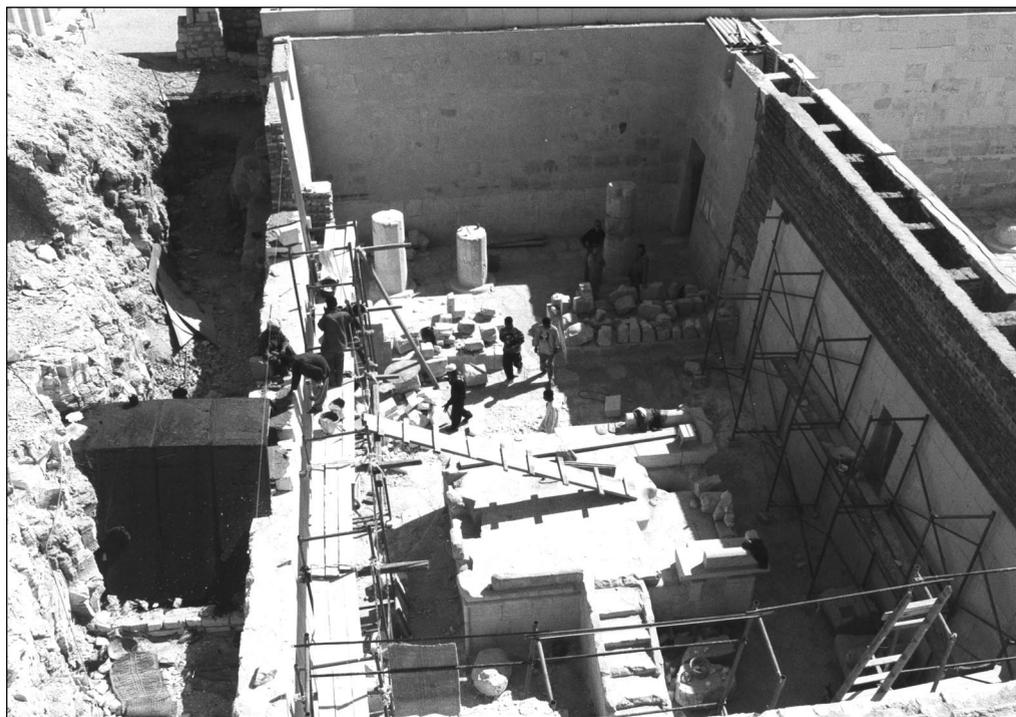
Fig. 2. Work on the construction of the north wall of the Solar Court and concrete ceiling above the Upper Chapel of Anubis (Photo M. Jawornicki)

The work on the northern wall of the court was connected with the construction of a concrete vaulted ceiling above the Upper Chapel of Anubis to protect its structure against possible danger from above (*Fig. 2*).³⁾ An iron framework was constructed, supported on the east by a newly built bench made of rough limestone blocks, and on the west on a similar bench constructed earlier to protect the foundations of the chapel.

The empty space behind the north wall of the solar court was filled with debris up to the top of the newly constructed

protective ceiling. Drainage will be installed in the next season.

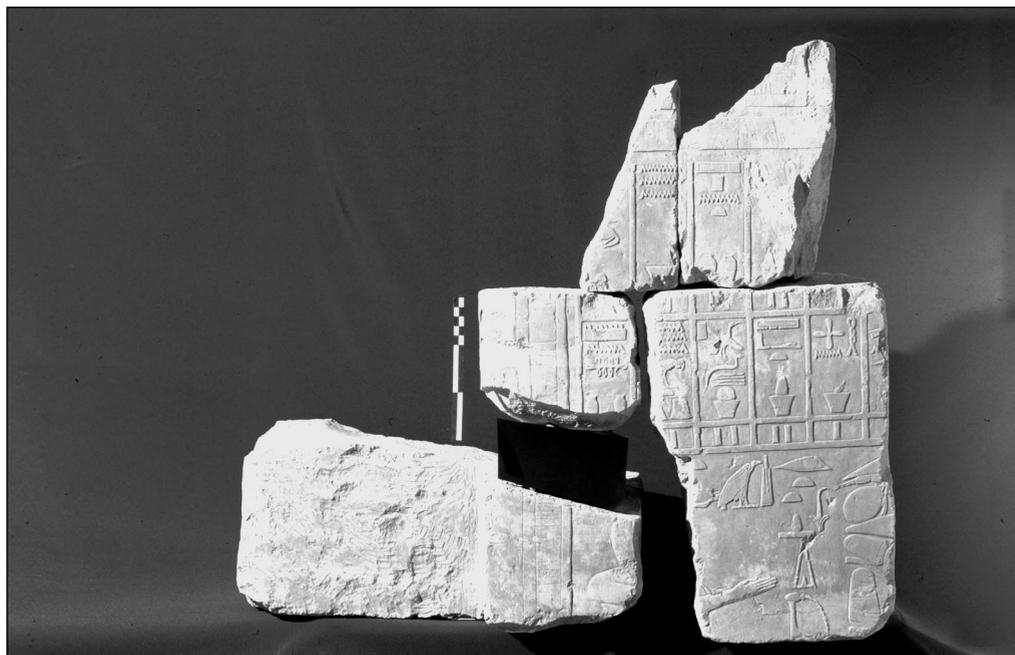
*Fig. 3. Fragment of the niche replaced by the Upper Chapel of Anubis
(Photo M. Jawornicki)*

The lintel above the entrance to the chapel, the doorjambs of which had been reconstructed in previous seasons, was completed this year.⁴⁾ Two original blocks decorated with the winged sun-disc and a fragment of inscription accompanying it were used in this reconstruction. A gypsum molding of the third block was inserted in the left part of the lintel. In this case the original block could not be used, because a lateral surface was also decorated, the decoration originating from a niche that

had been built into the north wall of the court originally and then replaced by the present chapel of Anubis. Since more blocks from the original niche have been found (*Fig. 3*), it will be possible to display it in the future, perhaps on the bench at the rear of the chapel of Anubis, thus conveniently illustrating the different stages in the architectural development of the temple.⁵⁾

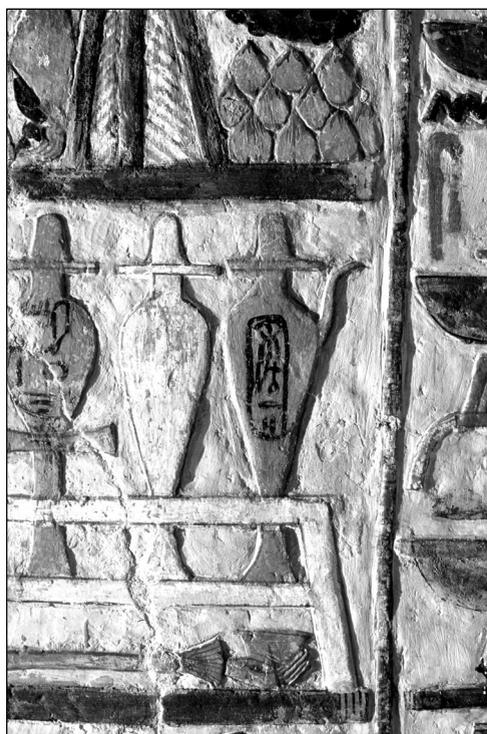
Fig. 4. A detail from the decoration of the Upper Chapel of Anubis, after conservation (Photo M. Jawornicki)

Earlier conservation work in the chapel of Anubis had been restricted to the most endangered places. The present effort concentrated on a thorough conservation of the decoration (*Figs. 4-5*). The polychromy⁶⁾ preserved in the chapel was cleaned

after first consolidating the damaged parts with PRIMAL AC-33 (Rohm & Haas). The blue and green pigments, which are highly susceptible to dirt and dust absorption, were cleaned with CONTRAD 2000 (10% solution in water). Modern putties from the earlier conservation treatment were replaced with new ones. Surviving ancient putties were carefully consolidated (with injections of PRIMAL AC-33). As a last step, the pigments and ancient varnish applied in some parts of the decoration were reinforced with PARALOID B-72. All traces left by ancient restorers from the post-Amarna times were also carefully preserved.

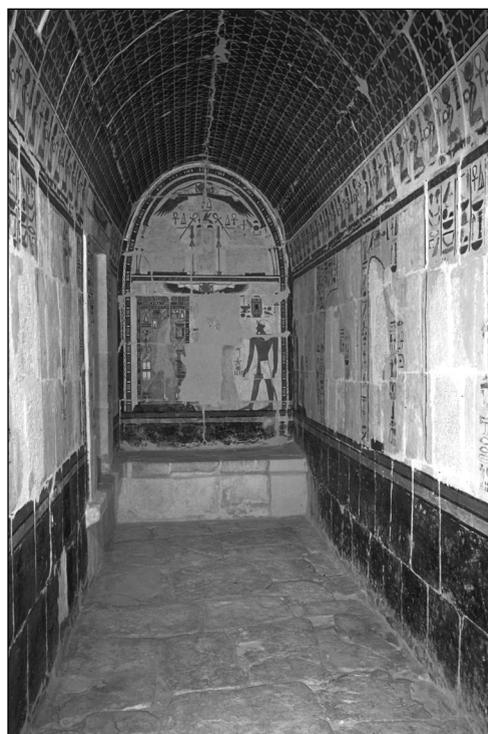
Fig. 5. The Upper Chapel of Anubis after completion of the work (Photo M. Jawornicki)

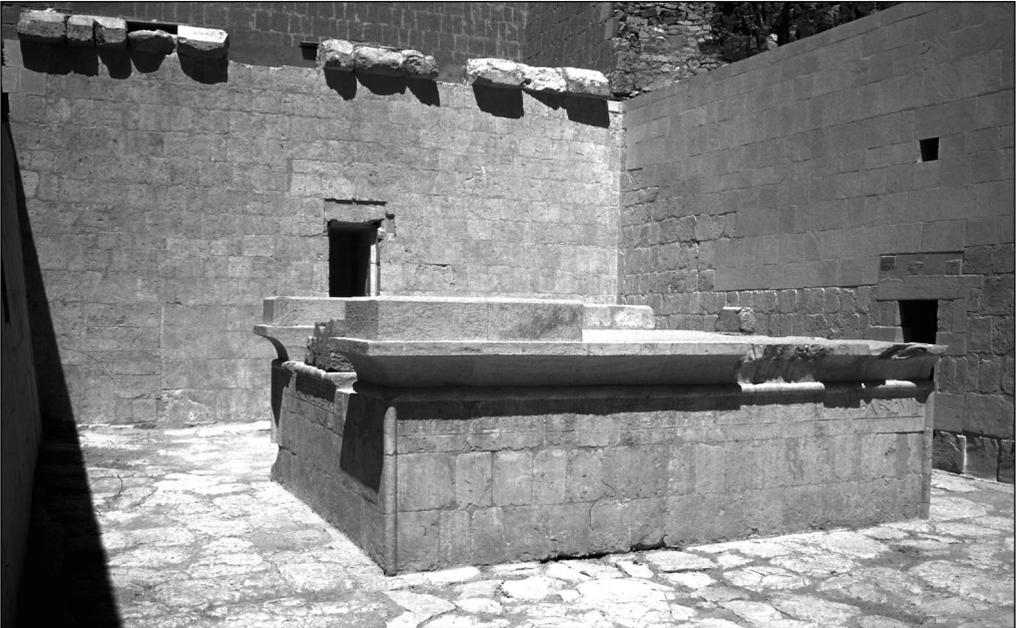
Fig. 6. The northwestern corner of the Solar Court after restoration
(Photo M. Barwik)

The ancient blocks of the cornice surmounting the top of the walls of the solar court were placed on top of the west wall (Fig. 6). As some of the blocks were in extremely poor condition, it was necessary to consolidate them with STEINFESTIGER FUNCOSIL 300. Where necessary, iron tenons and epoxy glue were used. To strengthen the small fissures in the stone structure injections of PRIMAL AC-33 (Rohm & Haas) were applied.

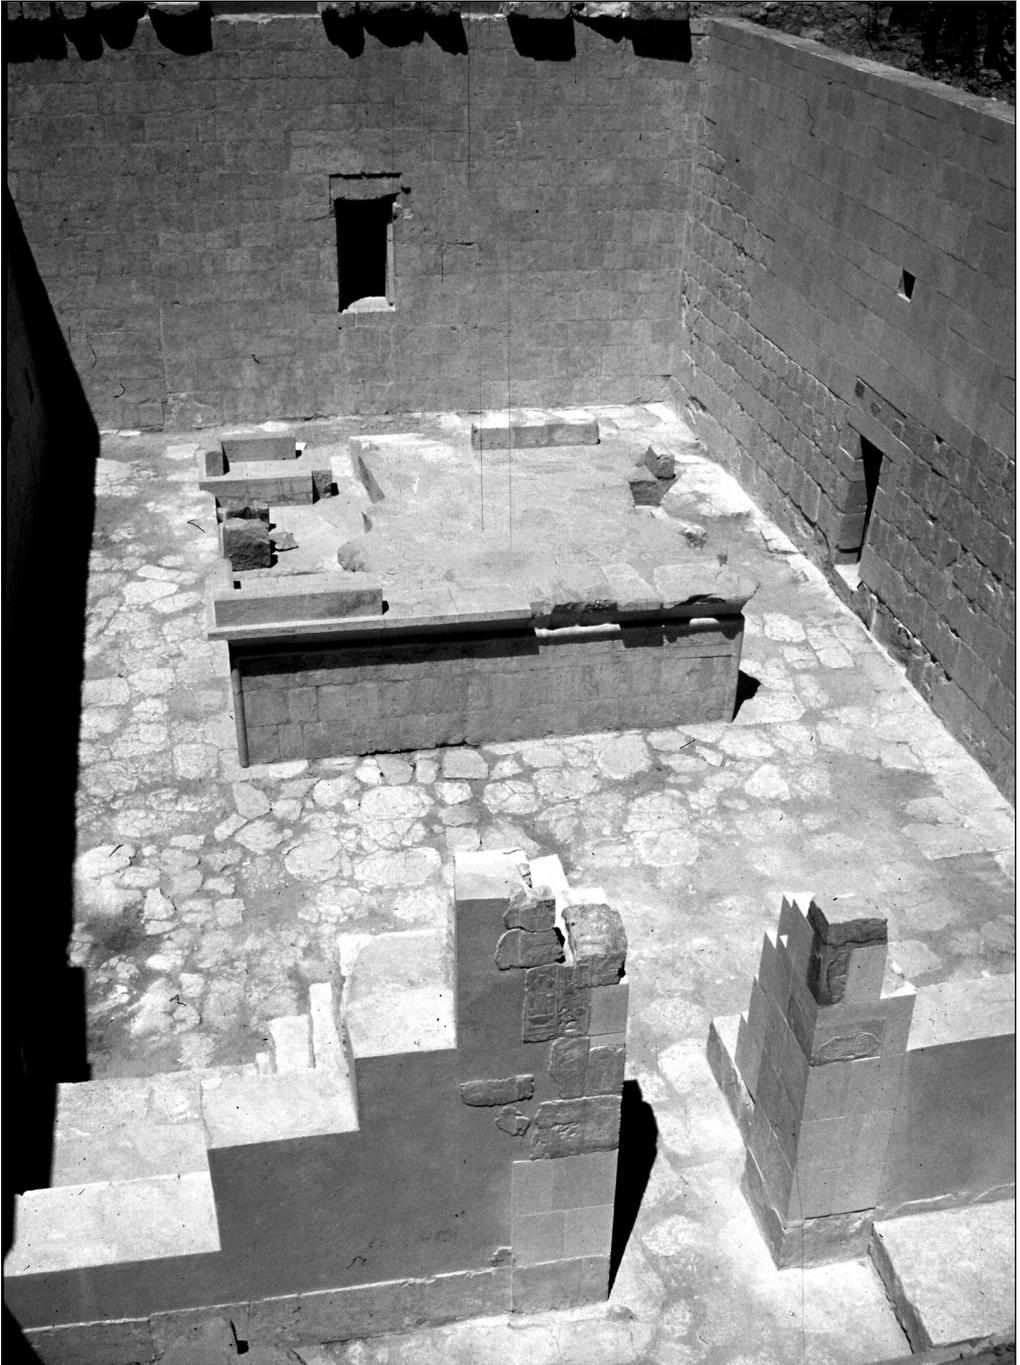
*Fig. 7. General view of the Solar Cult Complex in March 2002 (view to the northwest)
(Photo M. Barwik)*

The rest of the wall, up to its original height, was reconstructed of regular limestone blocks (cf. *Fig. 7*). Its back was made of rough limestone blocks. The joints of the blocks were filled with mortar, and a patina of yellowish ochre was applied to the new blocks to avoid a sharp contrast between the original blocks and new ones.

Eleven decorated fragments of the doorjambes of this portal were consolidated with STEINFESTIGER OH/510 (Remmers) and then put back in place. The structure of the portal itself was reconstructed of limestone blocks (cf. *Fig. 7*), being restricted to just the eastern face in view of a complete absence of any surviving pieces belonging to the western one. The western facade and the passage were fashioned on the manner of a well-ordered ruin, hence the undressed limestone slabs covering the two doorjambes on this side.

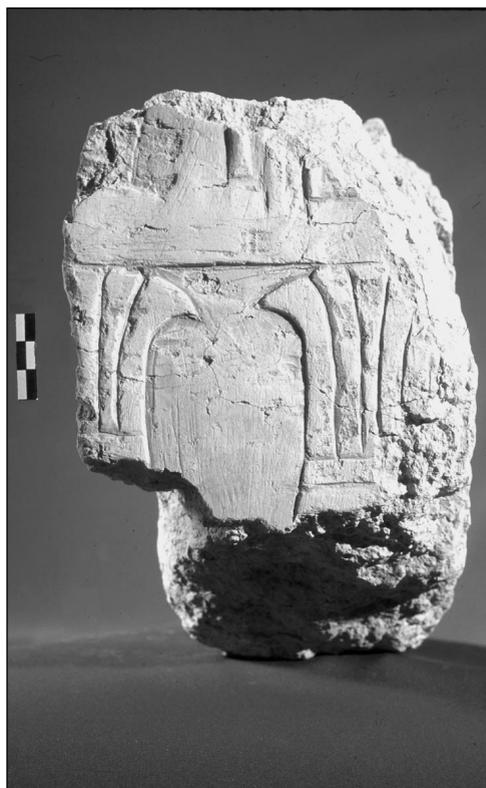
Fig. 8. Fragment of the decoration of the eastern tympanum of the Chapel of Tuthmosis I (Photo M. Jawornicki)

The ceiling in the chapel of Tuthmosis I had long posed one of the unsolved questions regarding the architecture of the Royal Complex. The unparalleled architectural layout of the chapel with one vertical and one sloping wall only added to the mystery. The discovery of some inscribed fragments (*Fig. 8*), which have been attributed to the eastern tympanum of the chapel, will, I think, prove decisive for resolving this issue.
