Polish Archaeology in the Mediterranean 14, 279-290

PALMYRA

SEASON 2002

Michał Gawlikowski

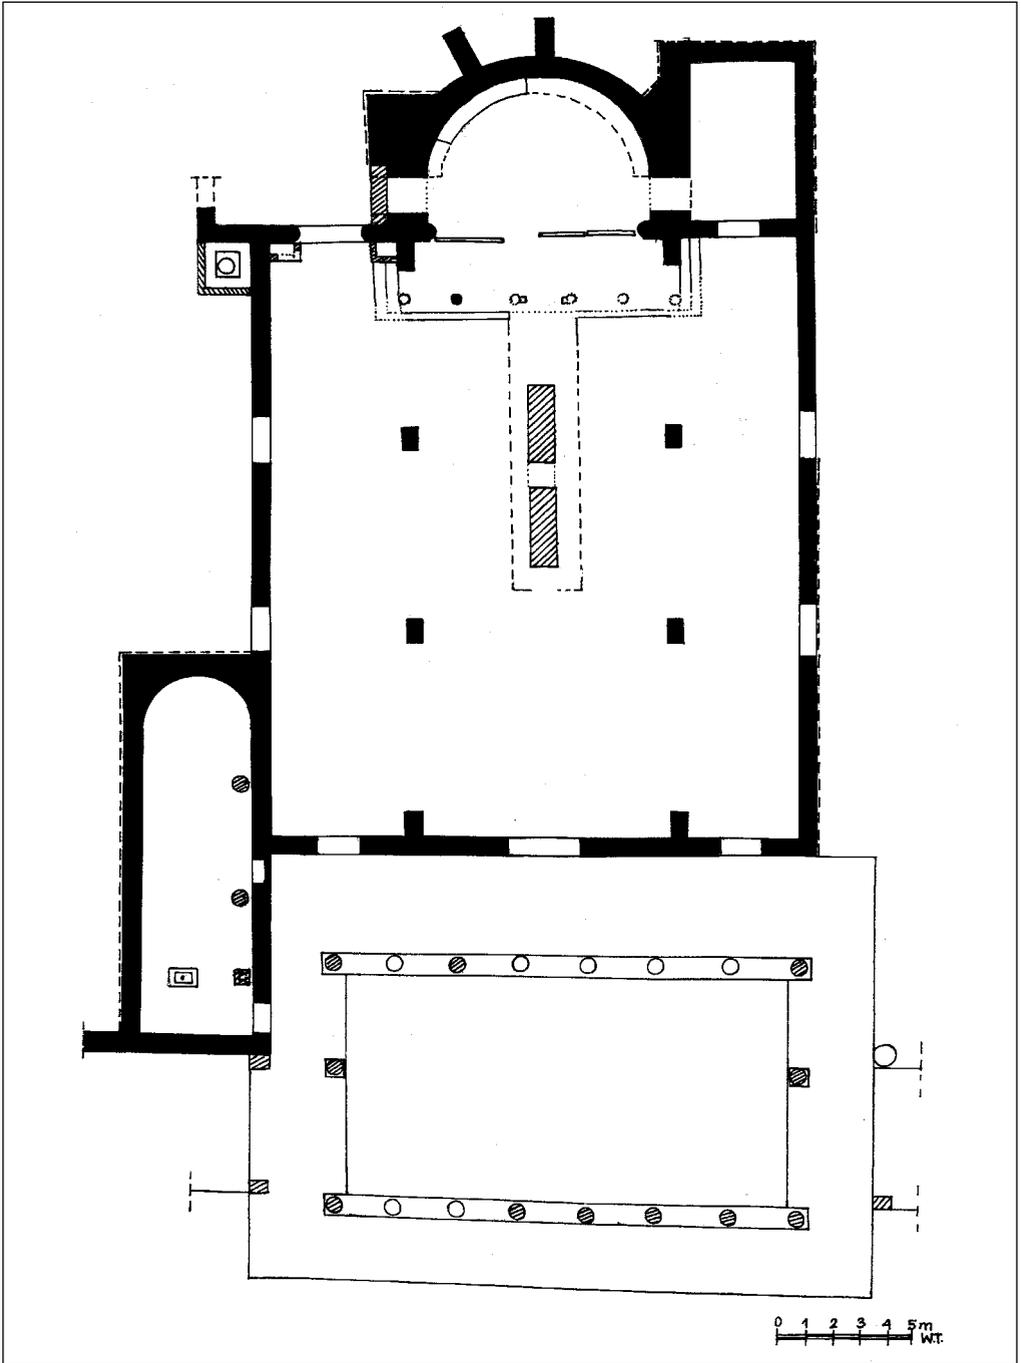
*Fig. 1. Schematic situation plan of Basilica III
(Drawing W. Terlikowski)*

This church, about 21 m wide at front and 23 m deep without the apse and dependencies, was excavated in 2001 and some two-thirds of the main body were cleared. This year we were able to complete the excavation in the aisles and the apse (*Fig. 1*). The fill, on the average 1 m thick, contained very few sherds, but included many stones, partly much-worn hard limestone slabs fallen from the lower walls, and mostly soft limestone blocks piled up in the ruins of the church waiting to be processed into lime. Two lime kilns were in fact identified in the northern aisle. There is not much left of the vertical elements of the nave and aisles. The floor all over the place was of white plaster, but it is extremely worn and large patches of the black ashy bedding can be seen everywhere

At the northern end of the atrium, where the Church Street reappears again, there was a narrow door, originally under the protection of the northern portico. It led two steps down into a rectangular room, 4.30 m wide and 13.70 m long, ending at the far end in an apse. This chapel extended all along the atrium wall and shared a part of its lateral wall with the northern aisle of the basilica (cf. *Fig. 1*).

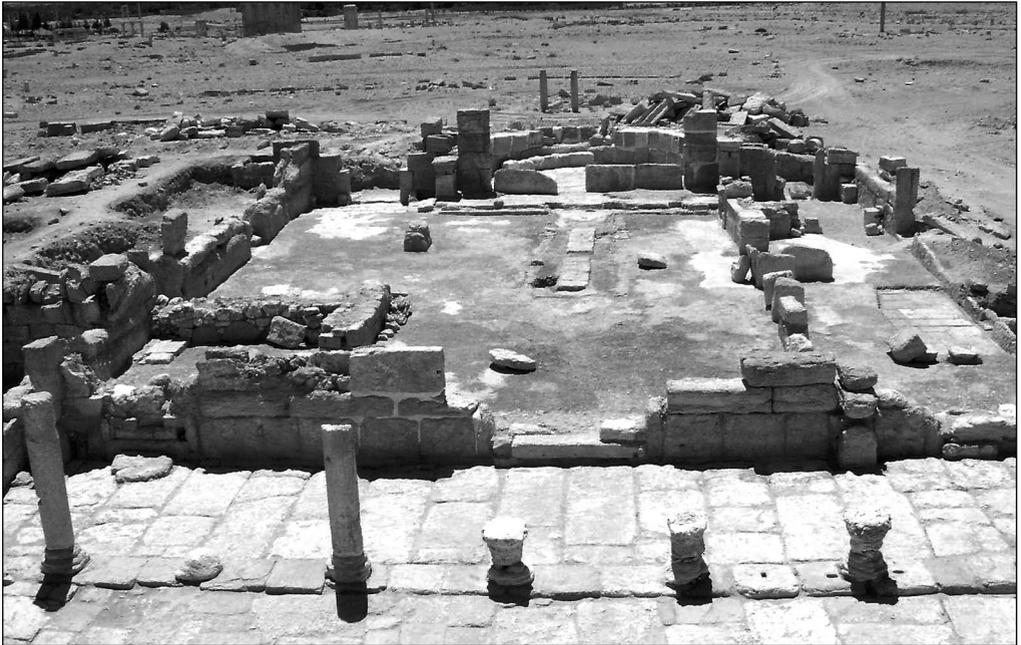
Fig. 2. Basilica III in 2002, seen from the west (Photo M. Gawlikowski)

(*Fig. 2*). The plaster floor covered the original flagging, as evinced in two test pits, one near a lateral door to the south, the other at the east end of the northern aisle.

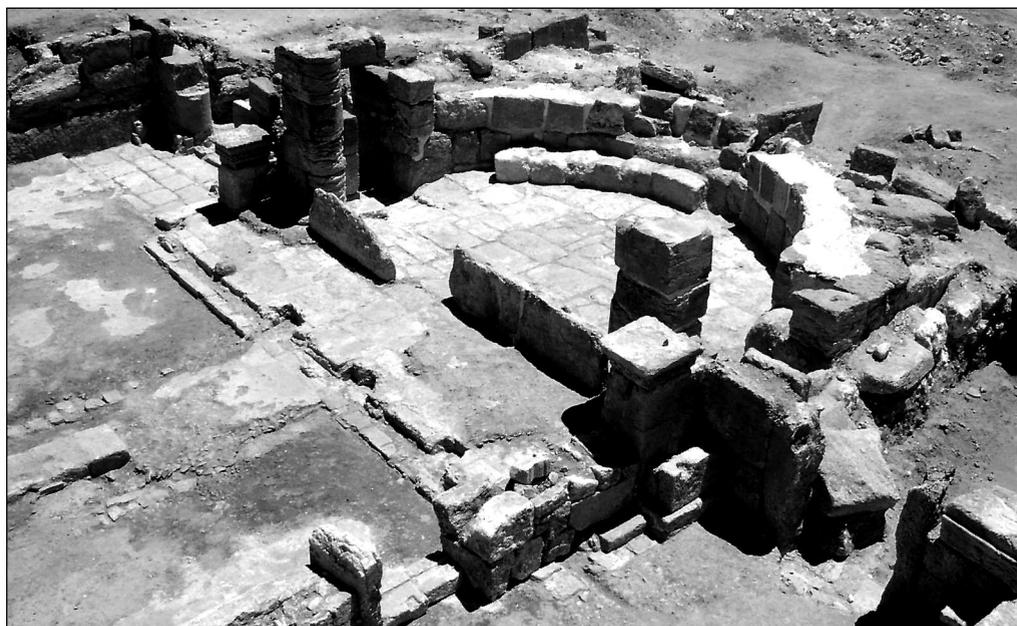
*Fig. 3. The apse of Basilica III after partial restoration
(Photo M. Gawlikowski)*

The sanctuary, advancing from the apse into the nave, was set slightly above the nave and paved with flagstones (*Fig. 3*). In the apse, the flagging had never been covered, unlike the body of the building. On the other hand, what is left of the *synthronon* is clearly secondary: a few blocks of white soft limestone set on the pavement against the curve of the apse. Laterally, there was a door on each side, leading to the dependencies, immediately behind the engaged columns that supported the great arch.

Originally, the sanctuary was delimited by a row of six colonnettes (dia. 35 cm) set into the front of the sanctuary (cf. *Fig. 3*). Only a stump of one of them has been preserved in place, showing that probably all of them were, like this one, of black granite. The middle pair stood on molded bases imbedded in plaster keeping them in place, but probably left apparent in front. The middle passage, 1.15 m wide, was flanked by two small pillars set against these two columns. One can imagine a light entablature and curtains hanging between the columns at this stage.

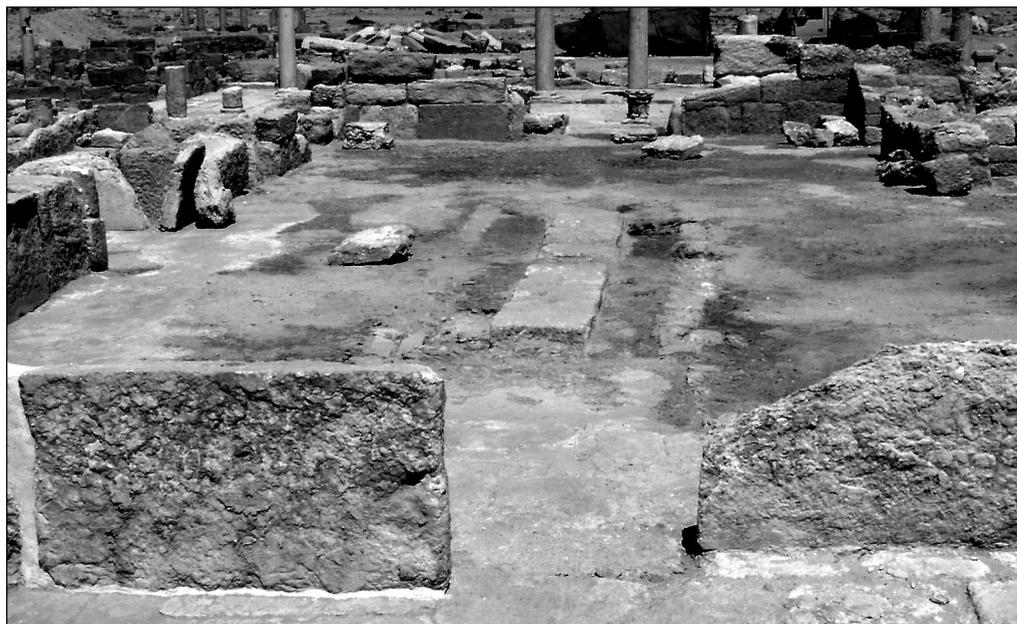
*Fig. 4. Remains of late cancelli slabs on the podium and in the nave of Basilica III
(Photo M. Gawlikowski)*

upright slabs, two of them found still in place while the third one has fallen, formed a barrier across the span of the great arch. It seems clear that they formed a *cancellum* of sorts (Fig. 4), but one remains puzzled by the asymmetry of their layout. The chronological relation of this barrier to the portico of the sanctuary and to the later *cancellum* is not apparent.

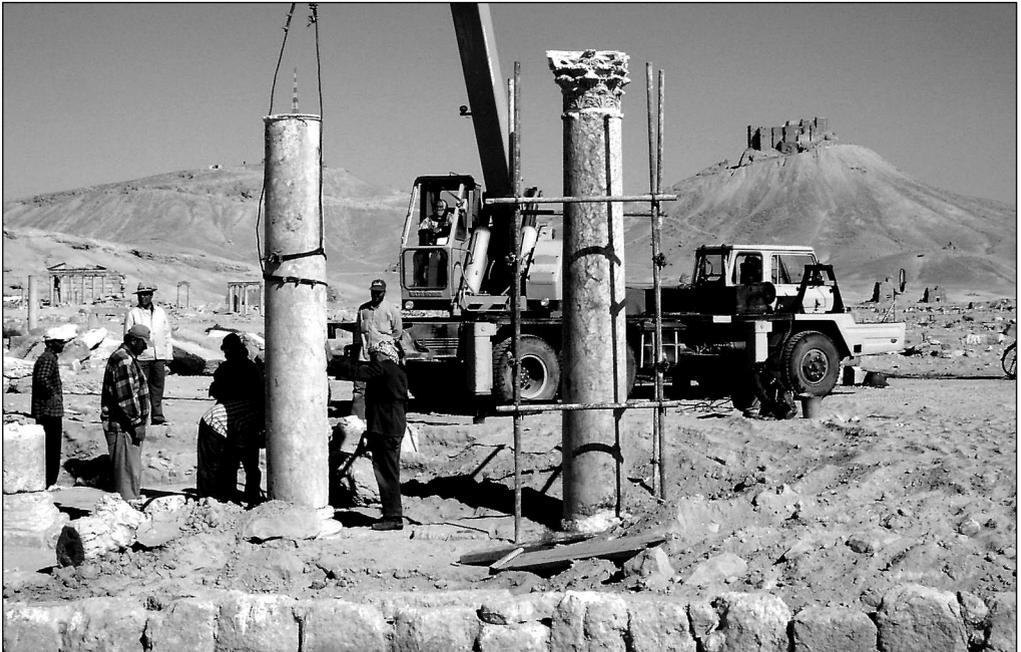
*Fig. 5. Raising of the columns in the atrium of Basilica III
(Photo M. Gawlikowski)*

This year we were able to raise four complete shafts (two of them with capitals) and three partially preserved ones, thus making the form of the atrium immediately clear to the visitor (*Figs. 5, 6-8*). Late enclosures between columns have been removed, as was also the wall crossing the atrium down the middle.

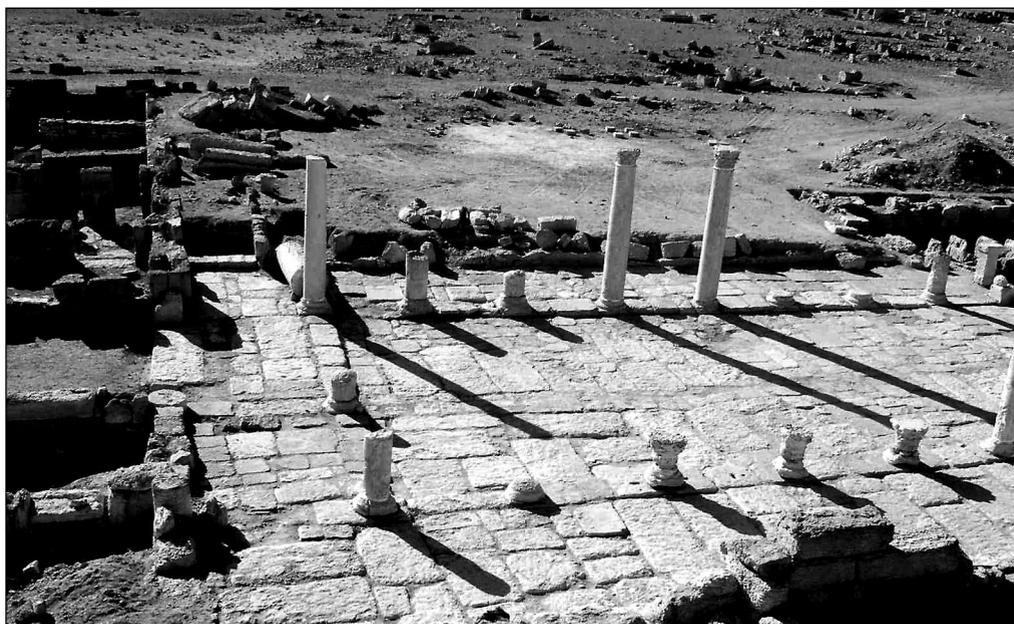
*Fig. 6. The restored atrium of Basilica III, seen from the east
(Photo M. Gawlikowski)*

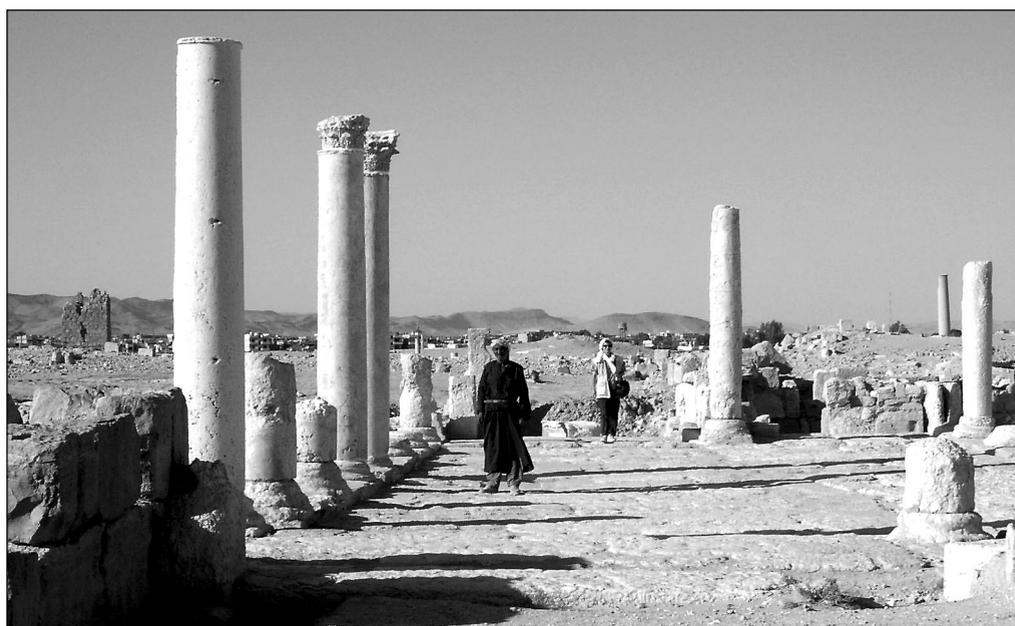
*Fig. 7. The restored atrium of Basilica III, seen from Church Street
(Photo M. Gawlikowski)*

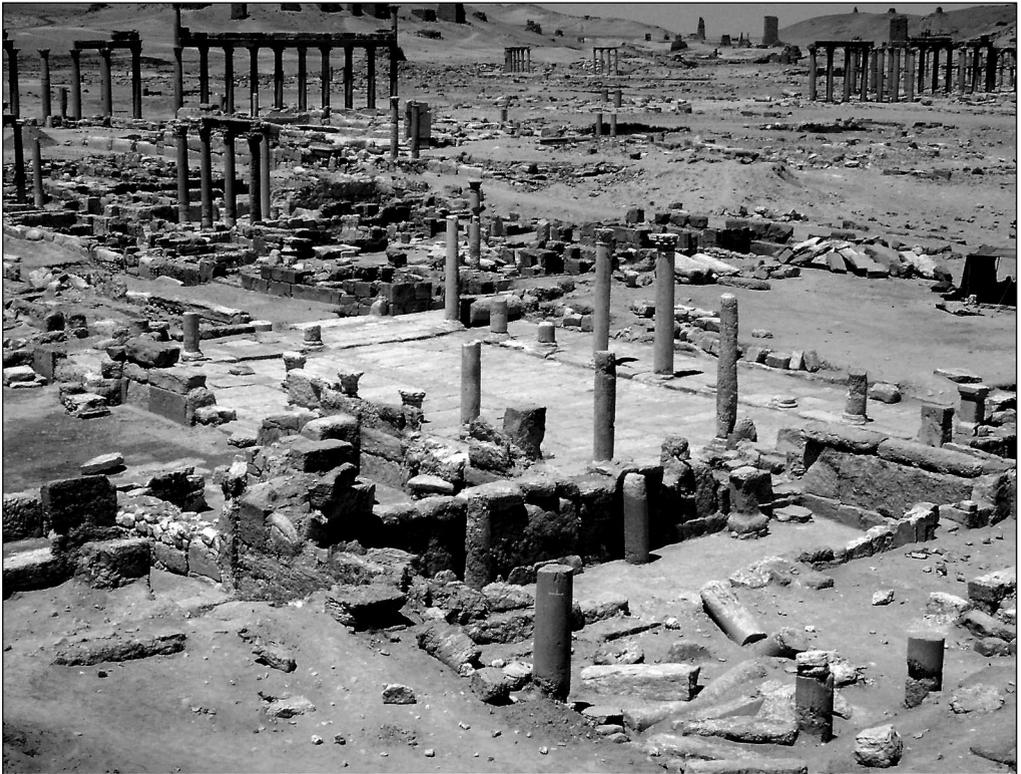
Fig. 8. The restored atrium of Basilica III, seen from the northeast. The south wall of the Northwest Chapel visible in the foreground (Photo M. Gawlikowski)

There are at present no features related to Christian cult practices left in the apse. On the other hand, the southern wall of the chapel has been singularized by two columns and an ancient altar set against it on the secondary floor. As this side corresponds to the *qibla*, it is possible that such an asymmetric arrangement might have corresponded to a late use of the chapel as a small mosque. This possibility will be checked in the future when a blocked niche in the same wall will be explored.

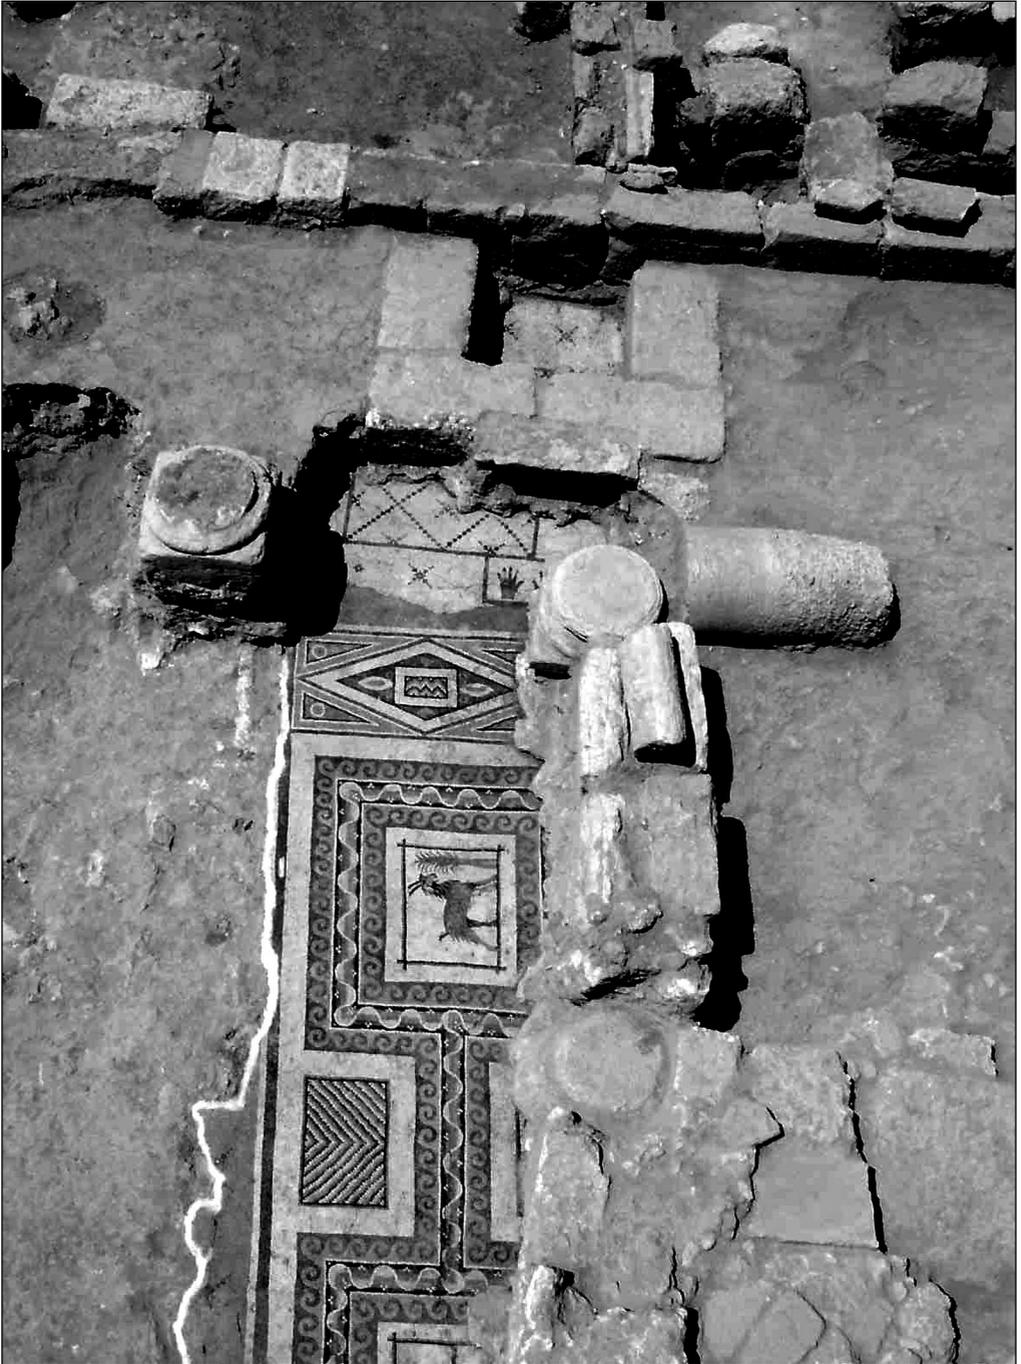
*Fig. 9. The uncovered part of the mosaic by the Great Colonnade
(Photo M. Gawlikowski)*

This year, a test pit below the late plaster floor revealed a well preserved mosaic about 1.20 m below the present level. After clearing as much of it as could safely be done in the limited time, a stretch about 9 m long N-S and some 2 m wide E-W became visible (*Fig. 9*). On the east the mosaic is broken some 2 m away from

The mosaic presents elaborate borders and geometrical designs, surrounding rectangular figurative panels, of which three were cleared. One of them represents a he-goat standing in front of a tree (cf. *Fig. 9* and cover design), another features two female griffins resting one paw on a severed bull's head (*Fig. 10*), and still another two panthers flanking a *kantharos* (*Fig. 11*). While it is definitely too early to risk an interpretation, it should be pointed out that all the motifs mentioned above are encountered in Dionysian iconography.

The workmanship is careful and professional, the color palette rich, especially in the animal figures: up to 14 shades of color could be identified among the tesserae used. One panel, however, at the southern end of the mosaic, stands out as fairly crude, on a background of a different color, being evidently a reparation; it consists of two hands with outstretched fingers, uniformly red, and probably of a magical significance (cf. *Fig. 9*, at top, between two column bases).

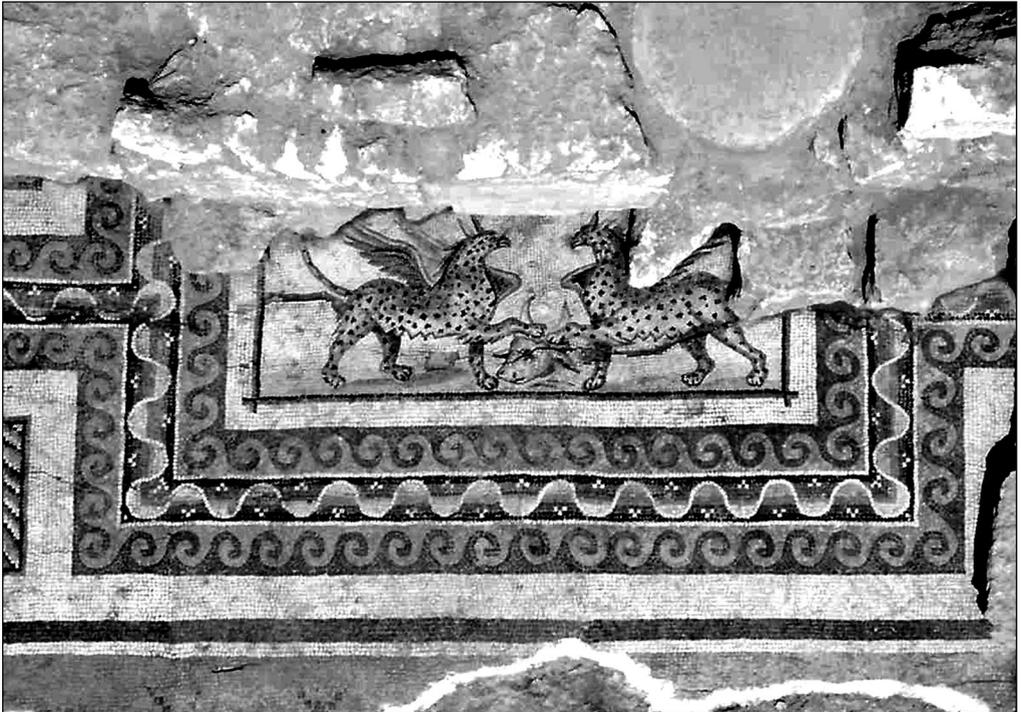
*Fig. 10. Mosaic panel with two female griffins
(Photo M. Gawlikowski)*

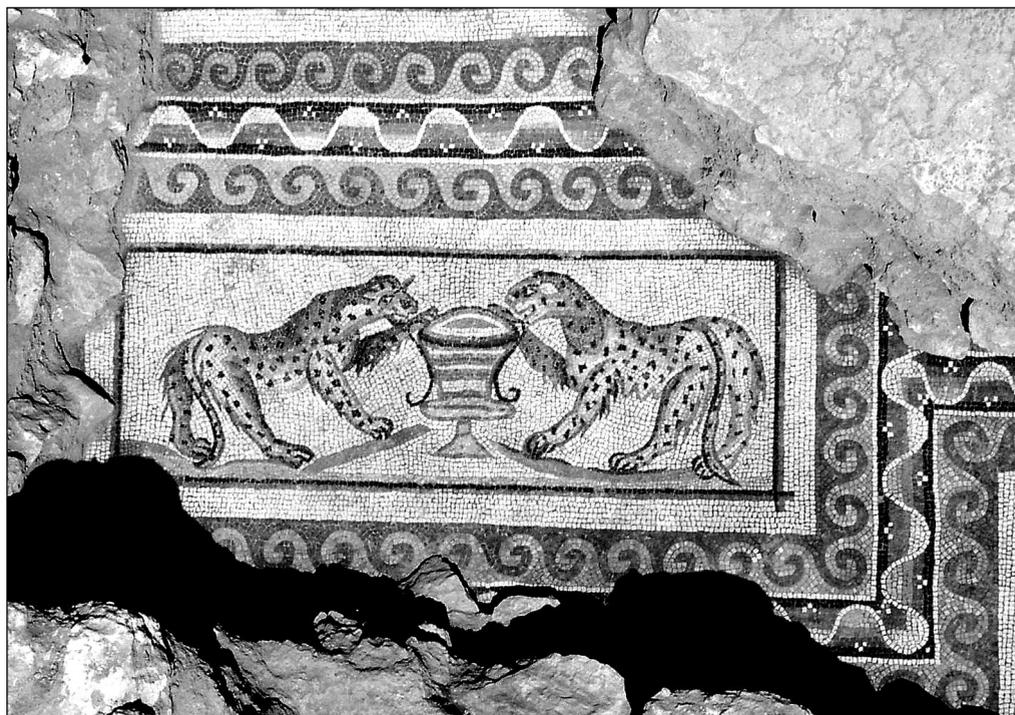
Fig. 11. Mosaic panel with panthers
(Photo M. Gawlikowski)
