**Marina El-Alamein: The Conservation
Season in 2002**

Polish Archaeology in the Mediterranean 14, 85-98

MARINA EL-ALAMEIN

THE CONSERVATION SEASON IN 2002

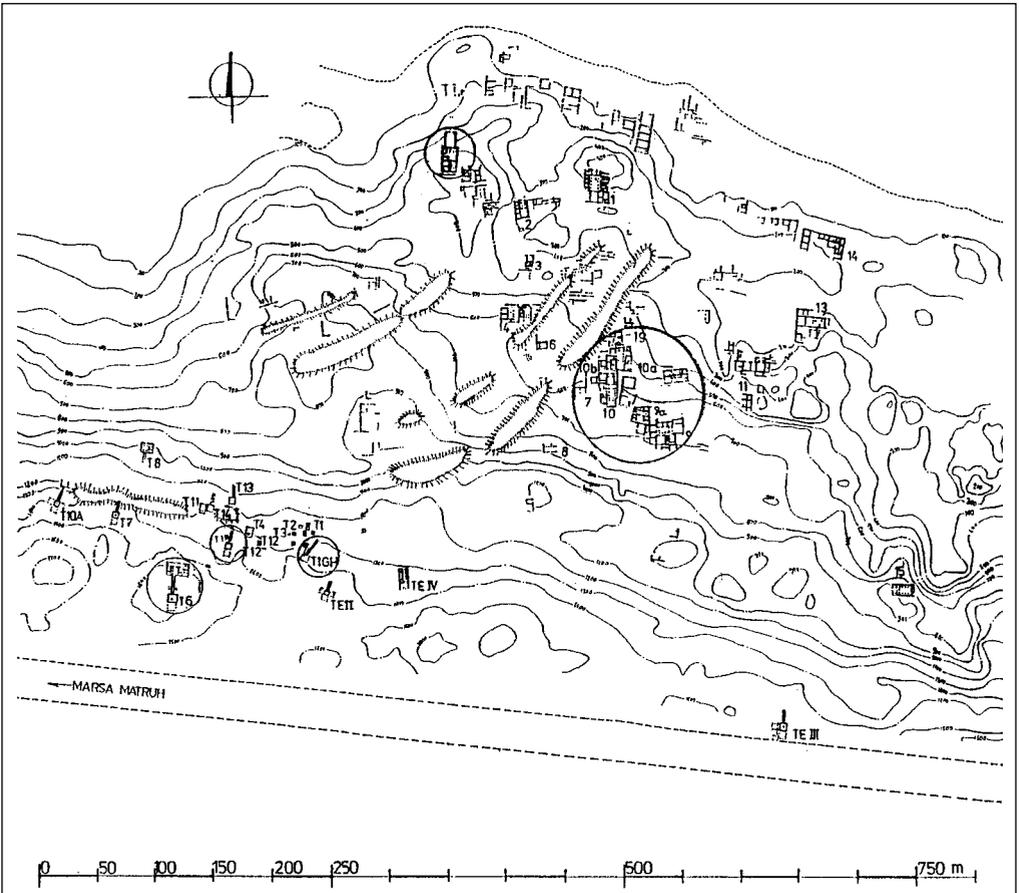
Fig. 1. Site plan. Circled areas indicate structures where conservation work was undertaken in 2002 (Drawing based on plan by the Polish Archaeological Mission Marina el-Alamein: K. Kamiński, J. & A. Dobrowolski with later additions)

In the town area the focus this season (Fig. 1) was on houses H 10, H 19 and H 21c with only some necessary maintenance conservation carried out in previously completed structures. Debris and earth from the earlier excavations in the neighborhood were removed from further areas of H 10“E” and H 19. As for H 21c, the great hall H 21“N” (10.45 by 7.50 m) was cleared in preparation for preservation work.

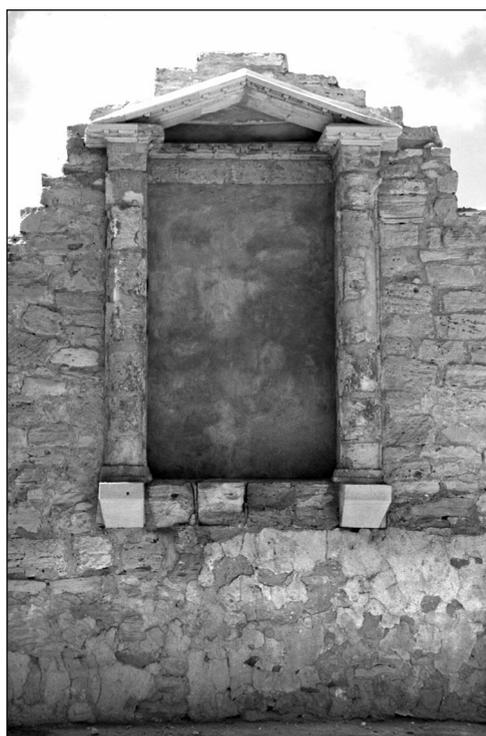
Fig. 2. The niche in room 2 of House 10. After reconstruction of the tympanum (Photo S. Medeksza)

In House H 10, apart from reinforcing the columns of the peristyle, some maintenance protection treatment had to be carried out on wall tops and joints. The key task of the season was the completion of an architectural aedicule, work on which had been ongoing since 1999.⁴⁾ The shafts of the side columns, the architraves and cornices had all been reassembled and reconstructed in the earlier seasons, and work had proceeded on a partial reconstruction of the tympanum.⁵⁾ Some 40% of the two decorated slabs constituting it had to be carved anew and set in their original positions, but using stainless steel dowels in addition to the original stone recesses to support the lower edges (*Fig. 2*).

Tympanum elements of the aedicule from H 10. Conservation followed the same basic procedure as in the case of the above-described aedicule and resulted in a remounting of the preserved fragments in their original position crowning the niche in room 2 of house H 10. The stainless steel dowels (□12 mm) that were used were 28 cm long and were spaced symmetrically on both sides of the tympanum base.

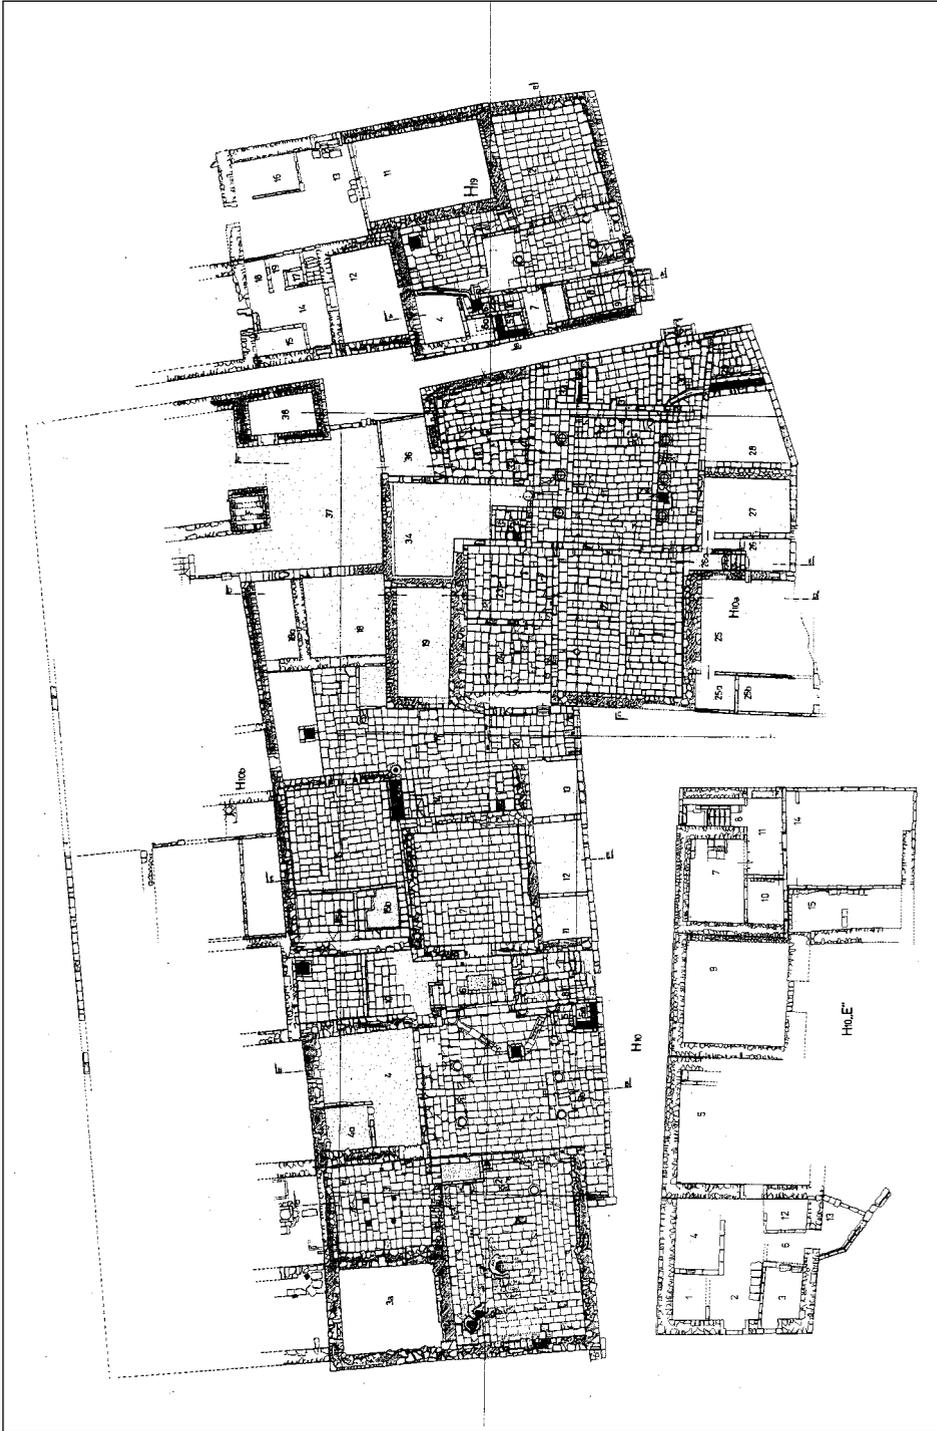
Fig. 3. Plan of houses H 10, H 10a, H 10b, H 10"E" and H 19. State in May 2002
(Drawing R. Czerner, E. Łuzyniecka, S. Medeksza, Z. Solarzewicz)

Most of House H 10b (*Fig. 3*) is still under the mounds of rubble and earth from earlier excavations. Partial reconstruction is planned of the courtyard (no. 37), as well as a bread oven (F, explored last year) and

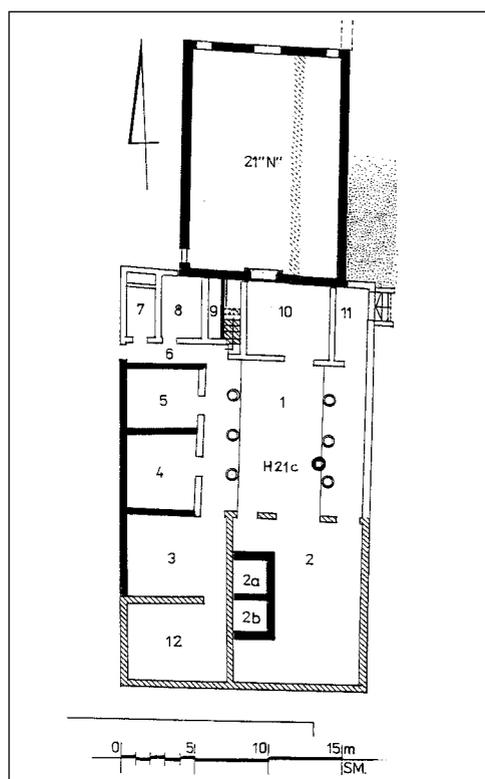
Fig. 4. House H 21c and hall H 21"N". Schematic plan showing work completed in 2002 (in black) (Drawing S. Medeksza)

An architectural survey of this building (which had been excavated previously by Egyptian archaeologists) was completed this year (*Fig. 4*), resulting in an un-

Restoration works included replacement of joints in the walls of rooms 2, 3 and 12, reinforcing and building up of walls in rooms 3, 4 and 5, restoring a stone pavement in room 10 and a partial reconstruction of the staircase (no. 9). A broken stone parapet ring was reassembled and returned to its original

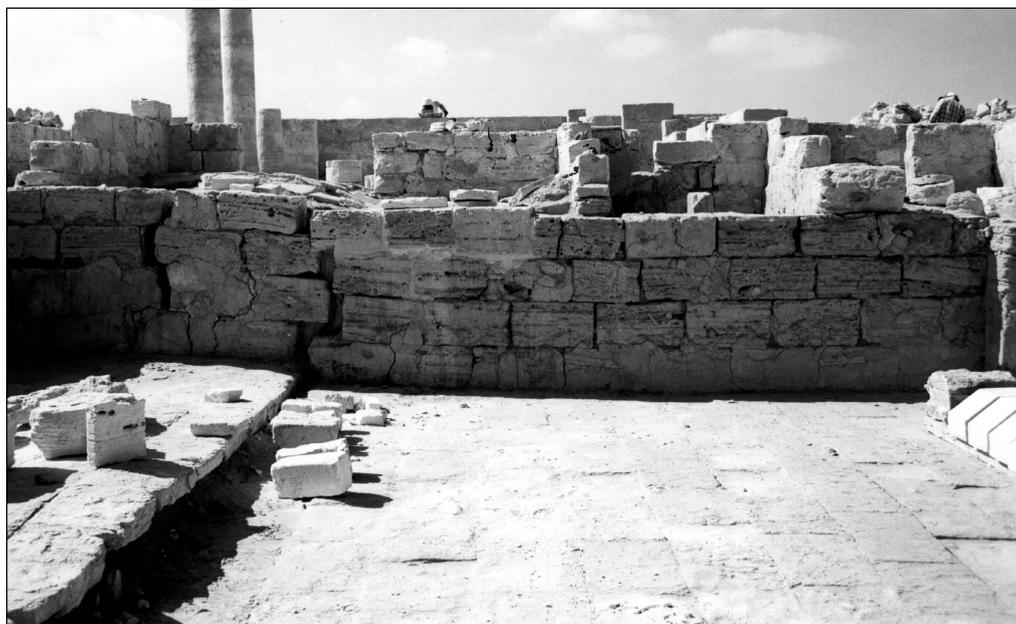
The hall H 21“N” incurred heavy damages due to earth subsidence, possibly in effect of an earthquake. The walls had cracked and slipped and a large section of the floor had settled (*Fig. 5a*). Restoration of the original form would have been extremely difficult and would have entailed a virtual rebuilding of the hall from scratch. It was deemed unnecessary and the preservation was limited to a structural reinforcing of the walls and floor with additional masonry. The crack in the floor and subsiding of the western two thirds of the hall can be seen also in rooms 10 and 1 of house H 21c abutting the hall on the south. Again, this difference in levels was kept. The walls were built up, especially the northeastern and northwestern corners, to a height of 1.20 m for the corners and 1.00 m for the walls. The cracks in the

Fig. 5a. Hall H 21 "N". Before conservation. Close-up view from the north of the cracked south wall and displaced pavement (Photo S. Medeksza)

walls were filled with masonry, but recessed with regard to the original wall face. For the walls, original stone blocks were used bonded in lime mortar mixed with some white cement.

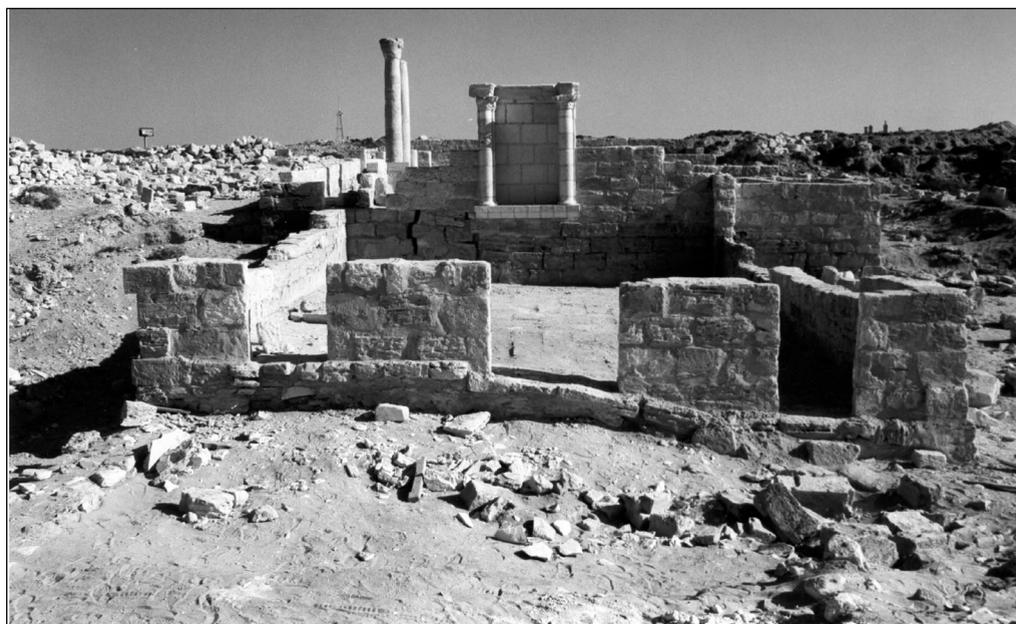
Fig. 5b. Hall H 21 "N". After reconstruction in 2002. View from the north with the reconstructed aedicule in the south wall (Photo S. Medeksza)

In the actual reconstruction, the lower parts of the niche were recreated in stone in simplified form. The original pieces of the upper part were protected and then reassembled. The tympanum was reinforced structurally and will be mounted in the coming season (see remarks in the specialized conservation section below in this report).

The meander cornice in the central part of the architrave was also glued together and the missing parts were reconstructed in stone. As a final step, the niche was remounted in its original position in the south wall of the hall and any small lacunae were filled with mineral mortar.

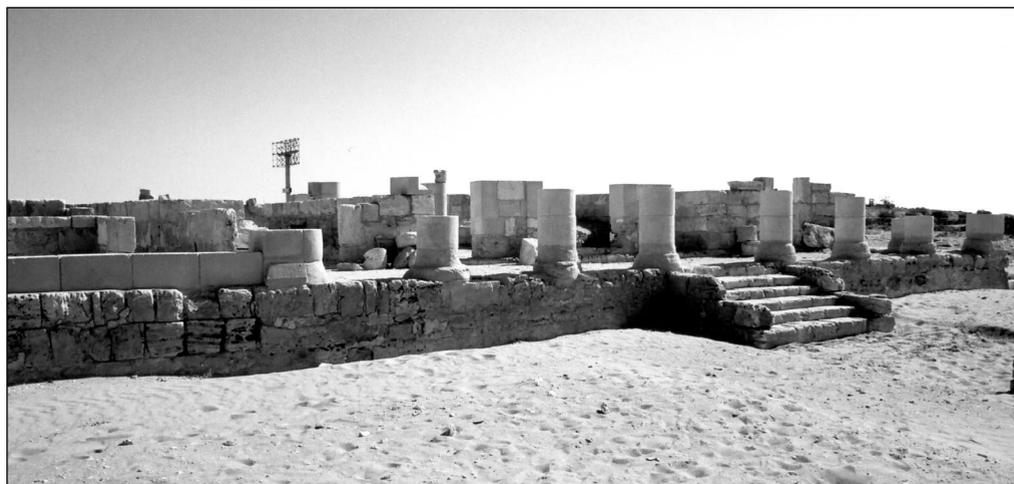
Fig. 6. Façade of the mausoleum of Tomb 6 after reconstruction in 2002. View from the northeast (Photo S. Medeksza)

In the course of the 2002 season several column drums were reconstructed of Helwan limestone, the objective being to recreate the rhythm of columns in the front portico. The two columns flanking the

main entrance were built up to a height of 1.15 m, while the remaining columns were made to be from 0.95 to 0.76 m high. The lime mortar used for the bonding included some white cement. No dowels were used as *anathyrosis* of the sections afforded sufficient adherence of the elements.

Landscaping around the tomb (done by the archaeological mission earlier in the season) was intended to make the facade of the monument better visible from the tourist route (*Fig. 6*).

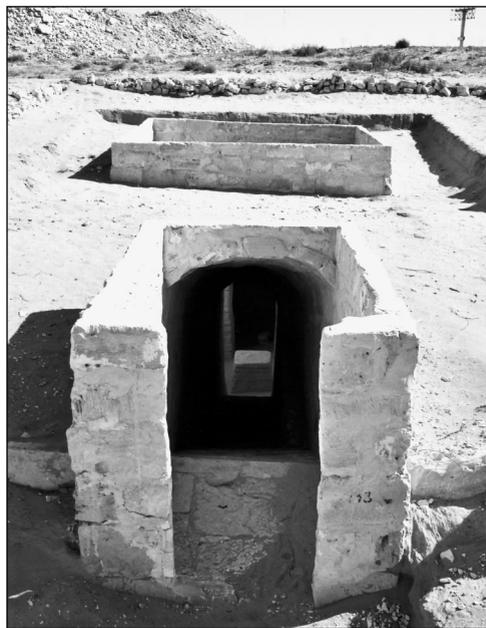
Fig. 7. Tomb 18. After conservation in 2002. View of the entrance from the north (Photo S. Medeksza)

In view of errors made in the rebuilding of the courtyard perimeter wall by an Egyptian team of builders working before the mission's arrival on site in 2002, it became necessary to undertake corrective steps. The uneven lower courses were covered with sand, the walls were leveled and the wall faces properly jointed.

The missing parts of the vault of the staircase, one near the courtyard and the other near the aboveground kiosk, were then reconstructed of new stones laid on

timber scaffolding. At the top end, the vault turned out flatter than desired due to weakness of the scaffolding, but the structure appears sound overall. The walls of the kiosk were built up to a height of 2 m and left thus in the absence of any elements from the roofing of this structure that could make a proper reconstruction possible (*Fig. 7*).

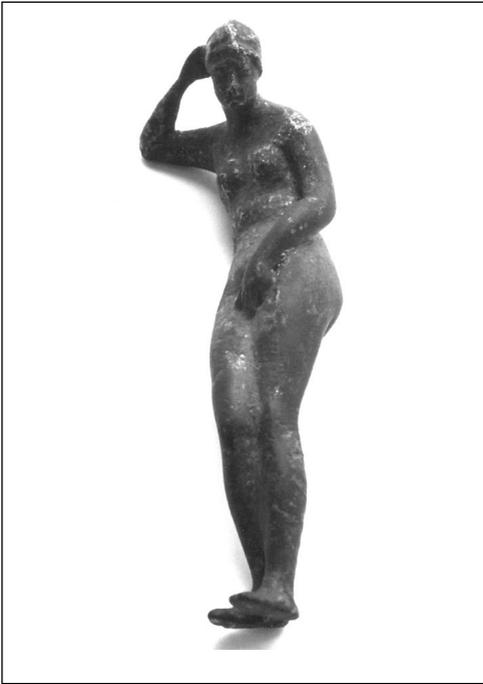
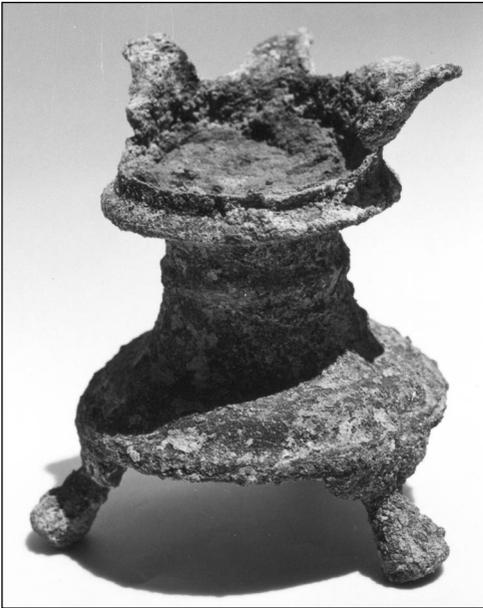
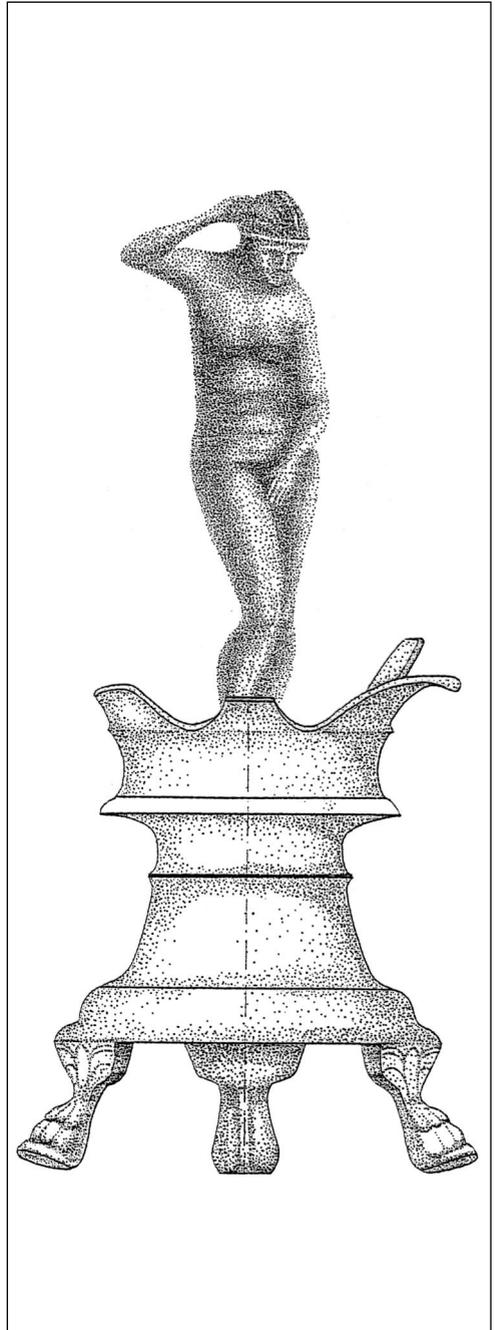
ly in the ground, the hole at the top covered with a paving slab of limestone and a piece of marble tile. The fill of the vessel consisted of sand with sherds of pottery, glass and animal bones. Inside the vessel an altar stand of bronze was found on the bottom and lying next to it a bronze statuette of Aphrodite, which had once stood in the middle of it on top (*Fig. 8*).¹⁴⁾ There were traces of burning inside the top of the altar.

Fig. 8. Bronze statuette of Aphrodite (top left) and altar stand (bottom left) found in a foundation deposit in House H 21c. Reconstruction showing presumed original appearance (right) (Photos P. Zambrzycki; drawing W. Grzegorek)

In the course of the season special attention was paid to the bronze finds: statuette of Aphrodite (cf. *Fig. 8*), stand, coins and pieces of jewelry. The necessary photographic documentation was made, after which the surfaces of these artifacts were cleaned using water solutions (10%) of sodium benzoate and trisodium EDTA. Mechanical cleaning was applied locally and post-conservation documentation was prepared.
