Polish Archaeology in the Mediterranean 15, 216-223

2004

THE PAINTED DECORATION OF THE CRUCIFORM BUILDING IN DONGOLA PRELIMINARY REPORT

Dobrochna Zielińska

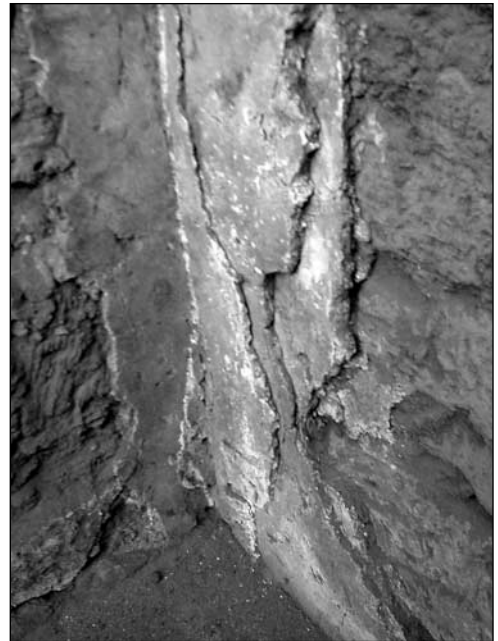
Fig. 2. Stratigraphy of lime plaster coatings preserved in the northern arm (Photo D. Zielińska)

An analysis of the remains has permitted the stratigraphy of plaster layers to be determined. Four separate layers of plaster were distinguished, including three coats of lime plaster and the fourth, latest of mud plaster (*Fig. 2*).²⁾

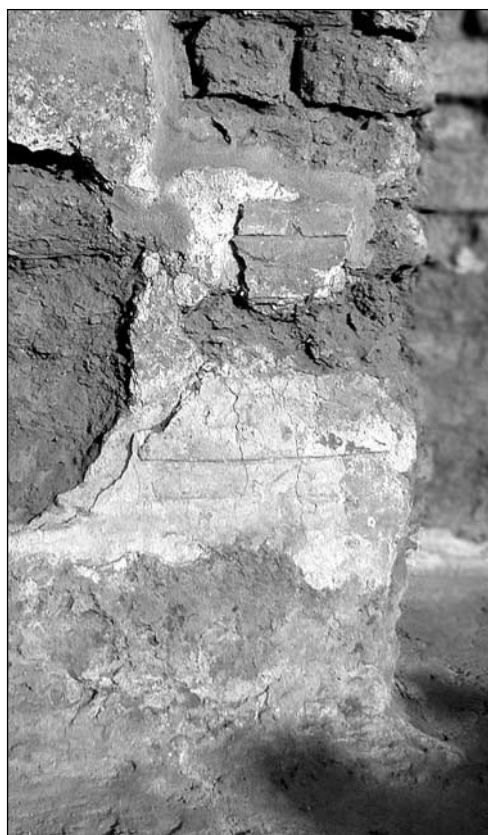
Fig. 4. Fragmentarily preserved stucco decoration on the second coating of plaster in the western arm (Photo D. Zielińska)

Fragments of illusionist pilasters were also preserved below the later floor in the western arm. The base, modeled additionally in stucco (*Fig. 4*), continued as a painted band, delimiting the illusionist decoration some 30 cm above the floor. Preserved fragments indicate that this could have served as the base of the wall in the entire interior.

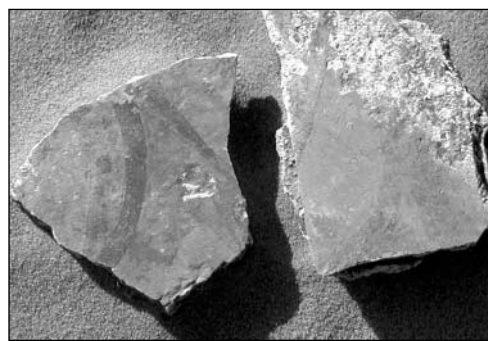
Fig. 5. Pieces of plaster from the second layer, demonstrating different techniques of applying paint: a) transparent, and b) matt (Photo D. Zielińska)

The pigments were applied in a variety of ways (*Fig. 5a,b*). It seems possible that the artist was conscious of the natural properties of particular pigments (their transparency), painting some areas very thinly in semi-transparent layers, and others with a smooth thicker layer (having the appearance of enamel).
