# KAFTOUN

## CONSERVATION AND RESTORATION OF THE MAR SARKIS CHURCH MURALS INTERIM REPORT

Krzysztof Chmielewski and Tomasz Waliszewski

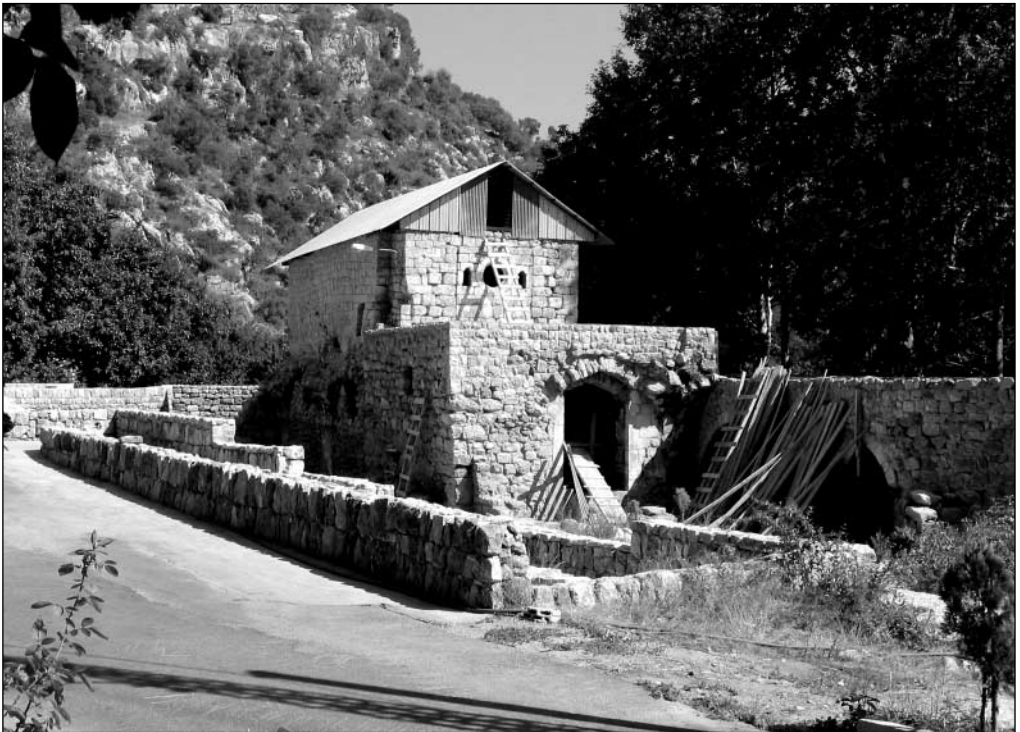
Fig. 1. *The Church of Mar Sarkis in Kaftoun, state in 2004*  
(Photo T. Waliszewski)

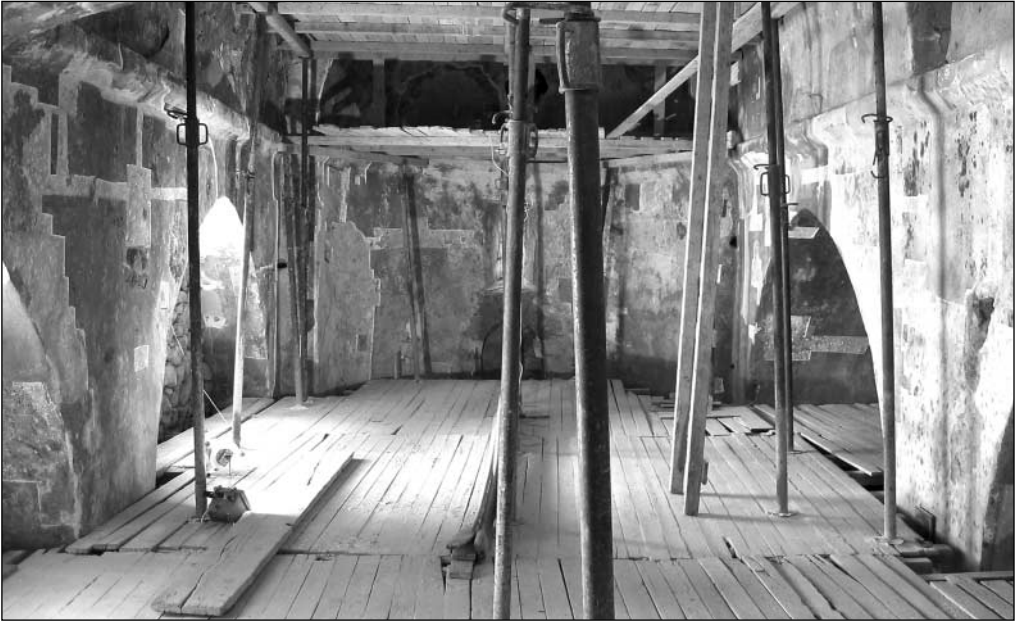
Secondary plaster on the church walls varies in thickness from 0.6 to 1.9 cm. Originally white, this lime plaster is now gray and green (due to fungi and mould deterioration) and more or less disconnected from the underlying layers in many places. Probes, ranging from 10 to 20 sq. cm, were executed through the plaster on all the walls and on the vault of the church. Knives, scalpels, chisels and hammers were used for the purpose. Whenever traces of painting were revealed, the probes were enlarged. Long and narrow probes will be executed across all of the walls and vaults to ensure that no further murals remain undiscovered [Fig. 2].

*Fig. 2. Church nave looking east, state during conservation work in 2004  
(Photo T. Waliszewski)*

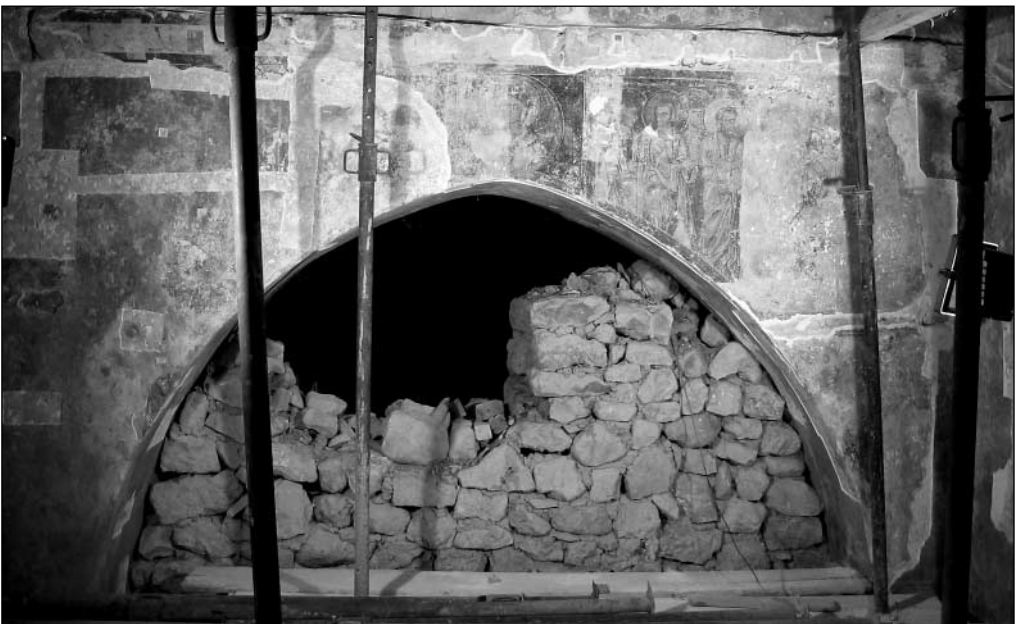
4. North wall of the nave, paintings on the cornice and below [Fig. 3]. Originally, both walls of the nave bore murals, including an inscription in Arabic running along the cornice from right to left, some scenes and a few single figures of saints or angels, all placed within border frames of deep claret color. For the moment, there are three fragments of painted plaster known from the northern wall. First from the west is a small fragment of Arabic inscription on the cornice, approximately midway along the length (maximum width 0.775 m, maximum height 0.245 m).

part of the inscription in Arabic on the cornice, a medallion with the bust of an angel, and a scene of what was likely a *Communion of the Apostles*. The latter consists of seven standing robed figures with halos around their heads, facing the first figure from the east, identified as Christ dispensing communion. Three Syriac inscriptions preserved above the heads of three of the figures. (Maximum width 3.83 m, maximum height 1.18 cm.)

A third, smaller fragment, situated below the above-described second fragment (between the end of the nave arch and the end of the wall close to the apse). Two fragmentary standing figures: a winged angel (on the left) and saint *Laurentios* (on the right); between them an inscription in Greek. (Maximum width 0.67 m, maximum height 1.07 cm).

*Fig. 3. North wall of the nave with uncovered traces of murals, state during conservation in 2004  
(Photo A. Karolczak)*
