TELL FARAMA (PELUSIUM)

REPORT ON THE THIRD AND FOURTH SEASONS

Krzysztof Jakubiak

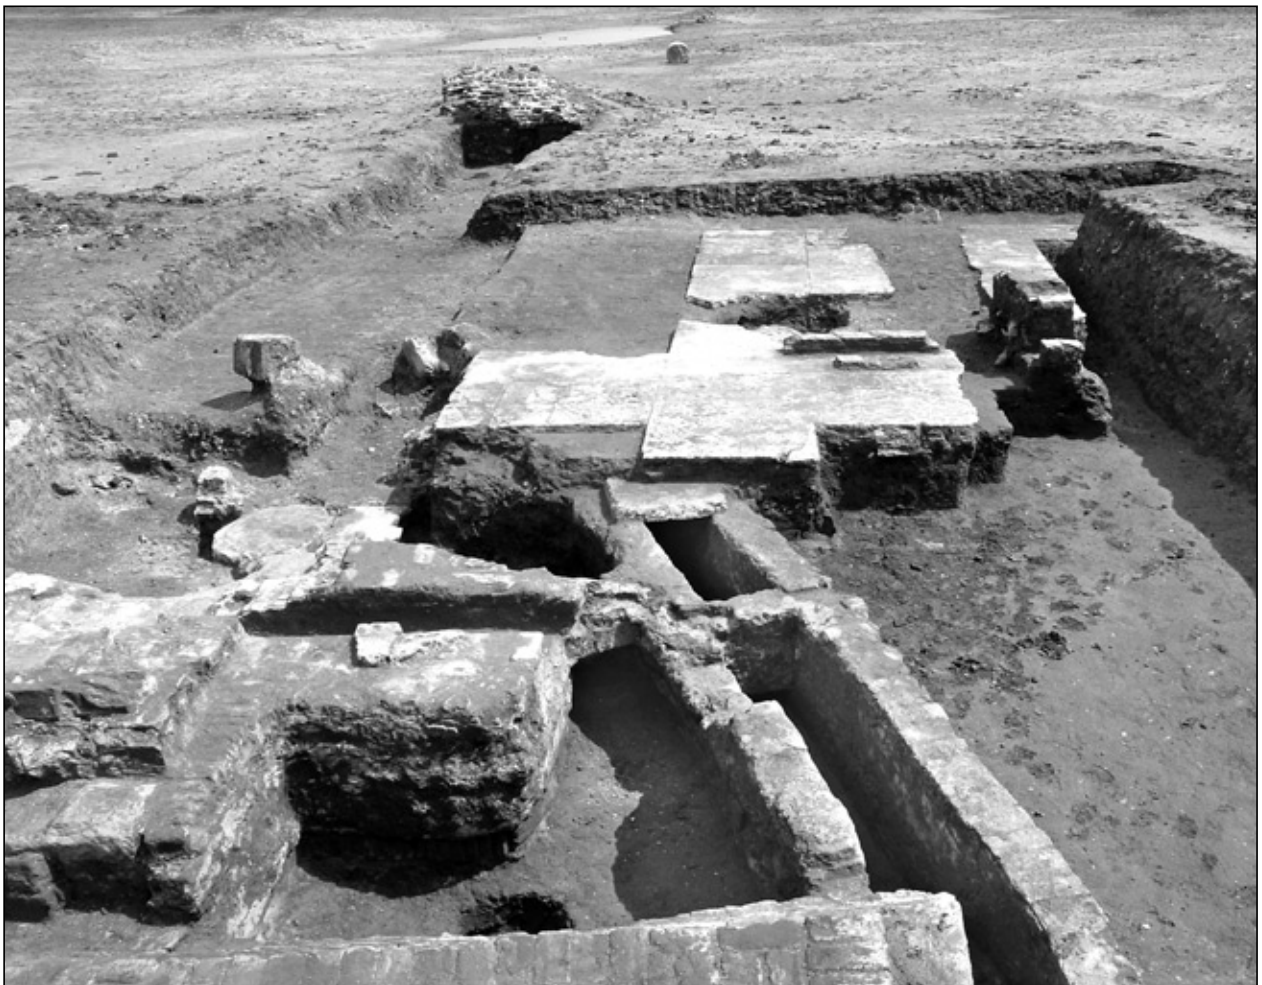
Fig. 2. Trench adjoining the eastern entrance to the theater, view from the west. Main sewage channel in the center (Photo K. Jakubiak)

were dated on archeological grounds to the Hellenistic period as well; they are represented in the section by brown earth mixed with lime and powdered brick (layer 4) and the ghost wall located south of this layer. It belonged to an apparently monumental building evidently preceding the construction of the theater. This edifice had its own sewage system connected with the main sewage drain (cf. *Fig. 3*) running E-W through the town (only one of the slabs covering this channel has been preserved *in situ*) [*Fig. 2*]. The two drains appear to be contemporary, but all joining channels between the two were destroyed when the building itself was dismantled immediately prior to or during the construction of the theater.

Superimposed on top of the main drain were two separate layers of flagstones, presumably marking the street levels already of the Roman period and associated with the theater entrance. The paving could have actually belonged not so much to a street as to a small square siding the

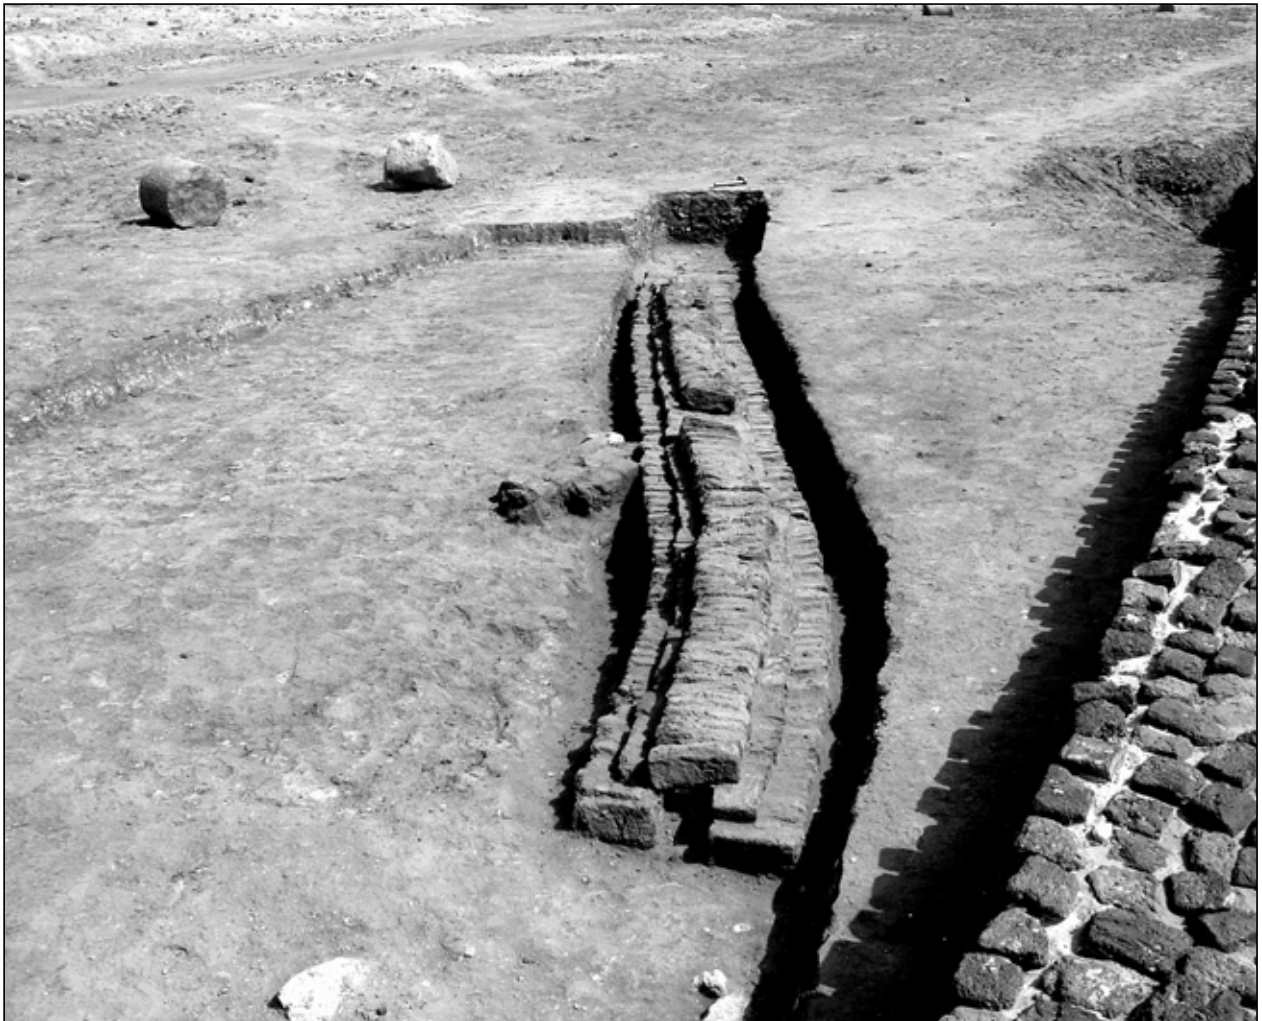
Fig. 4. Sewage channel discovered by the north façade of the theater. View from the west (Photo K. Jakubiak)

Upon investigation, an accumulation of red bricks spotted 5 m west of the entrance in the north wall of the theater proved to be part of a sewage system constructed together with the theater [*Fig. 4*] and apparently destroyed and taken apart at the same time as the theater. The flagstones covering it (none of which have survived *in situ*, must have been part of the northern peristyle. The pottery from this trench was relatively late, indicating that the destruction of the pavement and drainage

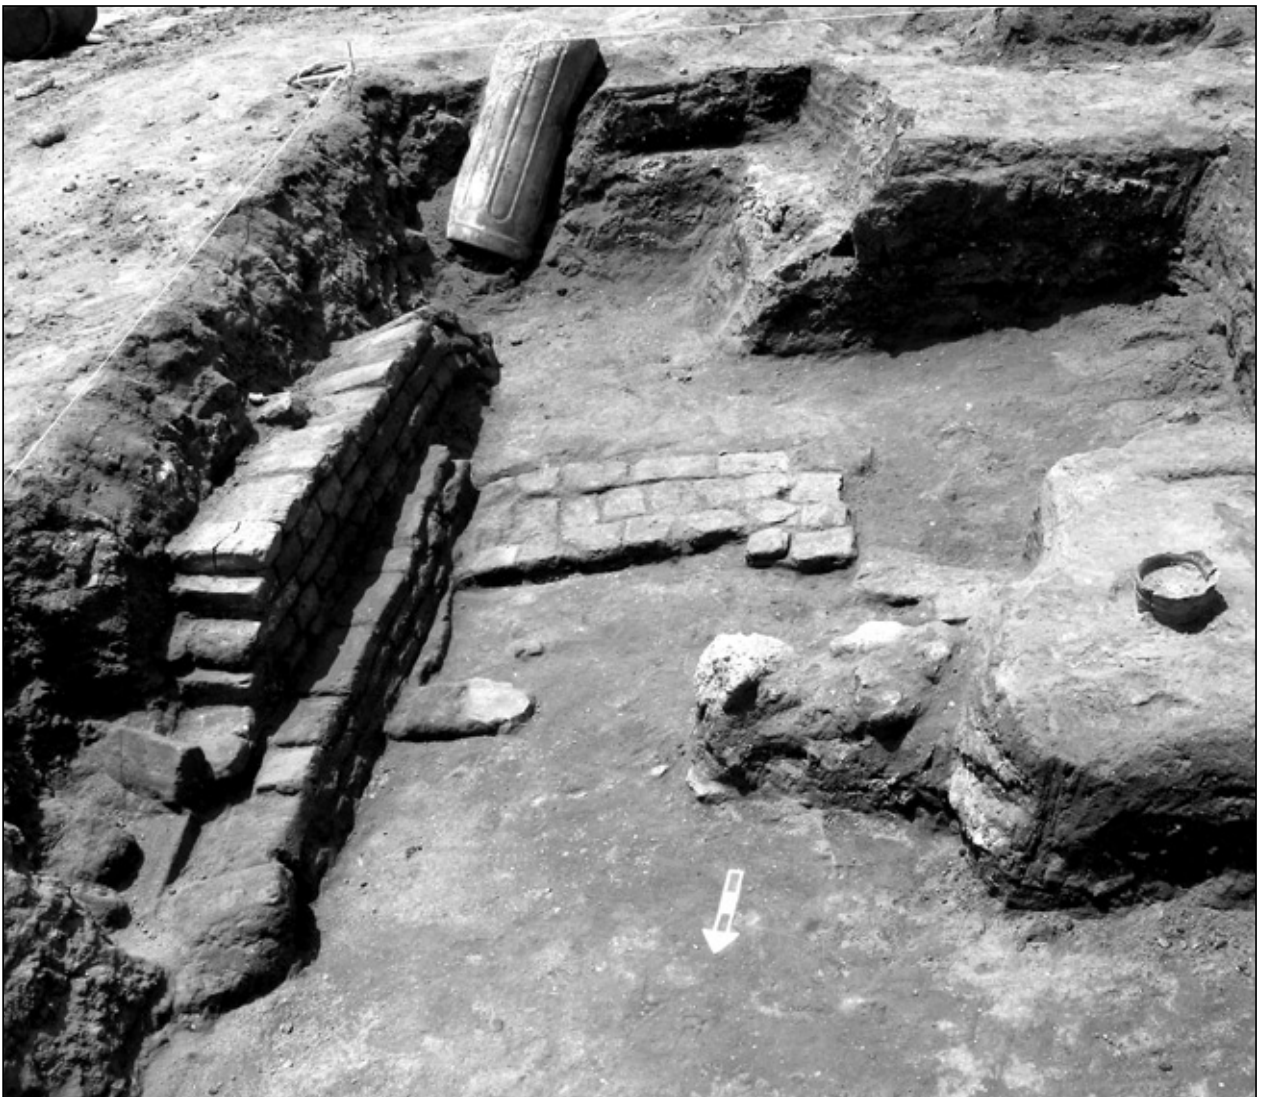
Fig. 6. Southeastern corner of the excavated trench in Sector 1, looking south (Photo K. Jakubiak)

The mound chosen for testing in the summer season of excavations was located 180 m north of the theater. The architecture uncovered in a trench 18 by 18 m proved to be heavily destroyed by numerous pits, as well as an obviously planned dismantling of the walls [Figs 5-6]. The suddenly increased demand for red brick as construction material can only be associated with the rapid building of the Late Roman

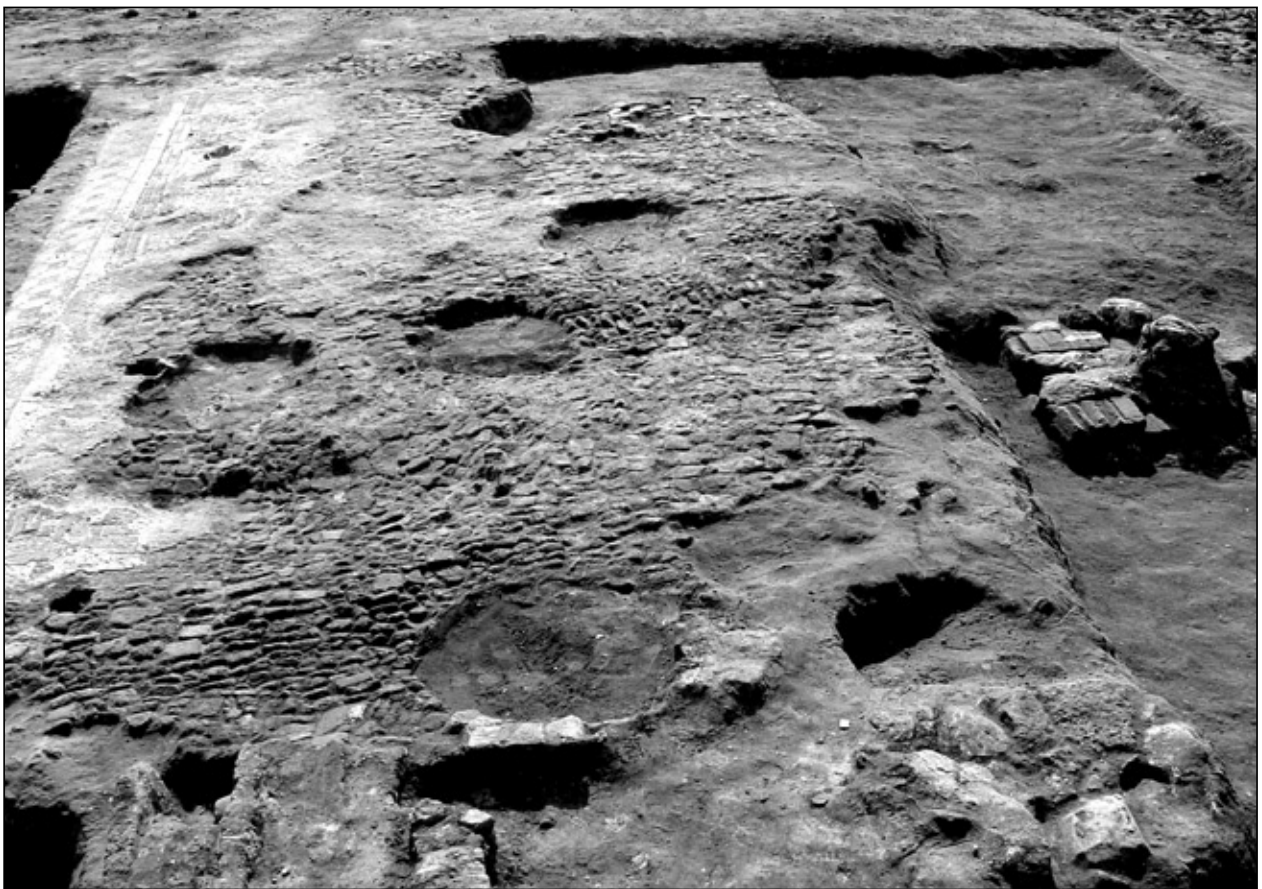
Fig. 8. Red-brick pavement substructure in the central part of Sector 2. View from the west (Photo K. Jakubiak)

0.40 to 1.50 m in width. The cubes were set in an ashy lime mortar resting on top of a red-brick substructure, which was raised on a layer of lime that was evidently intended as insulation. Heavily damaged and eroded fragments of a similar red-brick pavement were discovered immediately to the south of the mosaic remains [Fig. 8].

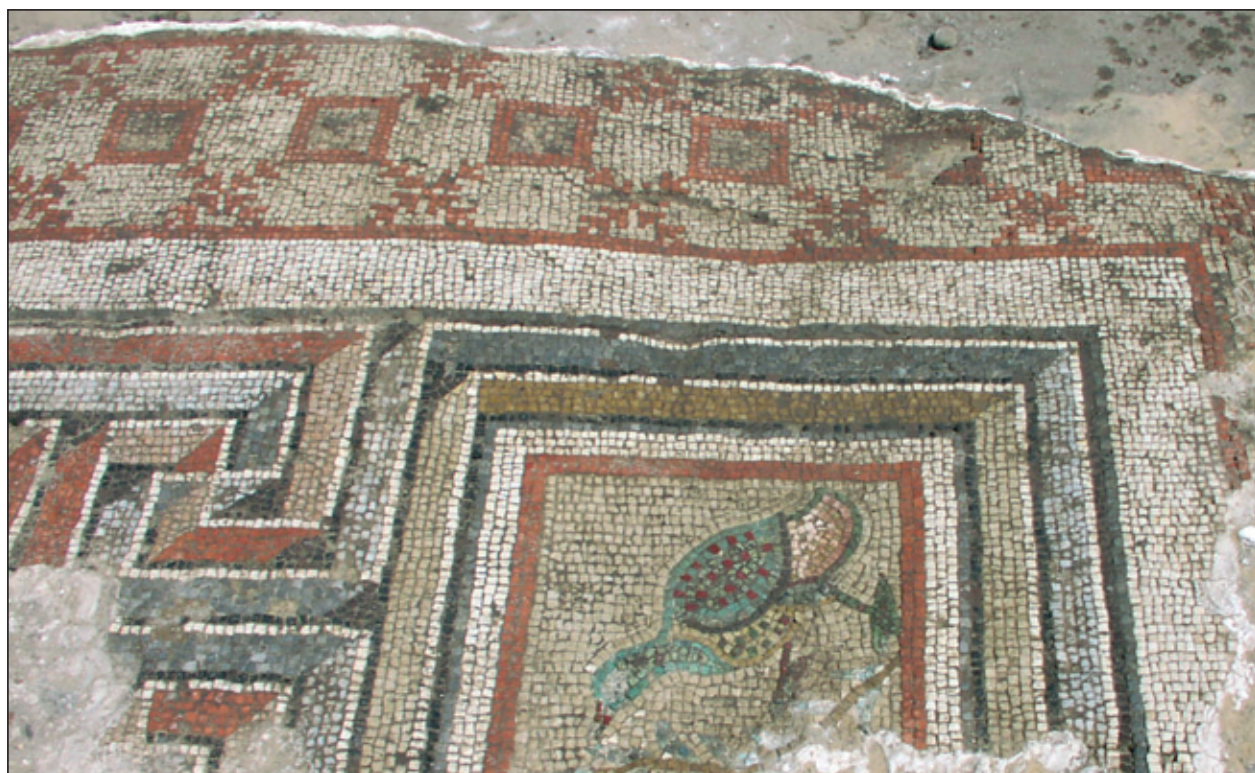
Fig. 9. Panel with duck and illusionist meander ornament from the northeastern corner of a central mosaic paneau (Photo M. Gawlikowski)

cally on the eastern and western sides of the composition. One of the smaller square panels in the northeastern corner of the mosaic contained a very well preserved representation of a duck [Fig. 9]. The colors of the tesserae include red, green, light green, gray and white. Stone, faience and glass (especially orange glass for the beak of the duck) were used to make the cubes. The other preserved panel, long and rectangular, depicted two ibises turned in opposite directions on either side of a central pomegranate tree [Fig. 10]. The contours of the birds were drawn with gray tesserae, while the bodies were filled with green cubes. The legs and bills were made of green faience tesserae and the wing outlines of blue glass. The illusionist meander was made of red, white, black, green, and pink cubes. A wide border framed the mosaic

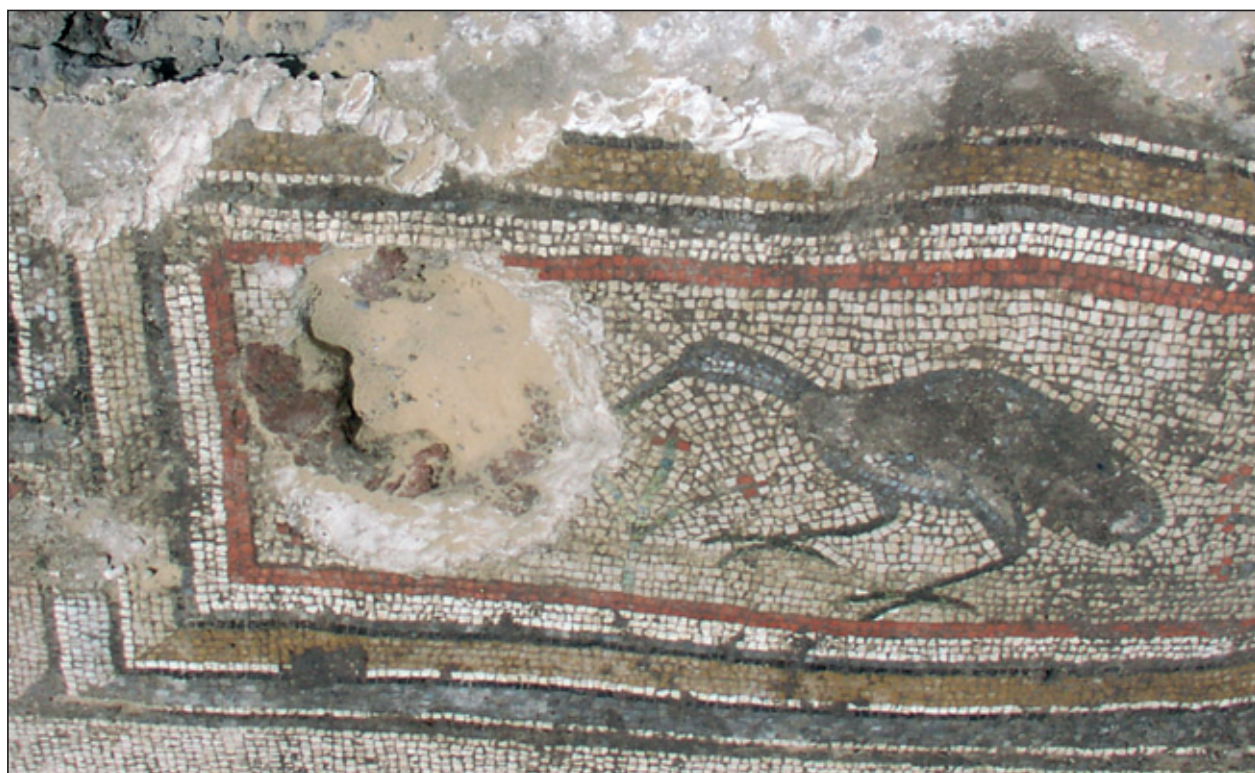
Fig. 10. Panel with ibis and pomegranate tree from the northern edge of a central mosaic paneau (Photo M. Gawlikowski)
