Hermitage 85 in Naqlun : Materials and Construction

Polish Archaeology in the Mediterranean 18, 207-212

HERMITAGE 85 IN NAQLUN: MATERIALS AND CONSTRUCTION

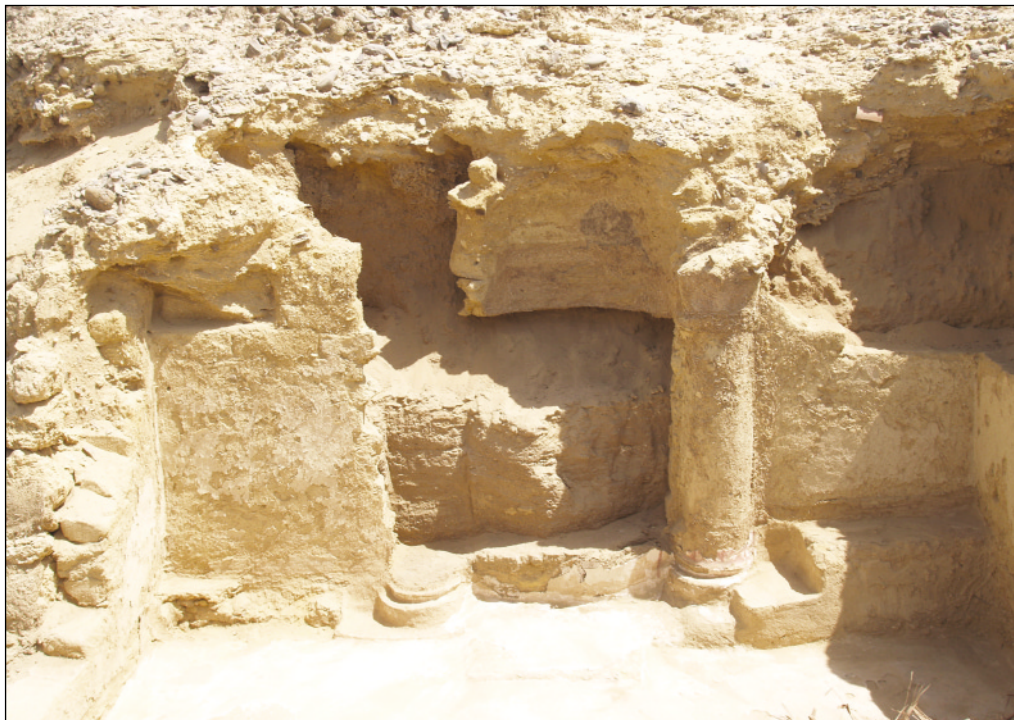
*Fig. 1. Prayer niche in the oratory of Hermitage 85
(Photo W. Godlewski)*

walls of the oratory were covered first with a thin coating (2-3 mm thick) of pale gray-beige plaster with chaff and then with an even thinner layer (1 mm or less) of almost cream plaster, produced from raw material of desert origin with chaff as well. The engaged columns and *mensa* in the niche between them had a coating of lime plaster (up to 2 mm thick) painted with a red ornament, laid on an underground of pale gray-beige and partly dark gray mud plaster.

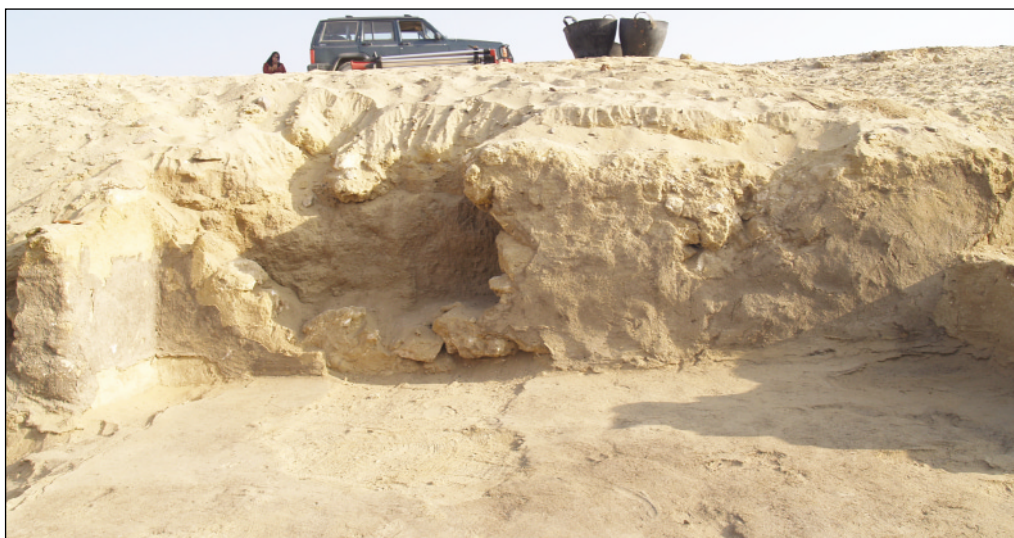
*Fig. 2. Remains of a mud floor and mud plaster on the walls of Room 5, view looking north
(Photo W. Godlewski)*

In other units, more of a domestic or living character, the walls were plastered in a different way. Preserved fragments show that at least the lower parts were covered with a thin coating (2-6 mm) of dark gray mud plaster containing fine chaff, smoothly passing into a floor made of the same plaster. Plasters of this kind are laid usually on a relatively thick underground (up to 2 cm) of grayish or pale-gray-beige plaster, both produced from raw material of desert origin.

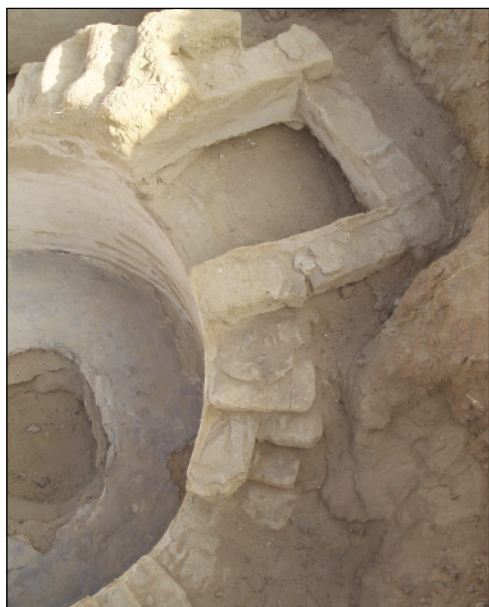
Fig. 3. Pit for storage jar and step down faced with brick in the southern pastophory (Room 6) (Photo W. Godlewski)

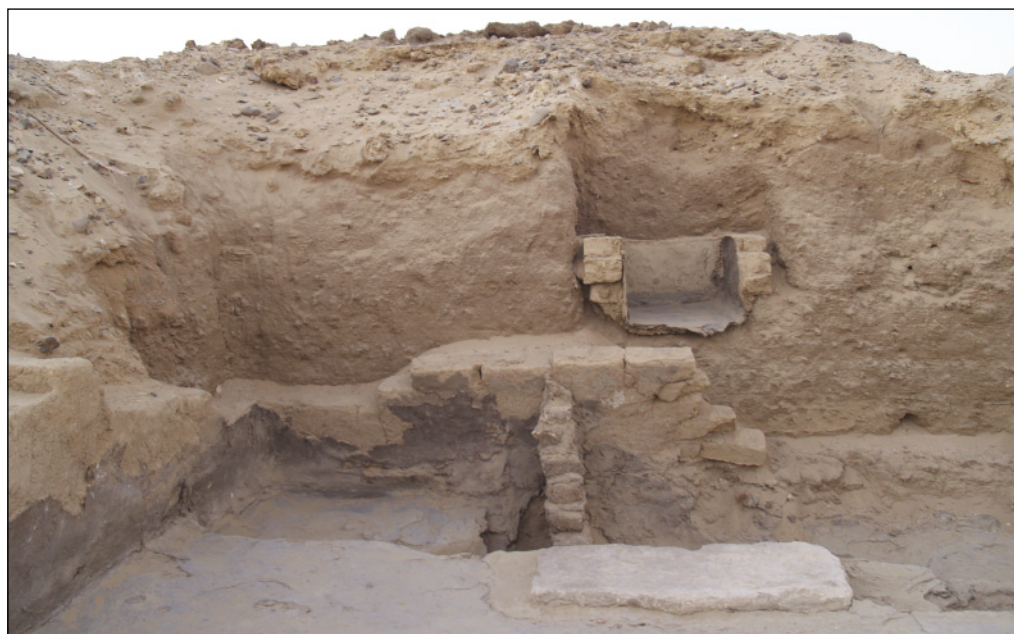
Fig. 4. The installations in Room 3, view looking north (Photo W. Godlewski)
