The Curtain Wall in Banganarti : Results of Research in 2006

Polish Archaeology in the Mediterranean 18, 403-409

THE CURTAIN WALL IN BANGANARTI

RESULTS OF REASERCH IN 2006

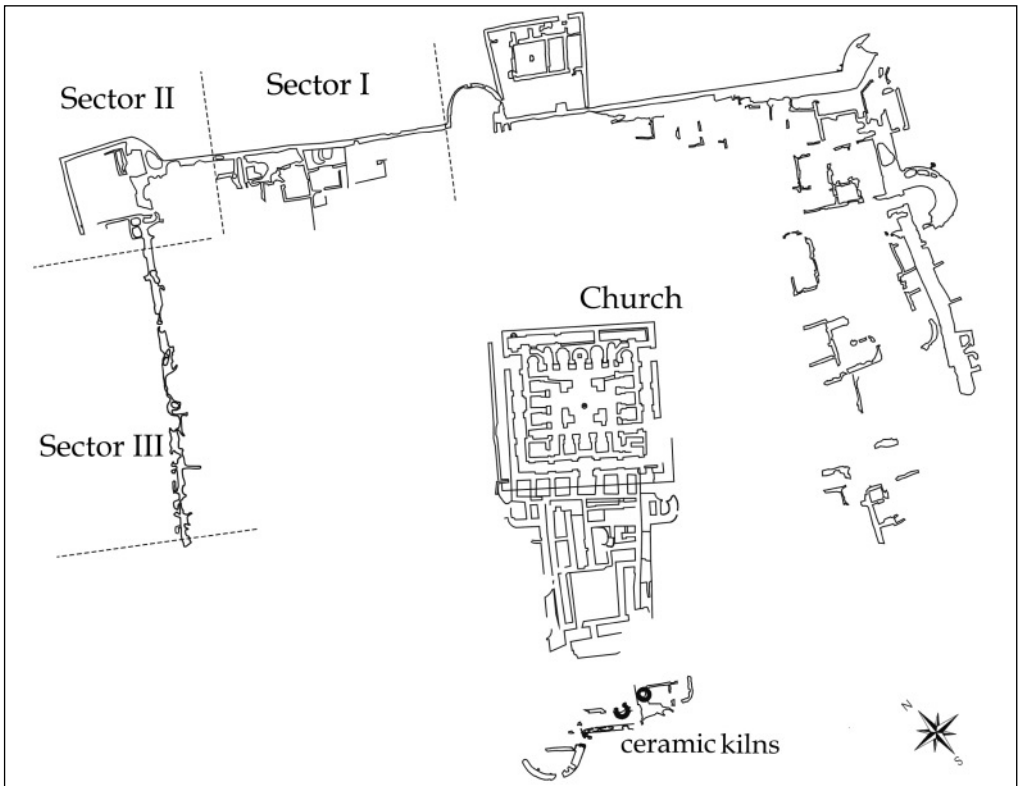
Fig. 1. The Baganarti fortifications, general plan after the 2006 season with sectors of research (Drawing R. Łopaciuk)

see above, B. Żurawski in this volume). The area was divided into three sectors [Fig. 1], covering a total length of about 100 m of the fortifications.

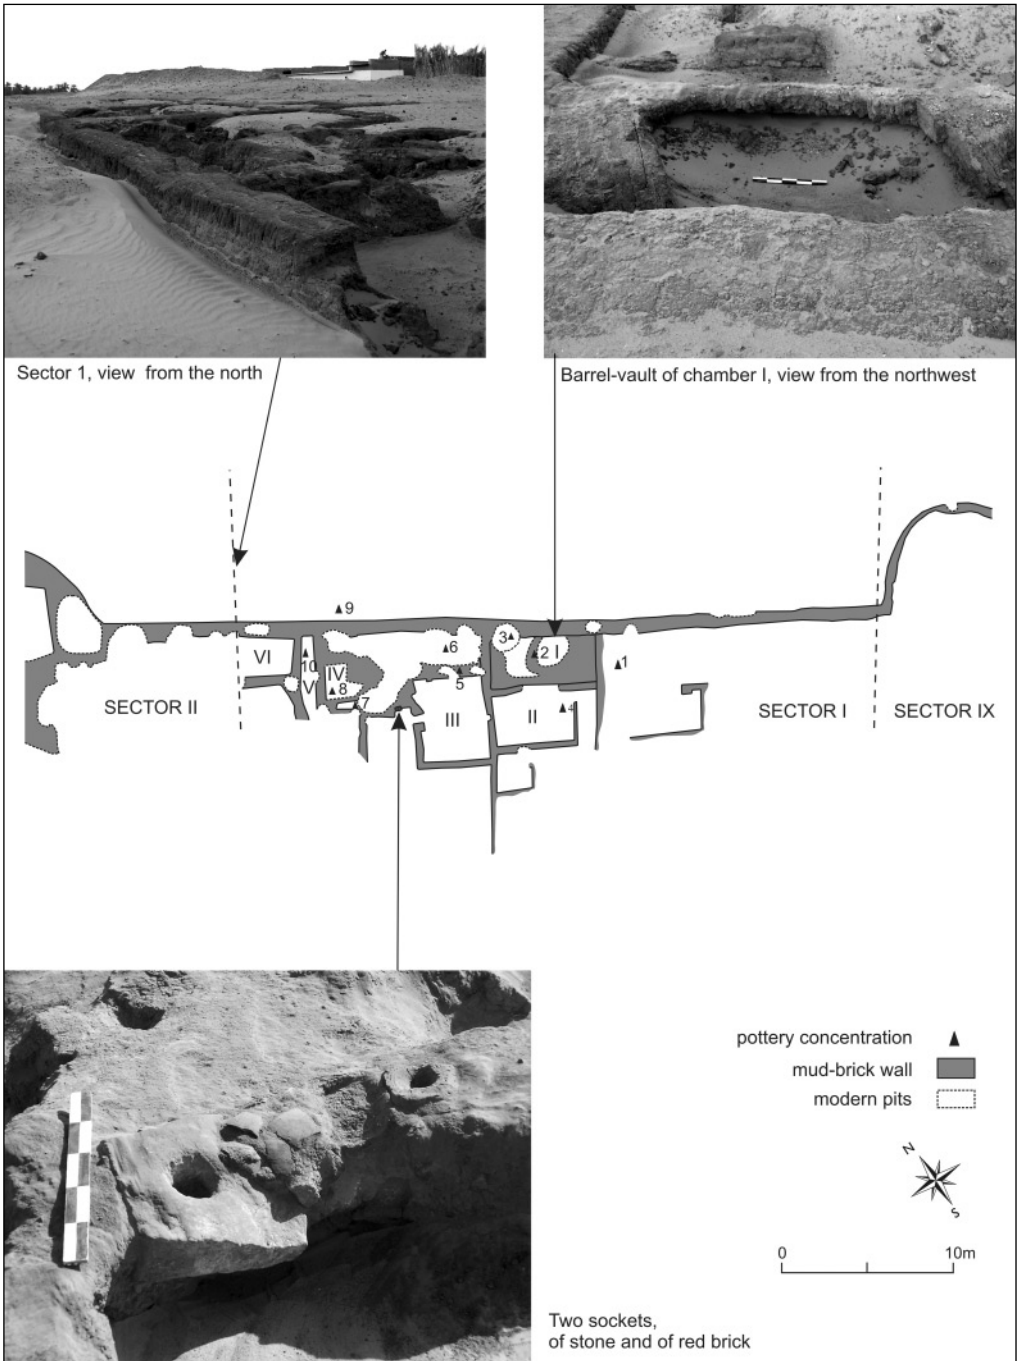
Fig. 2. Plan of the Banganarti curtain wall in Sector 1
 (Drawing and photos M. Drzewiecki)

The sector covers 37 m of the curtain wall between the eastern and northeastern towers [*Fig. 2*]. In the southern part of the sector, the wall was traceable on the sand surface, the northern part was revealed only after excavations in the 2006 season. A network of chambers (I-VI) was uncovered on the inside of the wall, but no additional structures beyond it.

The wall was c. 0.80 m thick in this sector, unlike a section of the southern line of the fortifications excavated in previous seasons, which reached a width of up to 3.30 m (Wiewióra 2005: 265). This considerable difference in thickness can be explained by different construction techniques. The south wall was a monolithic structure, but the section of the fortifications in Sector I had a series of long chambers (I, IV and VI) erected presumably together with the curtain wall, the purpose of this being to strengthen the construc-

tion [*Fig. 2*, top right]. The advantage of this technique is saving on building material, while creating spaces for either storage or dwelling. However, excavations in 2006 brought no evidence of such “secondary” usage of these chambers.

The walls of the chambers ranged in thickness from 0.30 to 0.60 m. Entrances were recorded in the case of chambers II and III. The former was entered from a narrow corridor, which ran SW-NE, while the latter had a door in the northwest side; this entrance was 0.55 m wide and the flanking jambs were thickened at this point. A short distance from this door there was a secondary deposit of two sockets for a revolving door beam [*Fig. 2*, bottom left], a stone one for the bottom side and one of red brick for the top (the hollow for the beam being in both cases c. 0.10 m in diameter).

Establishing whether these chambers were all built at one time or not is hardly simple. Chambers I, IV and VI seem to have been constructed along with the curtain wall. Chamber III does not fit the pattern, as it now appears, which could possibly indicate that it came into existence at a later time. A tentative assumption is that it was raised partly on top of the ruins of chamber IV.

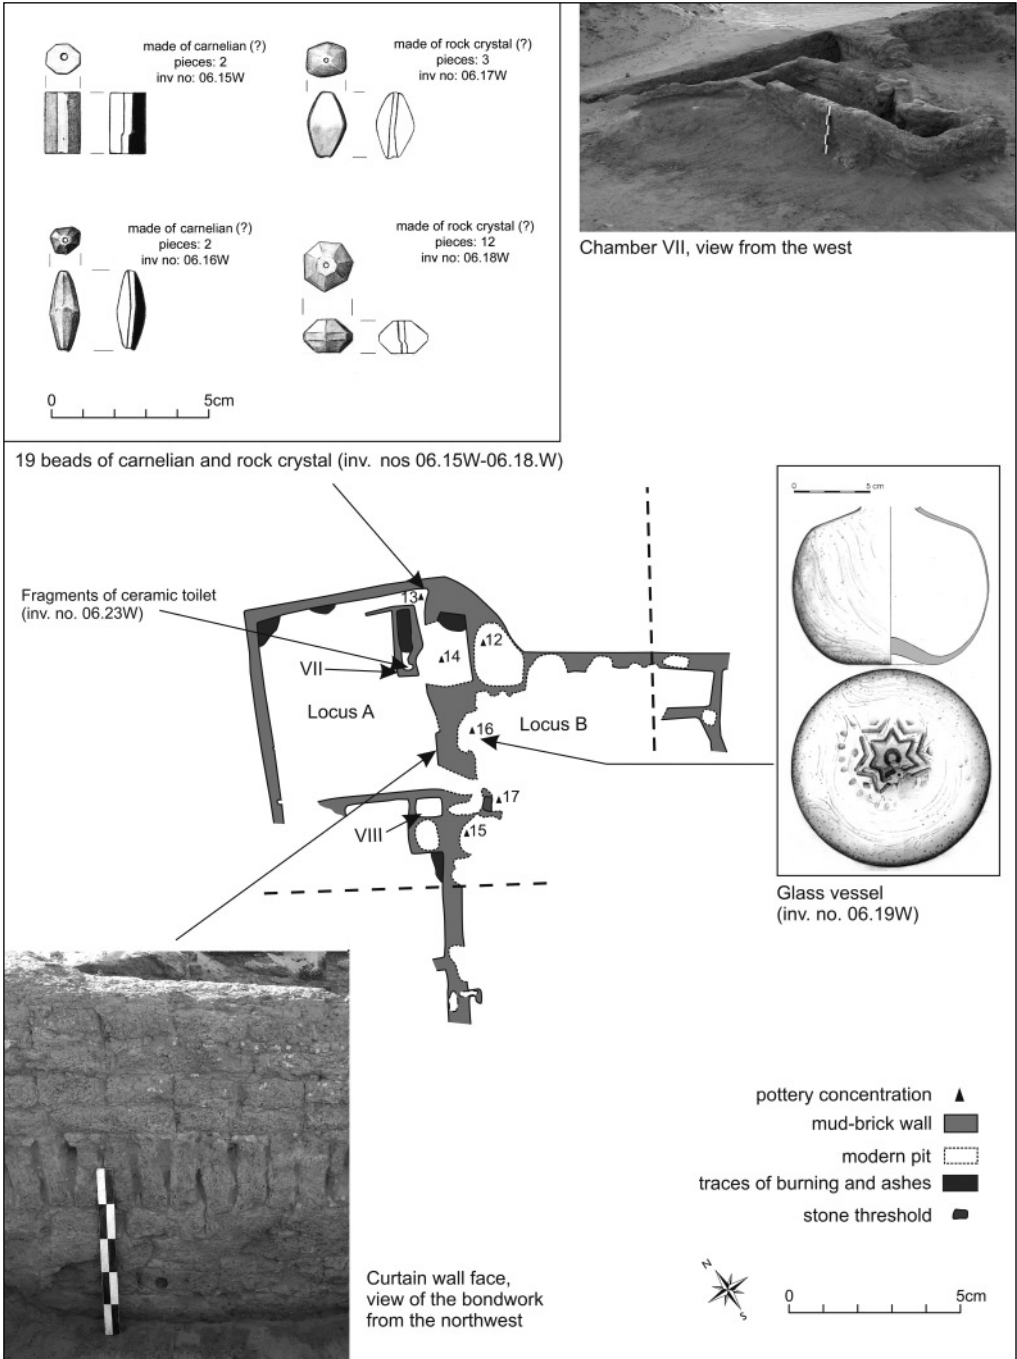
Fig. 3. Plan of the Banganarti curtain wall in Sector 2
(Drawing M. Momot; photos M. Drzewiecki)

The fortifications were made in their entirety of mud brick. The outer face featured cross bondwork (course of stretchers – course of headers) with single courses of headers-on-end [*Fig. 3*]. The collected ceramic material falls within a chronological range between the 11th and 14th century AD.

then either damaged to some extent or partly dismantled. A wall 0.60 m thick was built onto the fortifications from the northwest, incorporating part of the tower and the curtain wall, to form a space of about 100 m² (locus A). Inside this unit an elongated chamber (VII; c. 3.50 by 1.20 m) was constructed [Fig. 3, top right]. A ceramic toilet (Inv.no. 06.23W) found in the top parts of the layer and a horizontal layering of ashes suggests the chamber's function as a *cloaca*. Numerous concentrations of burning and ashes were also noted inside locus A.

The bead necklace (see above) was discovered together with a small bowl in the eastern corner of locus A (findspot marked in the plan in Fig. 3). It is more likely to be connected with the functioning of the later unit rather than the earlier defensive phases, and it was quite probably hoarded in this spot.

The only fragment of glass from this area, a broken small bottle with ovoid body and long neck, and a monogram on the base [cf. Fig. 3, center right], was located in the vicinity of a concentration of pottery (no. 16).

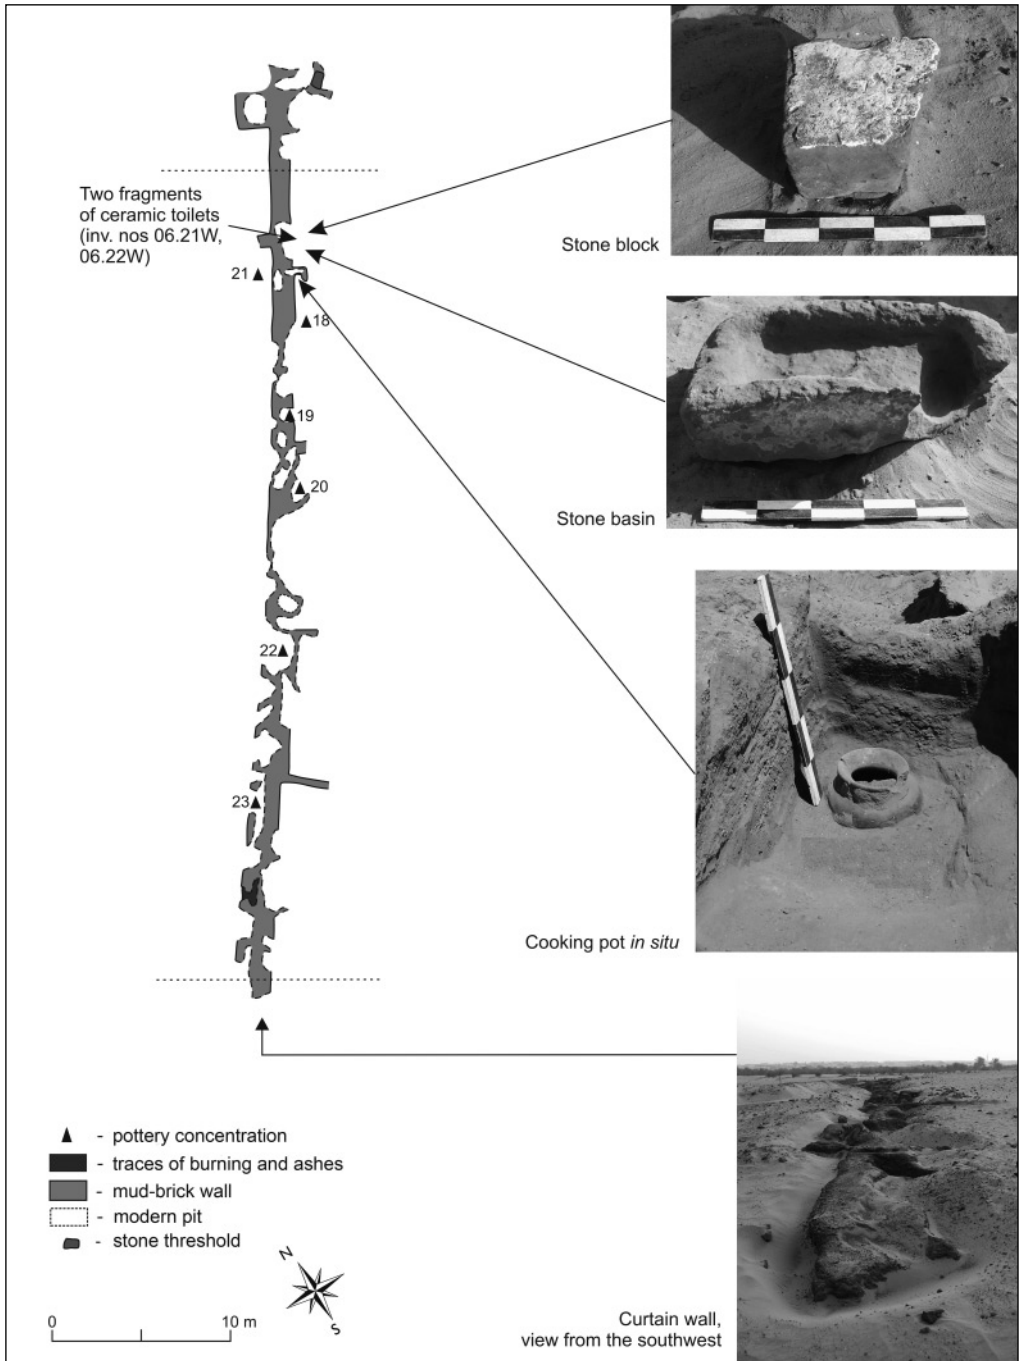
Fig. 4. Plan of the Banganarti curtain wall in Sector 3
 (Drawing and photos M. Drzewiecki)

The sector is characterized by intensive modern digging, making it difficult on occasion to trace the course and determine the thickness of the fortifications. Single walls built onto the face of the curtain wall presumably belong to chambers once located here [Fig. 4].

The slightly curved line of the fortification in this sector could be construed as intentional, in analogy to the situation in the southern part of the site, where the curtain wall there has been observed to avoid a round chamber standing near the inner face of the fortifications. The thickness of the wall here appears to change, from c. 1 m at the northeastern end to c. 2 m at the southwestern end.

a cooking pot still in place, sheltered from the elements in a crook of the curtain wall by its inner face [cf. *Fig. 4*].
