MARINA EL-ALAMEIN

SITE PRESENTATION PROJECT (ARCE/EAP)

PRELIMINARY ARCHAEOLOGICAL REPORT

Iwona Zych
with Artur Obłuski and Urszula Wicenciak

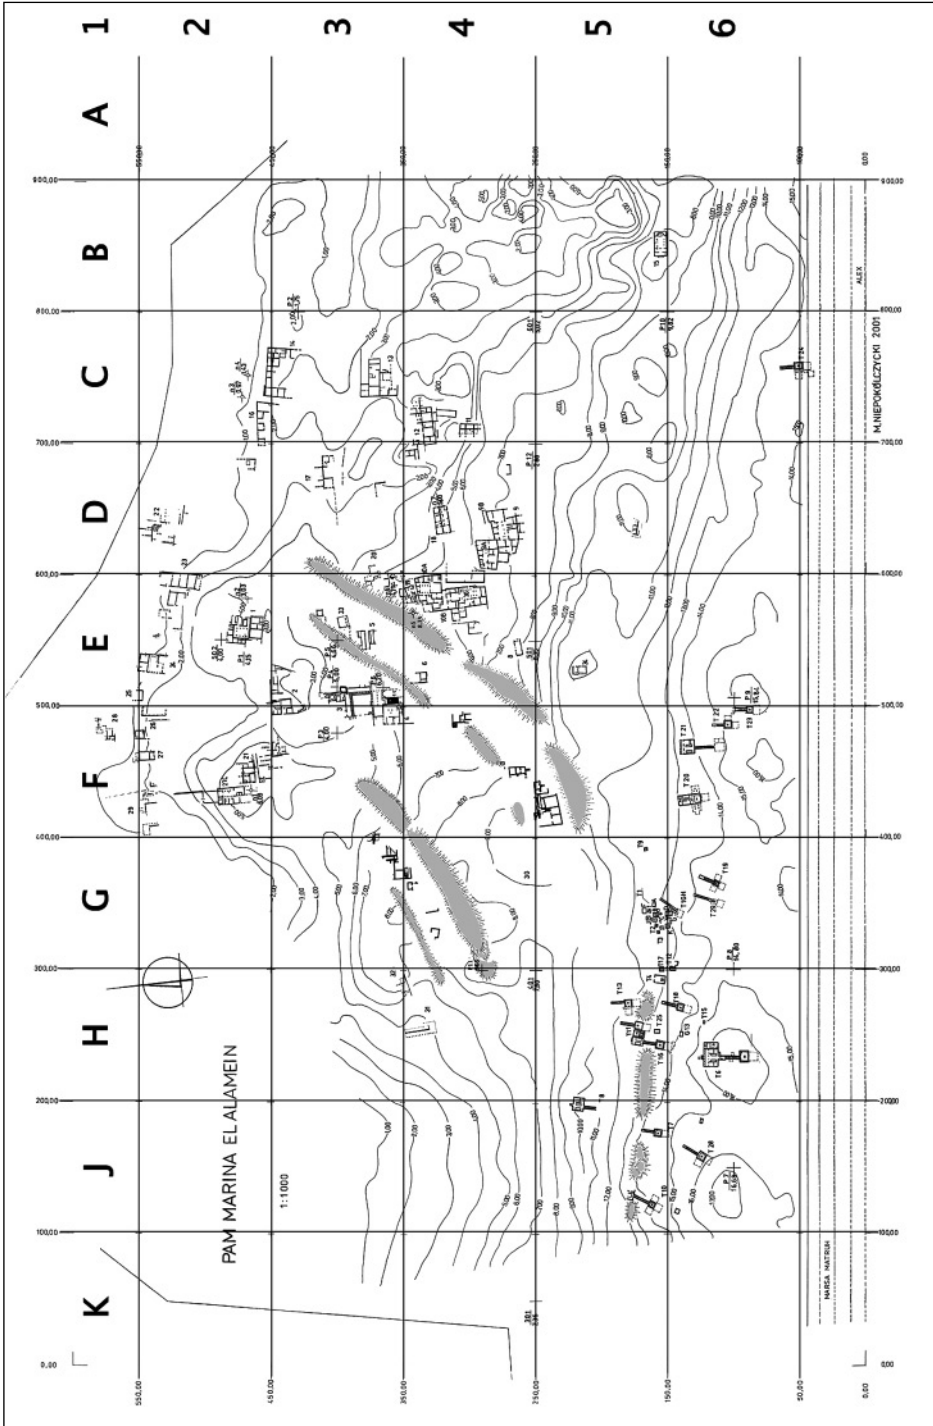
Fig. 1. Plan of the site of Marina el-Alamein introducing a grid of squares and including the results of the MASP survey in 2006; building dumps of the mid-1980s shaded in gray (PCMA archives, updated for MASP by A. Obtuski, U. Wicenciak)

The dumps in question, shaded gray in Fig. 1, appear on either side of two 'cuts', both some 25 m wide, traced under the future streets. They run parallel to one another, a few dozen meters apart. The eastern sides of the cuts were more heavily covered by sand and rubble excavated from the bottom. These mounds were from 10-12 m to 28.50 m wide at the base, rising to a height of from 2 to 3 m. The western-side dumps were smaller and less extensive and actually nonexistent over long stretches, the edges of the cuts being actually in undisturbed ground. All of the dumps presented a characteristic crescent-shaped pattern of ridges, resulting from loaders pushing particular scoops of material before them without any further leveling.

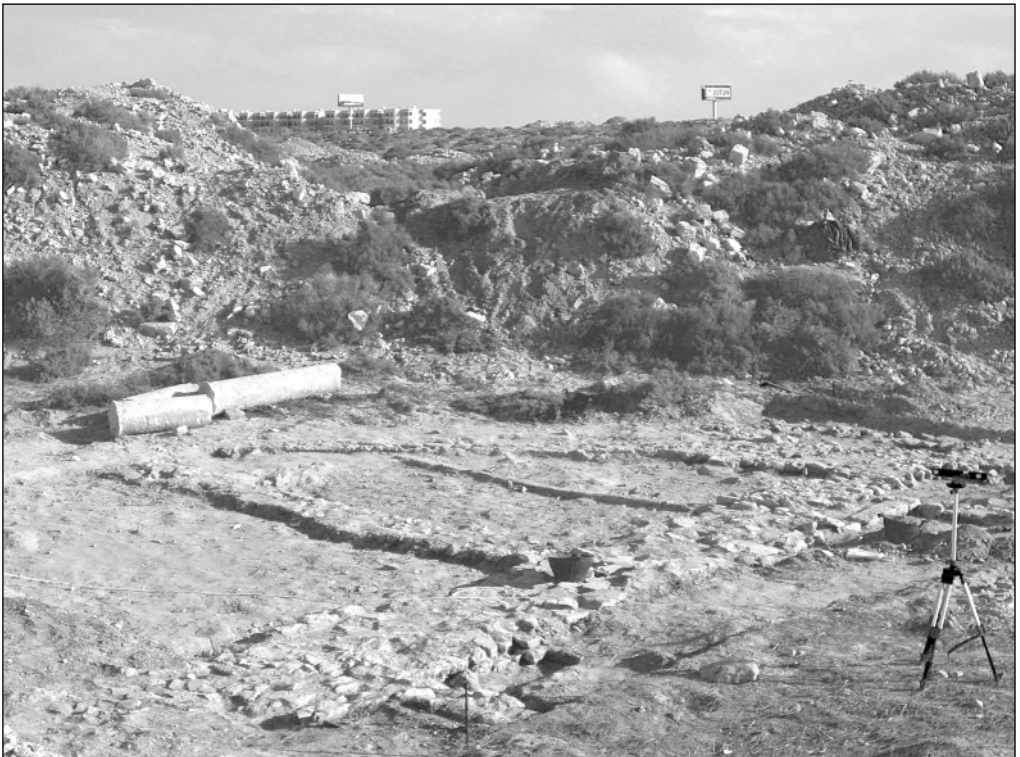
Fig. 2. One of the building dumps and the uncovered archaeological features in the western part of the bulldozed cuts (Tr05+07) (Photo A. Obluski, courtesy MASP ARCE/EAP)

Tests on a part of one dump demonstrated a classic case of inverted stratigraphy. Ancient remains were dumped at the very top and lying in the open for the past twenty years. Everything underneath was drifted sand, which had previously buried the ruins under a layer one to two meters thick. Loaders had lifted this natural layer (destroying in the process ancient walls and carrying with it modern debris), stopping for whatever reason at what proved to be Roman-age floor levels

[Fig. 2]. The occupational levels from the bottom of the 'cuts' ended up on top of the mounds. Moreover, with the length of the traced streets being between 130 and 180 m, it is only logical to assume that particular sections of the mounds contents corresponded to archaeological features found at the bottom of the cut in the immediate vicinity. Fieldwalking of the mounds largely bore out this assumption. Most obviously, there was a World War II bottle coming from the whereabouts of military trenches in the western of the cuts and a piece of water spout, which proved to fit a pipe in the wall of a structure uncovered in the eastern cut.

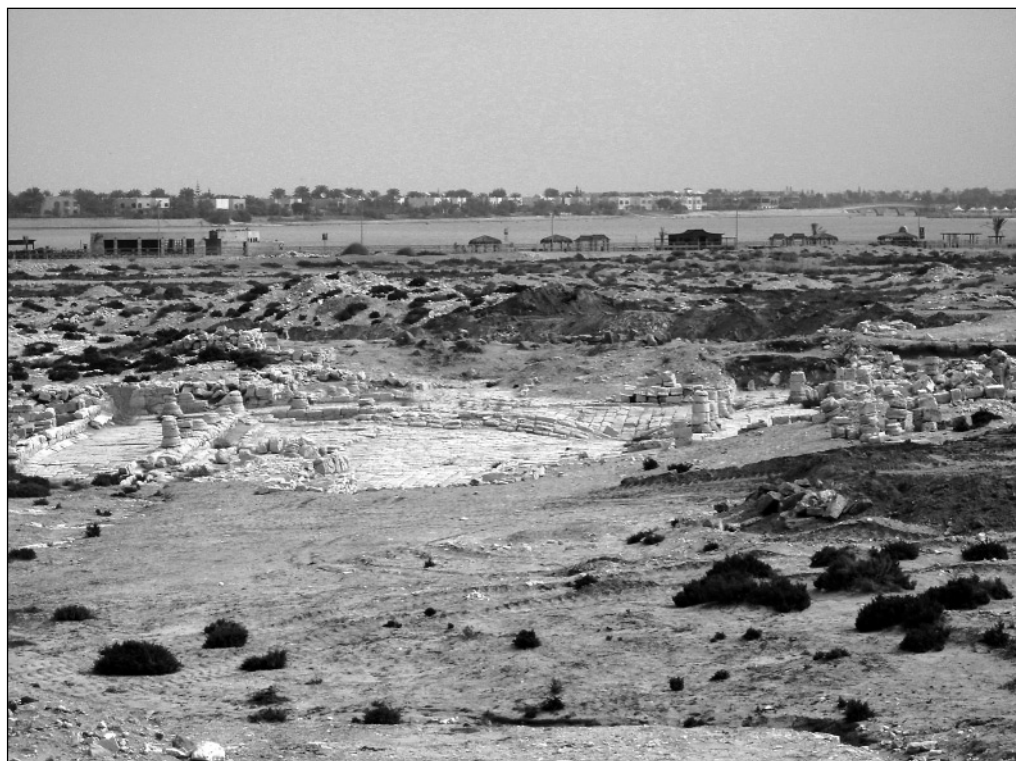
Fig. 3. *The eastern side of the main town square following removal of the dump, view from the west (Photo I. Zych, courtesy MASP ARCE/EAP)*

equipment. Once the tumbled debris of the underlying building started to appear on the surface, work in this area desisted [Fig. 3].² Finds from the disturbed surface layer in this area included sizable quantities of broken marble tiles and slabs, possibly from wall revetment and floor paving, a lion's leg of limestone which could have been a bench support (in analogy to the supports found in the South Portico), and several pieces of architectural cornice decoration matching pieces found earlier in the area by the archaeological mission and obviously belonging to the

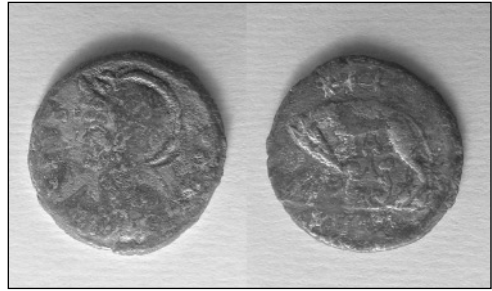
Fig. 4. Constantine's commemorative coin (AD 330-341), obverse and reverse (Photo A. Obluski, courtesy MASP ARCE/EAP)

building still concealed under layers of sand here. A dating find is a coin of Constantine the Great, one of a commemorative issue struck in AD 330-341, on the occasion of building the new capital in Constantinople [Fig. 4]. It and two other unidentified coins came from a patch of ashes and burning found between the tumble of blocks, hence it can be assumed with fair certainty that it reflects late occupation of the town square and its surroundings.

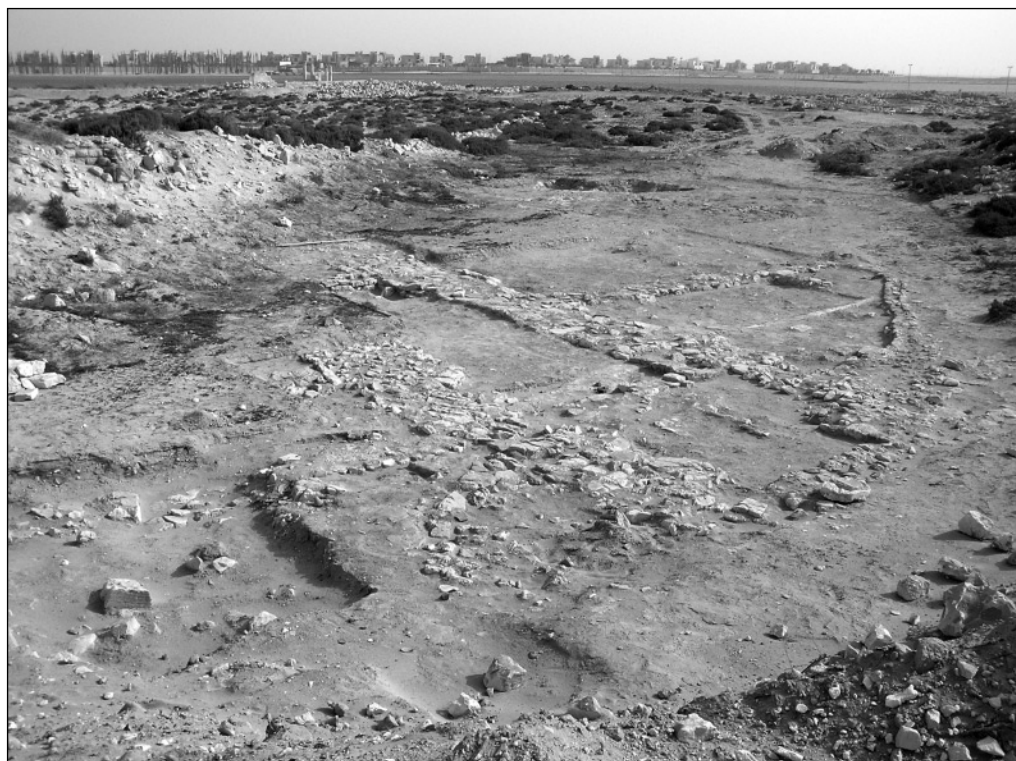
Fig. 5. View of the western cut looking north – ancient walls bulldozed at floor level; the pit at center back marks the position of a sunk exedra (Photo A. Obłuski, courtesy MASP ARCE/EAP)

The backfilling and landscaping operation took into account the results of the survey. In the case of the western of the 'cuts', the presence of a large exedra of unknown function and attribution, its location on the main E-W axis of the town, and the nearby presence of marble columns and bases – on the dump but logically

originating from this structure or close to it – prompted a decision not to cover the entire northernmost end of the cut [Fig. 5]. The exedra was connected with a double set of very thick walls, unlike anything discovered in Marina so far, and for this reason it was decided to leave the area open for regular excavations in the future. Also at the northernmost end of the eastern of the cuts the line of the landscaped slope was receded south beyond the trench, leaving the architecture here open for future excavations should such a project be considered. The backfill where it was accomplished measures from barely a few centimeters to over a meter of sand and

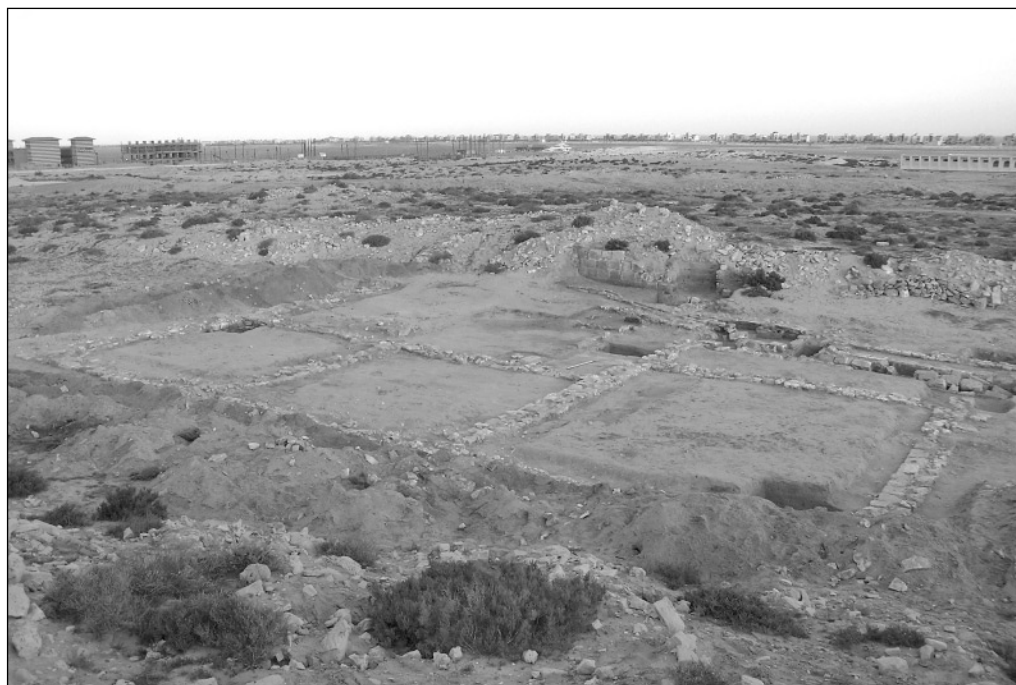
Fig. 6. General view of the cluster of rooms in Tr04 looking west; note wall of asblar blocks in the west side of the cut (Photo A. Obłuski, courtesy MASP ARCE/EAP)

The southernmost cluster of rooms (Tr04), separated by a presumed alley from a structure already outside the survey area, consisted of four units and a small paved area in the center [Fig. 6]. Thresholds to at least two of the units were observed. Evidence of destruction in a violent conflagration was present everywhere, including a deposit of objects evidently in use at the time of the catastrophe, composed of a small iron adze mounted on a wooden handle, iron fittings (of a box?) wrapped in plain cloth,³ bronze pyxis lid with hoop handle, terracotta fragment, a varied set of complete bowls, plates and jugs of plain and table wares, a faience bowl [cf. Fig. 11], and last but hardly the least, a fine example of a Cretan ivy-leaf lamp [cf. Fig. 10]. The combined evidence of this material places the catastrophic event in the second half of the 2nd century AD.

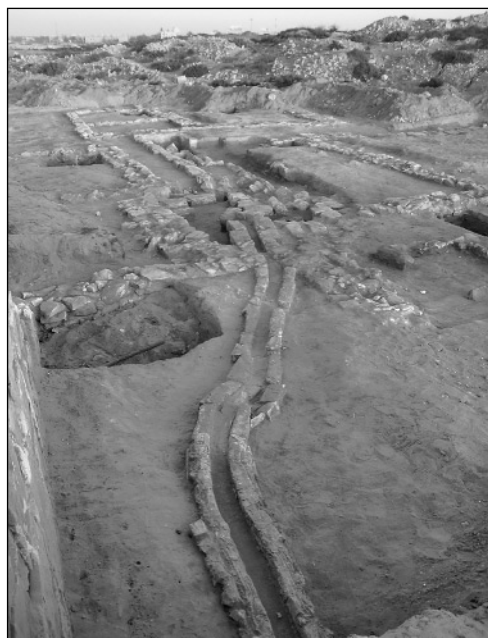
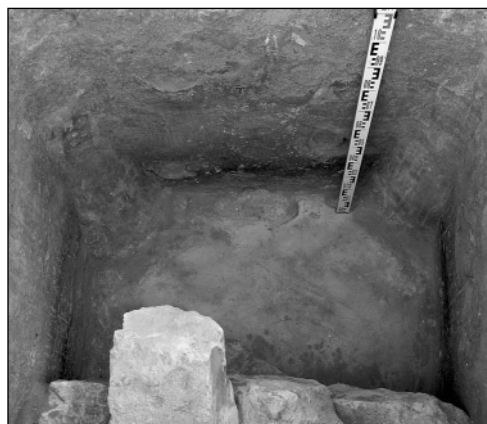
Fig. 7. Channel feeding a cistern in Tr04, view looking northeast (left) and detail of one end of the cistern with water-proofed plastering on the walls and characteristic corner projections (Photo A. Obłuski, courtesy MASP ARCE/EAP)

rectangular cistern with a curious sideways projecting extension was introduced, destroying a few house walls in the process. The cistern was probably fed through a channel that meandered somewhere from the southwest. The architecture north of the cistern feature fails to be easily identified for the moment [Fig. 7].

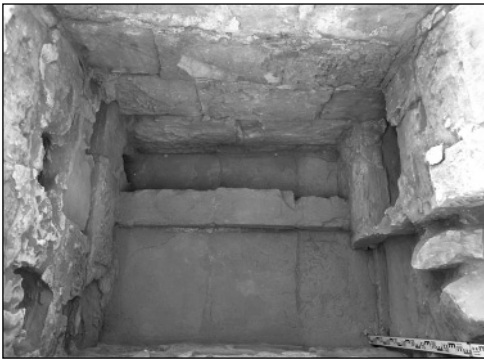
Fig. 8. *Latrine(?) compartment in a building in Tr03, top view. The entrance to the room was from the west (to the right in the photo) and the channel emptied into a street outside through a triangular hole in the east wall. Some kind of permanent seating had been installed above the channel (Photo A. Obluski, courtesy MASP ARCE/EAP)*

east of this structure) there stood yet another complex (Tr03), of which only the southeastern corner with well preserved latrine(?) was preserved [Fig. 8]. This building or at least the part of it that was recorded within the limits of the surveyed area was built entirely of slabs. Standing walls measured some 1.70 m. With the 3 m or so of tumbled wall slabs that were found lying practically in order immediately to the south of this structure, it gives us a height of at least 4.50 m for the building. Considering the small size of the latrine(?) unit in the southwestern compartment of this structure, one cannot but think of there being an upper floor to this building. The latrine had a paved floor and a waterproofed channel that emptied through a triangular opening in the wall into the open (?) space located to the south. The unit next to it was paved but with no other features to identify its function. A coin found fortuitously in the blocks from the collapsed upper parts of walls inside the presumed latrine suggest that the destruction occurred not earlier than in the earthquake of AD 164.

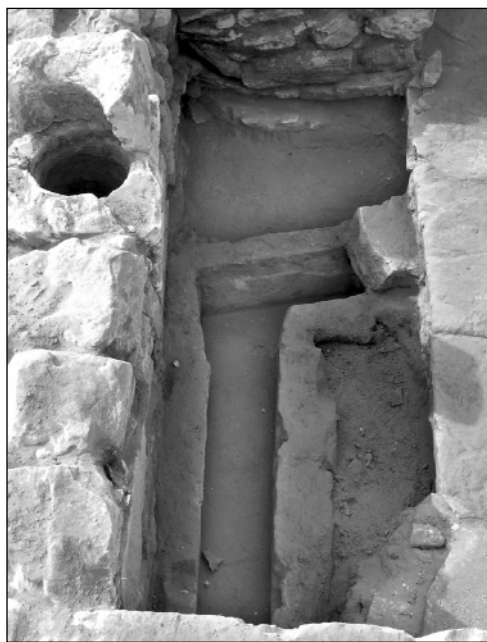
Fig. 9. Paved unit with well (to right), fireplace and bin in Tr01, looking northeast; the channel under the platform (photo at top right) was fed from a drain in the corner of the room and emptied into the well structure; the vertical drain in the wall above the channel was not connected with it (Photo U. Wicenciak, courtesy MASP ARCE/EAP)

corners [Fig. 9]. A masonry drain pipe was pierced through one of the walls (its outlet was not discovered unfortunately) [cf. Fig. 9, top right]. The paved area turned out to have a channel installation fitted under the earth platform in the eastern end, fed through a pottery vessel rim mortared to the floor and emptying in the general direction of the cistern in the southern part of the unit (the connection could not be traced because of overlying flagstones).

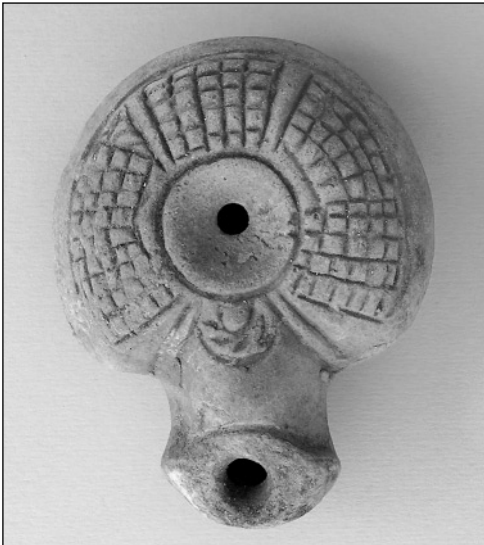
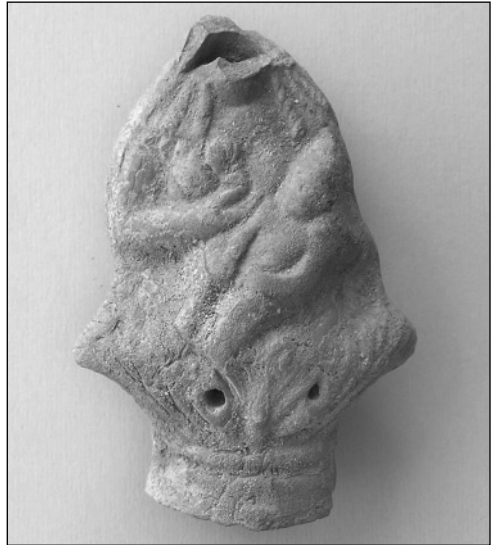
Fig. 10. Isis nursing Harpocrates, lamp handle attachment (bottom right) and “Frog”-type lamp from Tr01; Cretan ivy-leaf lamp from Tr04 (Photo A. Obłuski, courtesy MASP ARCE/EAP)

The next-door unit to the east yielded one of the small limestone altars discovered by the mission. The complex was also a source of two lamps of pointed interest for chronological reasons: An Isis-in-lotus-flower-nursing-Harpokrates lamp handle attachment and a “Frog”-type lamp, both of which can be helpful with the dating of these complexes [Fig. 10].

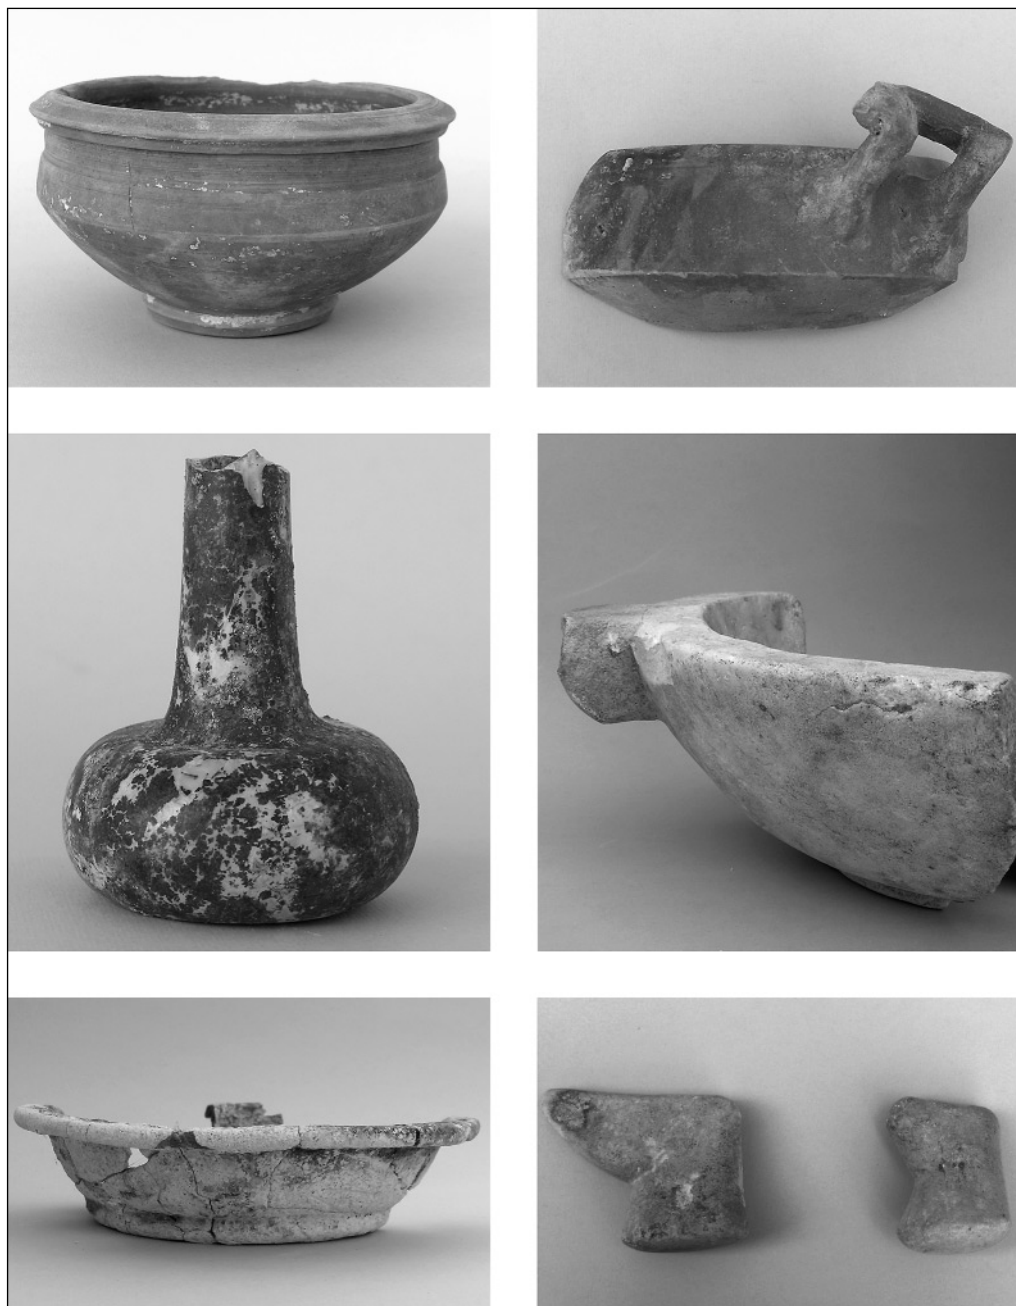
Fig. 11. Selection of finds from the survey (clockwise from top left): Cyprus sigillata krater P.40, 1st-century AD cooking pot, limestone mortar bowl, two limestone pounders with evidence of use on the working surfaces, 2nd-century AD faience bowl, glass unguentarium bottle of the 1st century AD (Photo A. Obłuski, courtesy MASP ARCE/EAP)

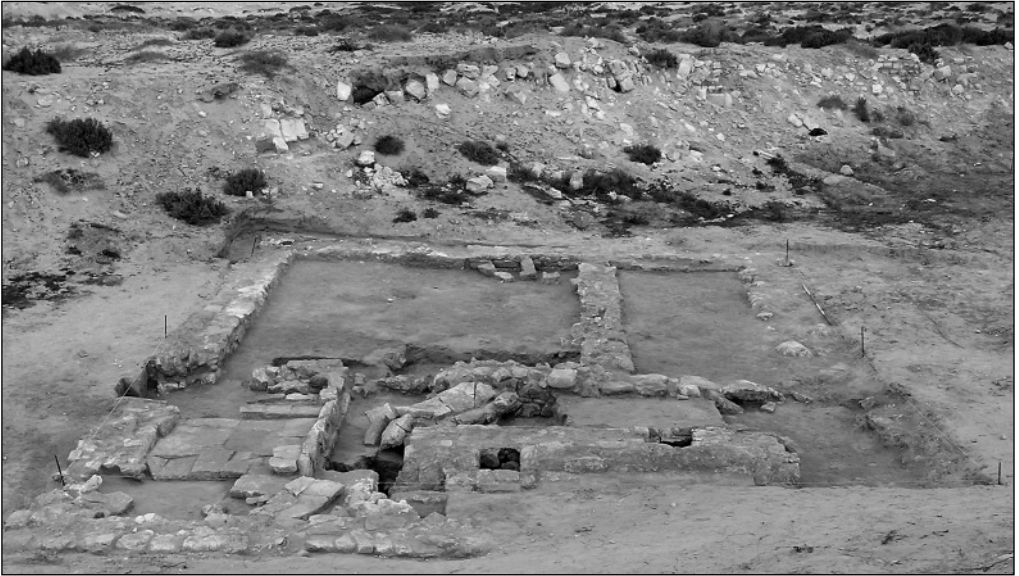
Fig. 12. General view of Tr06 with cistern in foreground, looking northwest; note remains of WWII structures in the western side of the cut (Photo A. Obłuski, courtesy MASP ARCE/EAP)

The cluster of units around a cistern in the middle of the surveyed area proved to be in effect part of a big complex that extended all the way to the north of the surveyed area. It also contained a big exedra opening to the east, the function of which cannot be ascertained at present except that it may have had some connection with water use. Further west of this feature, a double set of walls of a thickness up to 1.50 m not encountered in Marina so far (to the present author's knowledge) cut across the surveyed area, following a N-S orientation (Tr05+Tr07). These walls proved to be connected with the building, of which the

cistern was a part of in a later stage of its use (Tr06) [Fig. 12].

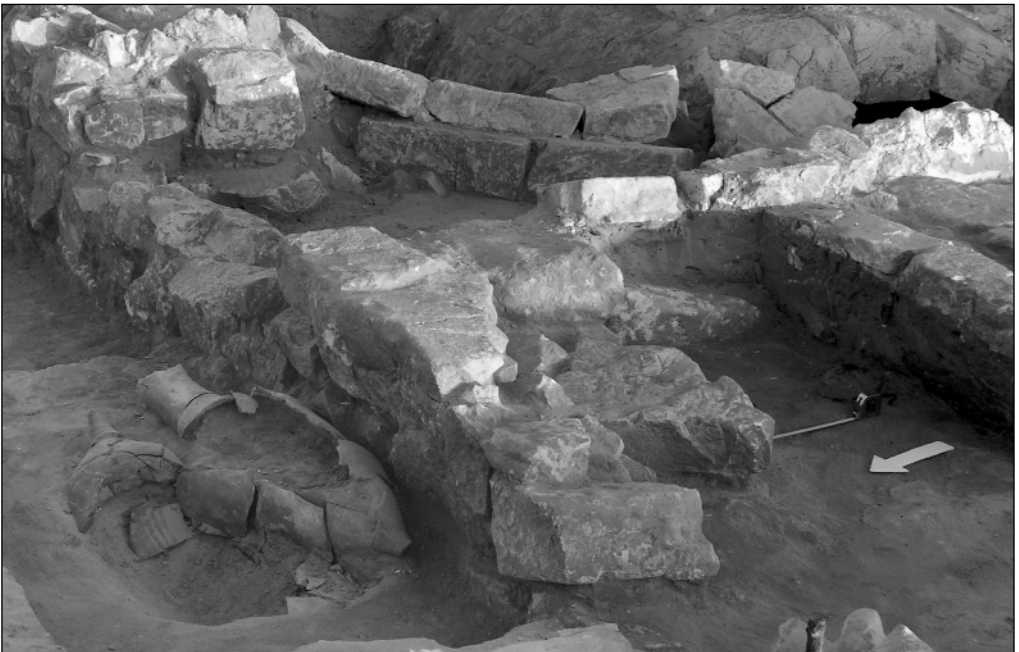
Fig. 13. Household area in Tr06 with bin containing amphorae on left and cistern with feeding channel for rainwater collected from the roof at center back and right, looking east (Photo A. Obłuski, courtesy MASP ARCE/EAP)

The cistern functioned in association with a paved area used for some household activities, a small kitchen area perhaps and storage space (perhaps open courtyard) where a bin containing three amphorae, one with *dipinti* and another one a typical Rhodian import of the 1st century AD, was discovered [Fig. 13]. A small limestone altar was also discovered here. The building obviously extended to the north, into the side of the 'cut', where an ancient wall was found to touch a World War II trench built practically on top of it [Fig. 14]. (Indeed,

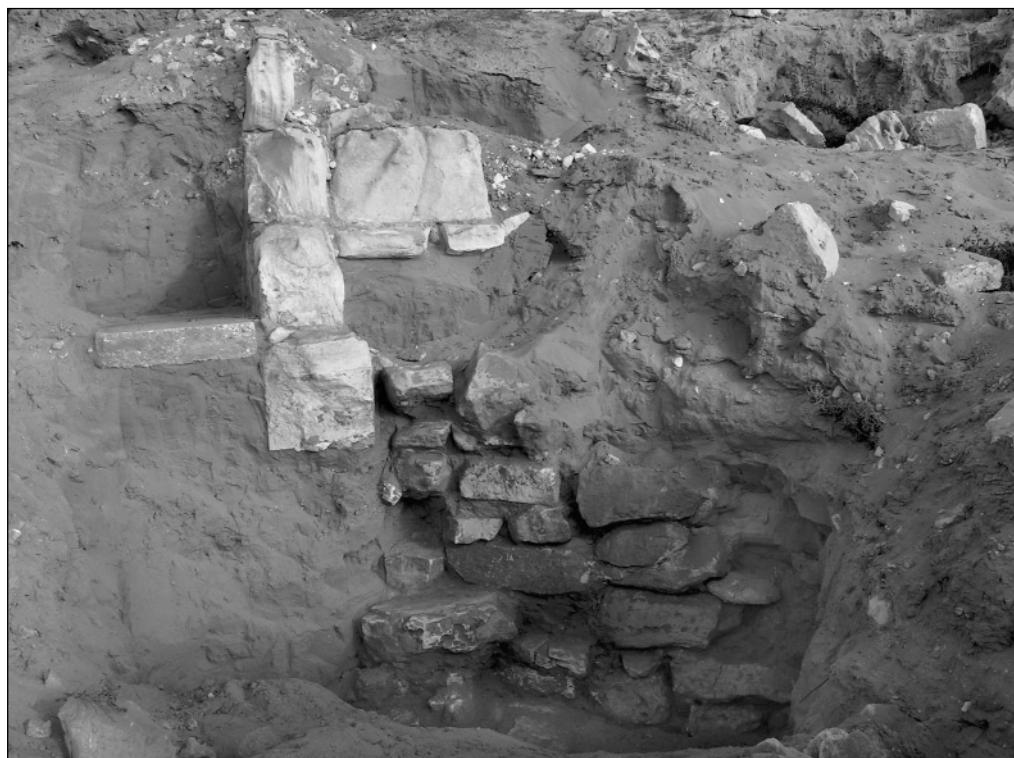
Fig. 14. World War II structure resting on top of ruined walls from the Roman age
(Photo I. Zych, courtesy MASP ARCE/EAP)

the center part of this area must have been drilled full of pits by the World War II structures,⁴ several of which were found alongside it and on the opposite side and which evidently destroyed much of this last-phase architecture in and west of Tr06).
