Banganarti Fortifications in the 2008 Season

Polish Archaeology in the Mediterranean 20, 273-282

Abstract: Excavations primarily in sectors II, VII and IX of the Banganarti defenses were designed to collect sufficient data for a preliminary phasing and functional analysis of the fortifications. Evidence was also recorded for human activity next to the defenses, including the presence of layers of burning at the foundation level of the curtain wall.

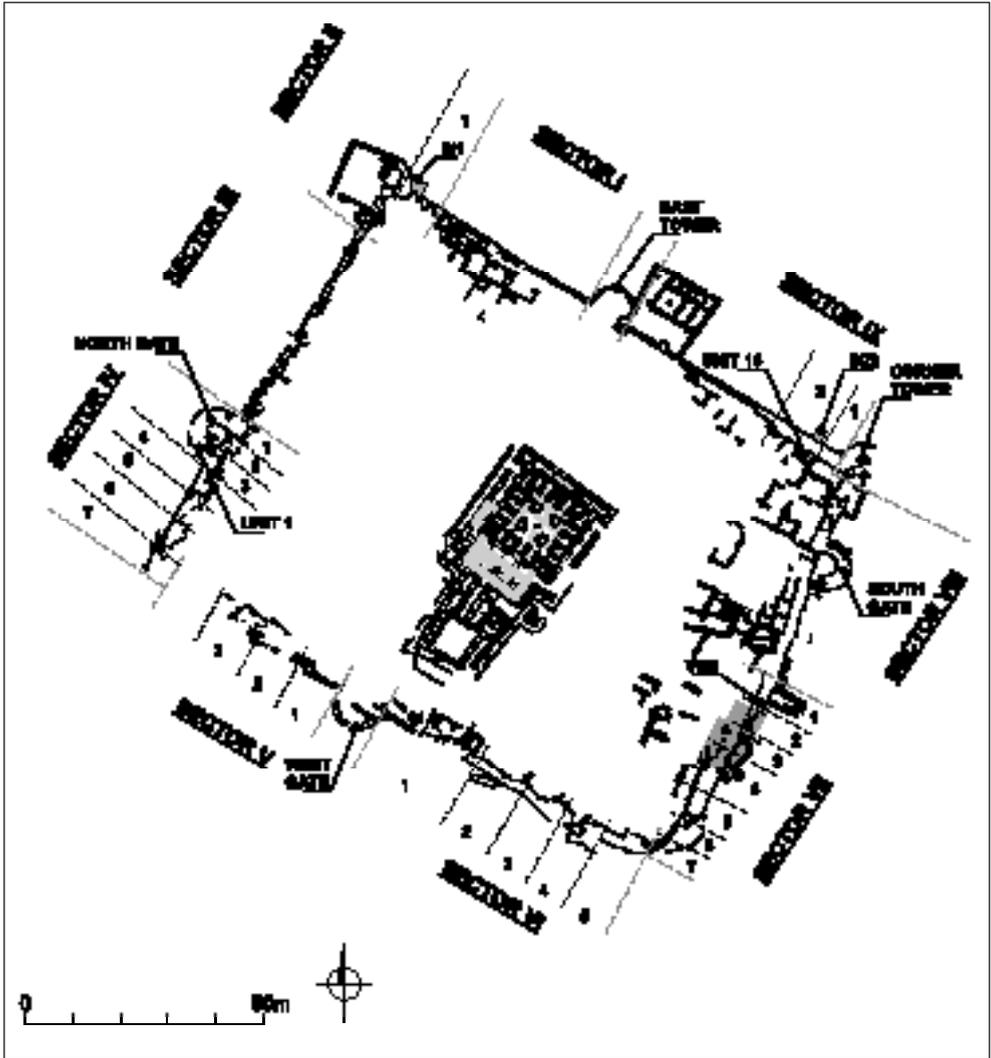
Fig. 1. Banganarti I, plan of the site with marked location of excavations carried out in the winter season of 2008 (R. Łopaciuk, M. Drzewiecki).

area trenches or surface sweeping of the line of defenses. The humus layer was cleared wherever the sweeping did not uncover the run of the walls and there was reason to believe that the plan was not straightforward. Four deep trenches were excavated: IX/2, Unit 16, VII/2, II/1 [*Fig. 1*]. Sweeping of the walls took place mainly in sector VII.

Trench II/1 (2.50 m x 1.80 m, depth reached 4 m) was traced by the outer face of the curtain wall at the junction with the northeastern corner tower [see plan in *Fig. 1*]. The wall face uncovered in this trench belongs to the second phase of

The trench (2.20 m x 1.50 m) was dug to a depth of approximately 2.75 m by the outer face of the wall in sector VII, section 1 and 2. In this part of the fortifications [see *Fig. 1*] the process of accumulation was extremely intensive. The layers that accumulated from the building of wall I to its rebuilding and the construction of wall II measured approximately 2.50 m.

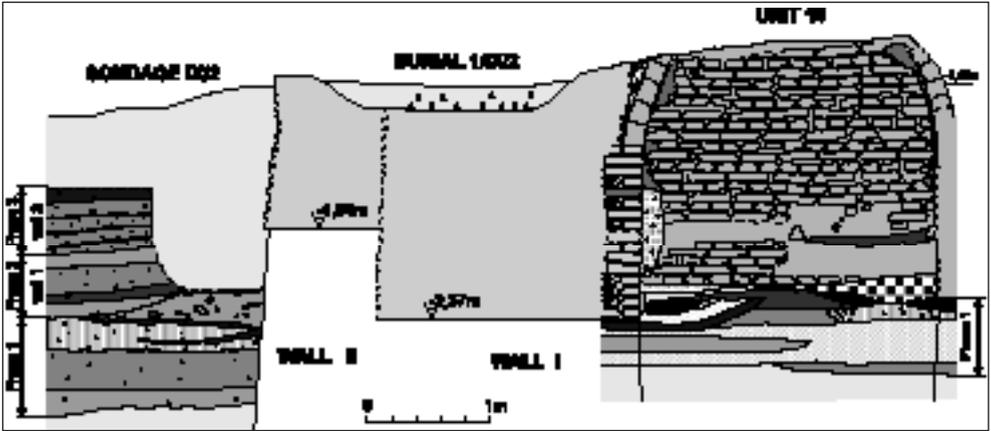
Fig. 2. Banganarti 1, section through the curtain wall and trench IX/2 and Unit 16 looking southeast (All photos and section drawings in this article by the author)

The mutual proximity of the trenches justifies their joint examination. Trench IX/2 (1.60 m x 1.30 m) was situated by the outer face of the wall, directly opposite the trench in Unit 16 (2.30 m x 3.00 m), which adjoined the inner face of this wall. The two trenches were dug to a depth of 3 m, uncovering the following occupational phases [*Fig. 2*]:

organic material and vessel pottery, especially on the outside of the wall. Traces of burning and ashes concentrated near the top of the deposit, as remains of open fires as well as spread horizontally over the surface [see *Figs 2* and *3–4*]. Pottery from these layers was dated from the 7th century (D. Bagińska, personal communication).

approximately 2 m thick and stood to a height of about 2 m [Fig. 2]. Unit 16 was erected at this time, adjoining the inner face of the wall with its longer side, taking advantage of the wall to spring one side of the unit's barrel vaulting [Fig. 4]. Meals

Phase 3. Building works carried out on the curtain wall in the 11th–12th century (Żurawski 2004: 223; Bagińska 2008: 421) consisted of a thickening of the wall structure by approximately 0.90 m on the outside [Figs 2, 3]. Wall II had its foundations 0.73 m above the level of the first wall foundations. The existence of this wall is correlated with a highly regular structure of the layers outside the walls [Figs 2, 6]. It could be due to a regular deposition of refuse connected with meal preparation, that is, ashes, burning, seeds and other. Meal preparation could have continued, among others, in Unit 16, which remained in use throughout the functioning of this second phase of the curtain wall.

0.20 m deep) was found filled with yellow sand containing human bone remains (inhumation burial 1/XI/2) [see *Fig. 2*], too fragmented however for a determination of body position and orientation.

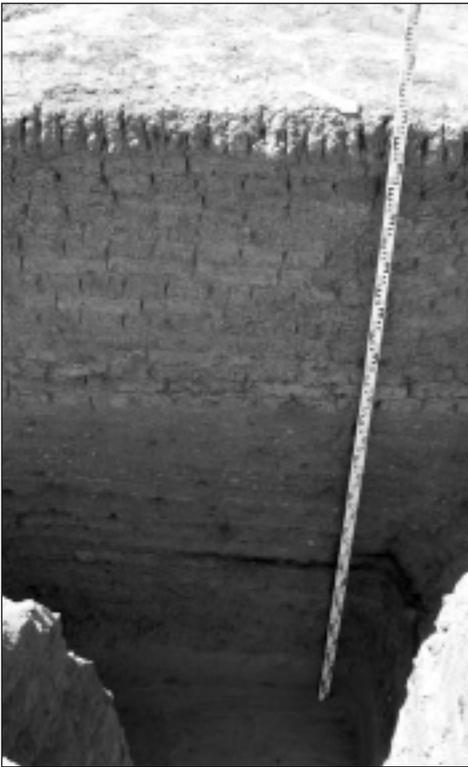
Fig. 3. Trench IX/2. Outer face of curtain wall (Wall II), view from the southeast

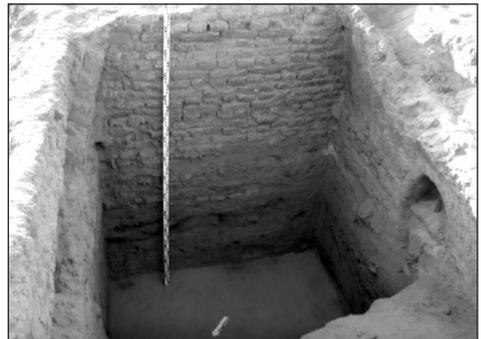
Fig. 4. Trench in Unit 16 with accumulations underlying the foundations and opening in southeast wall

contained remnants of organic substances. Other finds connected with meal preparation included stone grinders and the rim of a glass bottle most likely for storing condiments. A narrow opening in the southeast wall led into another unit or more probably a small courtyard. The opening must have also acted as ventilation. At some point it appears to have been blocked with dried brick, creating a small niche [see *Fig. 4*].

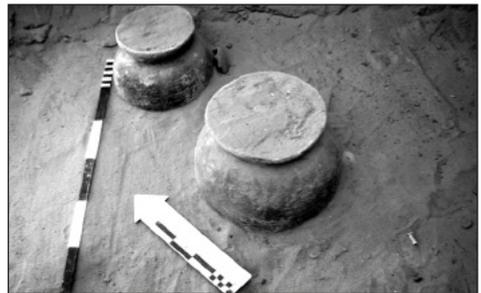
Fig. 5. Two of the cooking pots and glass bottle in Unit 16

were prepared in this unit. Most of the pottery from the unit consisted of hand-made vessels and bore evidence of burning. Eleven pots on different levels were found still standing in place [Fig. 5], on layers of burning and ashes; some of them still

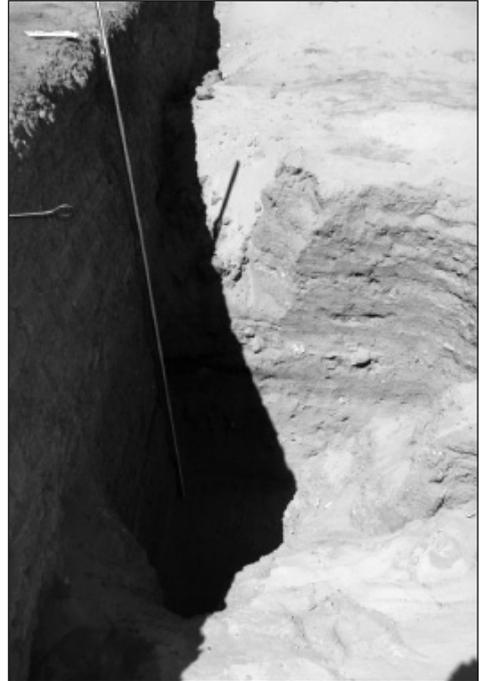
Fig. 6. Trench IX/2. Deposits from Phase 3 against the outer face of the wall, view from the northwest

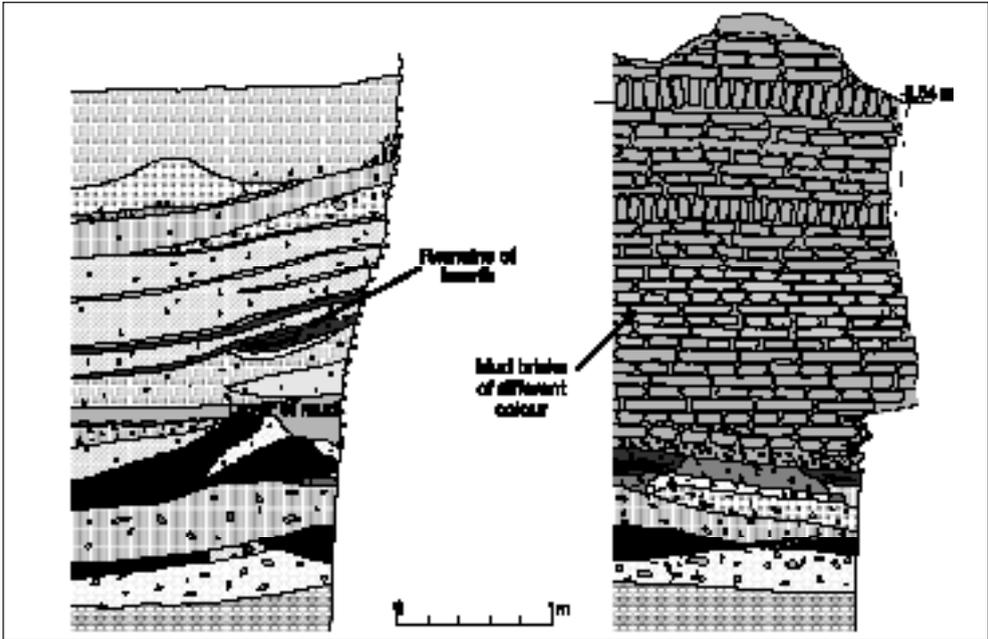
Fig. 7. Trench II/1, sections in line with the south and east trench wall

the fortifications (wall II) [Fig. 7]. The following phases were distinguished:

– Wall II. The outer face of the curtain wall featured a header–stretcher bond separated on two levels with a course of upright headers. Six courses of bricks in the central part of the wall differed from the other bricks in color and overall state of preservation [*Figs 7, 8*], as if they had been made of different source material. A modern pit has destroyed almost entirely the interface of the curtain wall and tower. The only remaining

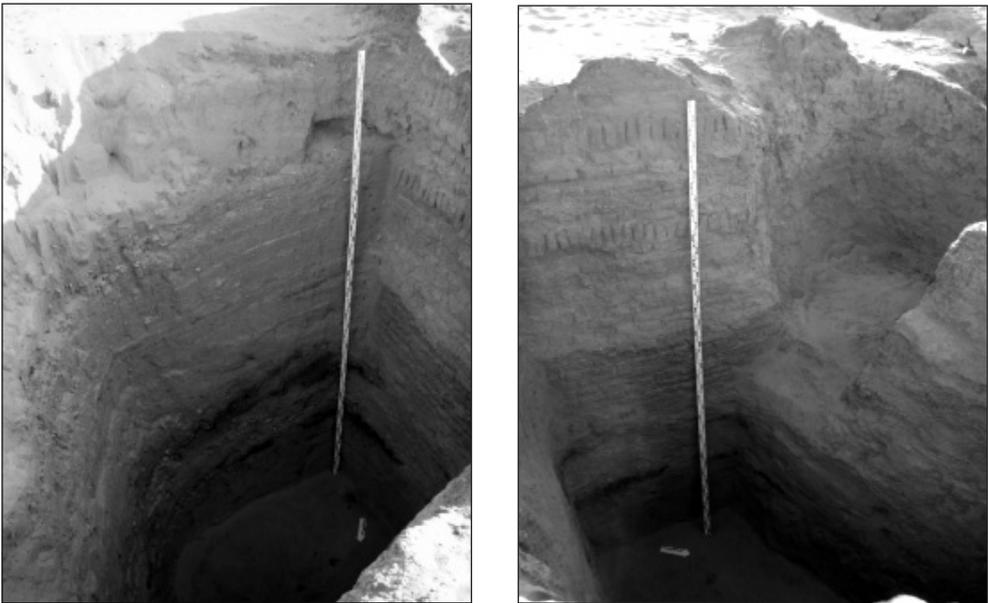
Fig. 8. Trench II/1, the outer face of wall II (left) and the eastern trench wall

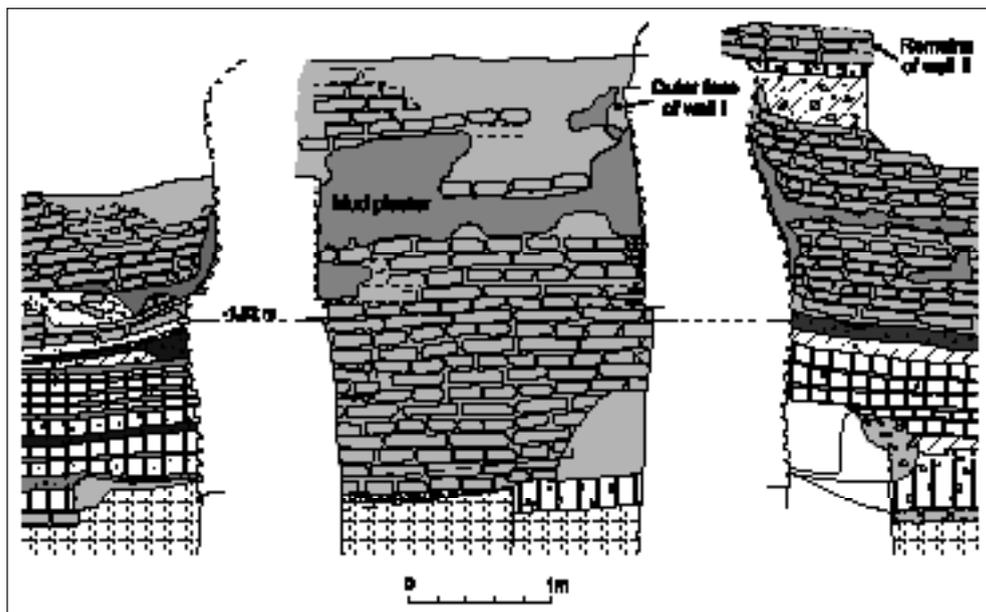
Fig. 9. Trench VII/2, face of wall II (middle) and sections of trench walls perpendicular to the wall (Drawing M. Woźniak, M. Drzewiecki)

In this place, the new wall (wall II) was erected on top of the remains of the old one (wall I) and was thicker by about 0.90 m. Wall II, dated to the 11th–12th century, was preserved here in residual form, that is, three courses of mud bricks in the top layers of the trench [see *Fig. 9*].

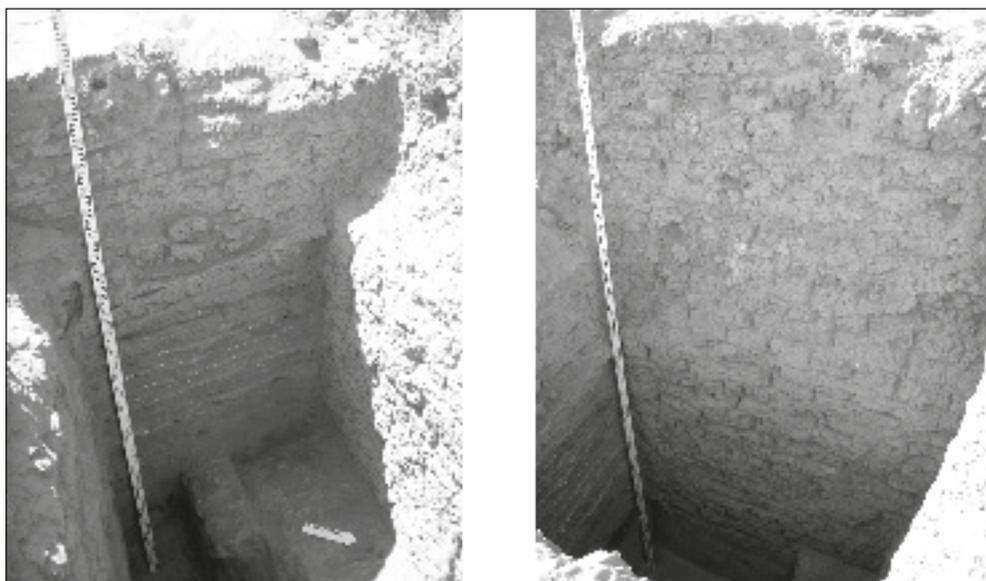
Fig. 10. Trench VII/2, outer face of wall II (right) and remains of structures erected against the outer face of this wall

from the start. Sometime between the 7th and the 11th century structures were erected against the outer face of this wall in this part of the site [*Fig. 10*]. The walls of these structures were coated with mud plaster. The outer face of the curtain wall was already severely damaged when they were plastered. The fill produced some potsherds, mostly belonging to thick handmade pots. A layer of rubble was documented, referred most probably to a phase of destruction when the structures attached to the wall fell into ruin. In the 11th century the curtain wall was in considerable disrepair; in this period an extensive program of rebuilding and refurbishment was implemented on the whole site.

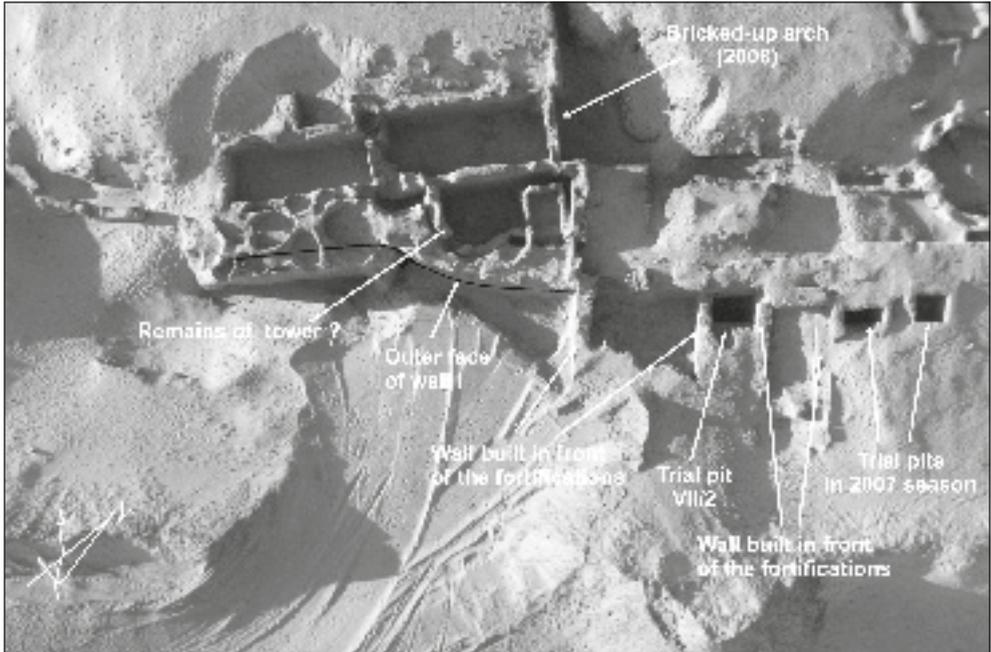
Fig. 11. Aerial view of sector VII, winter 2008
(Kite photo B. Żurawski)

After cleaning it turned out that wall I was in a good condition [Fig. 11].

Remains of structures attached to the outer face of the wall were documented in this sector as well [Fig. 11]. These structures resemble those documented in trench VII/2 (see above).

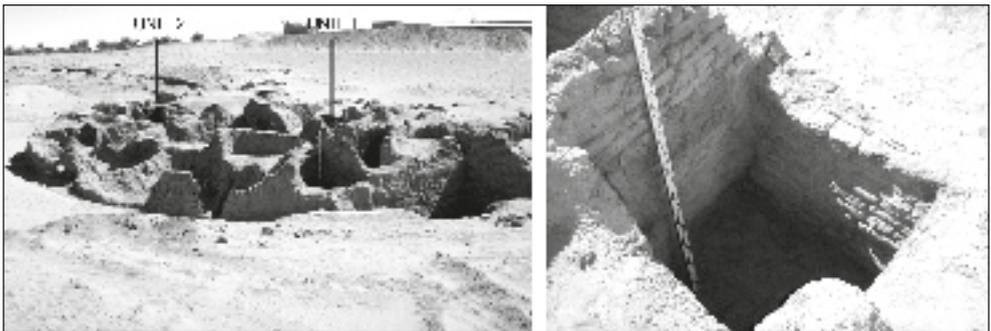
Fig. 12. Units 1 and 2 in the North Gate (on left) and state of preservation of Unit 1

Two discontinuous sections of the semicircular wall of the North Gate uncovered in 2007 [see Fig. 1] were designated as Unit 1 (SE wall 1.27 m, SW wall 1.32 m, NE wall 1.00 m, NW wall 1.22 m; 1.90 m deep) and Unit 2 (NE wall 1.17 m, SE wall 0.80 m, SW wall 1.15 m, NW wall 0.95 m; 1.95 m deep). These two features were distinguished on the ground by fill, composed of burning and pink-shaded ashes(?) (sampled for analysis). This color of the fill was not documented anywhere else on site. Unit 1 [Figs 12, 13] was situated close to the blocked outer passage and was less well preserved than Unit 2 (for work here, see Drzewiecki 2010: 342–346).

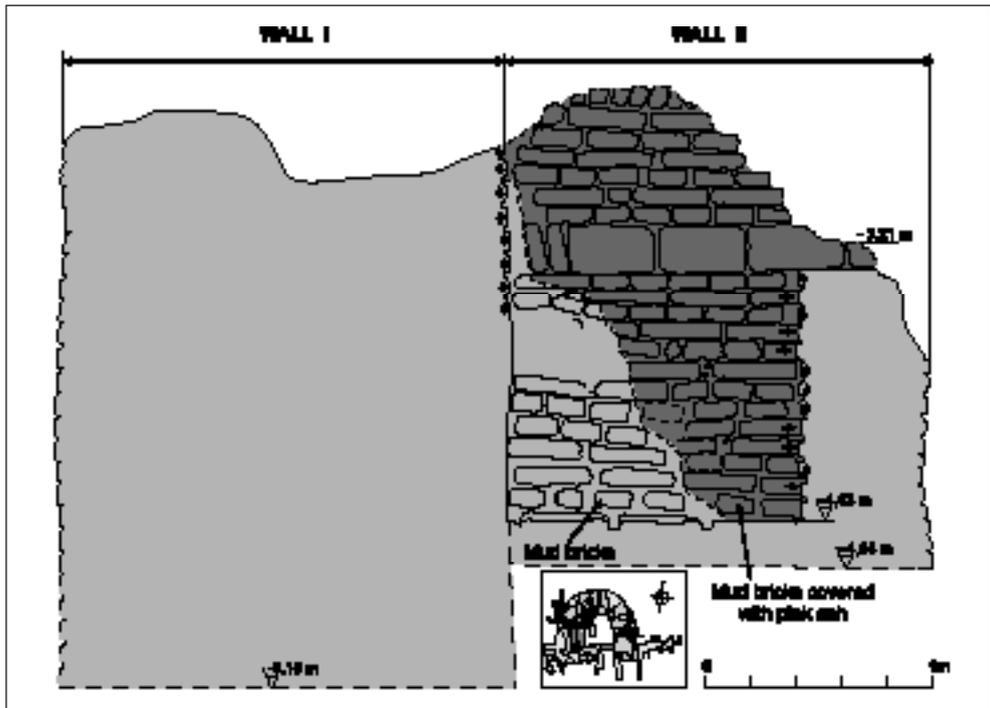
Fig. 13. Cross-section through outside wall of the North Gate presenting phases of construction and Unit 1

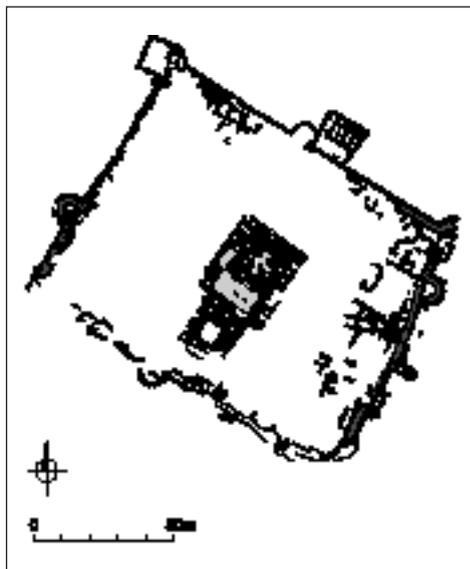
Fig. 14. Defenses of Banganarti in the earliest phase, preserved sections of Wall I marked in gray (Drawing R. Łopaciuk, M. Drzewiecki)

The autumn season in 2008 provided sufficient data for a preliminary phasing and functional analysis of the Banganarti fortifications. The course of the earliest defenses (wall I) was traced [Fig. 14]. An interesting point to consider is the presence of layers of burning at the foundation level of the curtain wall. Synchronizing the layers documented in various trenches could answer questions about major conflagrations, which were either separate events or had consumed most of the complex (Drzewiecki forthcoming).
