THE ENCLOSURE WALLS OF BANGANARTI AND SELIB AFTER THE 2010 SEASON

Mariusz Drzewiecki

Abstract: Banganarti 1 (ROM 53, BNG 1) and Selib 1 (ROM 100, SLB 11, SLB 1), lying approximately 9 km apart in the southern Dongola Reach, had been perceived as twin sites of analogous nature. In 2010 the enclosure wall in Selib was surveyed and the investigation of the fortifications in Banganarti was continued, in both cases aiming to test the theory about the similarity of the two complexes. A detailed examination of the enclosure walls enabled a comparison of the wall architecture, building materials, state of preservation and settlement intensity in the neighborhood.

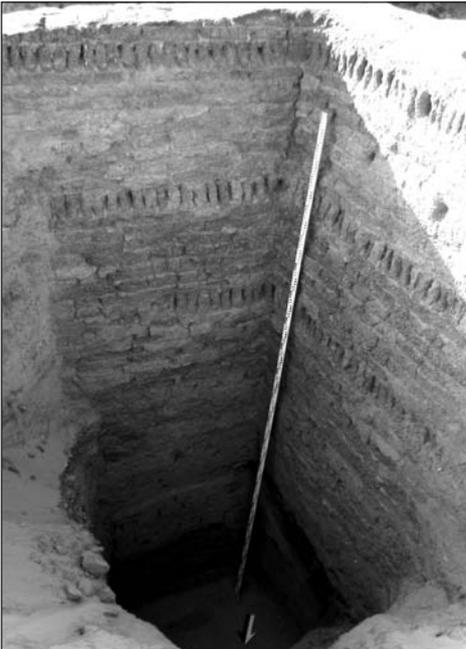
Fig. 3. *Banganarti 1, corner of mud-brick walls where the eastern tower joined the main wall (3/E/2010) (Photo M. Drzewiecki)*

Banganarti is a rare example of well preserved early medieval mud-brick fortifications [Fig. 3]. A different material, either stone or baked brick, was used in places of key structural importance [Fig. 6], such as arches above the entrance and the bottom of the foundations, but there does not seem to be any pattern that could speak in favor of there being a building principle. The size of mud bricks was varied, possibly because of the numerous episodes of repair and rebuilding, as well as building techniques.

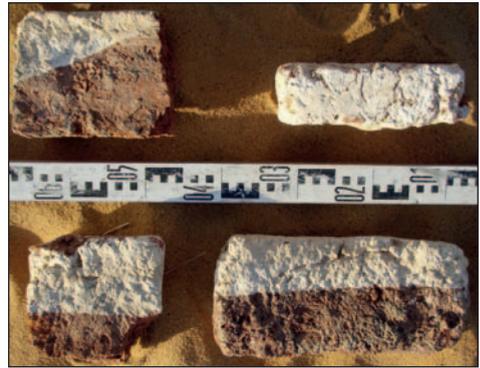
Fig. 11. Selib, partly white-painted red bricks found along the curtain wall (Photo M. Drzewiecki)

Few artifacts were recorded next to the enclosure wall in Selib — mostly well fired storage jars and *qawadis* pots used for drawing water in water installations (*saqiya* wheels). Some red bricks, partly painted white, were also found [Fig. 11]. No attached architecture was recorded along the outside of the curtain wall. Only small sections of the wall were cleared on

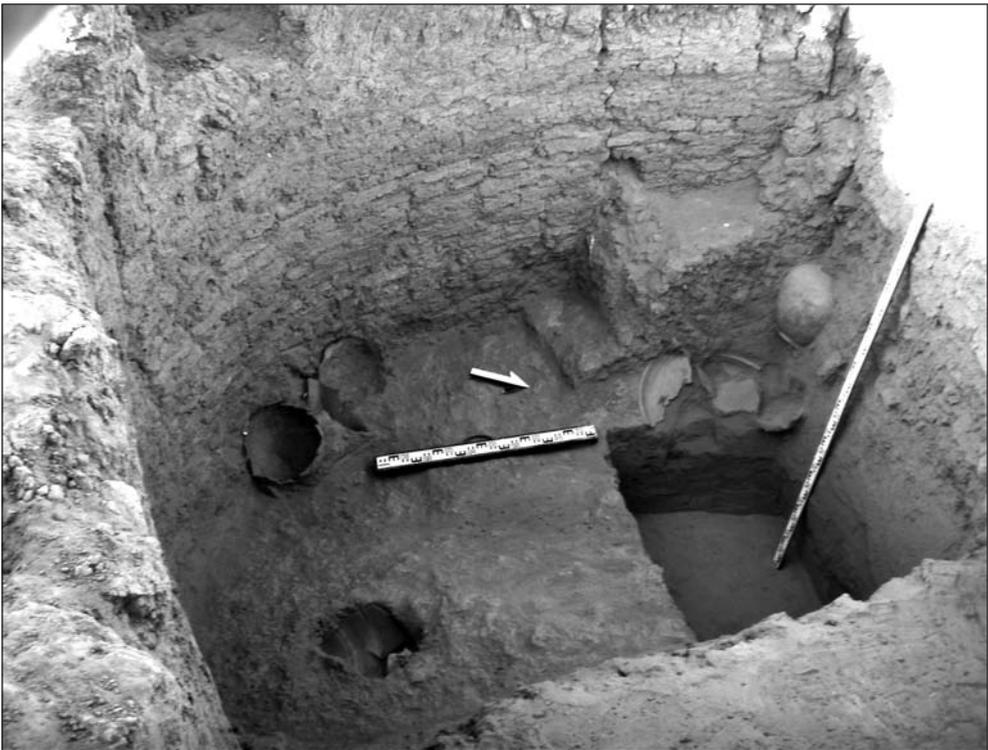
*Fig. 13. Banganarti 1, Unit 6, storage vessels along the wall
(Photo M. Drzewiecki)*

(such as seeds), all of which represented refuse dumped outside the walls. A set of amphora mud stoppers was recorded in the area of the southeastern gate during excavations in 2010 [Fig. 12, left]. Some of these were stamped and bore traces of red pigment on the surface. Two clay seals were also recorded [Fig. 12, right]. Remains of architecture were noted both on the outside and inside of the enclosure wall [see Figs 1, 8], but they were more concentrated on the inside. Artifacts found inside were in much better condition comparatively, whole pots being found much more frequently, for example, and even in some cases undisturbed in remains of hearths or in a room corner, nestled against the walls [Fig. 13].
