Non-invasive investigation of the Western Basilica at Ptolemais

Światowit 8 (49)/Fasc.A, 41-44

NON-INVASIVE INVESTIGATION OF THE WESTERN BASILICA AT PTOLEMAIS (PLS. 52–57)

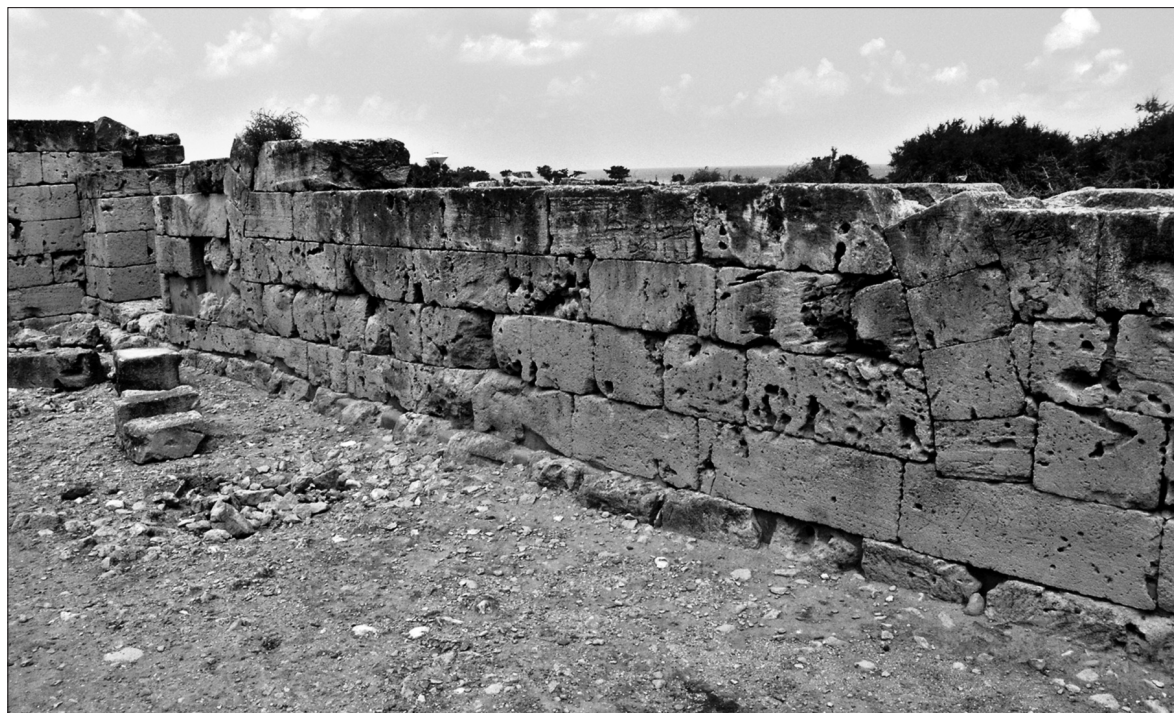
Fig. 2. Relics of the structural arch in the northern wall of the basilica (J. Kaniszewski).

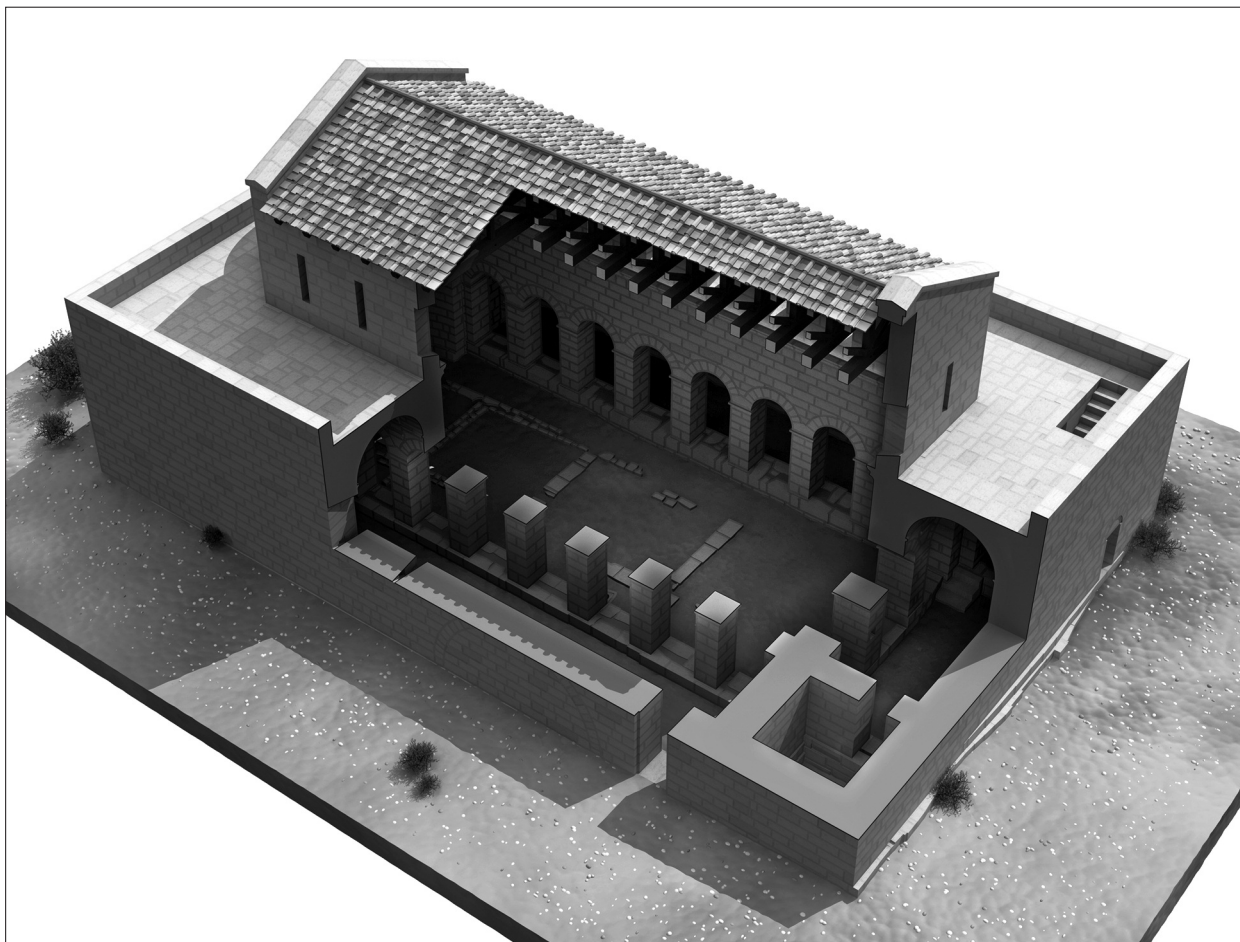
Fig. 6. 3D reconstruction of the Western Basilica (J. Kaniszewski).

of the construction of windows in the main nave. However, they are far too few, which indicates that the windows in the upper part may have been constructed in a way that is hard to detect in the available architectonic material. In a 3D reconstruction, we propose simple, rectangular openings, widening towards the inside and devoid of any profiling (**Fig. 6**). Such a solution is based on both the lack of sufficient number of similar architectonic elements and the shape of the only preserved window in the lower part of the church, in the north-eastern room.

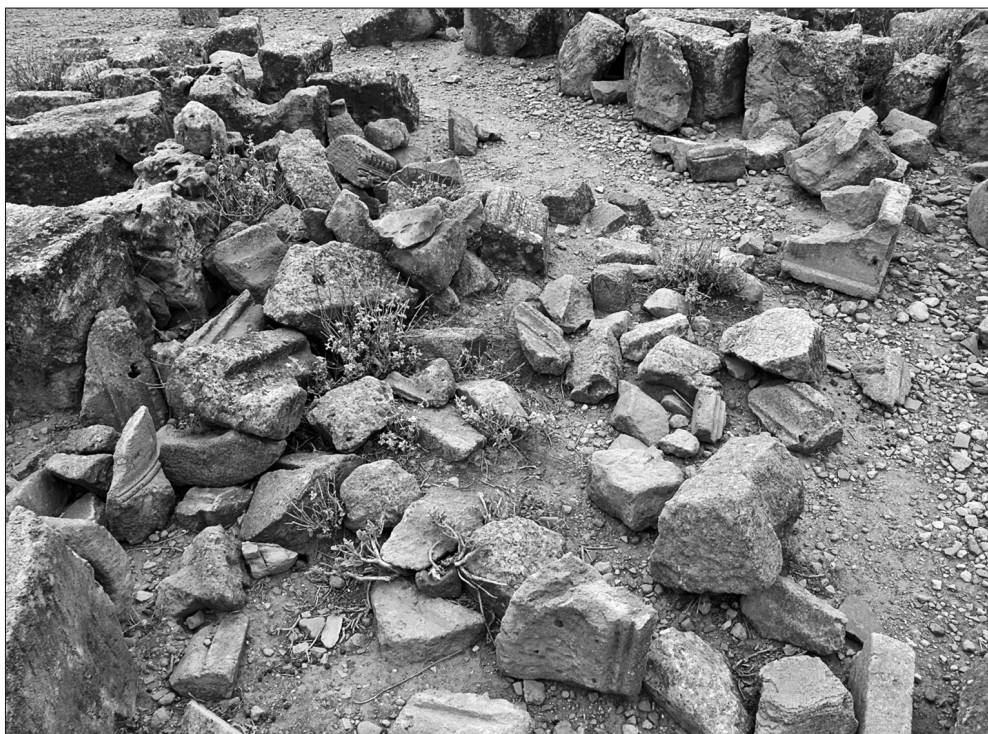
Fig. 7. Scatter of small architectural details (J. Kaniszewski).

eastern part of the nave, vertical architectonic elements can be discerned resting on the structures of interest and undoubtedly belonging to the arrangement of the basilica interior. The rubble heap has preserved a rich collection of several dozen fragments of small architectural details (**Fig. 7**). These elements, which include fragments of partition walls, a capital, and small profiled elements, are presumably relics of the constructions dividing the nave. At this point, we also need to mention another architectural detail identified among the rubble, namely a stone basin (**Fig. 8**). It has the diameter of 98 cm and the height of 52 cm; its inner surface is coated with hydraulic mortar, and a drain hole is visible in its lower part.¹¹

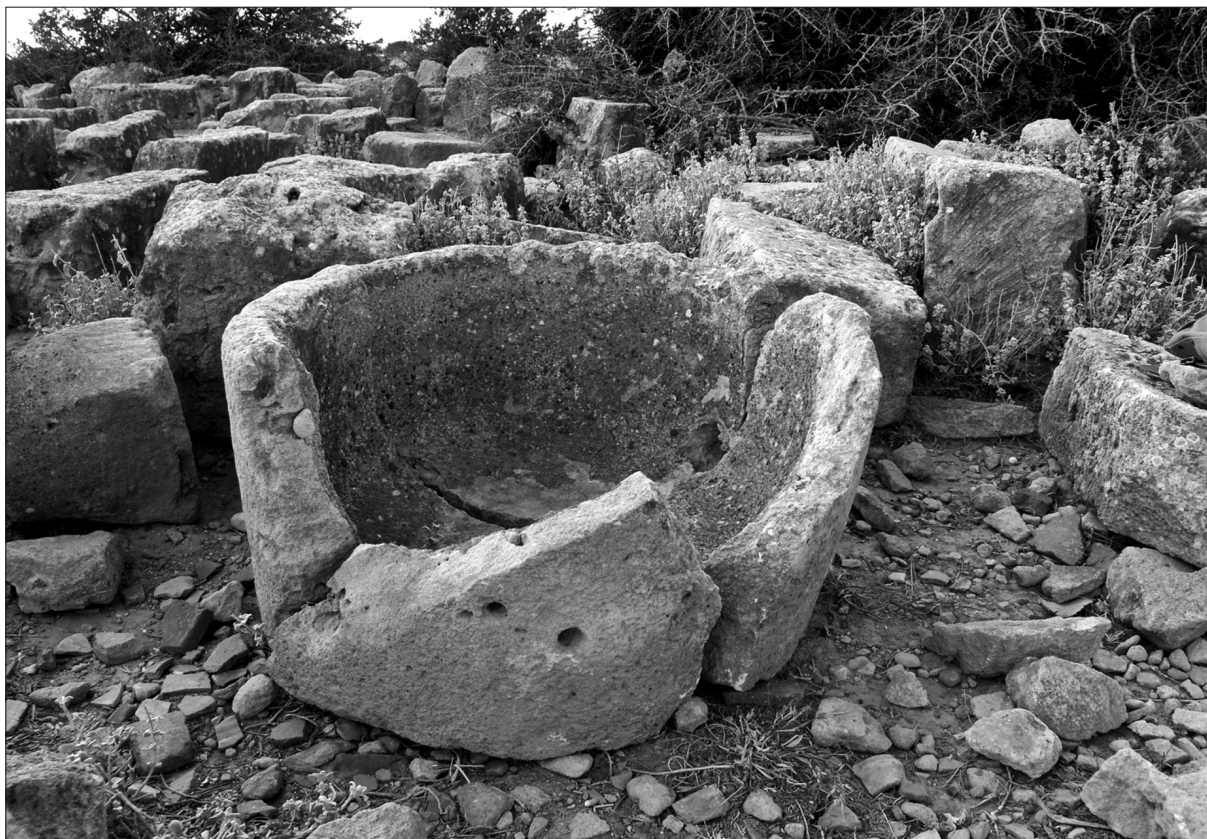
Fig. 8. Stone basin (J. Kaniszewski).

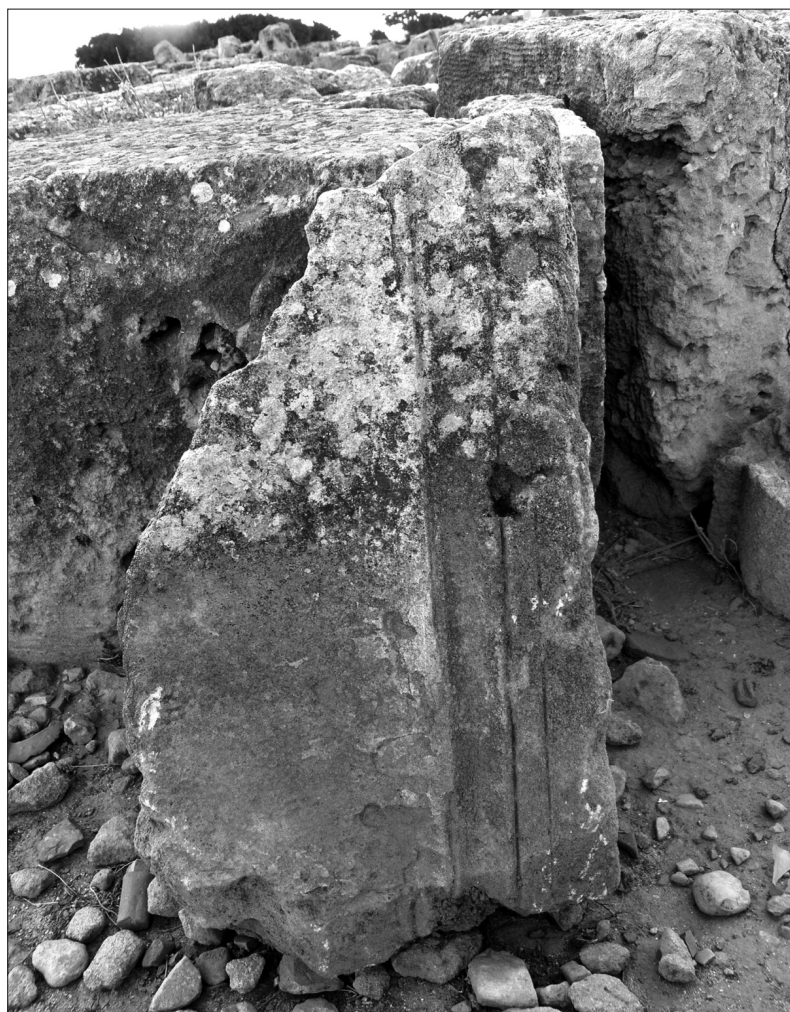
Fig. 9. Fragment of a profiled slab with remains of polychrome decoration (J. Kaniszewski).

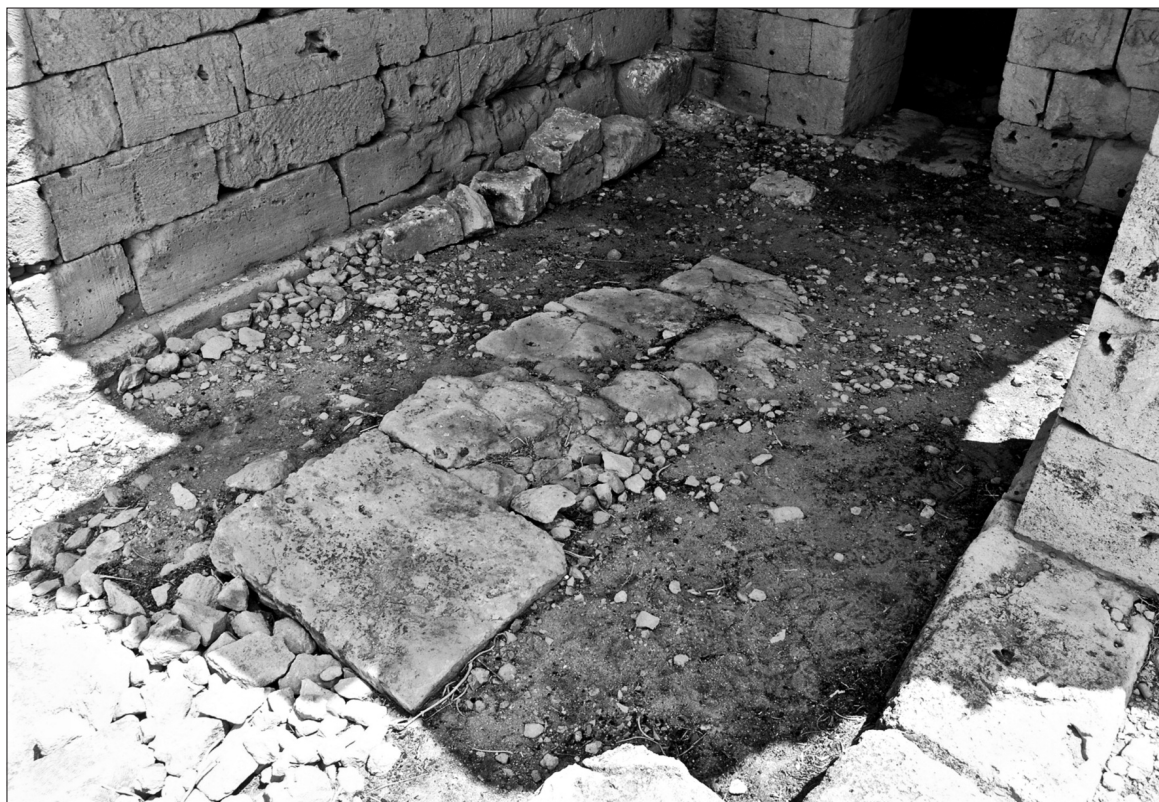
Fig. 10. Remains of stone pavement in the northern aisle (J. Kaniszewski).

As a result of the inventory studies and surface survey carried out inside the church and on the spoil heaps, we have secured archaeological material giving a general idea on the decoration of the interior of the Western Basilica. The walls of the northern aisle and the southeastern chamber have preserved fragments of plaster¹² (**Fig. 1:A**). Small fragments of plaster discovered on the spoil heap are covered with white and red paint. The largest fragment, painted with a red band against a white background, suggests that the walls may have been painted in a geometric design associated with the architectonic structure of the building. At this point, we also need to mention the remains of polychrome decoration that have survived on a fragment of a stone partition, originally constituting most probably part of some structure inside the nave (**Fig. 9**). During the surface survey, we managed to identify a few dozen tesserae, which suggest that the floor of the basilica, at least in part, may have been laid with a mosaic. Around sixty tesserae are in white and only two in dark-grey. Next to the tesserae, we have also discovered more than twenty small fragments of worked marble,¹³ possible elements of *opus sectile*. In the eastern area of the northern aisle several stone slabs were found, most probably the remains of the original floor (**Figs. 1:F, 10**). In the light of the material finds at

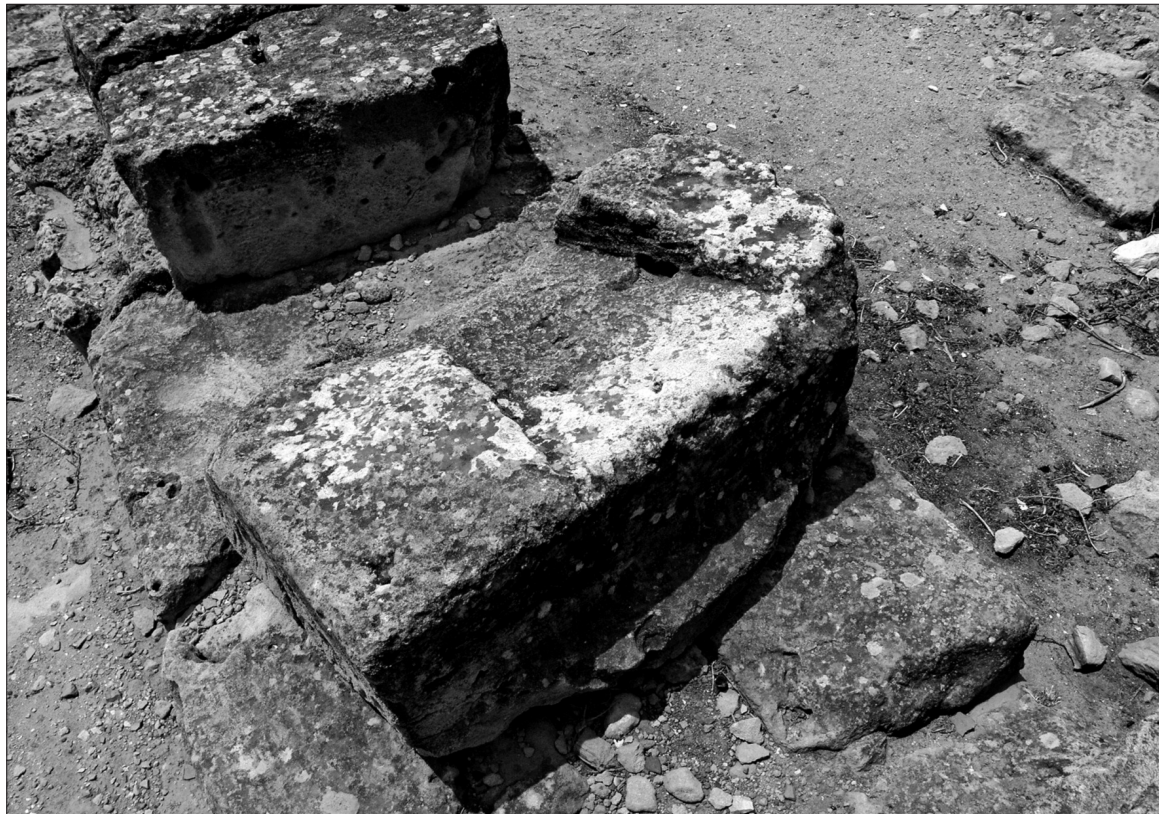
Fig. 11. Lintel of the window in the aisle (J. Kaniszewski).

During the inventory work, we identified two stone blocks (Figs. 11, 12) allowing the reconstruction of a window in the wall of the aisle (Fig. 13). This window has a form of a narrow slit, splaying and dropping inwards. Its width on the outside and inside the basilica is 11 and 54 cm, respectively. In this, the window was similar to the one in the north-eastern chamber. One of the fragments is finished with a cornice, which allows us to place the window directly under the vault of the aisle. The use of this form of window in the lower parts of the building, in conjunction with thick walls and two pairs of narrow doors, could be an additional argument to support the claim that the Western

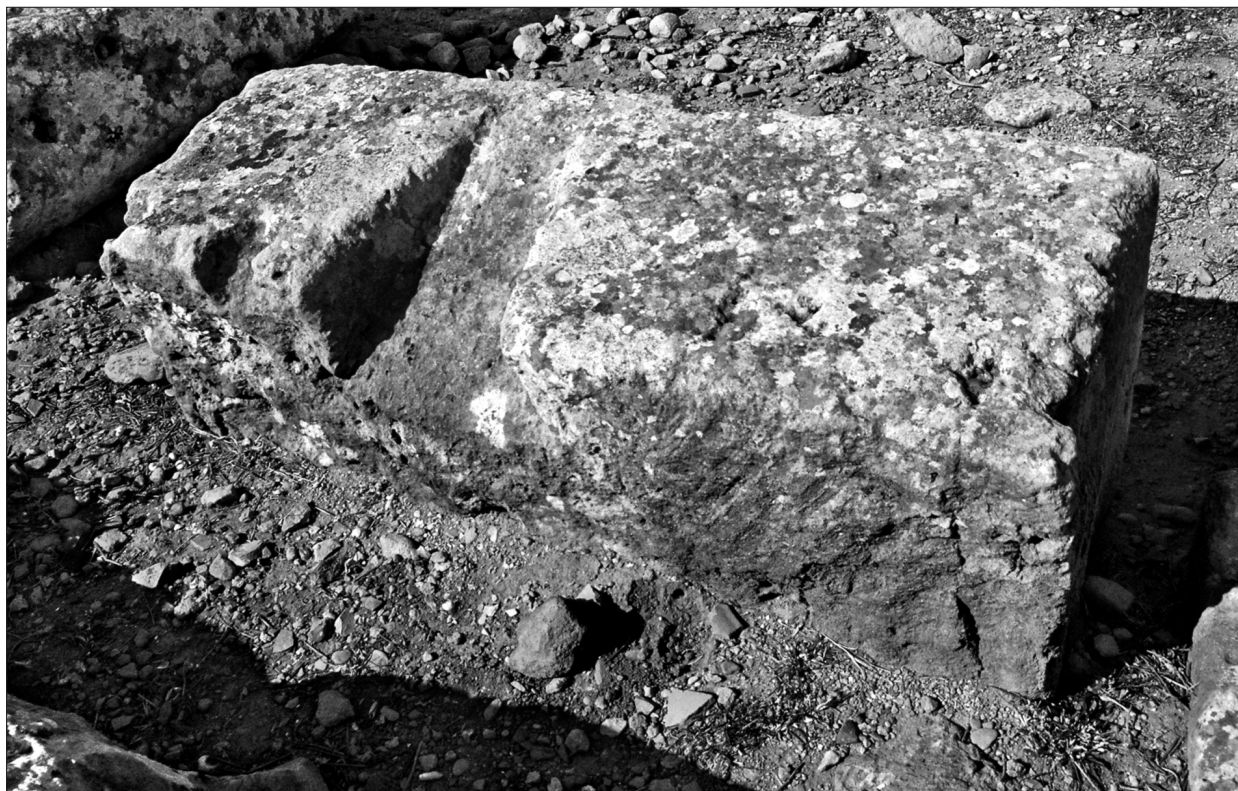
Fig. 12. Lower fragment of a window in the aisle (J. Kaniszewski).
