**Excavations in Balaklava (Sevastopol,  
Ukraine) : season 2011 : discovery of  
Fortifications of a Roman Fort**

Światowit : rocznik poświęcony archeologii przeddziewowej i badaniom  
pierwotnej kultury polskiej i słowiańskiej 9 (50)/A, 173-182

## EXCAVATIONS IN BALAKLAVA (SEVASTOPOL, UKRAINE) – SEASON 2011. DISCOVERY OF FORTIFICATIONS OF A ROMAN FORT

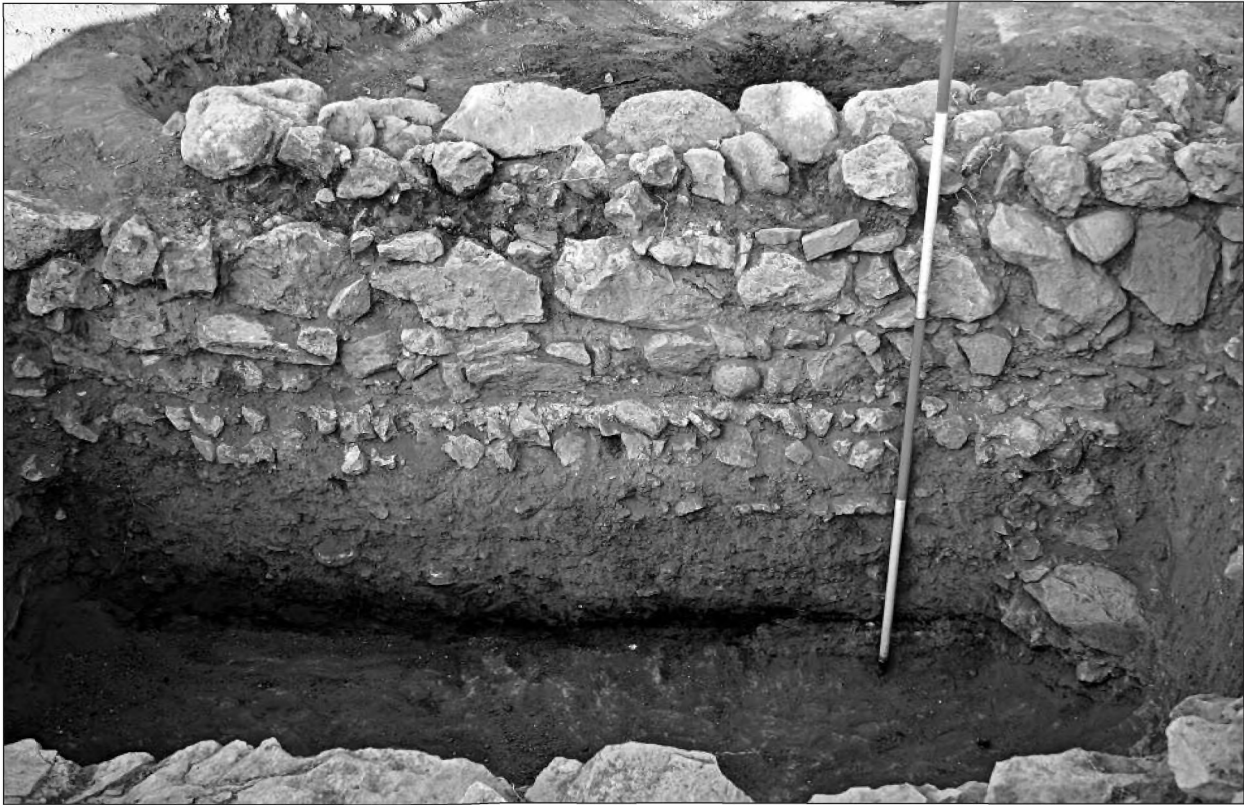
Fig. 2. Western wall of the barracks (view from the east). Foundations go on the layer of pavement of small pebbles. Layer of burning (dated to the turn of the eras) can be seen below in the section (Photo A. Trzop-Szczypiorska).

The hitherto examinations confirm that the earliest settlement phase in this part of Balaklava corresponds to the layer of burnt daub with admixture of charcoal (Fig. 2). This layer is accompanied with portable relics, which may be related to the Hellenistic Period. However, the latest finds (e.g., fibulae of Aucissa type) are to be related to the turn of the eras. In this phase there are no remains of permanent buildings, including stone architecture, within the examined area (KARASIEWICZ-SZCZYPIORSKI, SÁVELA 2011).

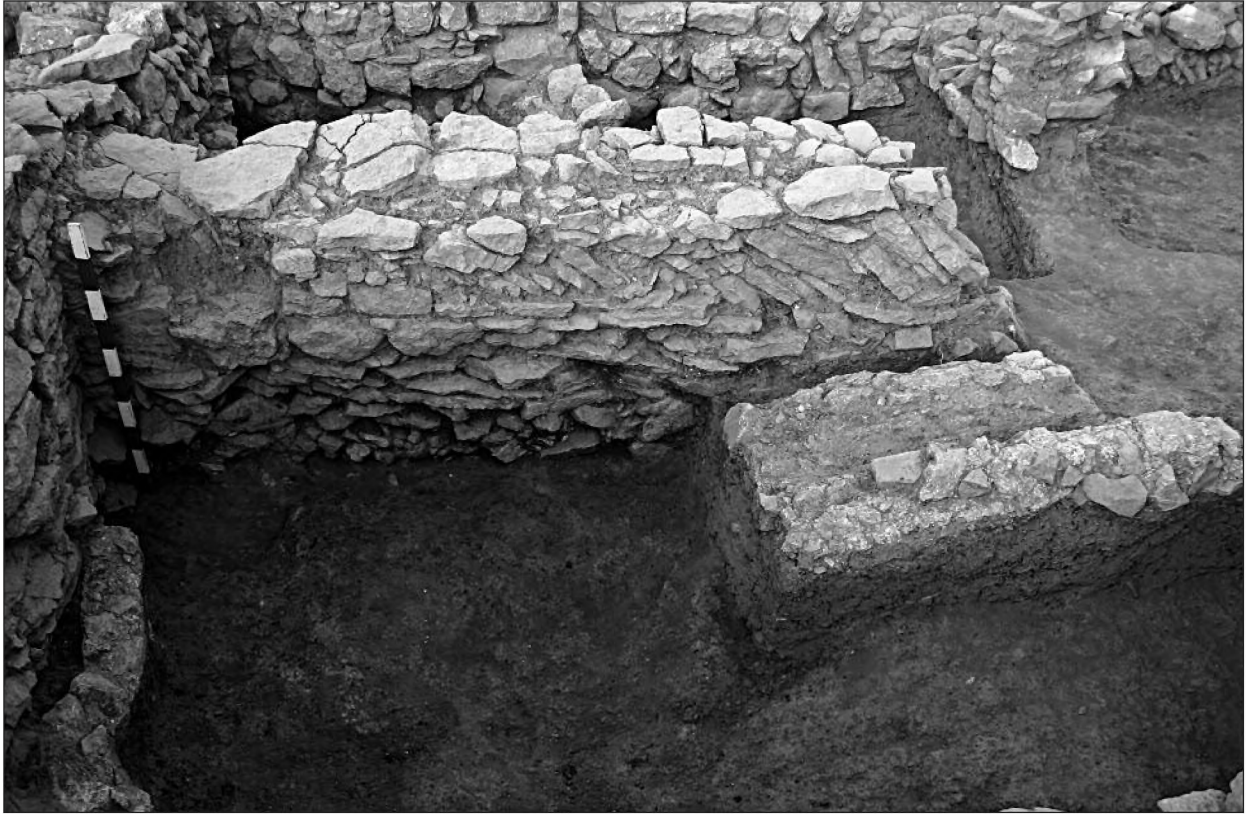
Fig. 3. Examinations in the interior of the barracks (view from the east). Fragment of the canal (water conduit?) and the reservoir situated below the foundations of the barracks. Cf. Fig. 1:6,7 (Photo A. Trzop-Szczypiorska).

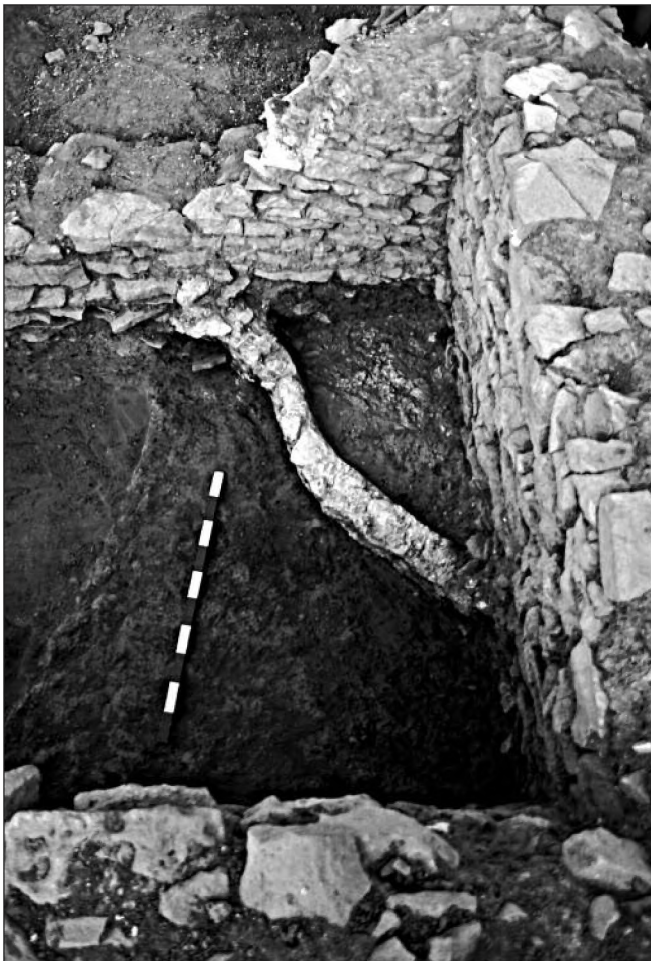
Fig. 4. Examinations in the interior of the barracks (view from the east). Fragment of the reservoir situated below the foundations of the barracks. Cf. Fig. 1:6 (Photo A. Trzop-Szczypiorska).

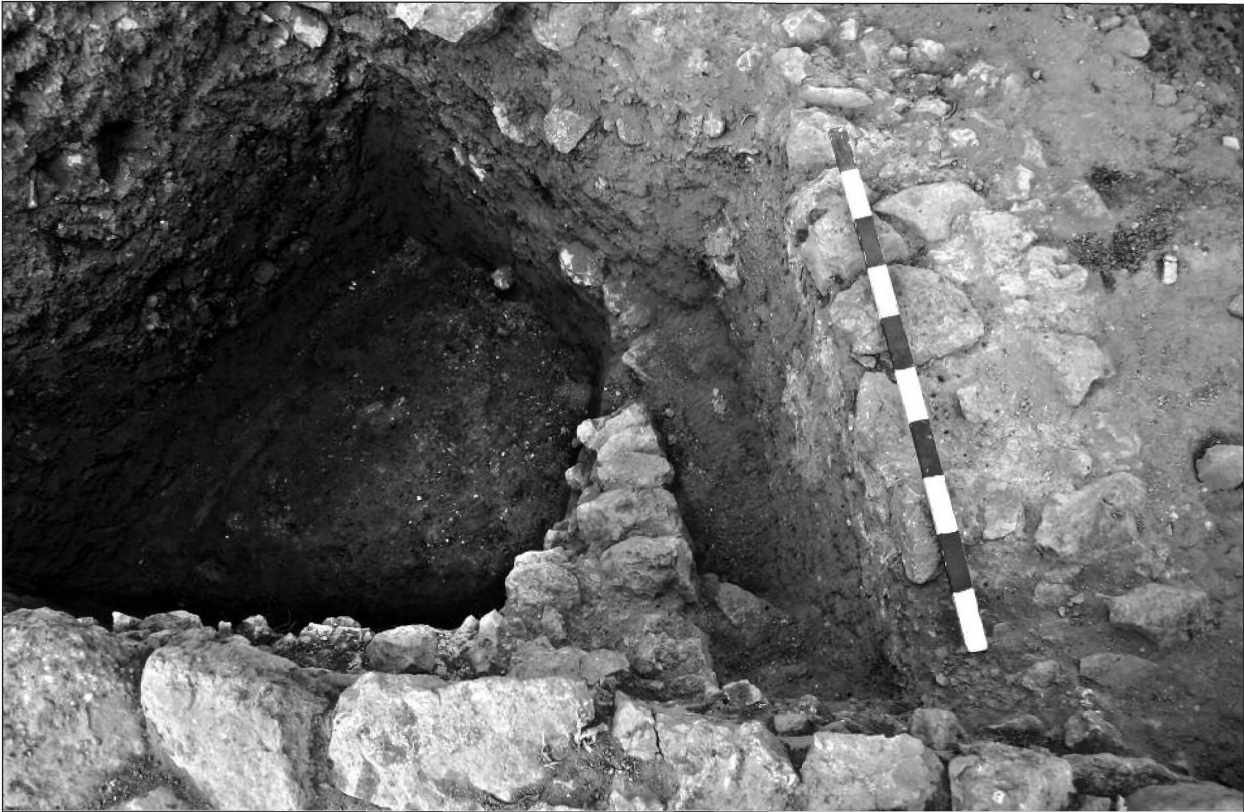
Fig. 5. Sewage canal in the street to the west of the barracks (view from the east). Canal comes out from under the western wall of the building and is cut with a Modern period pit. Cf. Fig. 1:4 (Photo A. Trzop-Szczypiorska).

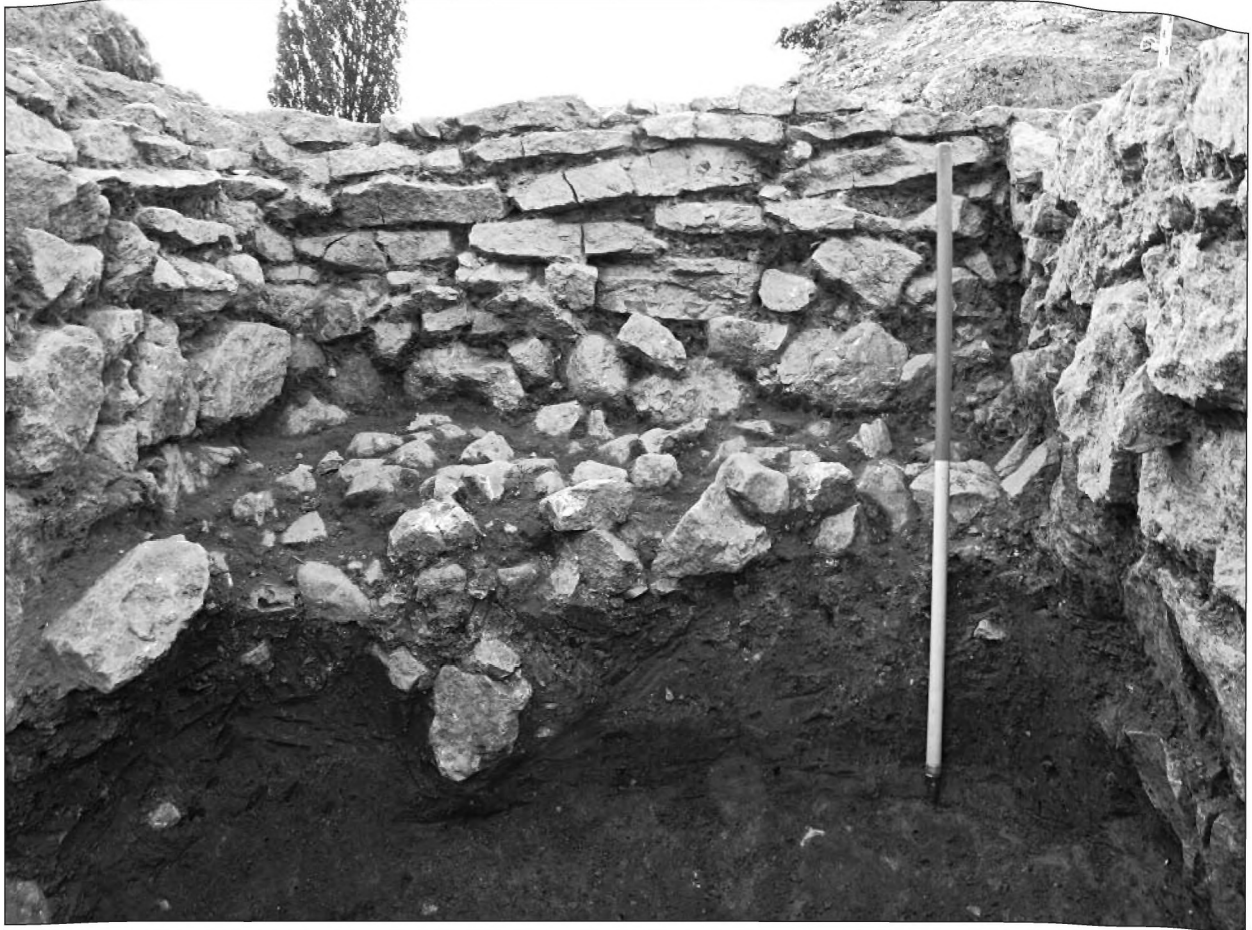
Fig. 6. One of the western rooms of the barracks in the course of excavations (view from the south). Remains of the pavement which adjoins the eastern wall can be seen in the room (Photo A. Trzop-Szczypiorska).
