The roman army and the walls of Chersonesos

Światowit : rocznik poświęcony archeologii przeddziewiczej i badaniom pierwotnej kultury polskiej i słowiańskiej 11 (52)/A, 87-112

THE ROMAN ARMY AND THE WALLS OF CHERSONESOS

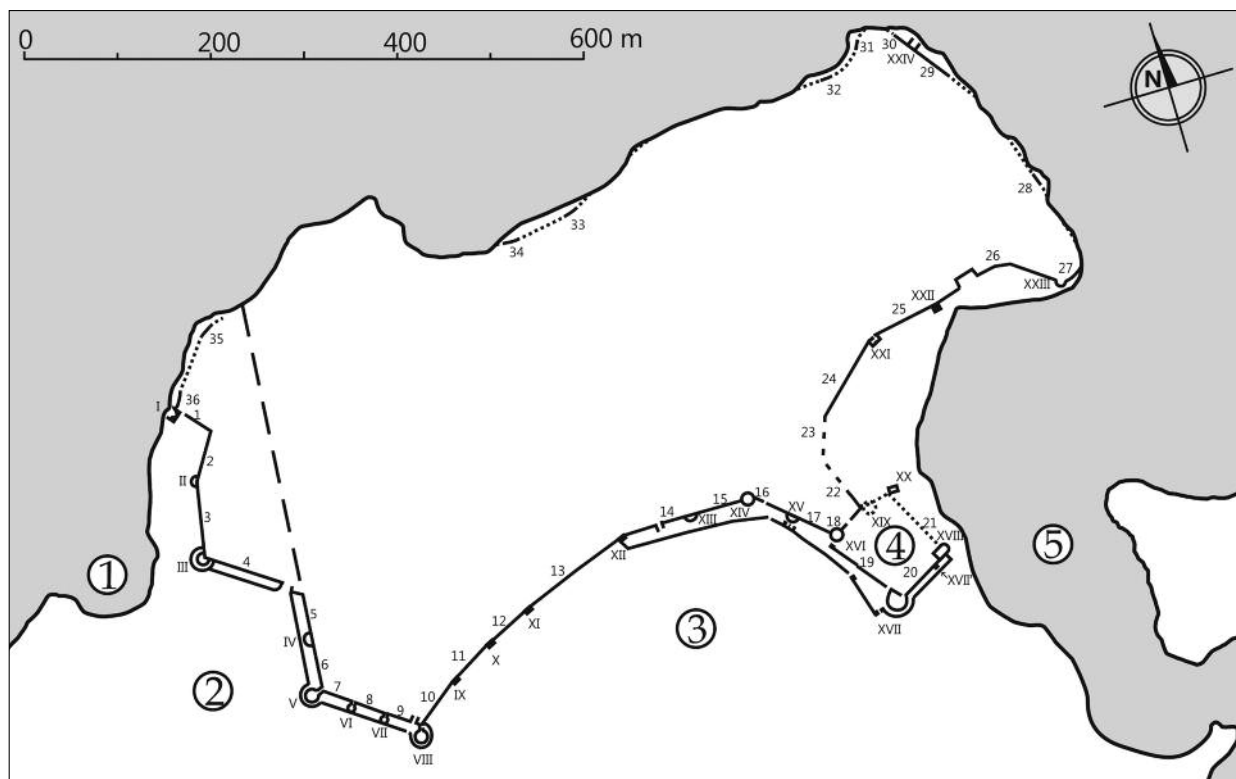
Fig. 1. Chersonesos Taurica. General plan. Curtains of town walls are marked with Arabic numerals and turrets are marked with Roman numerals (after: BERT'É-DELAGARD 1907, drawing P. Zakrzewski). 1 – Pесоnаâ Buhta (Sandy Bay); 2 – Pесоnаâ Balka (Sandy Ravine); 3 – Karantinnaâ Balka (Quarantine Ravine); 4 – citadel; 5 – Karantinnaâ Buhta (Quarantine Bay).

Research on the town’s walls has lasted since the beginning of systematic archaeological excavations, that is, since the 1880s. A significant input into the discovery of the fortifications was brought by K. Koscûško-Valûžinič. He was the first director of the local “antiquities depot” in Chersonesos and worked upon the order of the Imperial Archaeological Commission. Results of research and incidental discoveries which were made on the town’s walls at the turn of the 19th and 20th c. were systemised by A. Berthier de Lagarde, an engineer serving in the Russian army. He proposed a system of numeration of curtains and turrets which is still in use in modern research and documentation (BERT’E-DELAGARD” 1907). It is also used for the needs of this paper (Fig. 1).

Na zakończenie warto także zwrócić uwagę na plany nieistniejących obecnie umocnień w południowo-zachodniej części Chersonesu (**Ryc. 1**). Rozmieszczone w niemal identycznych odległościach trzy małe prostokątne baszty (nr IX, X, XI) wyglądają jak typowy przykład umocnień fortu lub obozu rzymskiego. Zastosowany kształt baszt sugeruje, że przebudowa miała miejsce w III w. Prawdopodobne zaangażowanie wojska rzymskiego w modernizację wspomnianego odcinka murów pozostawałoby w zgodzie z hipotezą Karola Kościuszko-Waluszynskiego o zlokalizowaniu w tej części umocnień „małej cytadeli” (KOSCŪSKO-VALŪZINIČ 1895: 58), być może dodatkowego miejsca stacjonowania wojska rzymskiego w pobliżu murów. Teorię tę zdają się także potwierdzać wyniki ponownej analizy grobów z okresu rzymskiego z pobliskiej części cmentarzyska (KARASIEWICZ-SZCZYPIORSKI 2013).

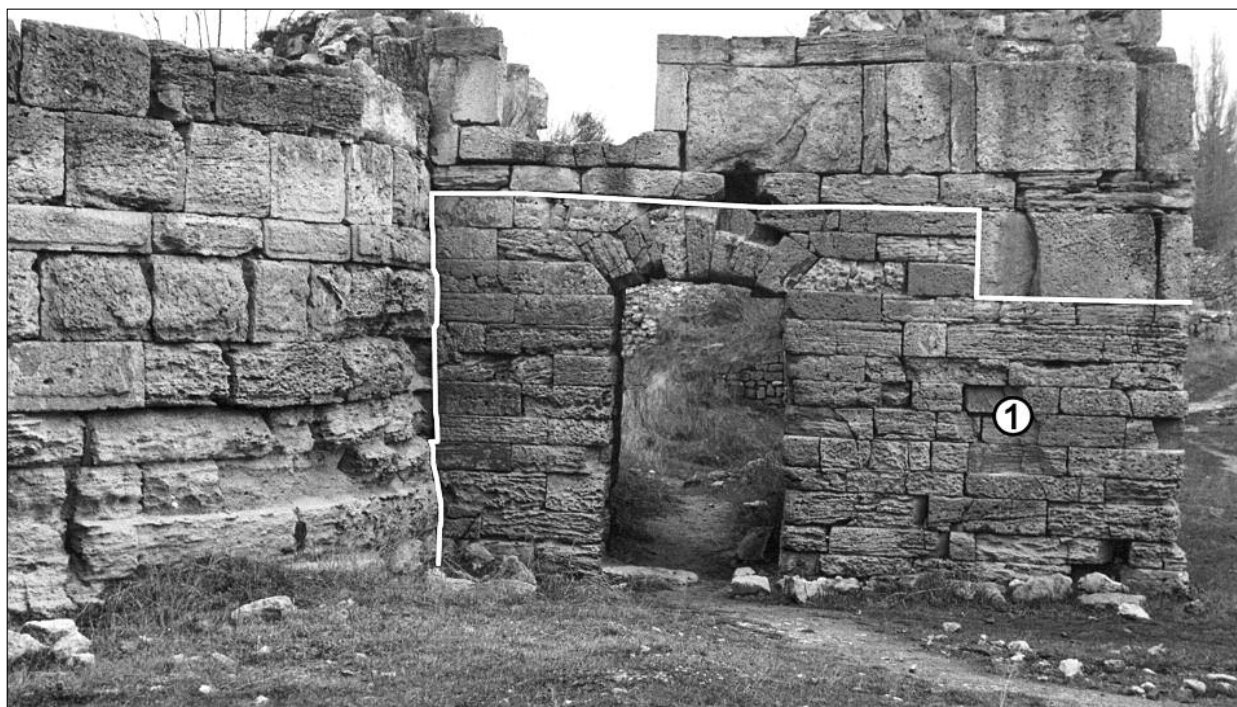
Fig. 2. Curtain 19, interface with the earlier Turret XVI. View from the outer ward (R. Karasiewicz-Szczypiorski). 1 – surviving part of the defensive wall from the earliest building phase (Hellenistic wall).

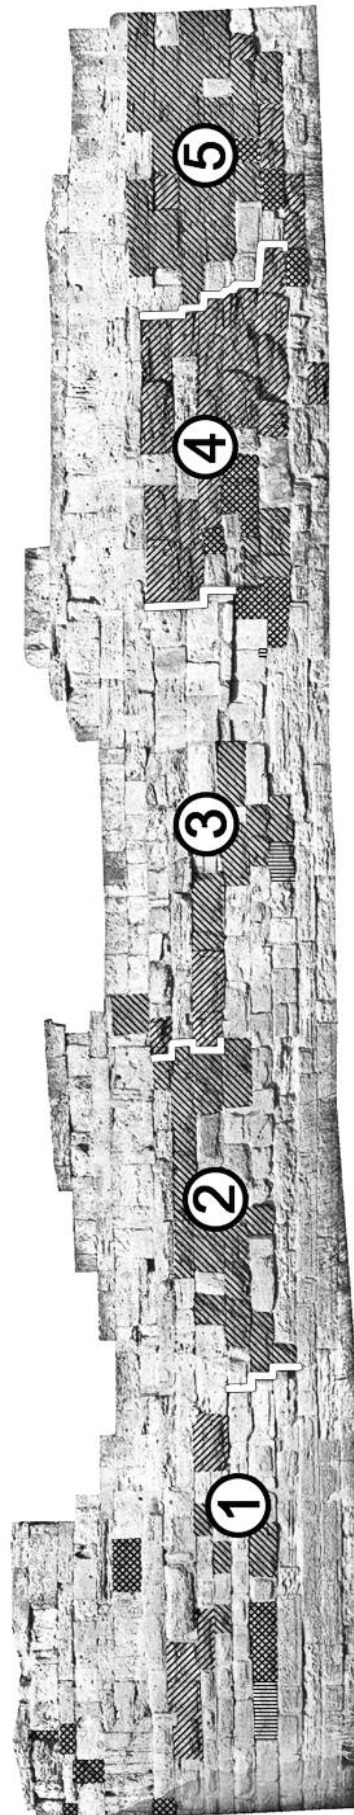
Fig. 3. Curtain 17. View from the outer ward (R. Karasiewicz-Szczypiorski, J. Kaniszewski). 1–5 – sectors differing with regard to selection of building material.

of a mass use of Lithotypes 9 and 10 are central layers of blocks in surviving remains of Curtain 17 (Fig. 3). Bearing in mind the present level of the terrain and counting from below, these are rows from 3–4 to 8–9 (closer to Turret XV) and rows from 2–3 to 8 (closer to Turret XVI).

The analysis of distribution of both raw materials and the share of other admixtures in Curtain 17 allows to propose several hypotheses which can enrich our knowledge on the construction of the defensive walls and reasons behind their rebuilds. The discussed phase (i.e., the preserved sequence of layers of blocks) in the external face of Curtain 17 can be divided into 5 segments. A different distribution of raw materials in isolated segments may suggest that these were constructed subsequently (from left to right), that is, starting from Turret XV. Segment 1 (Fig. 3:1) consists almost exclusively of Lithotype 1, with a minimum admixture of Lithotypes 9 and 10. In this case it must be firmly stressed that the entire analysis omits instances of occurrence of individual blocks belonging to types which do not occur regularly, in larger quantities, in a given structure. These blocks were considered traces of later repairs, consisting in filling of subsidence in the existent face. Segment 2 (Fig. 3:2) is mainly Lithotype 1 in its lower parts, replaced with Lithotype 10 in its upper parts. Segment 3 (Fig. 3:3) is also a mixture of Lithotypes 1 and 10, with a reservation that the latter occurs in the segment's lower parts, chiefly near Segment 2. Segment 4 is chiefly Lithotype 9 (Fig. 3:4), while Segment 5 is almost exclusively Lithotype 10 (Fig. 3:5).

First of all, the rebuild of Curtain 17 was carried out in such a manner that blocks from the previous phase (Segment 1) were initially used. In Segment 2 (Fig. 3:2) the construction was also started with the use of blocks which may have been salvaged. Then, new building material was used. Segments 3 and 4 are already dominated by new building material; however, both segments differ significantly. Such a sequence may imply that for the needs of the reconstruction one initially salvaged blocks from an earlier defensive wall which was destroyed or dismantled. On the other hand, the use of two types of rock may suggest that two different building teams worked on the walls next to each other, or that the raw materials were supplied from different pits in a quarry during subsequent building stages. In each case this observation proves that the curtain was constructed not simultaneously in its entire length, but in stages – in segments from left to right.

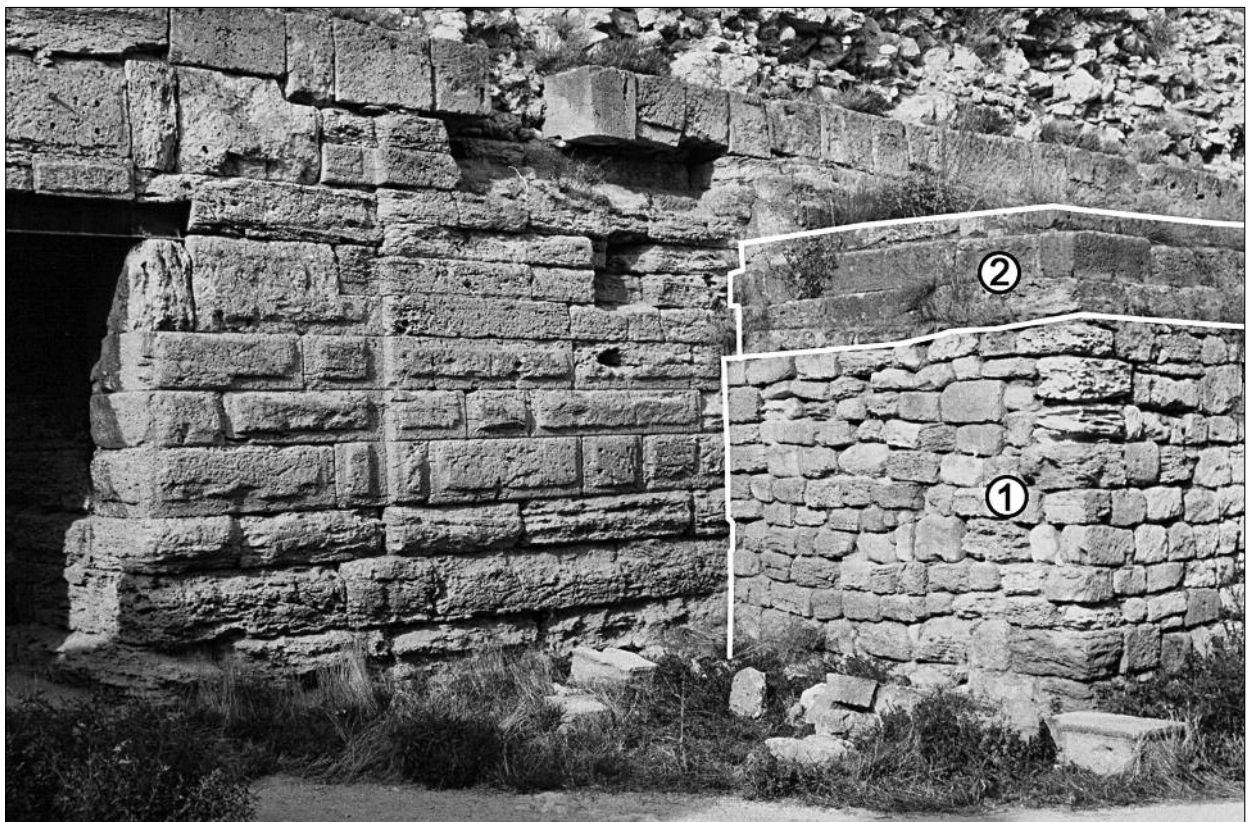
Fig. 4. Curtain 16 and Tomb 1013. View from the outer ward (R. Karasiewicz-Szczypiorski). 1 – walls of the tomb, constructed from roughly cut blocks; 2 – upper part of the structure, made from regular blocks.

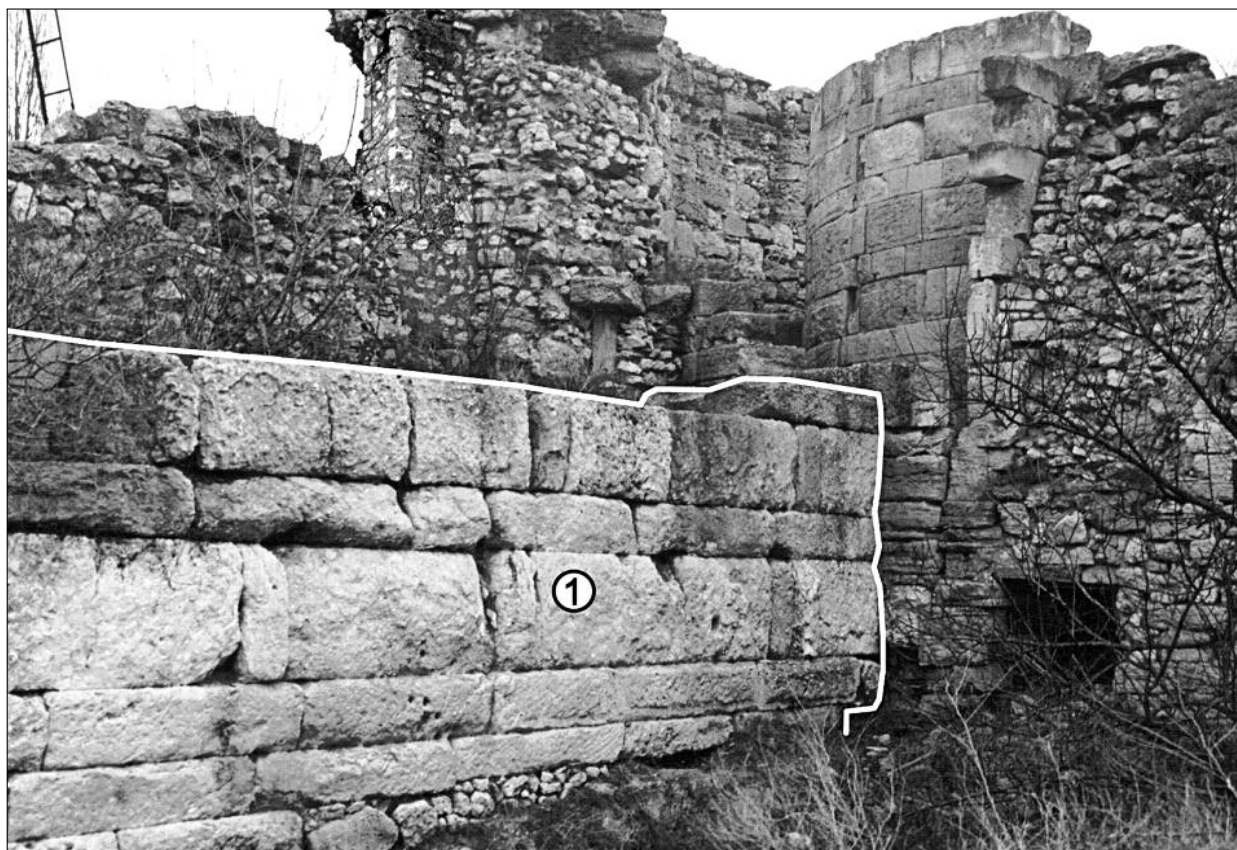
Fig. 5. Curtain 20. View from the interior of the citadel (R. Karasiewicz-Szczypiorski). 1 – remains of the defensive wall constructed in the Roman Period from Inkerman stone.

Lithotype 3 was used as building material in one of the phases of Curtain 20, which came into existence simultaneously with the rectangular Turret XVII. The mentioned structures are dated to the end of the Roman Period (cf. ANTONOVA, BABINOV 1970: 249). However, in the light of

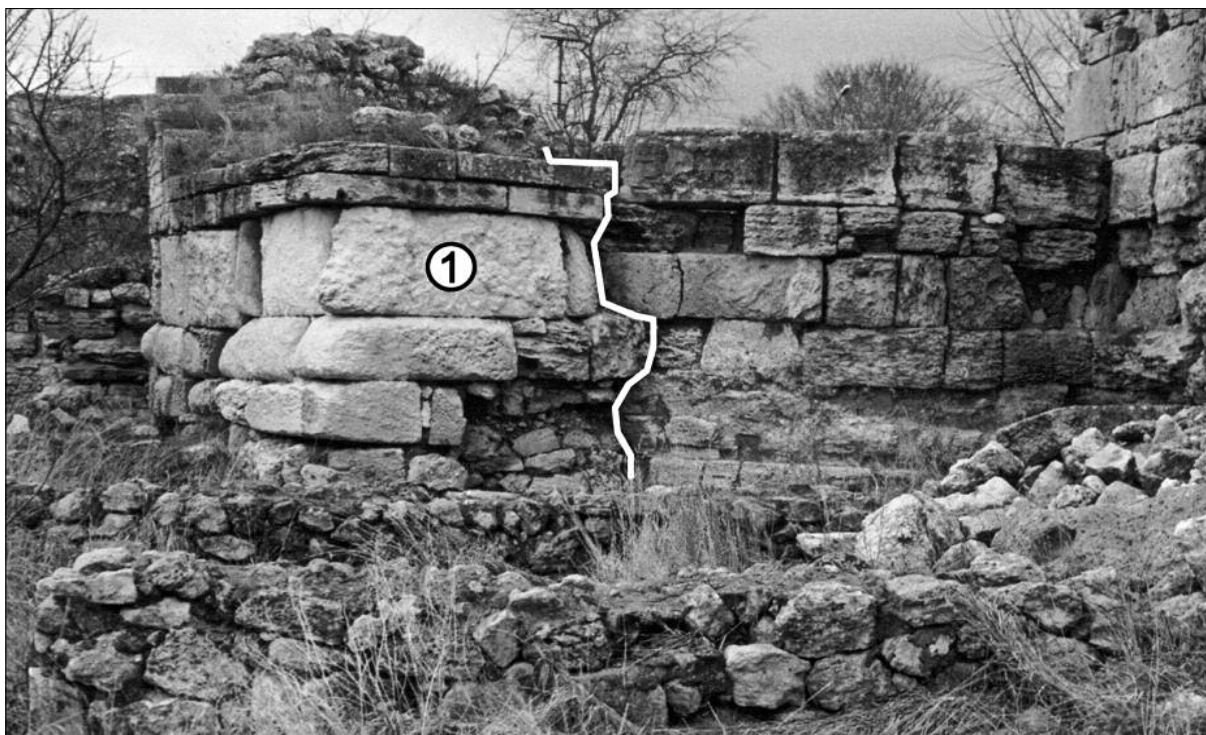
Fig. 6. Thickening of Turret XVI. View from the interior of the citadel (R. Karasiewicz-Szczypiorski). 1 – remains of part of the wall constructed from Inkerman stone.

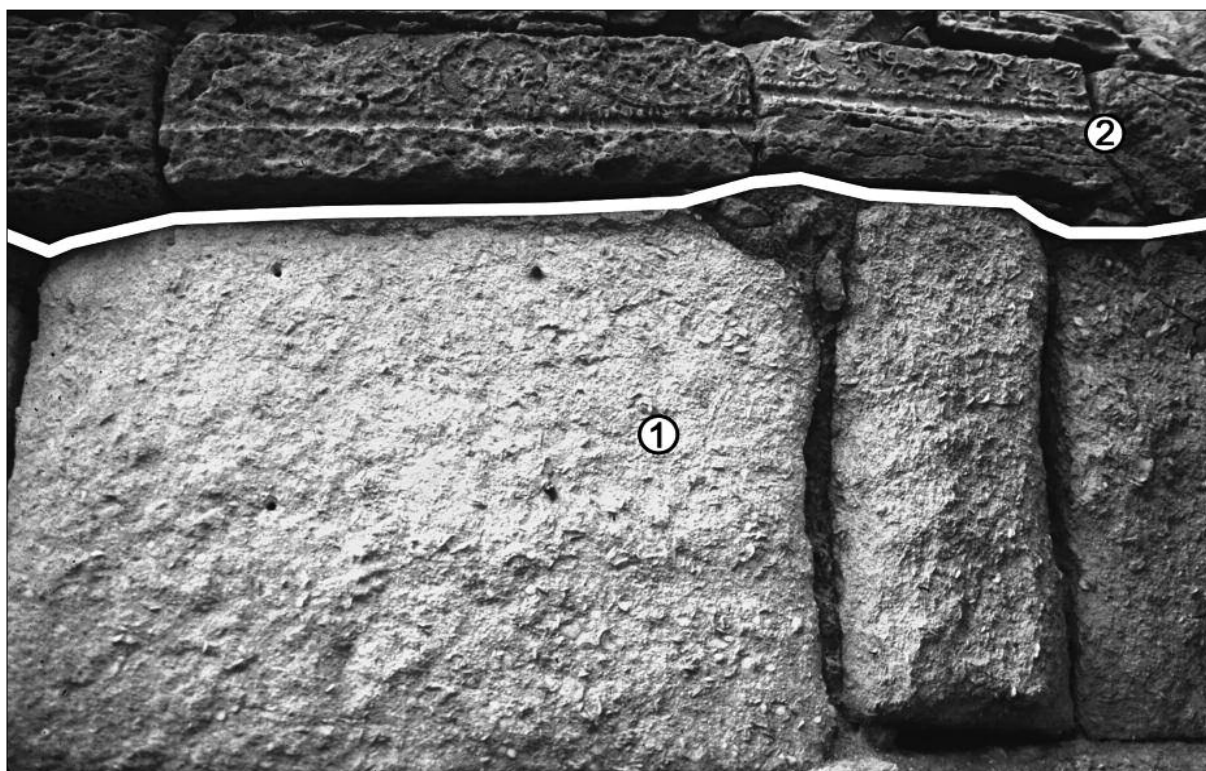
Fig. 7. Thickening of Turret XVI (R. Karasiewicz-Szczypiorski). 1 – blocks of Inkerman stone; 2 – fragments of secondarily used architectural details.

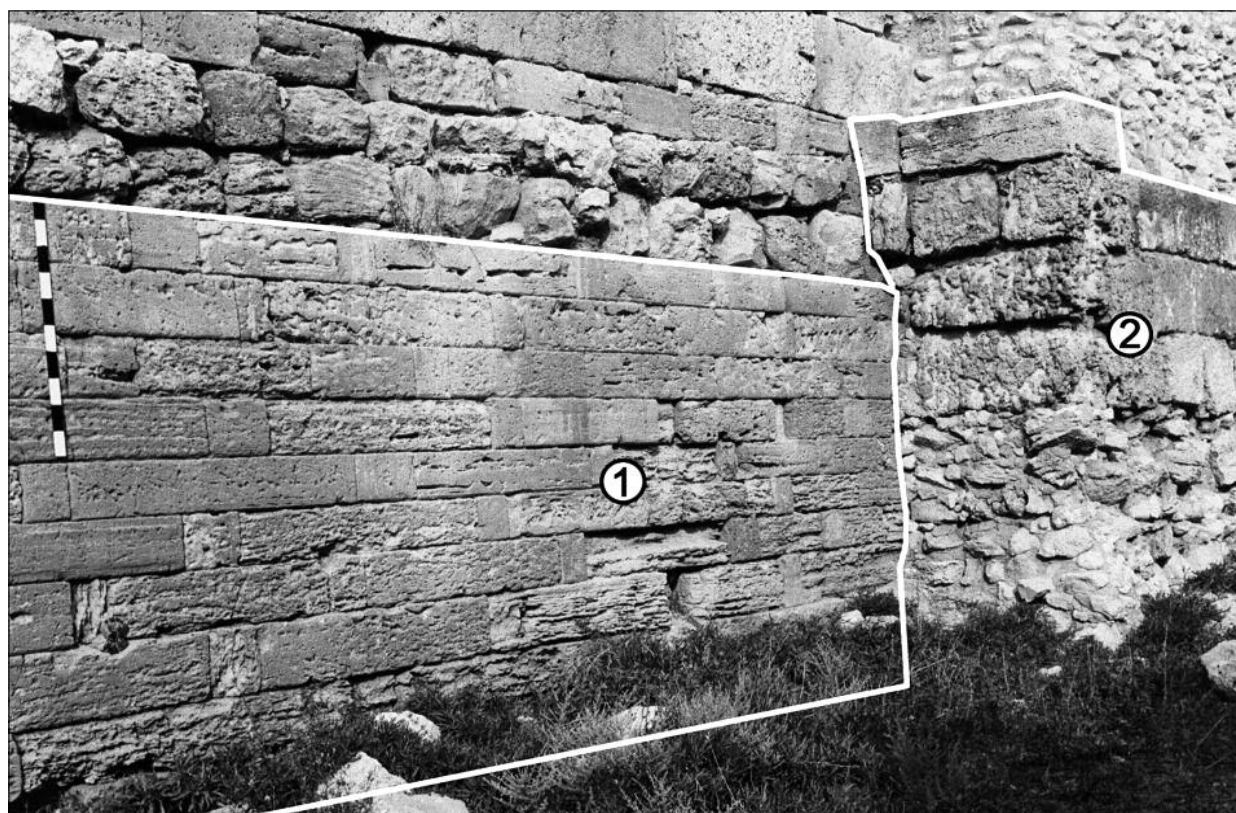
Fig. 8. Curtain 19. View from the outer ward (R. Karasiewicz-Szczypiorski). 1 – surviving part of the defensive wall from the earliest building phase (Hellenistic wall); 2 – thickening of the defensive wall in the neighbourhood of Turret XVII.

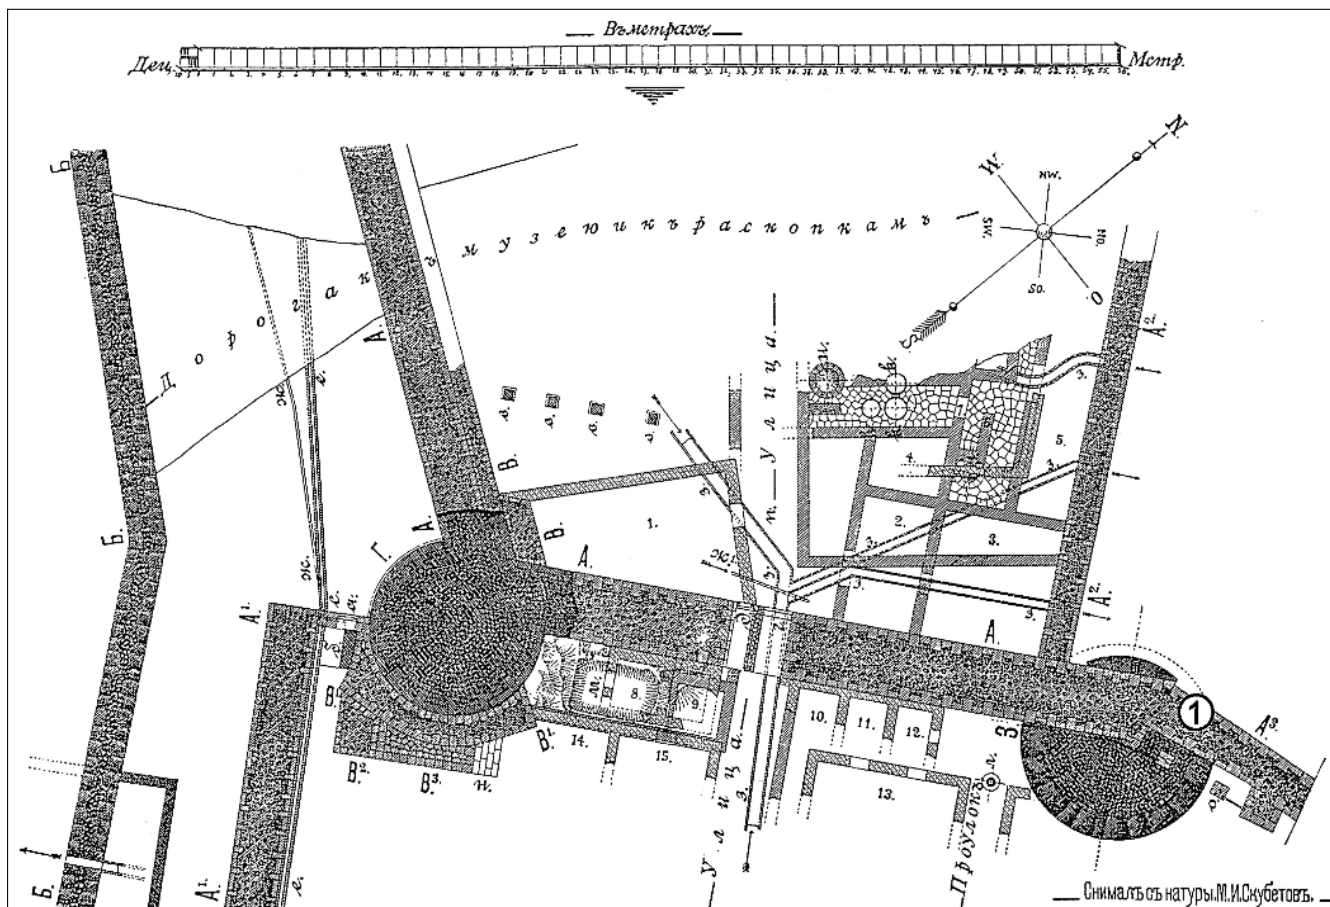
Fig. 9. Chersonesos. Plan from the excavations of Kosciuszko-Valužinič (1908: pl. III). 1 – remains of the supposed gate on the ruins of Turret XIX.

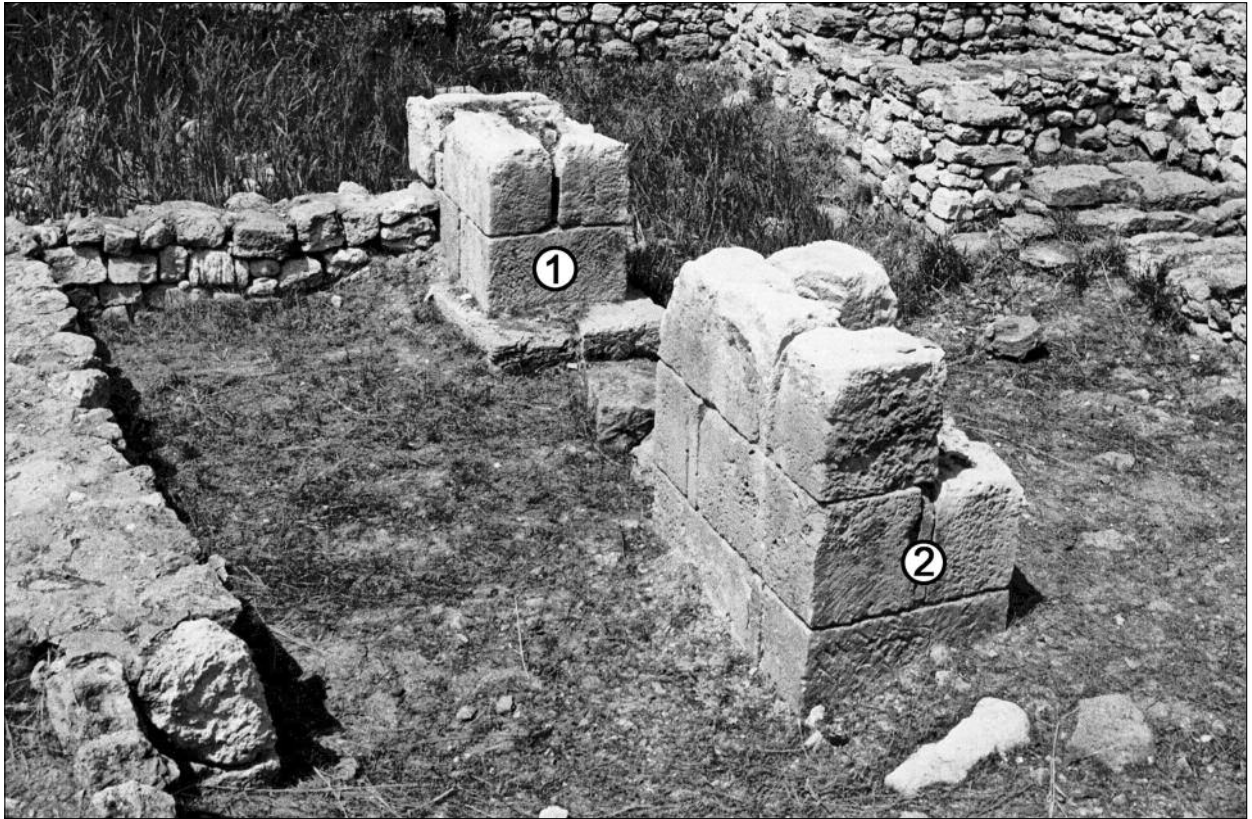
Fig. 10. Pillars in the territory of the port quarter (1 and 2). Remains of the supposed gate from the Roman Period (R. Karasiewicz-Szczypiorski).

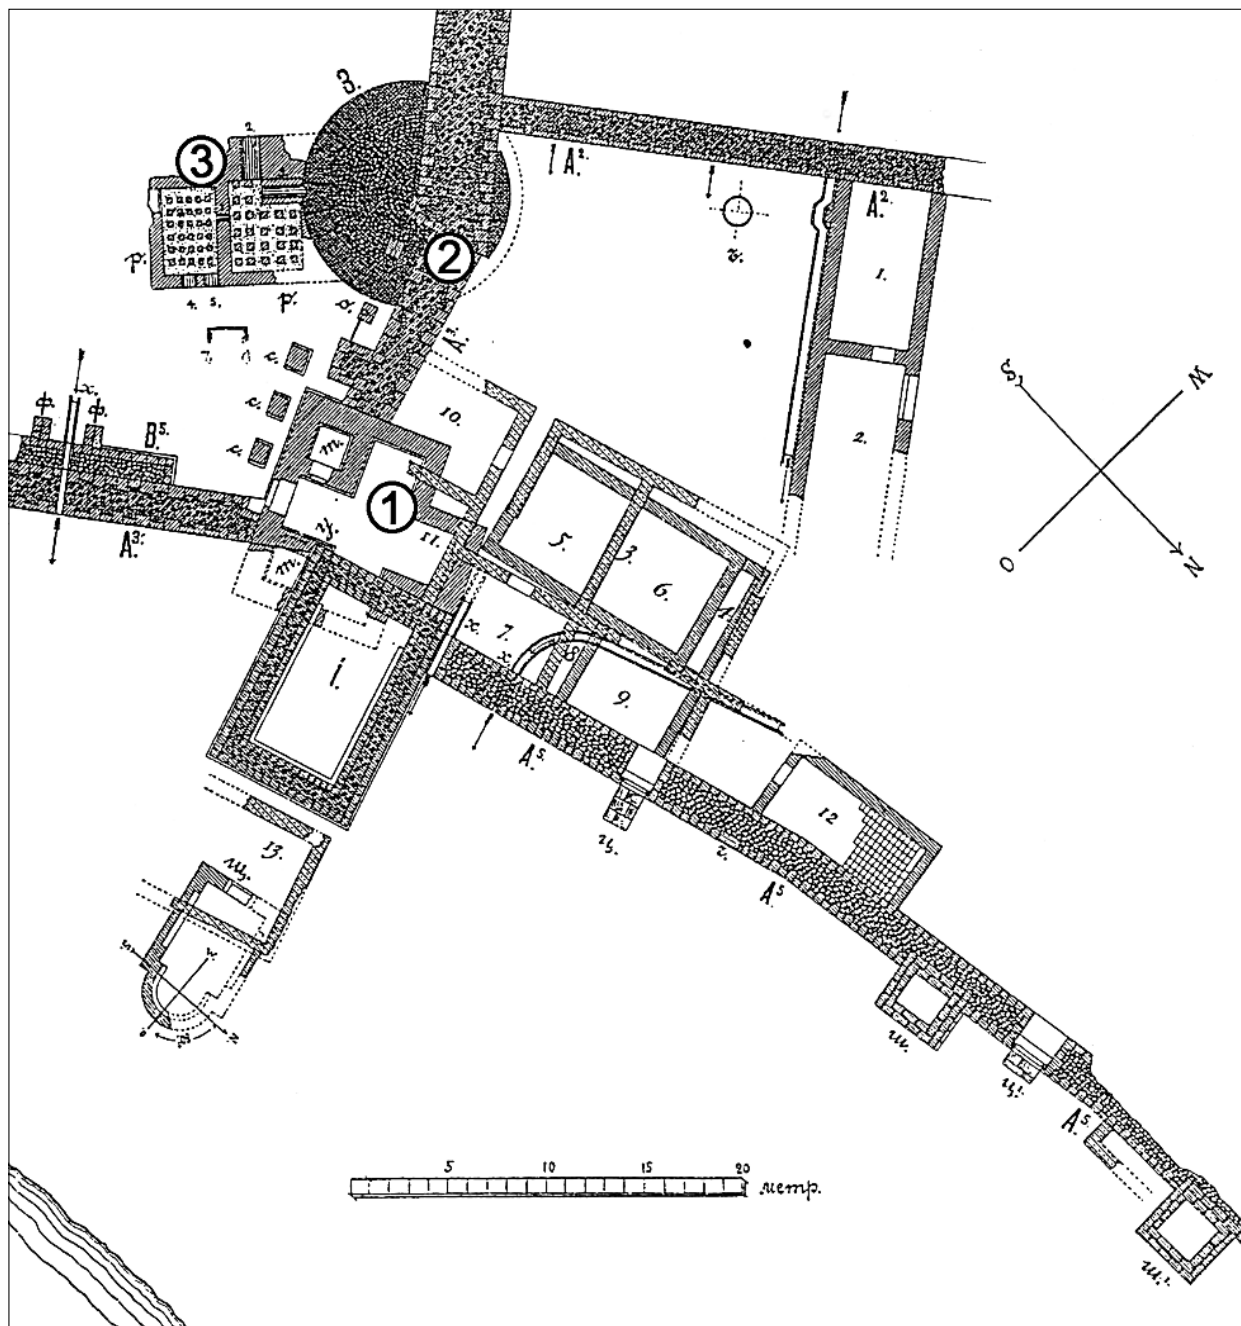
Fig. 11. Chersonesos. Plan from the excavations of Koscůško-Valůžinič (1909: pl. II). 1 – remains of Turret XX; 2 – remains of the supposed gate on the ruins of Turret XIX; 3 – rooms with hypocaust cellars – remains of the therms in the citadel.

Turret XX “on the plan of a cross.” It seems that it is the outline of the foundations (which is known, as in the previous case, from the documentation of Koscůško-Valůžinič) that may point to constructors of the mentioned building (KOSCŮŠKO-VALŮŽINIČ 1909: pl. II; **Fig. 11:1**). In the defensive system of Chersonesos there are no other similar solutions. It is also difficult to find turrets on the plan of a cross at other Roman Period sites. On the other hand,
