## Dongola, Sudan - Season 2013-2014

## DONGOLA, SUDAN – SEASON 2013–2014

**Keywords:** church, Dongola, Makuria, monastery, Nubia

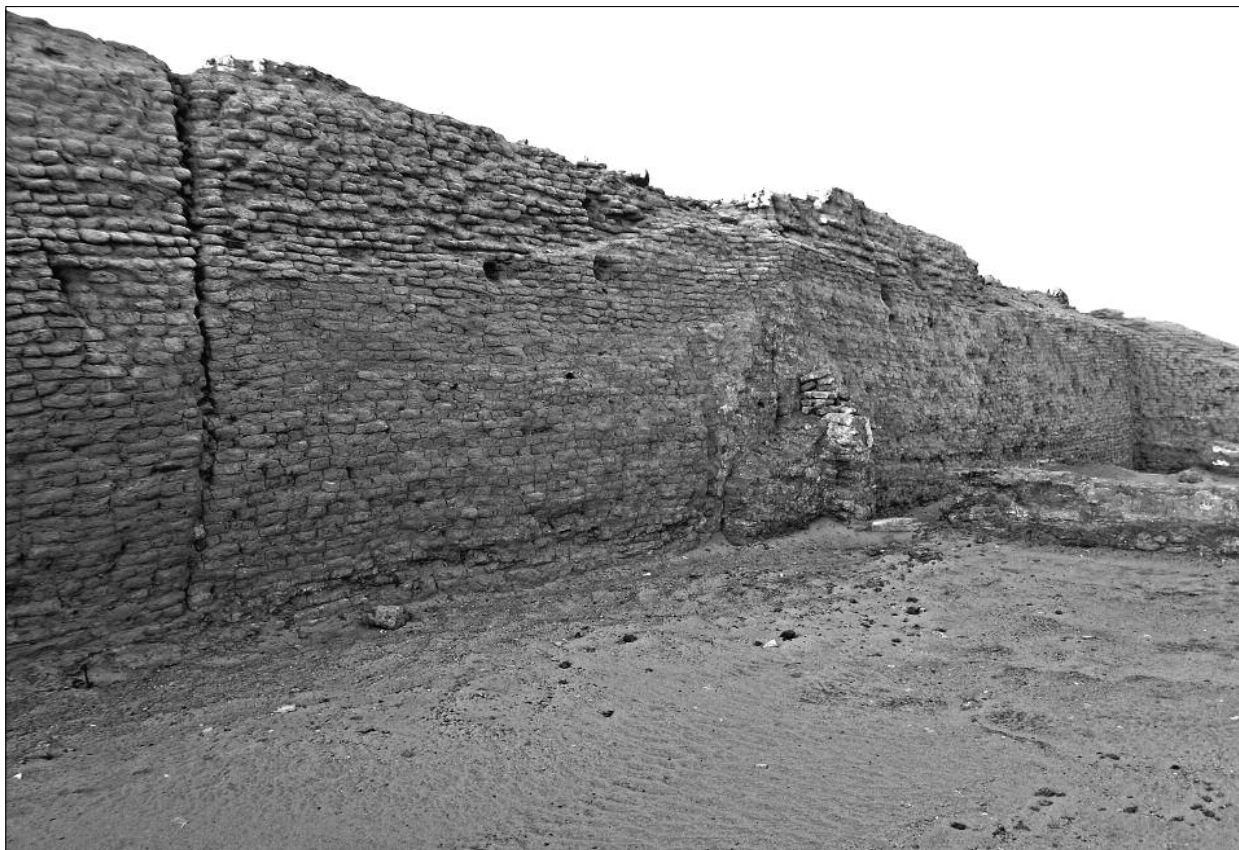
Fig. 1. Mud brick casing wall between Towers NW and N.2. View from NE (Photo W. Godlewski; Archive of PCMA).

reinforce the original walls of the Citadel dating back to the 5<sup>th</sup>/6<sup>th</sup> c. (Fig. 1). Towers N.1 and N.2 were also refurbished. The aim of these measures was to shield unprotected dwellings perched atop the somewhat damaged original fortifications, whose curtain wall measured 5.6 m in width. Several sectors of low-rise residential buildings were constructed on the sand deposit on which the casing of the Citadel walls was founded, additionally stabilising the dunes at the foot of the walls (Fig. 2). Investigation of these

- fortyfikacje i przylegające do nich zabudowania mieszkalne (**Ryc. 1, 2**), w których odnotowano znaleziska z okresu Fundż (XVI–XVII w.; **Ryc. 3**);
- stanowisko SWN: kościół Archaniola Rafała, gdzie odsłonięto szereg malowideł naściennych (**Ryc. 5**), oraz pałac Johanna (budowla B.I) – z późniejszą zabudową (okres Fundż; **Ryc. 6**);
- kom H – klasztor św. Antoniego, gdzie odczyszczono

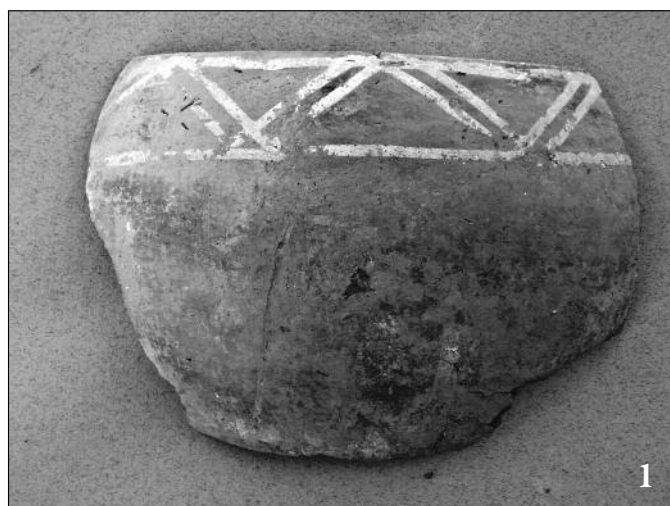
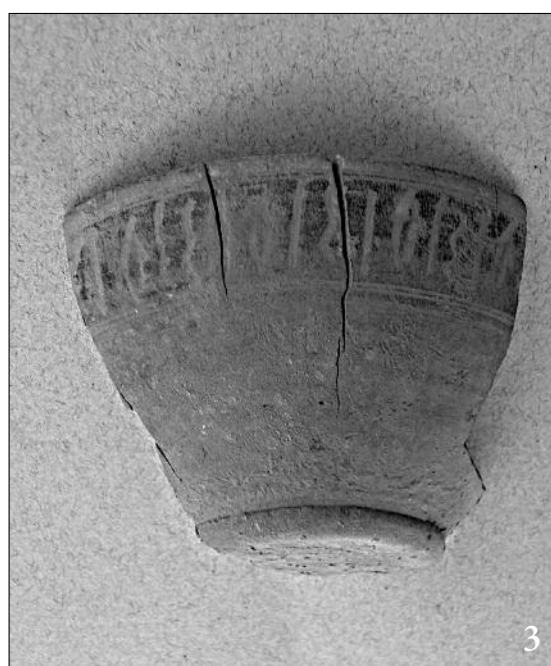
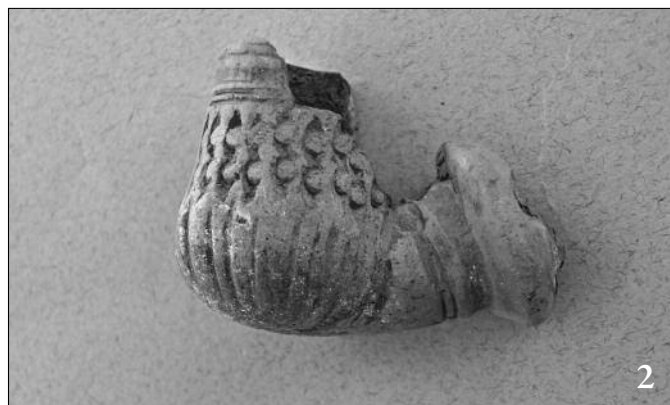
Fig. 3. Finds from the Funj Period houses. 1 – handmade pot; 2 – pipe stem; 3 – wooden bowl (Photo W. Godlewski; Archive of PCMA).

houses yielded numerous finds, above all hand-formed ceramics (**Fig. 3:1**), fragments of textiles, as well as amulets and pipe stems (**Fig. 3:2**), which provided grounds for dating them to the end of the 16<sup>th</sup> c., as well as wooden objects (**Fig. 3:3**). On the eastern side, the fortifications were additionally reinforced with two walls running parallel to the original ramparts. One of them was built of roughly hewn sandstone blocks likely reclaimed from a representative structure in the Citadel, and the other was constructed of broken ferruginous sandstone and bricks. The two walls also stabilised the sand dune at the foot of the Citadel walls (**Fig. 4**).

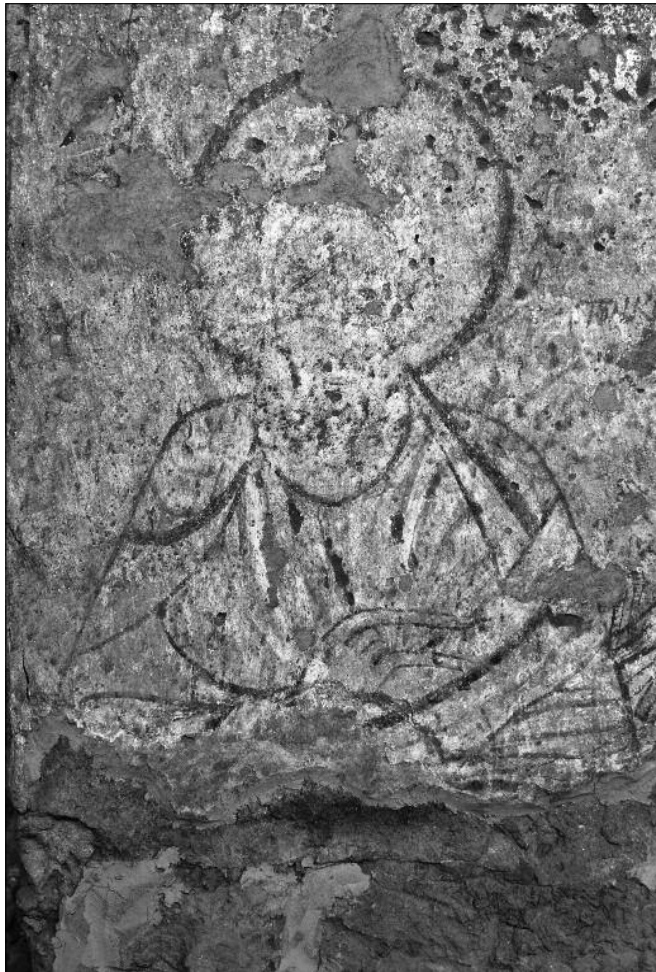
Fig. 5. The Church of Archangel Raphael, *prothesis*, east wall. Apostle Peter (Photo D. Zielińska; Archive of PCMA).

In the Citadel, work continued on the SWN site, in the palace of King Ioannes (SWN.B.I) and in the royal church (of Archangel Raphael, SWN.B.V). Murals preserved on the walls and pillars of the church, and in particular their state of preservation, hindered the progress of works in the naos and the *prothesis* of the church. Inside the *prothesis*, on the northern and eastern walls, several compositions were brought to light and subjected to consolidation works. The paintings show priests of the church of Raphael offering gifts to the enthroned Virgin Mary and the apostles (**Fig. 5**). The murals are supplemented by Greek inscriptions (legends) and prayers in Greek and Old

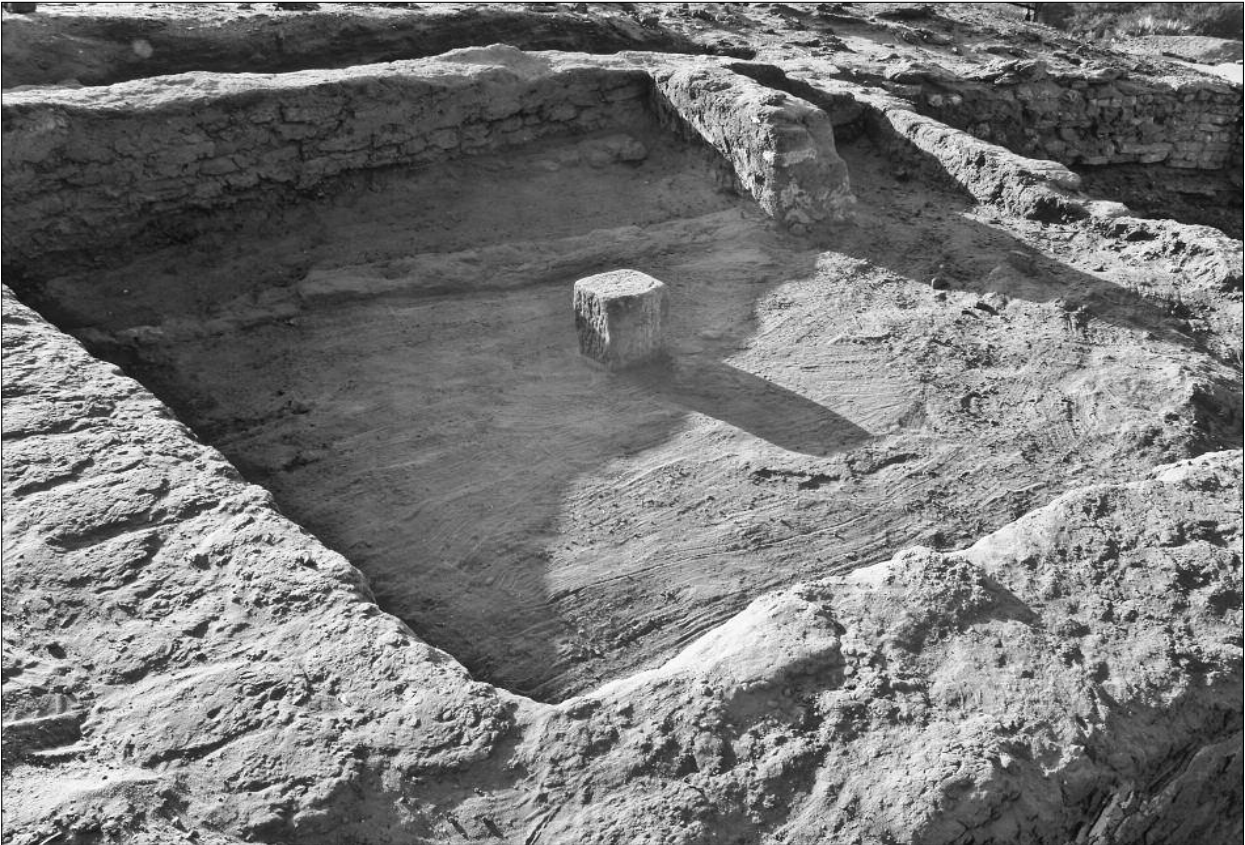
Fig. 6. Site SWN. House of the Funj Period, built over the SE part of the destroyed palace of Ioannes (Photo W. Godlewski; Archive of PCMA).

In the palace of King Ioannes (SWN.B.I) work was conducted in the south-eastern part of the complex, bringing to light mainly Funj Period dwellings built on the relics of the upper floor of the palace (**Fig. 6**). Excavations conducted in the palace staircase (B.I.01), beneath its baked brick vaults, yielded a large assemblage of animal bones which, to judge by pottery recovered from the same layers, was deposited there in the 14<sup>th</sup> c.

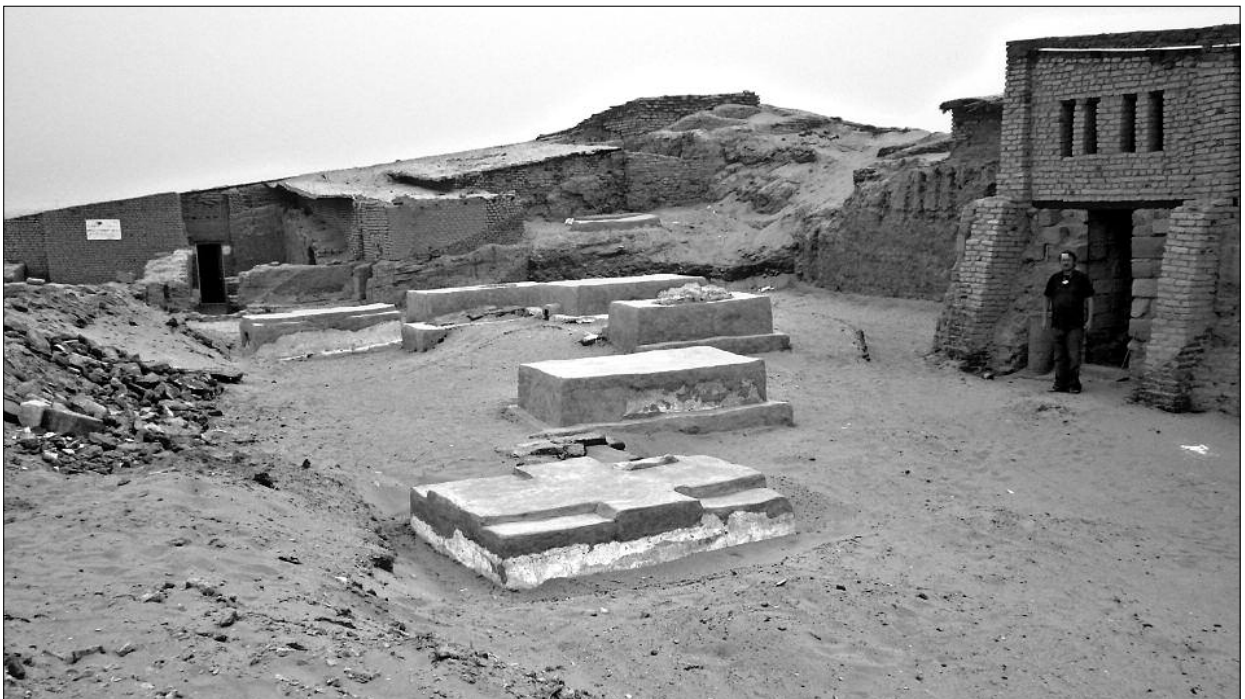
Fig. 7. The tombs on the courtyard on the western side of the Southwest Annex of the Monastery of St Anthony (B.III), after renovation (Photo W. Godlewski; Archive of PCMA).

Conservation works were conducted in Building III of the Southwest Annex, decorated with numerous wall paintings, and on tombs in the cemetery (Fig. 7). The superstructures of the tombs vary in form, but the most common type is a cruciform body on a rectangular platform. The tombs were built of baked brick and carefully plastered. Funerary stelae were mounted on their western walls, where their impressions are still visible, and oil lamps were placed in small niches. One of the tomb superstructures preserves a text written on the plaster in Greek: it is a prayer for the soul of a woman named Kariti.

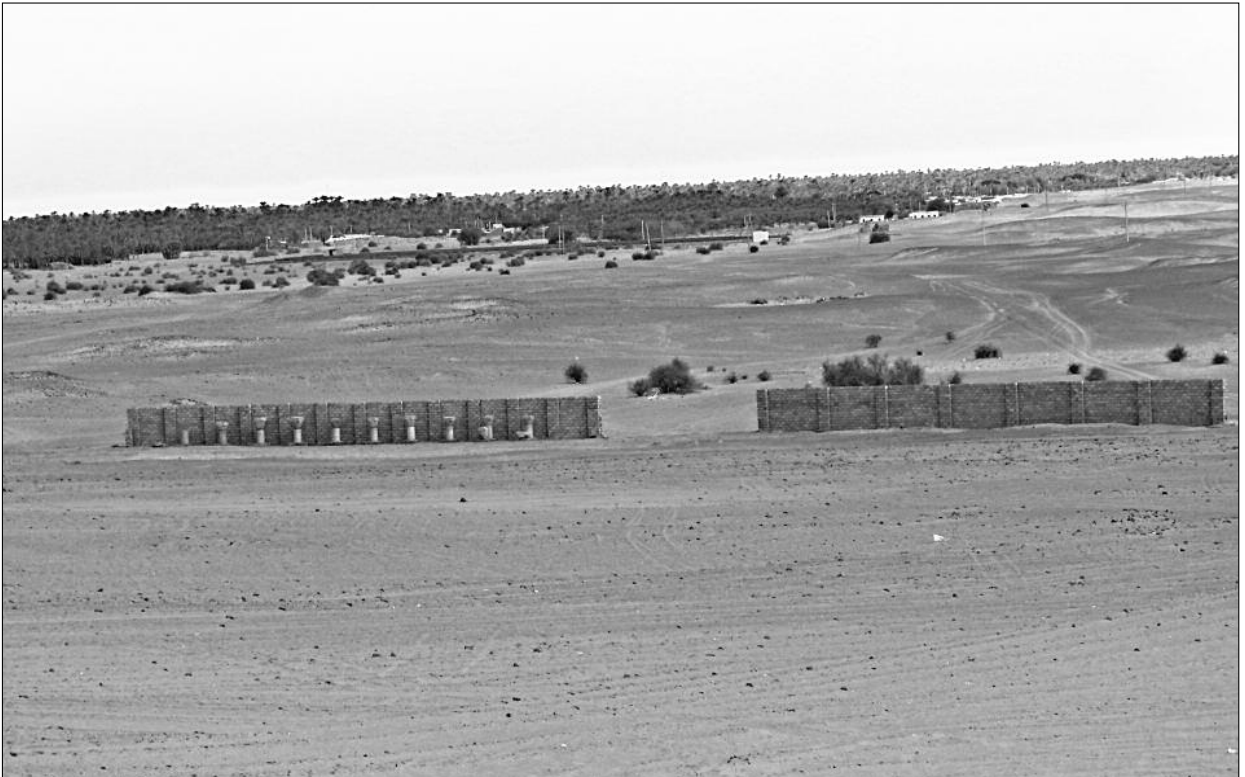
Fig. 8. The shield wall, protecting the sacral complex from sand. View from S (Photo W. Godlewski; Archive of PCMA).

As part of the site management project, the team began removing archaeological dumps accumulated during earlier excavations and started the construction of a wall to the north-east of the sacral complex encompassing the Cathedral and the monumental Cruciform Building. The wall, which is to measure three meters in height, will shield the exposed buildings from encroaching windblown sand. Two sections of this wall have been built, spanning a total of 70 m (Fig. 8). The space along the inner face of the western section of this wall was used for the exhibition of granite capitals from the Dongolese Cathedral dated to the end of the 7<sup>th</sup> c. They were mounted on cement bases measuring one meter in height (Fig. 9).

W ramach zarządzania stanowiskiem – jego ochrony i udostępniania zwiedzającym – wzniesiono mur zabezpieczający przed nawiewaniem piasku (**Ryc. 8**), a jego wewnętrzne lico wykorzystano jako tło eksponowania granitowych kapiteli z katedry dongolańskiej z VII w. (**Ryc. 9**). Szersza informacja o wynikach prac tego sezonu, jak i w latach wcześniejszych, znajduje się na stronie internetowej UW: [www.polacynadnilem.uw.edu.pl](http://www.polacynadnilem.uw.edu.pl).

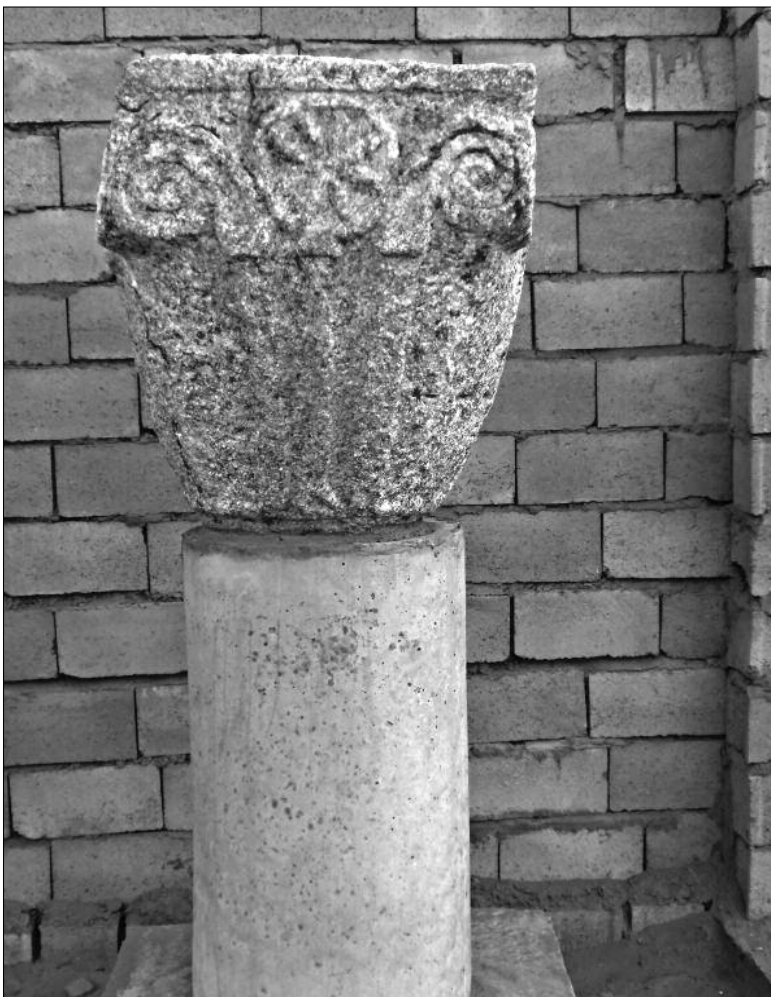
Fig. 9. The granite capital of Cathedral III (end of the 7<sup>th</sup> c.) exposed in front of the shield wall (Photo W. Godlewski; Archive of PCMA).
