Deir El-Bahari: Conservation Work and Studies

CONSERVATION WORK AND STUDIES

STONE BUILDING MATERIAL STUDIES

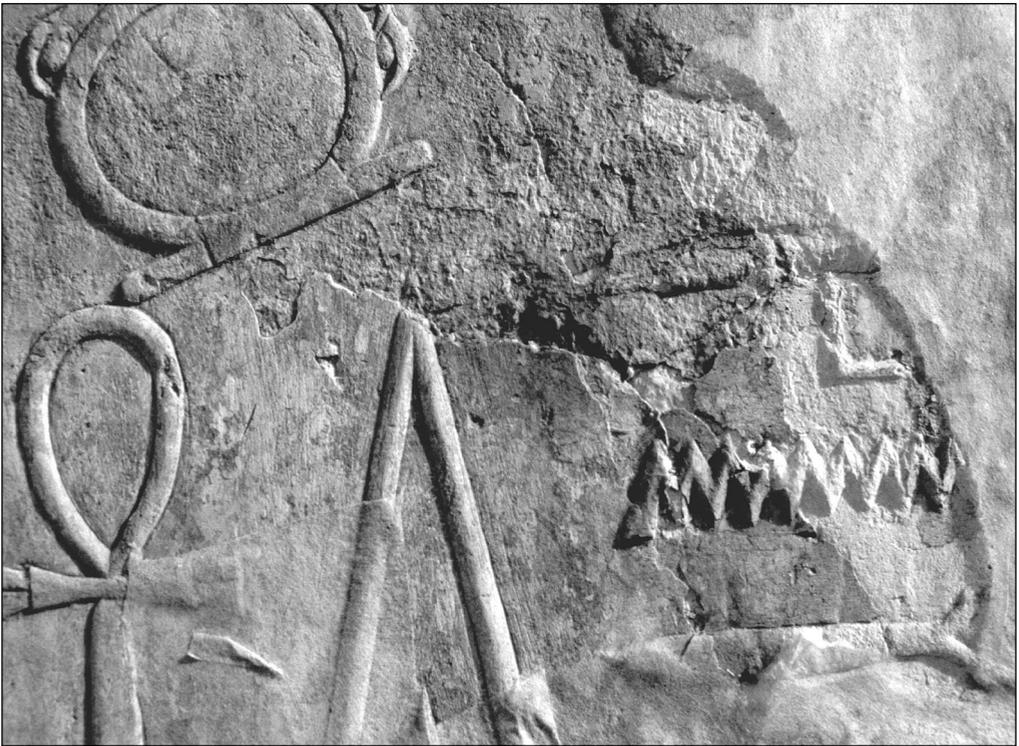
Fig. 1. An example of exfoliation. Block without polychromy from the northern wall of the Upper Courtyard (Photo R. Gazda)

shrinking processes and the extent of damages. In consequence of these processes, concentrations of loamy substances packed parallel to the face of the stone immediately under it were created (exfoliation phenomenon (*Fig. 1*)).

The research findings have helped in a more precise choice of conservation preparations used in the restoration. Blocks belonging to the marl group were first treated with a preparation neutralizing loams: Funciosil Antihigro by Remmers, followed by the stabilization method that reinforces the stone with silico-organic preparations of the Funciosil series: 100, 300 or 510 by Remmers.

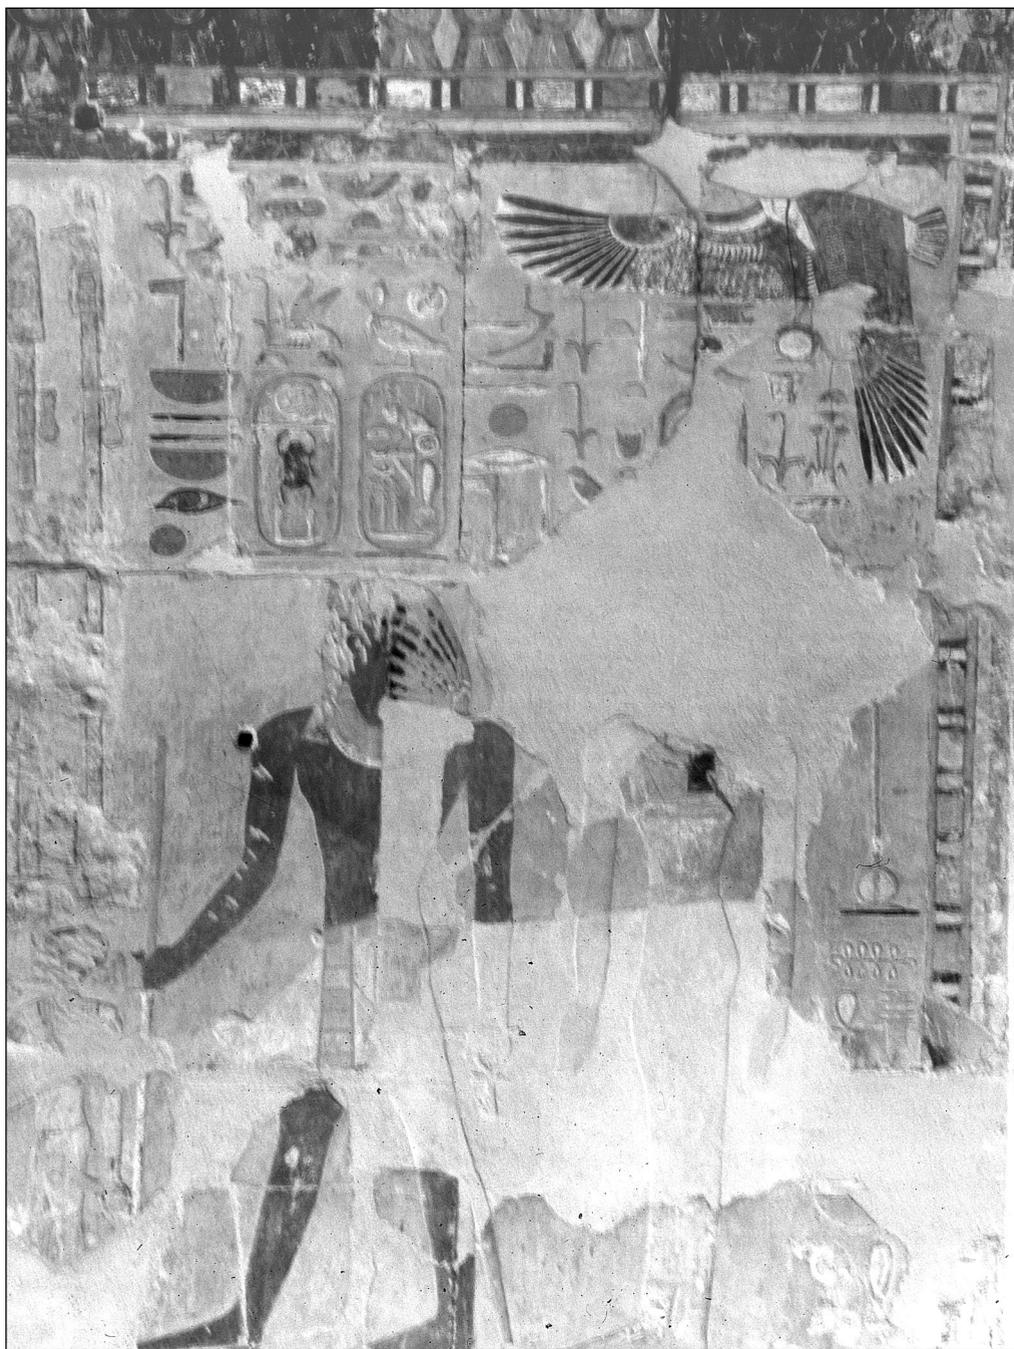
Fig. 2. Representation of King Tutmosis I with Ahmes and Neferure, Hall of the Bark. Conservation of polychromy: A. Bogusz-Gazda, M. Lulkiewicz-Podkowińska, K. Rachuta-Wierniewska; reconstruction: R. Gazda (Photo R. Gazda)

the wet plaster technique.⁵⁾ Further work of this kind was done on representations of the north and east walls of the Upper Courtyard (*Fig. 2*). The final aesthetic effect on the north wall of the Upper Courtyard was achieved applying a silico-organic binder-based renovation paint for

historic monuments, Pulverfarbe by Remmers.⁶⁾ The paint was used to cover plaster and the artificial stone slabs mentioned above.⁷⁾ The color merging of the new stone used in the restoration was achieved with the help of a transparent paint, Funcosil LA by Remmers.
