Polish Archaeology in the Mediterranean 10, 261-271

HAWARTE

EXCAVATIONS, 1999

Michał Gawlikowski

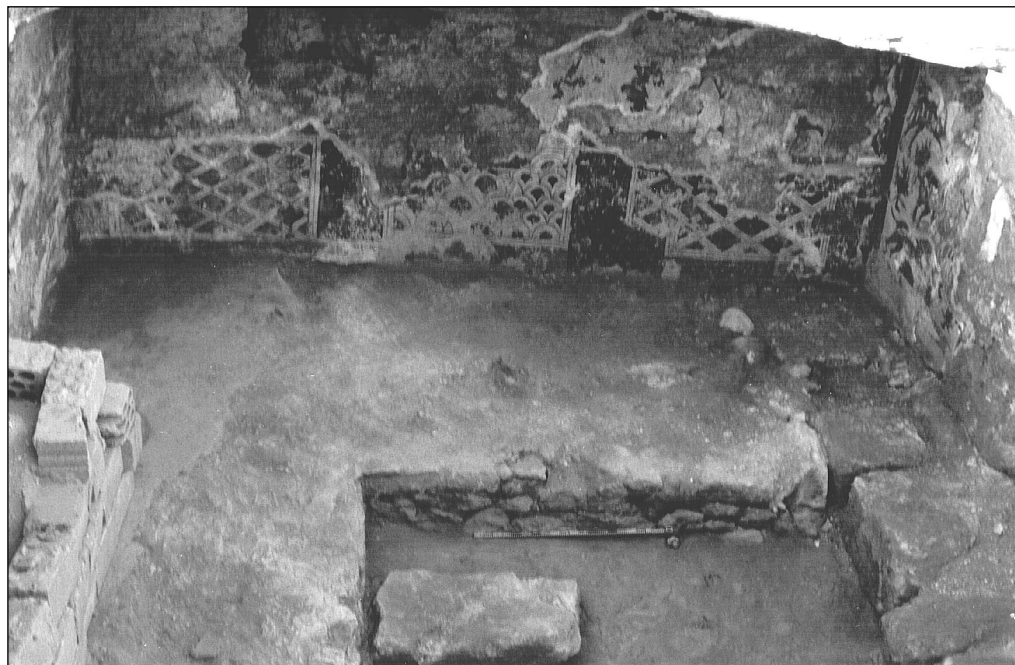
Fig. 3. The south wall of the main room and the L-shaped bench (Photo M. Gawlikowski)

bench under the eastern wall turns at right angles along the south wall (*Fig. 3*), to stop short leaving a passage 60 cm wide along the western wall, probably meant to allow easy access to the benches. These are 2 m wide from the walls to the central space about 35 cm below. They are mostly rock on the eastern side, in one place completed with a rough stone structure, and built entirely on the southern side. All are plastered over. The benches were further reinforced with huge stone slabs provided with a raised border. Several of these, badly broken, were found in the rubble.

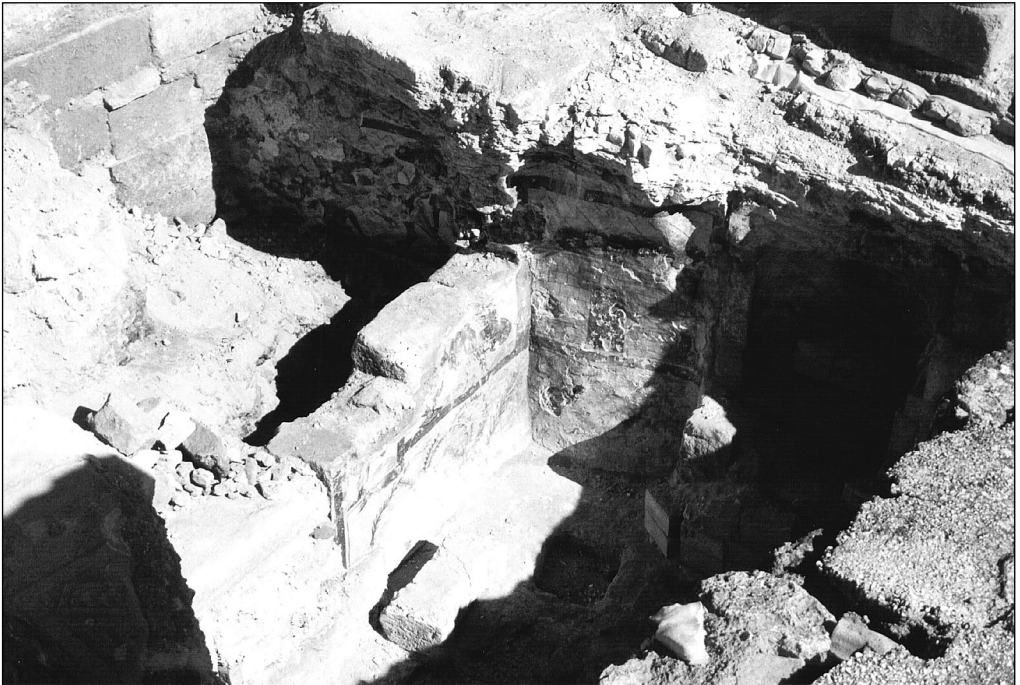
Fig. 4. The partition wall between the main wall and the vestibule under excavation (Photo M. Gawlikowski)

Of the room on the western side from which the mithraeum could be entered we can see now only the northeastern corner. While the visible part of the right, east-

ern wall corresponds only to its lower half (*Fig. 4*), because the higher courses have been removed as described above, the north wall is practically complete in its
