Deir El Bahari: The Temple of Hatshepsut : Season 1999

DEIR EL-BAHARI

THE TEMPLE OF HATSHEPSUT

SEASON 1999/2000

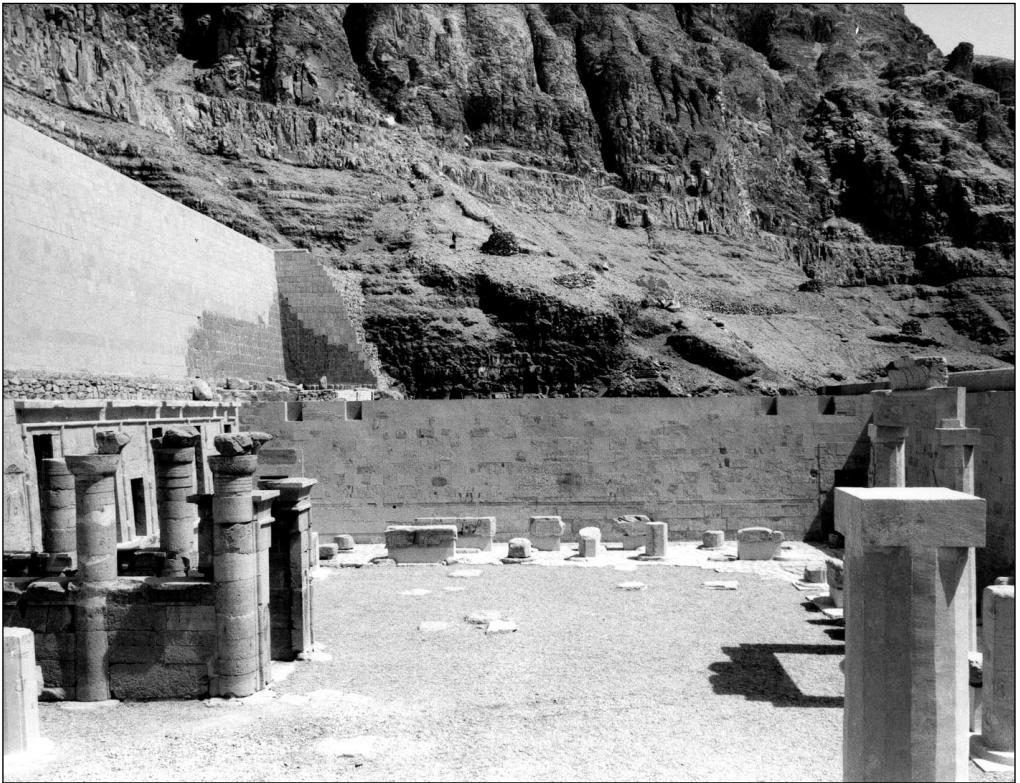
*Fig. 2. Temple of Hatshepsut. Upper Courtyard, after restoration, March 2000
(Photo W. Jerke)*

The restored part of the southeastern Colonnade of the Upper Courtyard with the already mounted architrave⁶⁾ on the main Courtyard and temple axis is the strongest element of the whole aesthetic restoration idea (*Fig. 1*). Columns of the western side were restored to about the middle of their height, permitting full view of the restored facade of the Main Sanctuary. The colonnade of the northern side and the northern part of the eastern side was marked with column bases, architrave blocks placed on artificial benches and restored pavement slabs. A good display of the restored wall decoration, mainly scenes

of the Beautiful Feast of the Valley, has thus been achieved (*Fig. 2*).

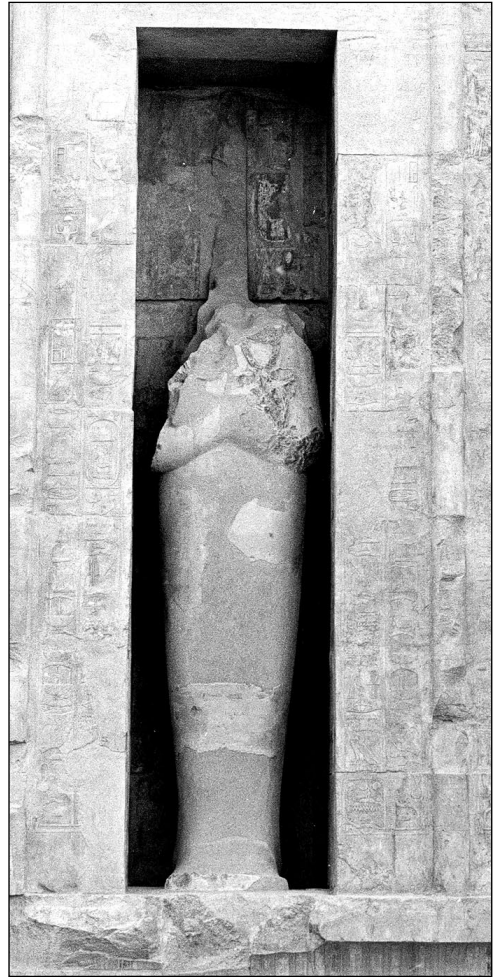
Fig. 3. *Temple of Hatshepsut. Upper Courtyard. West Wall, Niche L with the restored headless statue of the Queen. Cartouche of Hatshepsut on the back wall of the niche revealed after cleaning (top right) (Photo W. Jerke)*

Cleaning and conservation work in the large niches (Niche L especially) revealed cartouches of Hatshepsut (cf. *Fig. 3*) that had been chiseled away in antiquity, but since space was lacking behind the statue heads, the name of the Queen was never

Three more statues have been restored in the large niches of the Western Wall, using 37 original fragments. In effect, there are now four restored (headless) statues of the Queen in the form of Osiris in the niches: G, J (restored in spring 1999), L (Fig. 3), R.⁹⁾

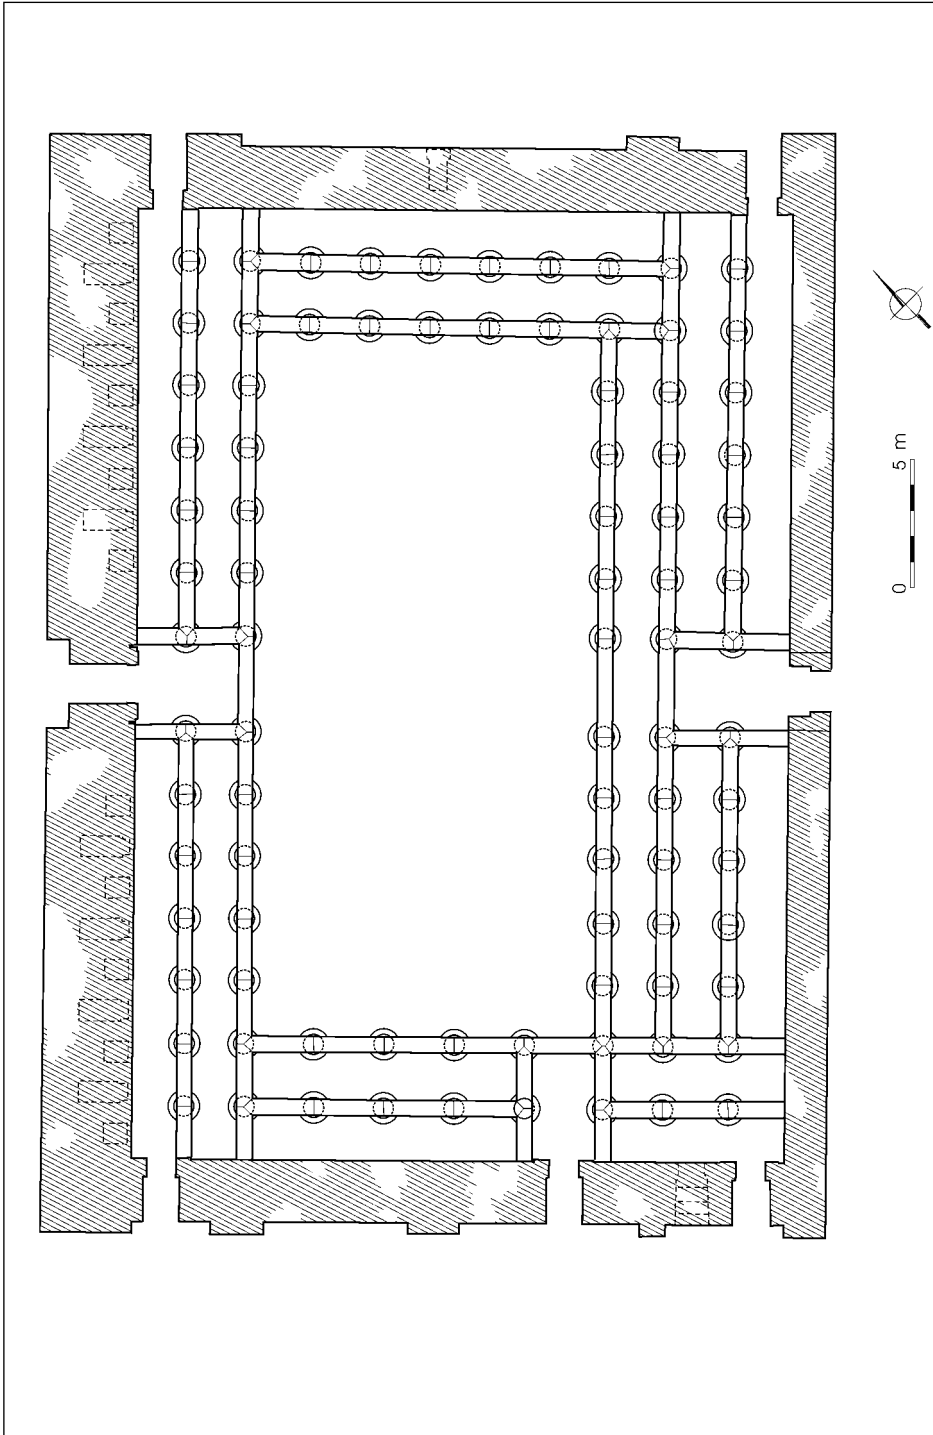
Fig. 4. Temple of Hatshepsut. Plan of the Upper Terrace with the proposed restoration of the Upper Courtyard Colonnade, after A. Kuwańica (in 1999) (Drawing M. Puzkarski)

The reconstruction follows the original design assuming an open courtyard surrounded by two rows of columns on three sides. A successive stage of the development of the courtyard design called for a third row of columns to be added to the east side of the colonnade (*Fig. 4*).¹⁴⁾

Studies of restored architrave sockets and preserved architrave elements led to the calculation of the distance of the inner (first) column rows (13, A and 14) from, respectively, the northern, eastern and southern walls. It turned out to be 4 cubits. Between the first and second rows (i.e., between Row A and Row B, between Rows 14 and 12, between 11 and 13, between J and i) the distance is 4.5 cubits. At the eastern end of the colonnade, the distance between the second (B) and third (C) rows is 5 cubits. In the middle of the southern wall, the distance between rows I, II, III, IV and i measures 5.5 cubits. Between the western wall and the inner row (J), the distance is 3.5 cubits (*Fig. 5*). Once this was established, it became necessary to dismantle and move the bases of the previously reconstructed columns in

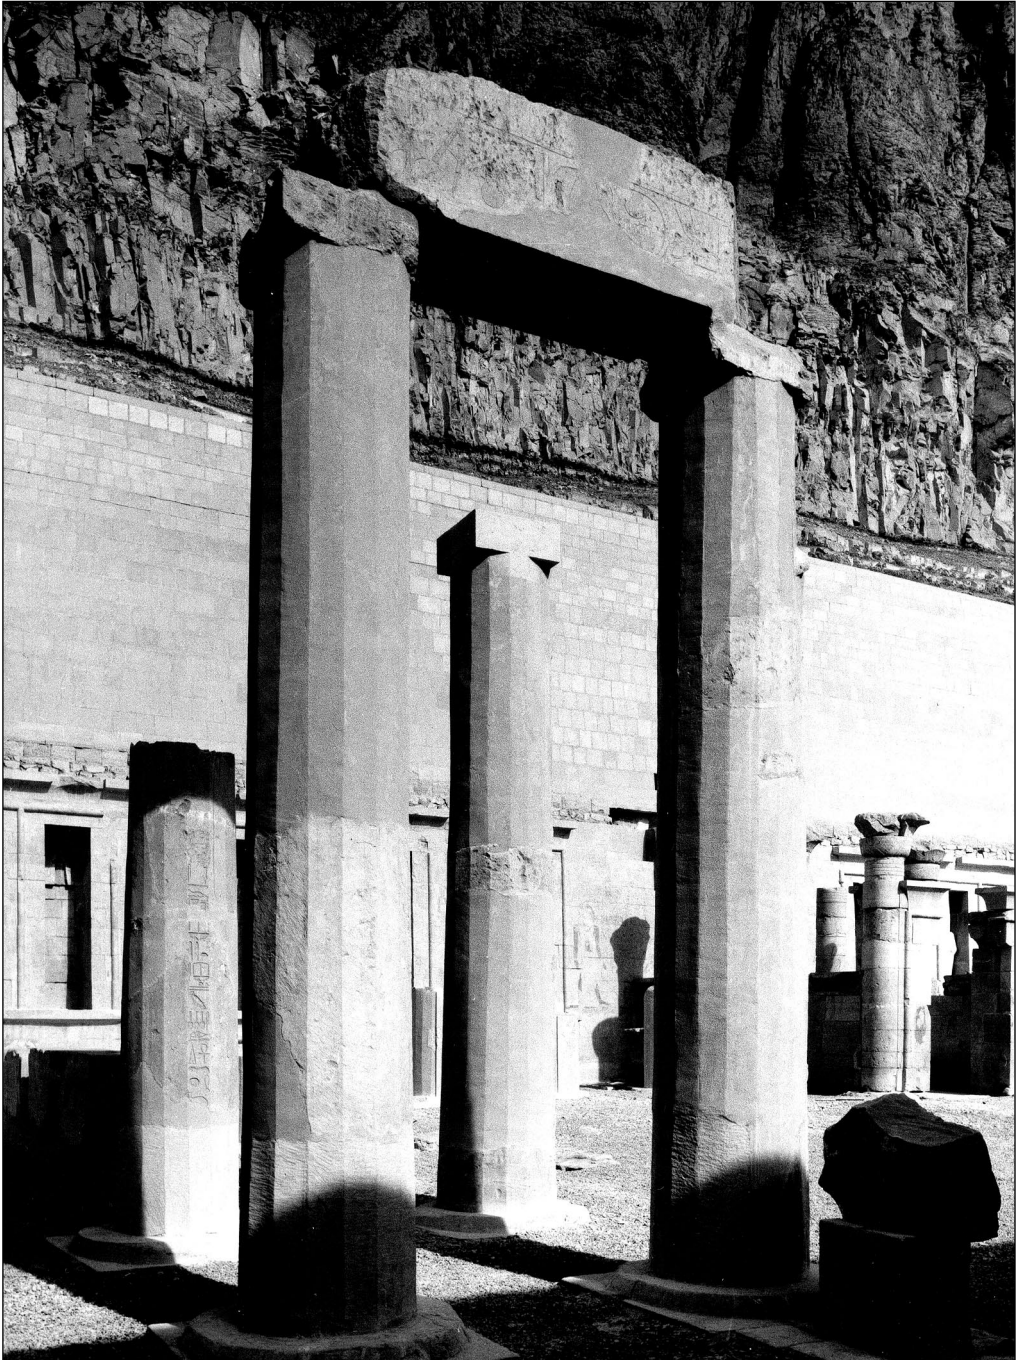
Fig. 6. Temple of Hatshepsut. Upper Courtyard, restored architrave A 22 on top of columns C 12 and C 14 of the third colonnade row marking the second courtyard axis (Photo W. Jerke)

A study of extant column fragments permitted partial anastylosis of the remains of the colonnades.¹⁹⁾ An architrave (A 22) was raised onto two of the restored

columns (C 12 and C 14) here (*Fig. 6*). The end result is a clear marking of the third (C) row of columns and, by the same, of the position of the second main axis that had led to the Chapel of Hatshepsut (cf. *Fig. 5*). Thus, one of the most important architectural concepts of the Queen's temple design has been recognized anew.

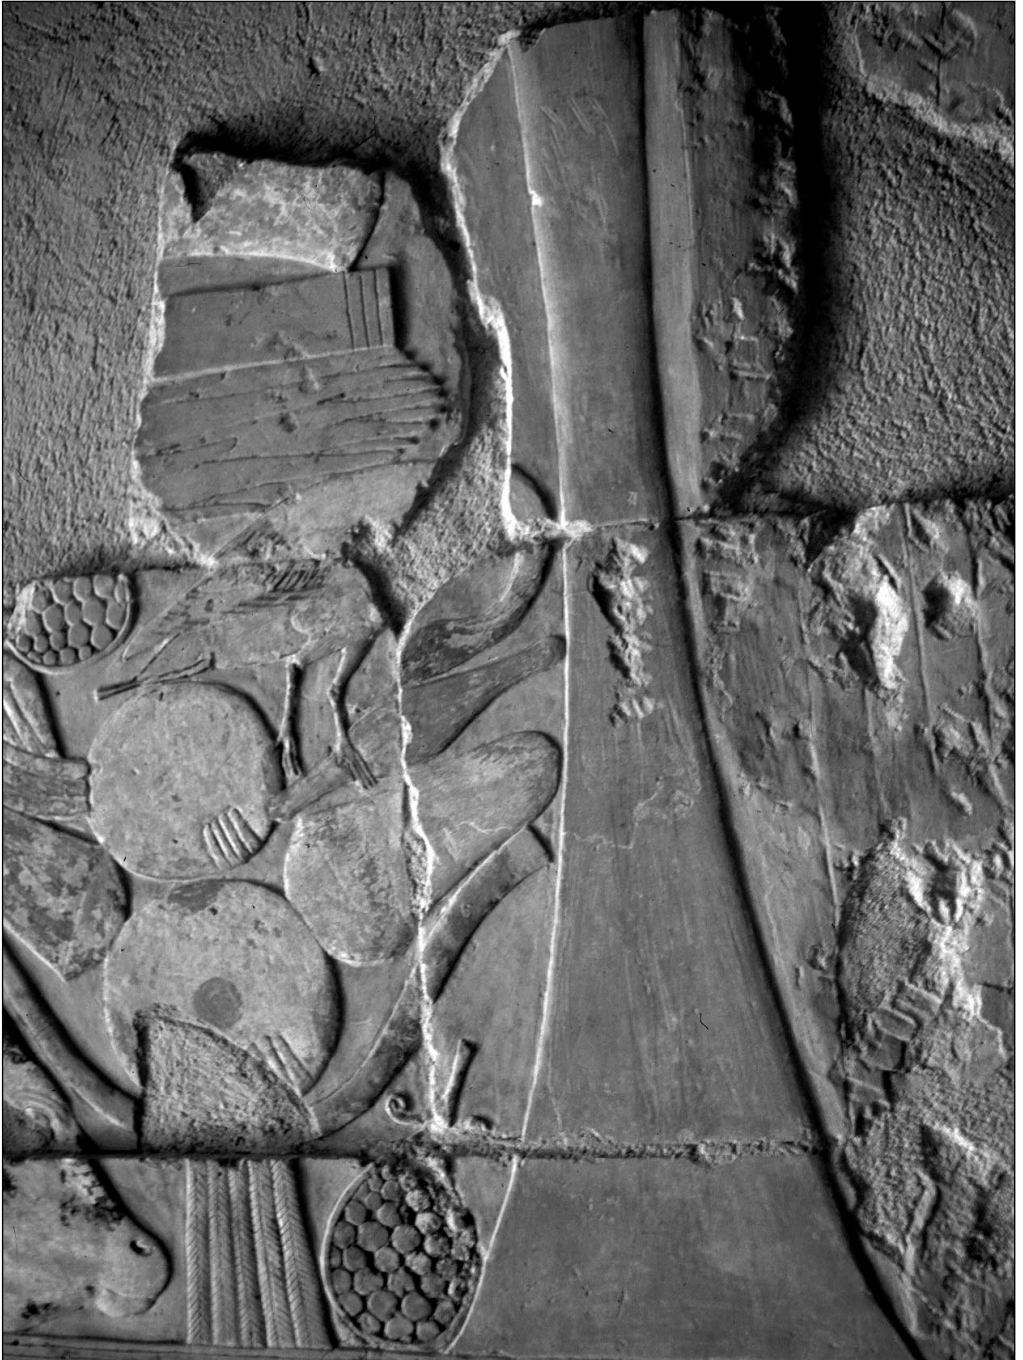
Fig. 7. Temple of Hatshepsut. Bark Hall, South Wall. One of the dedication inscriptions in a tall ring-stand, revealed during cleaning work on the walls (Photo M. Jawornicki)

In the Bark Hall, where a thick layer of dirt and soot had been removed from the wall surfaces in the previous seasons,²¹⁾ the *kbeker*-frieze at the top of the wall decoration and the eastern wall, under the vault of the ceiling, were cleaned. Important new hieroglyphic inscriptions (*Fig. 7*) and details of the painted decoration were revealed under the dirt. The entrance to the Ptolemaic Sanctuary, a unique example of this feature in Ptolemaic architecture) was given the final touches,

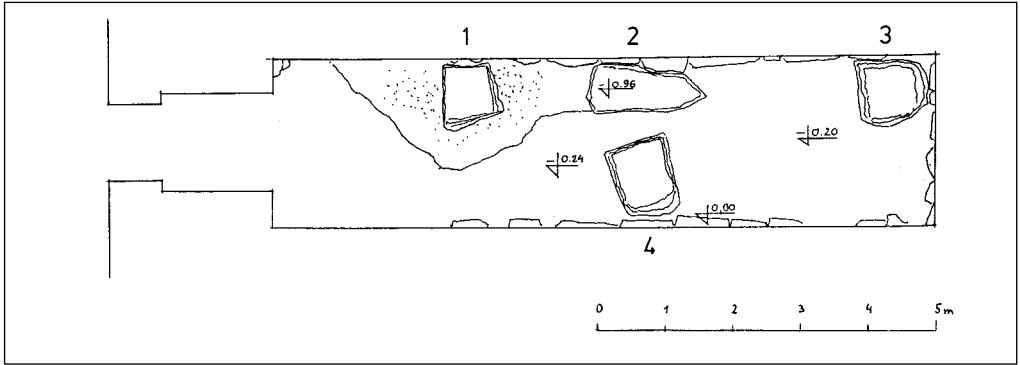
Fig. 8. Temple of Hatshepsut. Plan of the Third Intermediate Period tombs (shaft openings) hewn under the Northern Chapel of Amun (Drawing A. Kwaśnica)

Four shafts were found hewn in the bedrock under the pavement in the Northern Chapel of Amun (*Fig. 8*). One of these (Shaft 2) was never finished in antiquity. Three others appear to be tombs of a later period. The tombs consisted of shafts more than 3 m deep and undecorated burial chambers located to the west (*Fig. 9*). They contained remains of burials disturbed in the 19th century.

To consolidate the tomb structures after exploration, a stone wall was built in Tomb

1, directly under the foundation of the west chapel wall, and another one between the burial chambers of Tombs 1 and 4. These two tombs were filled again, while Tomb 3 was left open. In the future, the mouth of the burial shaft will be closed with a special glass plate and electric lighting will be installed inside the burial chamber.

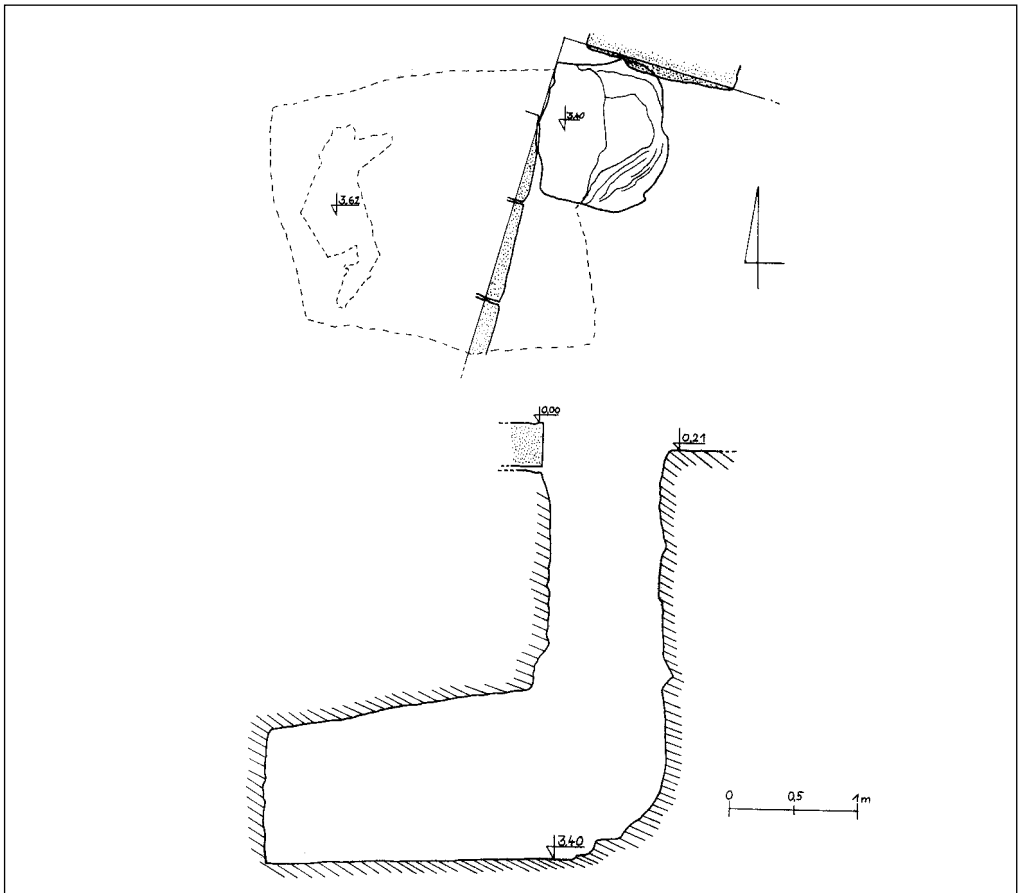
Fig. 9. Temple of Hatshepsut. Tomb of the Third Intermediate Period (shaft and burial chamber) under the Northern Chapel of Amun (Drawing M. Budzanowski)

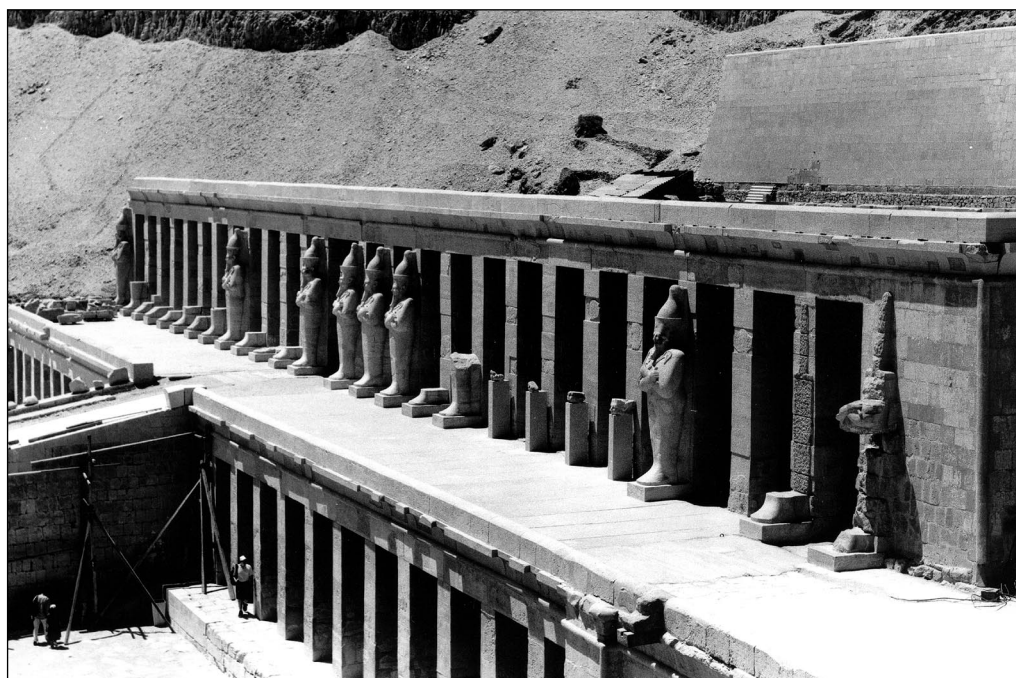
Fig. 12. Temple of Hatshepsut. Upper Portico. Facade with restored monumental figures of the Queen (Photo W. Jerke)

In previous seasons five gigantic stone statues of Hatshepsut were mounted on the pillars of the facade of the Upper Portico (Fig. 12).²⁹⁾ All of them depicted the temple founder in standing position in the form of Osiris. Many original fragments from the surviving statuary elements had been selected and remounted in the torso, shoulders and arms of these statues.

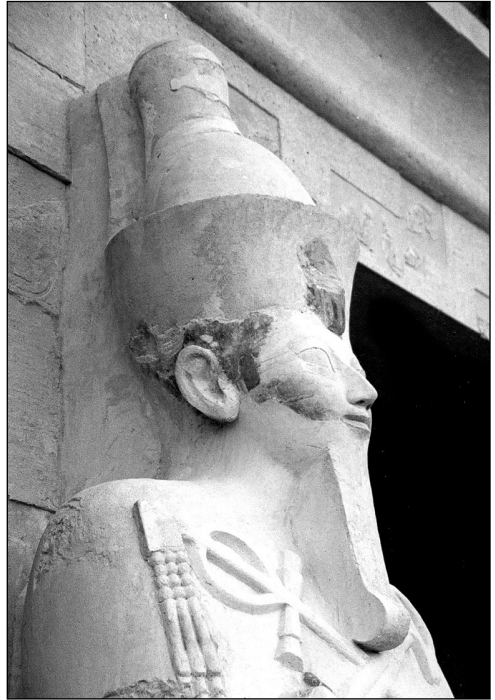
Fig. 13. Temple of Hatshepsut. Upper Portico. Head of Figure XII with the restored ureus-element (Photo W. Myjak)

Now an important statue fragment was found in the filling of the tombs in the Northern Chapel of Amun. An ureus (field no. 1/NA/S1/S'00) was introduced into Statue XII (Fig. 13).³⁰⁾ The flanking statue of the Queen (XIII) on the opposite, northern side of the facade entrance was completed up to its full height. Several corrections were introduced into all of the already restored statues, seven in number.

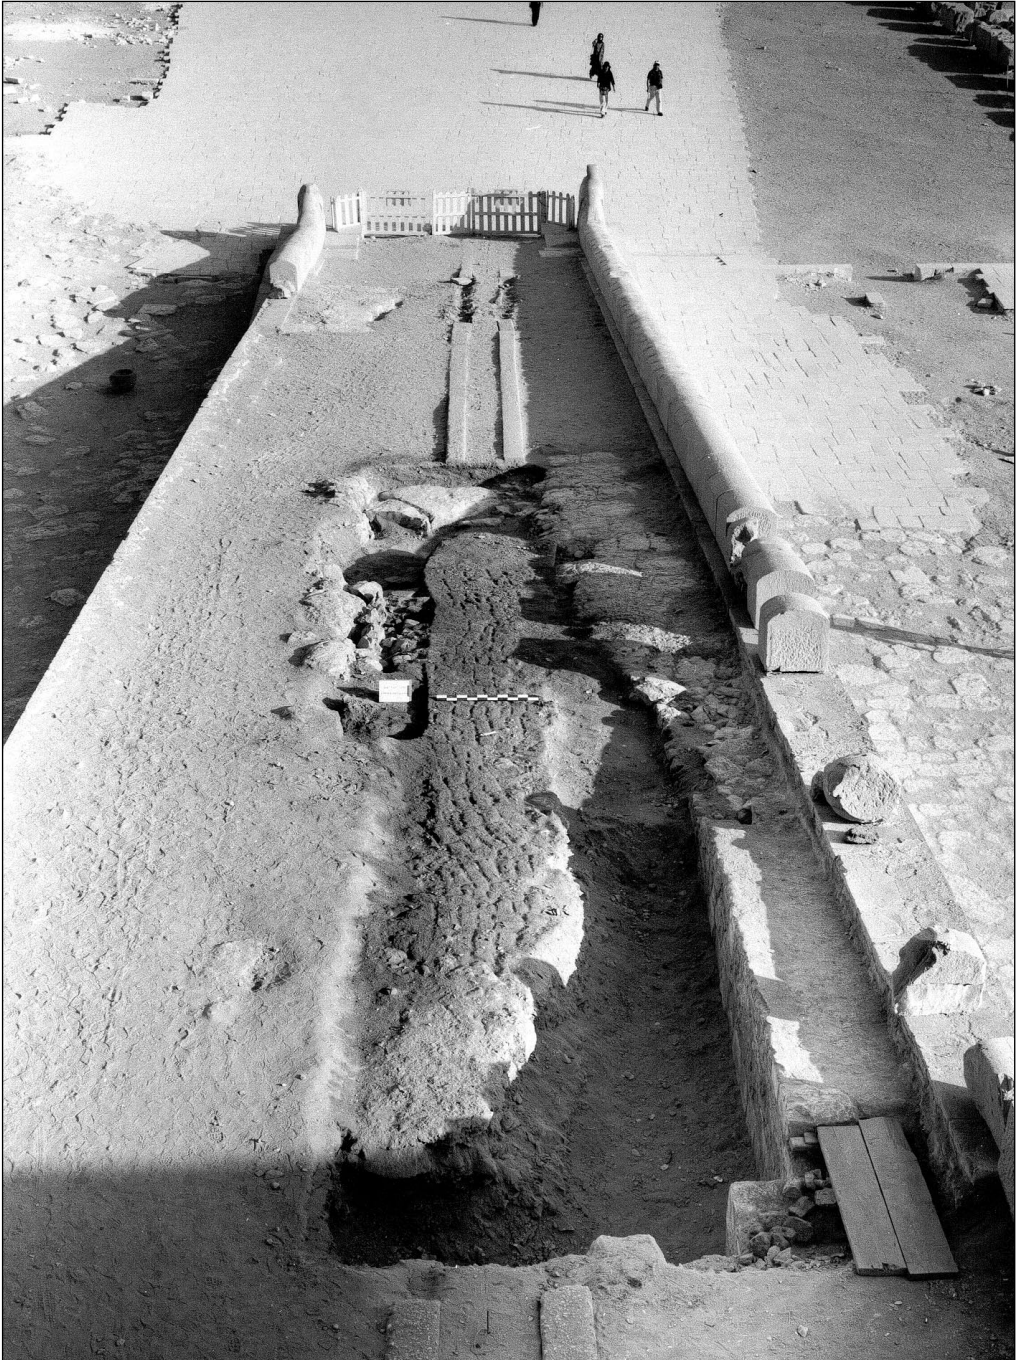
Fig. 14. Temple of Hatshepsut. Excavations on the Upper Ramp
(Photo W. Jerke)

Naville's excavations at the beginning of the 20th century failed to explain sufficiently the ramp architecture. The present investigations³¹⁾ on the Upper Ramp (Fig. 14) provided data for preparing a rec-

onstruction project. The documentation of the first and second levels of the preserved stone masonry, as well as the archaeological material have contributed to an understanding of ramp structure and its

stages of destruction. The ramp was apparently paved and had courses of stone laid across it at intervals, forming steps of

a kind right in the middle of the limestone pavement. The steps were 3 royal cubits wide, 2 palms high and 2 cubits deep.³²⁾

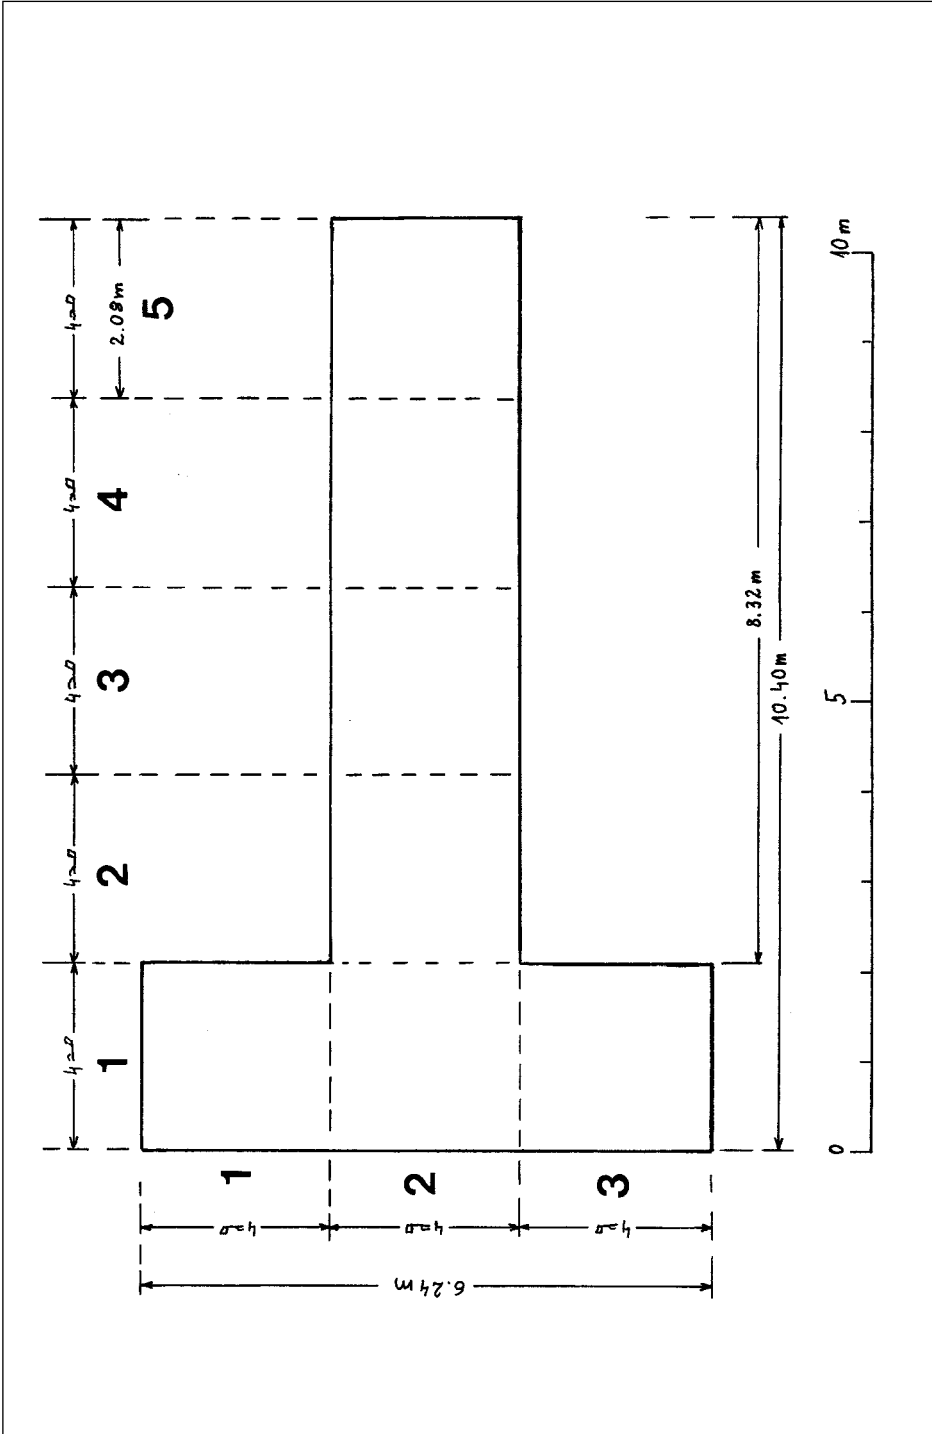
Fig. 15. Temple of Hatshepsut. Plan of the restored T-shaped pond on the Lower Terrace, after M. Boruta (in 1999)
(Drawing Z.E. Szafranski)

Two T-shaped ponds, located at the foot of the Lower Ramp, were re-excavated by the SCA Gurna Inspectorate. On request from the SCA, a restoration of the pond outlines has been prepared, based on measurement studies of the extant mud remains and of pond representations in the Bark Hall of the Main Sanctuary of Amun. Each pond was 10.4 m (20 cubits) long and 6.25 m (12 cubits) wide. Each consisted of 7 cubit-modules (one module: 4 x 4 cubits), the module proportions being 3:5 (*Fig. 15*).³⁶⁾
