Deir El-Bahari: Conservation Work at the Temple of Hatshepsut, 1999

Polish Archaeology in the Mediterranean 12, 206-214

CONSERVATION WORK AT THE TEMPLE OF HATSHEPSUT, 1999/2000

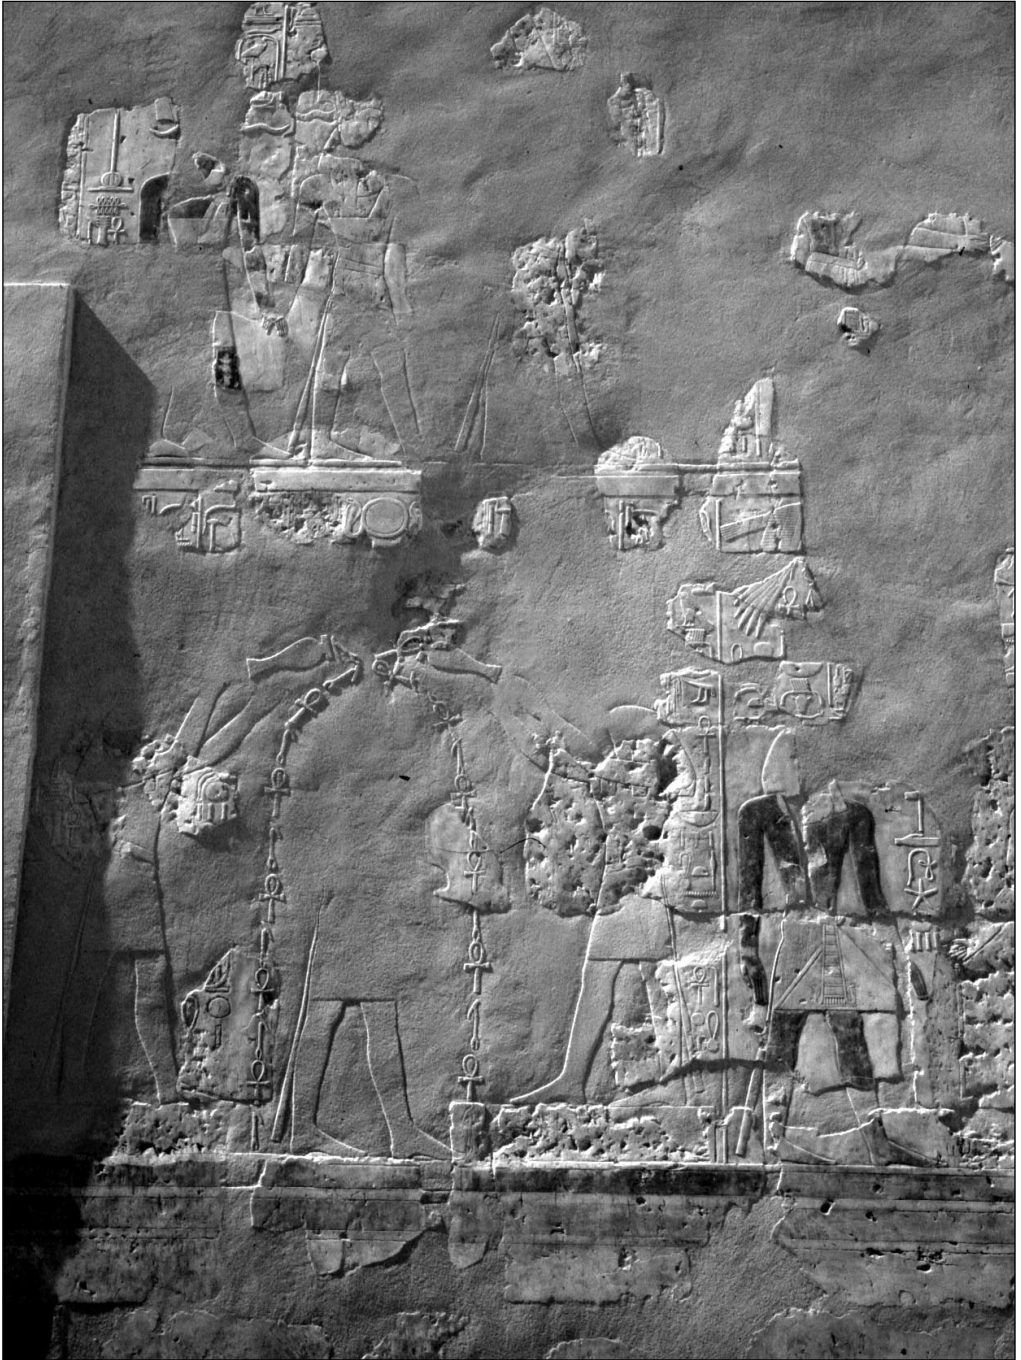
Fig. 1. Temple of Hatshepsut, Upper Courtyard. South Wall, restored figural representations (Photo R. Gazda)

Reconstruction of the figural representations above the niches K, M, O, as well as of the figure of Thutmose III (standing in front of Amun) was carried out in mineral plaster in relief technique, as was also the partial reconstruction of representations of Thutmose II and Thutmose III in cult scenes, symbolic representations of the Nile and the scene of the purification of the king by Seth and Horus, located above the scene of the kings being joined by Amun (*Fig. 1*). The missing outlines of four barks in scenes on the southern part of the east wall were carved in plaster, thus clarifying this register of the decoration (*Fig. 2*).

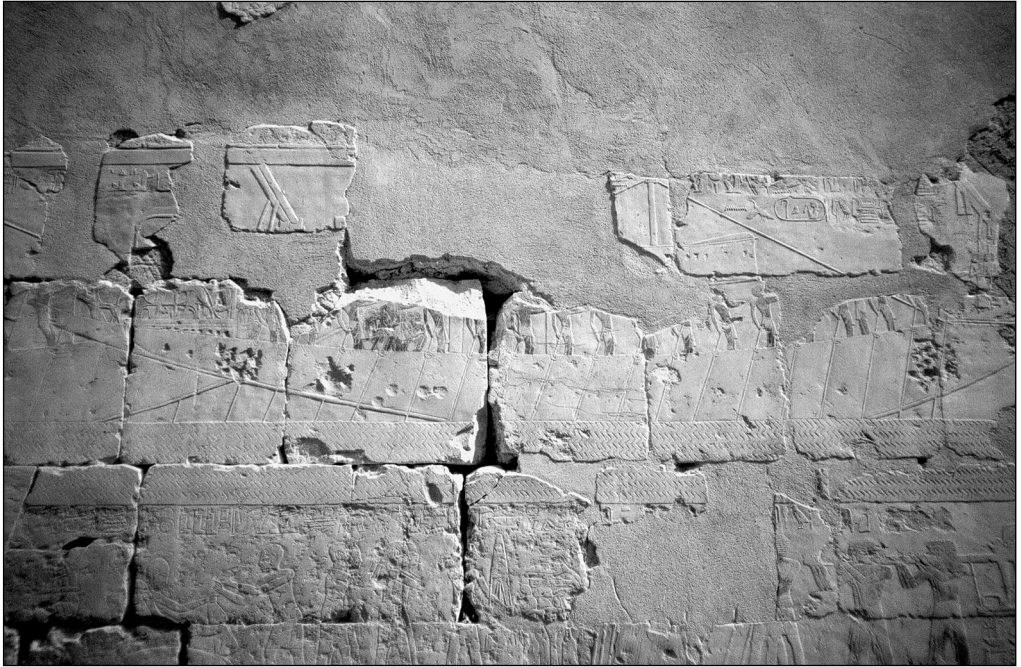
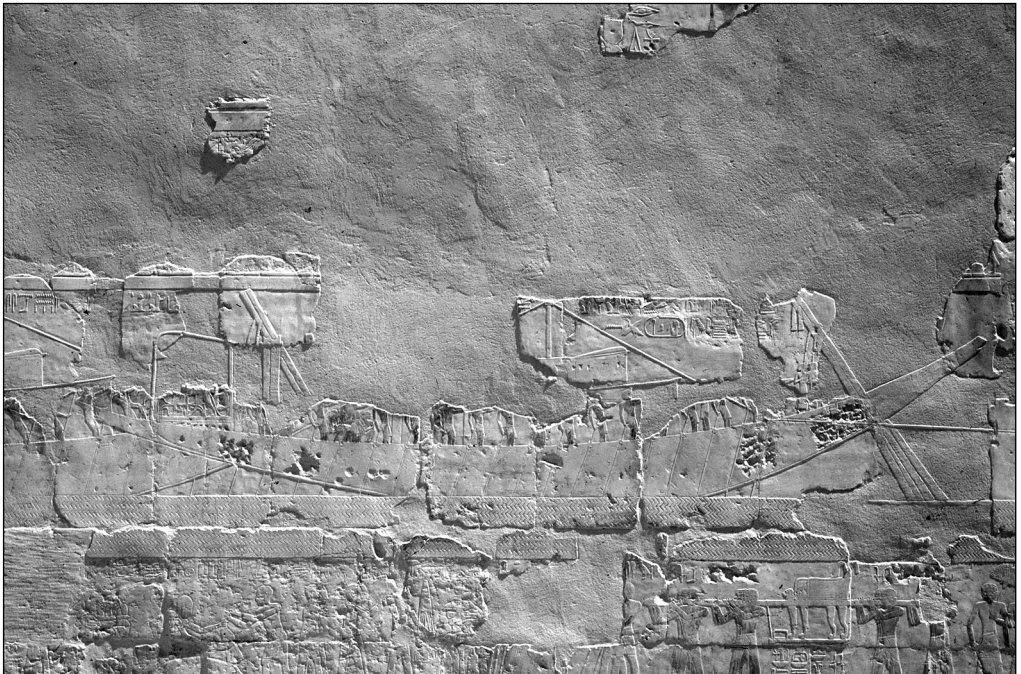
Fig. 2. Temple of Hatshepsut, Upper Courtyard. East Wall, representation of a bark, before (above) and after (below) restoration (Photo R. Gazda)

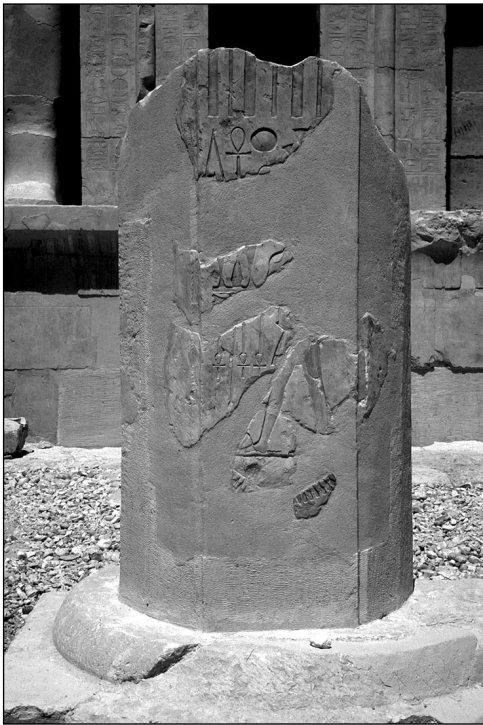
Fig. 3. Temple of Hatshepsut, Upper Courtyard. Restored column no. i 7 (Photo R. Gazda)

The process of column anastylosis followed one of two methods, depending on the quantity and form of the surviving original fragments. The first was the stonemason's method using new blocks and inserting the original elements into appropriate niches cut into the new stone (columns restored in the 1980s: C 12, I 12, I 14, i 8, i 6). The second method and one that permitted a more neutral working of the background around original parts, required a structural core to be prepared out of mineral putty (reinforced with stainless steel) and covered with aesthetically treated plaster. The tops of the columns were modeled in imitation of natural mechanical destruction processes occurring in the past, e.g. i 9, i 7, i 5, i 3 (Fig. 3).

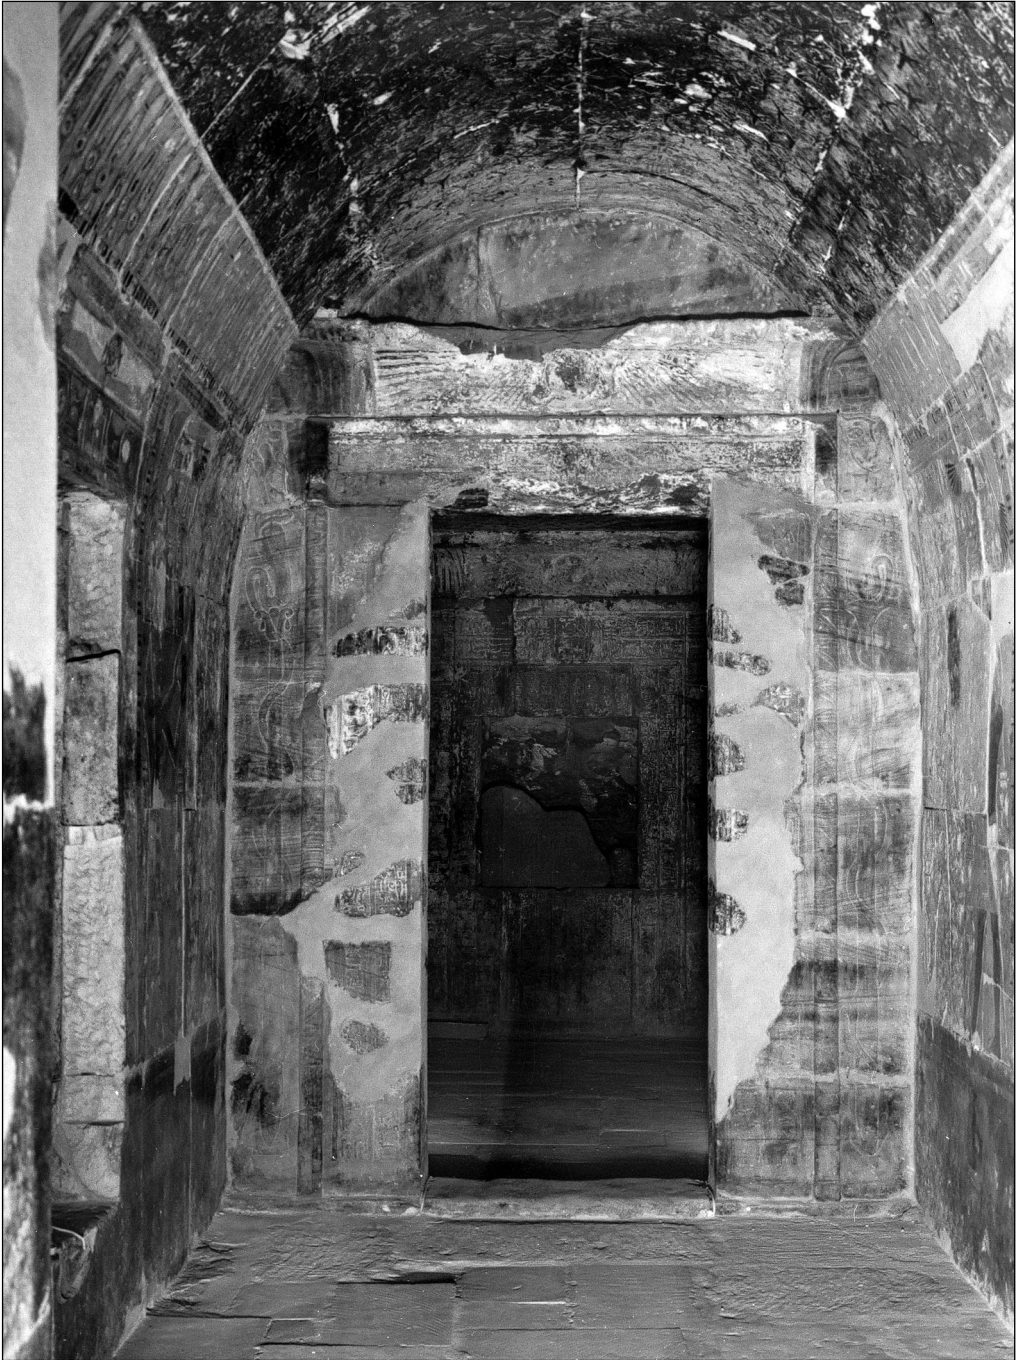
Fig. 4. Temple of Hatshepsut, Ptolemaic Sanctuary. Restored facade with traces of gilded inscription on the jambs (Photo W. Jerke)

The final element of the restoration project in this part of the temple was the facade of the sanctuary, which now shines with all the splendor of its gilded decoration. Some of the original sandstone pieces were now reinserted into the jambs (*Fig. 4*). Small pieces of the gilding can be seen also on the west wall of the sanctuary.
