## Hawarte: Third Interim Report on the Work in the Mithraeum

Polish Archaeology in the Mediterranean 12, 309-314

## THIRD INTERIM REPORT ON THE WORK IN THE MITHRAEUM

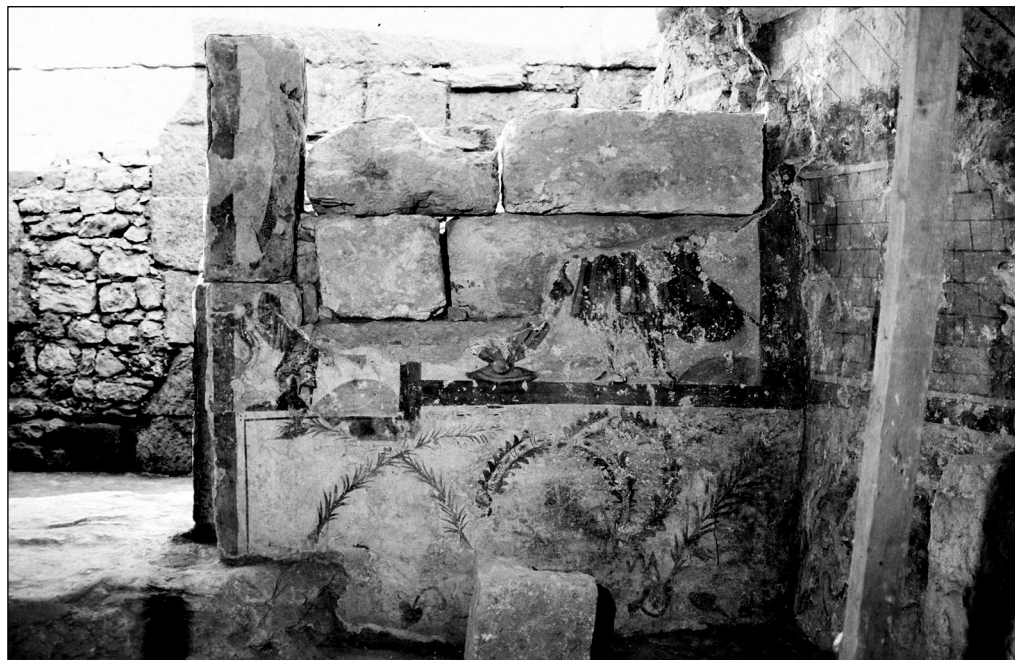
*Fig. 1. The passage from the main room to the vestibule with the partly restored northern jamb (Photo T. Szmagier)*

the narthex and the nave. As the latter was dismantled in 1999, recovering some stones belonging to the original structure, it now became possible to restore the dividing wall of the mithraeum nearly completely; in particular, two doorjambs were erected to their full height. One of them still bears some painted plaster.

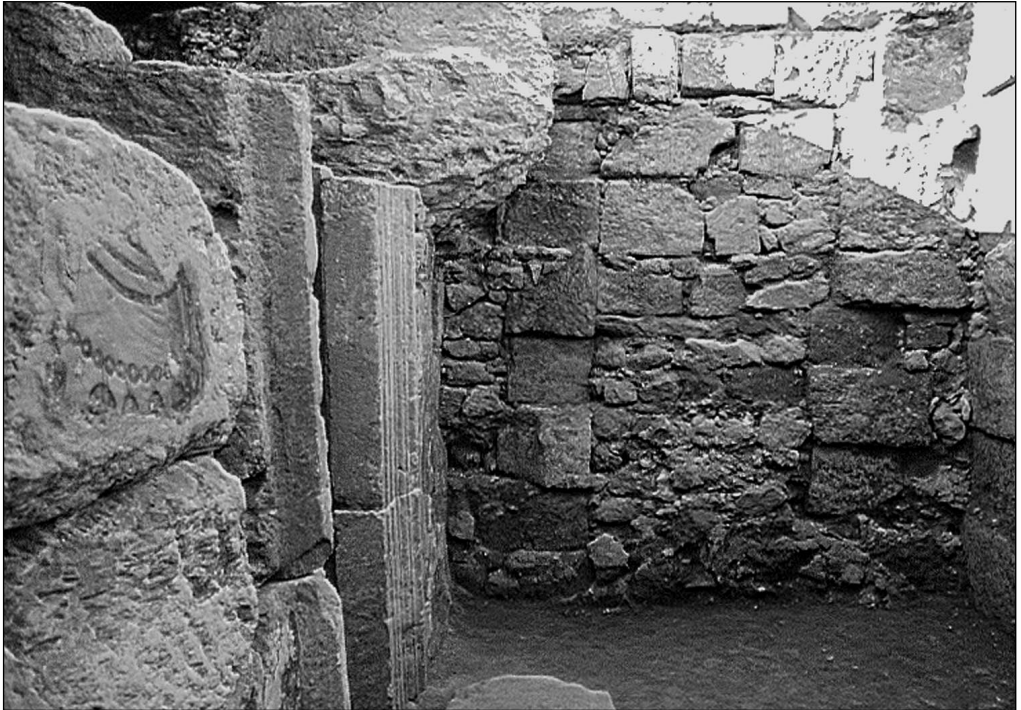
*Fig. 2. The excavated part of Room B with the restored jambs and the later foundation to the south (Photo T. Szmagier)*

Under the mosaic level a trench was excavated on both sides of a foundation dug into the mosaic by the builders of the second church. This done, we found ourselves between the exposed foundations of the church on the west and south (*Fig. 2*), some 4 m below the level of the earlier mosaic, and the original east and north walls of the mithraeum vestibule (Room B). The fill

consisted for the most part of broken tiles, most likely from the roof of the room, and loose stones, all thrown in to support the narthex mosaic dated to about 400 AD.

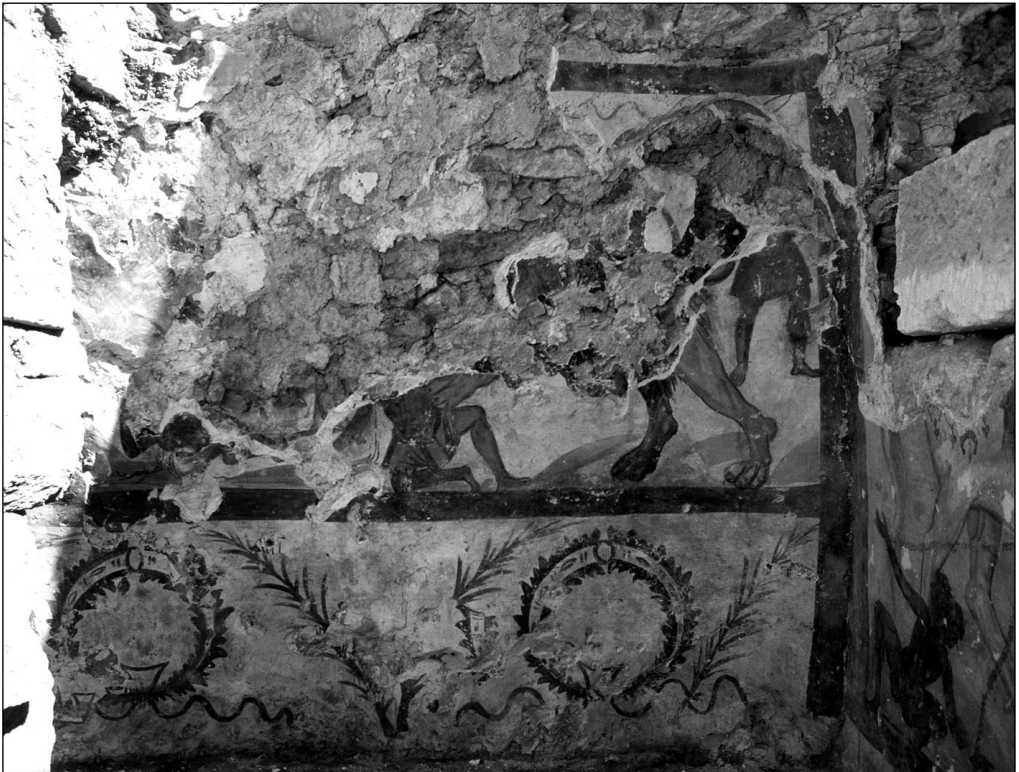
*Fig. 3. The north wall of Room B with remains of the lion painting (Photo T. Szmagier)*

The north wall, which is bedrock with small stones and tiles filling the cavities (seen already in 1999) was exposed again and consolidated. The painting is badly damaged due to the poor quality of the support, but the subject is clear: two facing lions tear apart little black men, presumably representing some evil forces (*Fig. 3*). It was estimated that the original west wall of this room runs not further than 50 cm behind the foundation of the church facade.

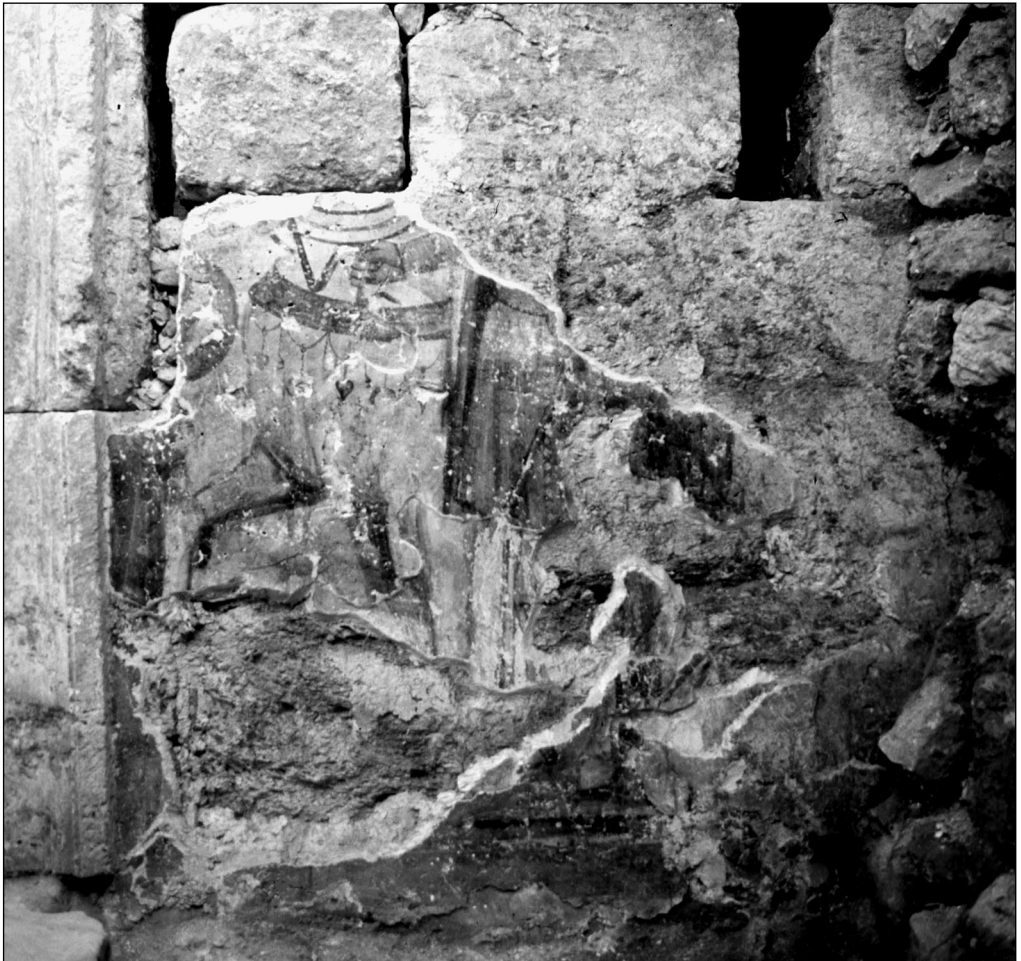
*Fig. 4. The horseman to the right of the entrance to the main room  
(Photo T. Szmagier)*

Right and left of the doorway leading from vestibule B into the main room A, there are some very unusual paintings. The one on the left was cleared already during the last season. It represents a dismounted horseman holding on a chain a monstrous creature: a naked black man with two heads. We had initially assumed this to be Mithra himself, but now another horseman, practically a mirror projection, has appeared on the other side of the door (*Fig. 4*). The part of the wall where his prisoner would have been depicted is not preserved, but every other detail is mirrored from one side to the other. There were two layers of painting representing consecutively the same subject. The two horsemen were apparently conceived as guardians of the entrance to the main room of the mithraeum, warding off the forces of evil.
