CAIRO

FUNERARY COMPLEX OF AMIR KEBIR QURQUMAS

Restoration Project Progress Report, 2000

Jerzy J. Kania

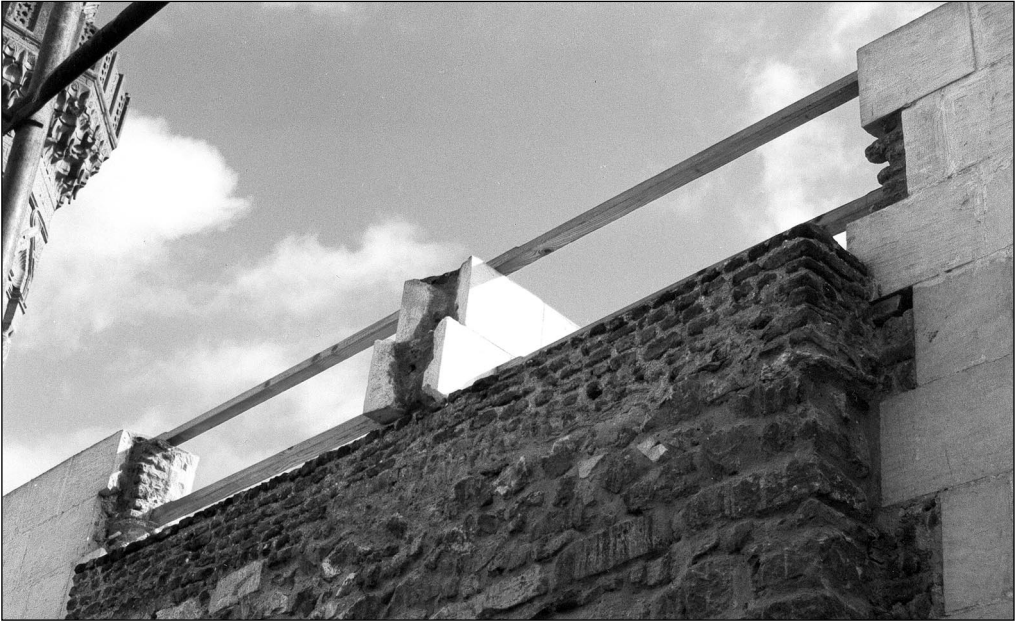
Fig. 1. Khanqab. Upper part of the northwestern elevation crowned with a safety balustrade between newly reconstructed Mamluk-like sections (Photo J.J. Kania)

wooden balustrades and safety grasps, installed along the top of the outer walls of the entrance facade (northwestern). In view of the fact that parts of the reconstructed wall, having received the form of Mamluk times, were now raised in certain sections of the facade, the level of the balustrades was also varied accordingly. Between the “Mamluk” stretches, a double-level balustrade, 1.10 m high for adults and 0.60 m for children, was installed (*Fig. 1*). A similar principle was followed along the

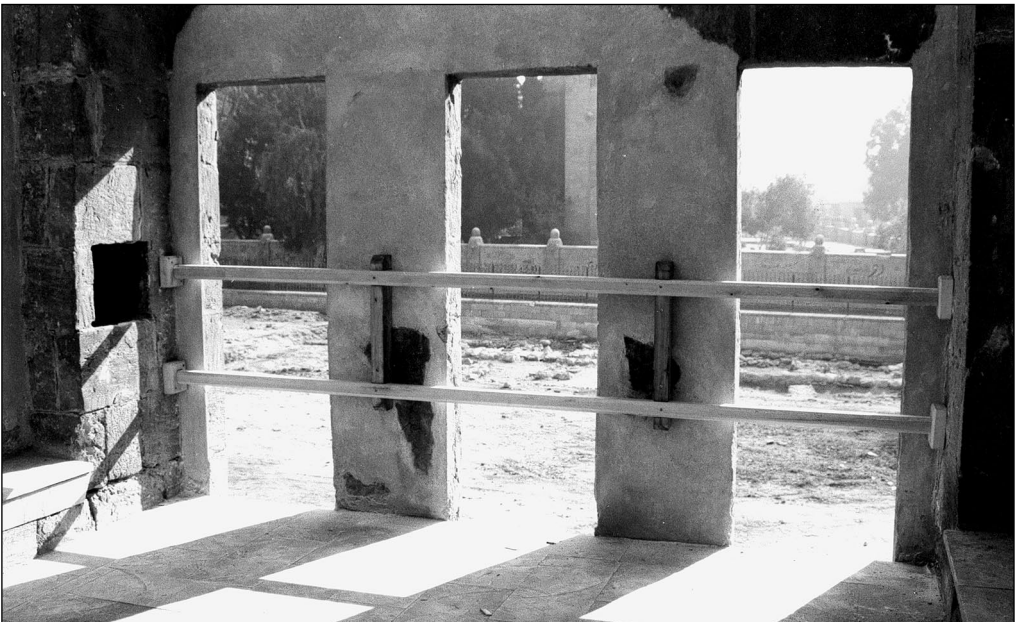
Fig. 2. Khanqab. Upper floor of the southeastern outer wall. Safety balustrade viewed from the interior (Photo J.J. Kania)

front elevation with the dominant window openings on the upper floor. The vertical wooden elements permitting the horizontal balustrades to be installed were concealed on the inside of the structure and attached to the pillars between the walls (*Fig. 2*). The predominant horizontal articulation of the modern safety elements is intended to achieve their visually neutral character. Tourist traffic flow will be channeled through four (of eight) staircases, which have been reconstructed with historical accuracy and only these have been equipped with vertical ladder-like safety grasps in the inner spaces between particular flights. The ground floor part of the building, which served both now and in the past as the entrance to the particular residential units,

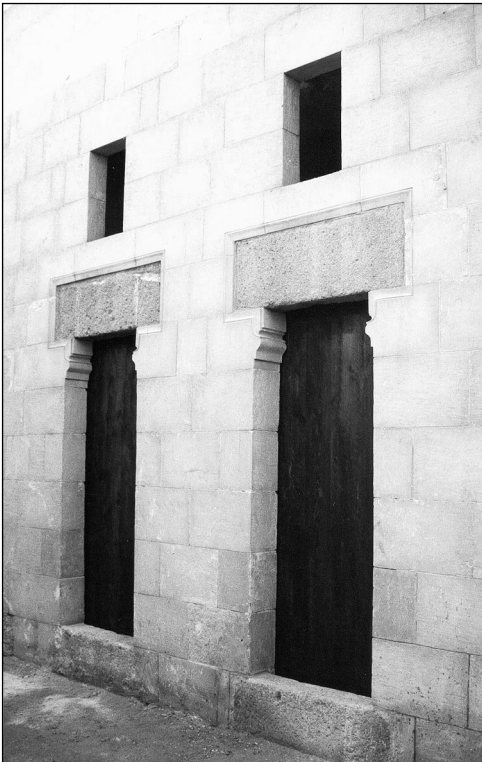
Fig. 3. Khanqah. Lower part of the restored northwestern elevation. Two entrances leading to the separate residential units. State after mounting the wooden shutters (Photo J.J. Kania)

was fitted out as much as possible with reconstructed door carpentry. Two outer entrances were fitted with wooden doors mounted in appropriately shaped frames in the reconstructed parts of the elevation (*Fig. 3*). Barred window openings also reappeared in this fragment of the facade, the windows provide light for the vestibule from which there is access to a staircase and a vaulted storeroom. Following the Egyptian sides' suggestions to adapt these rooms for non-troublesome forms of usage, single-wing wooden doors have been installed in all the storerooms. The doors are fitted with wooden bolts reconstructed on the basis of parallels (*Fig. 4*). The six external openings without frames will be protected with one-piece openwork grids of steel.

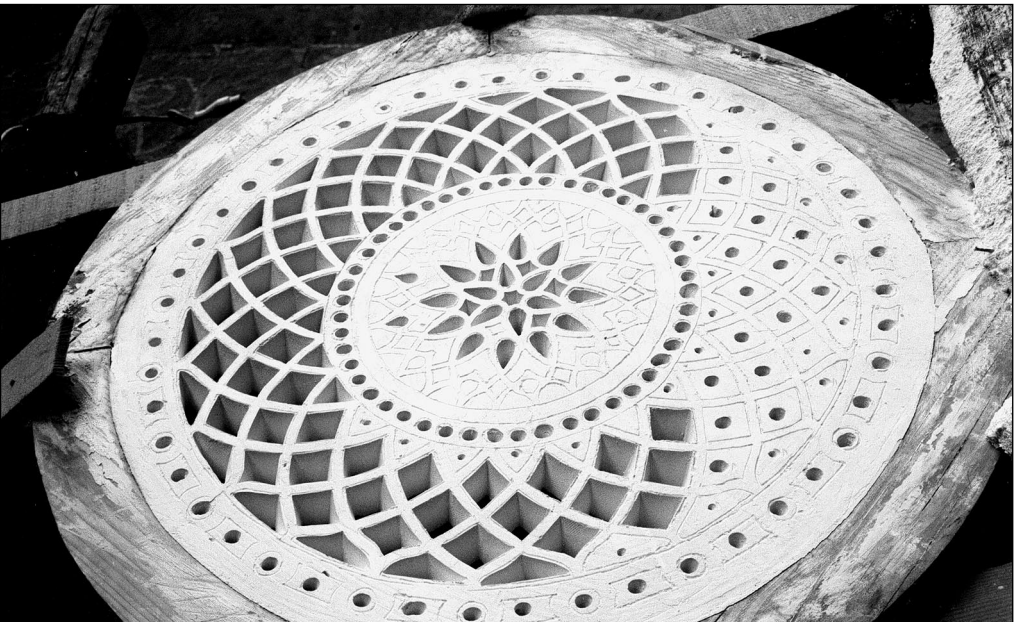
Fig. 6. Qubba. Qammariyyat workshop. Detailed view of a round qammariyya being prepared for the oculus in the mausoleum dome (Photo J.J. Kania)

frames had been taken down, a study of the *qammariyyat* composition was carried out, identifying precisely the colors and ornament, as well as important technical guidelines for the designing work. The conceptual and technical designs, approved by the Egyptian side, were executed in the spring (*Fig. 6*). By end December all the openwork stuccowork for the openings situated above the ceiling-roofs of the neighboring *madrasa* and the adjacent side roofs of the funerary courts had been completed. The *qammariyyat* will be installed once the glass elements have been restored.

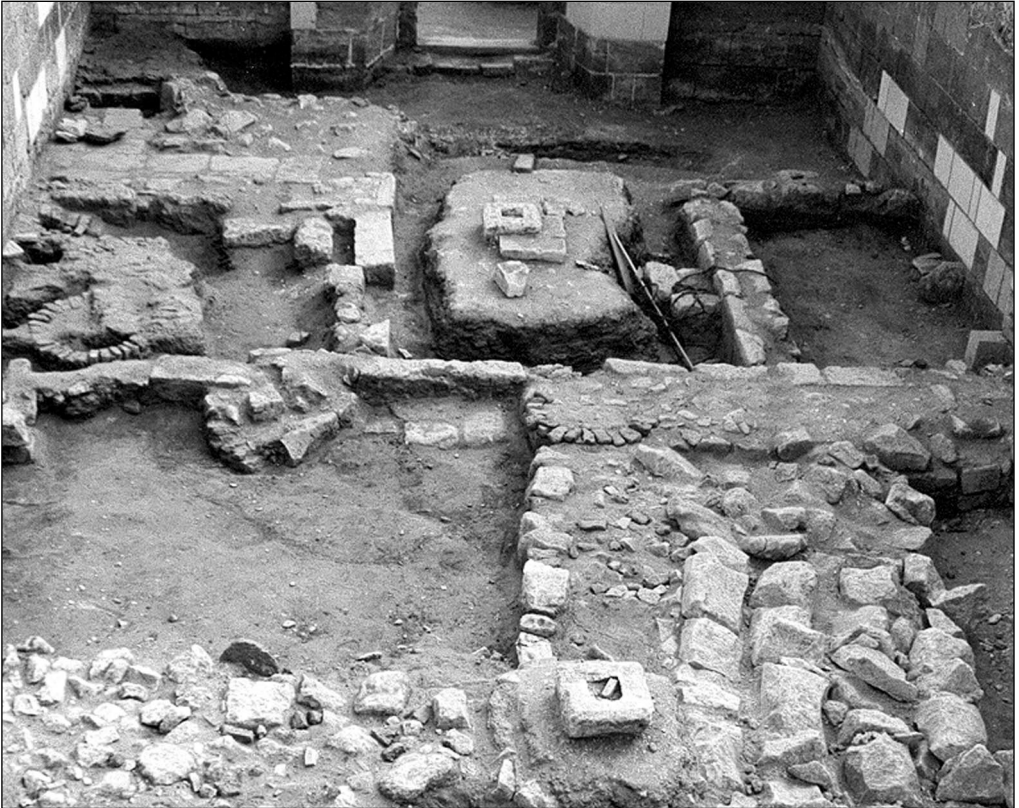
diversity of this structure over the ages (Fig. 7). The internal division into habitation units, domestic and industrial, the latter in the form of brick furnaces of unidentified function, has been delineated. The explorations brought to light chiefly kitchen pottery and skeletal material originating from domesticated animals.

Fig. 7. *Tahuna*. Eastern building. General view of the architectural discoveries made during excavations in 2000 (Photo J.J. Kania)

The outcome of archaeological research did not modify in any way the architectural-conservation conception adopted for the *tahuna*. Relics of the discovered interior walls were fully recorded and then they were protected with a layer of sifted sand, which was at the same time the bedding for stone flagging of the

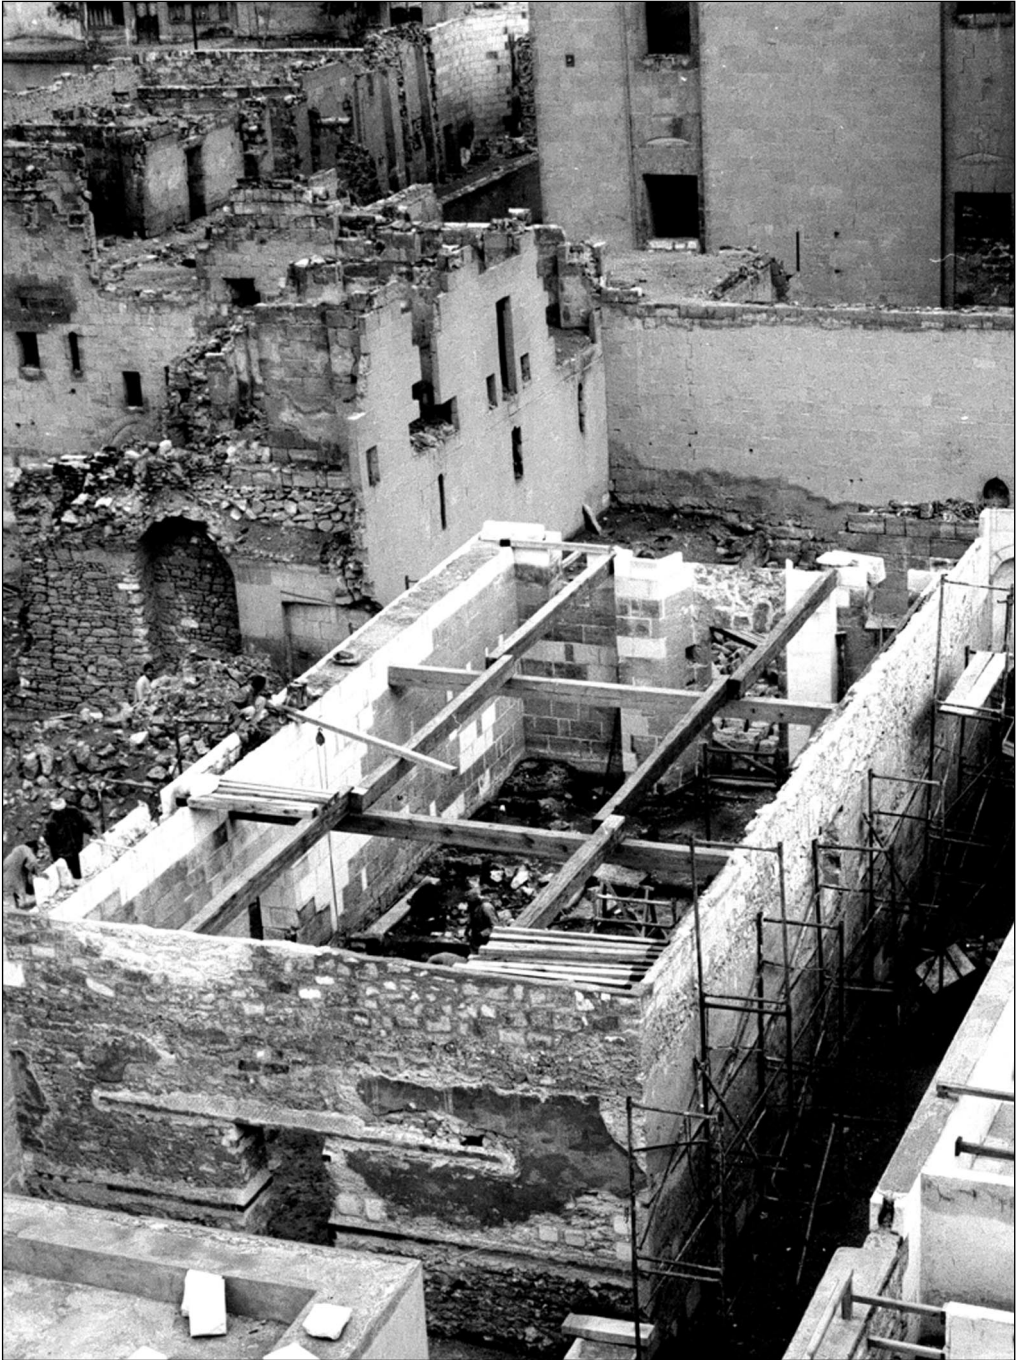
Fig. 8. Tabuna. Eastern building. The main structural timbers. State during roofing works (Photo J.J. Kania)

Ottoman period, which is to be reconstructed in the future. The outer walls of the structure, especially the tops, were reinforced to support the thrust of the wooden ceiling, which was reconstructed based on research and parallels (Fig. 8). Detailed attention was devoted to the zone bordering the court of Guirbash Qashuq, the so-called *hawš*, where in the north-western corner of the *tahuna* a reconstruction of the window opening of the old *sabil* was executed. This part of the *tahuna* is being reconstructed to serve as a stuccowork workshop producing reconstructed *qammariyyat* for mausoleums and madrasas of the Northern Cairo Necropolis.

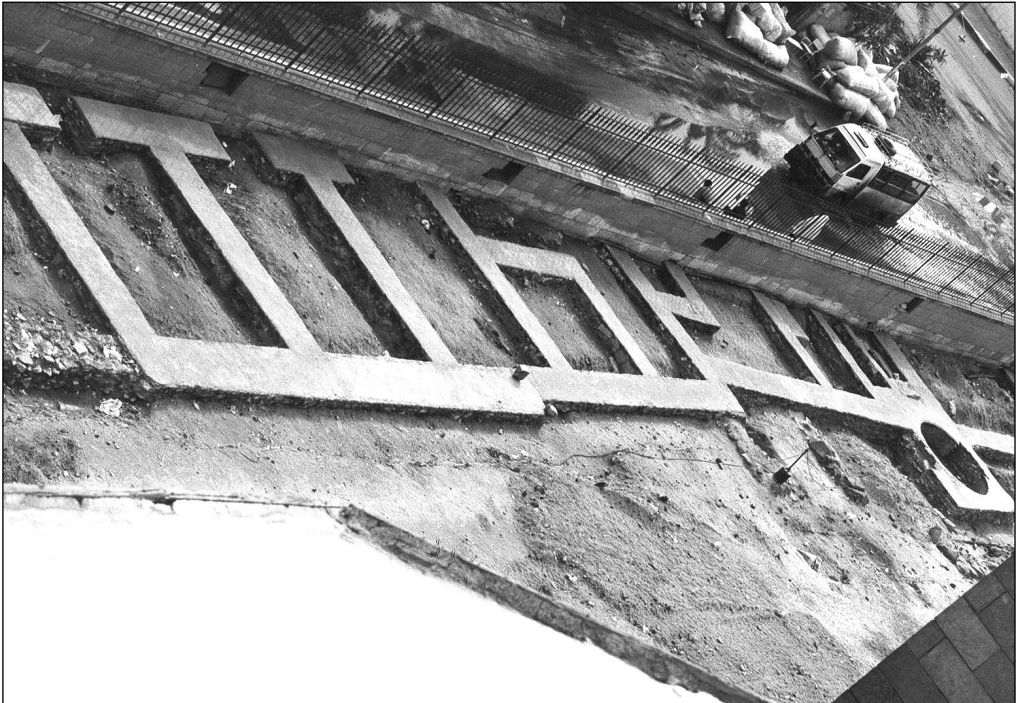
The foundations of residential units and industrial installations discovered in 1993 were now protected. Fortunately, part of the foundations were included within the limits of the conservation zone established earlier and hence on the inside of the modern fence surrounding the complexes

Fig. 9. Rab'a. Uncovered foundation courses of habitation units. State during preservation works. View from the roof of the madrasa (Photo J.J. Kania)

of Inal and Qurqumas. The layout of the walls can be traced on the ground; the remnants have been protected from the elements (*Fig. 9*). This architecture is proof of the existence of a road for merchant caravans and a pilgrims' road to Mecca.
