HAWARTE

EXCAVATION AND RESTORATION WORK IN 2001

Michał Gawlikowski

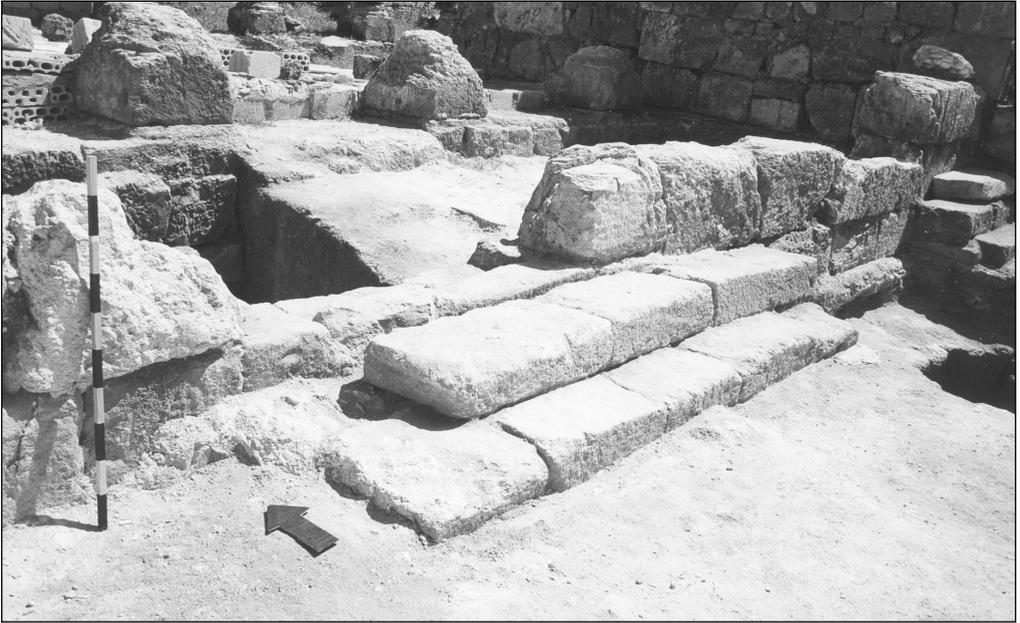
Fig. 1. The south portico and southwestern corner of the church, showing our excavations underneath (Photo M. Gawlikowski)

One of the planned objectives of the season was finding and excavating the original entrance to the mithraeum, to serve if possible as a permanent access to the underground site. We knew already that there was another painted room to the south of the main room, which could not be excavated as long as the modern house remained in place. Accordingly, it was our first task this year to tackle this area, hoping to discover the entrance (*Fig. 1*).

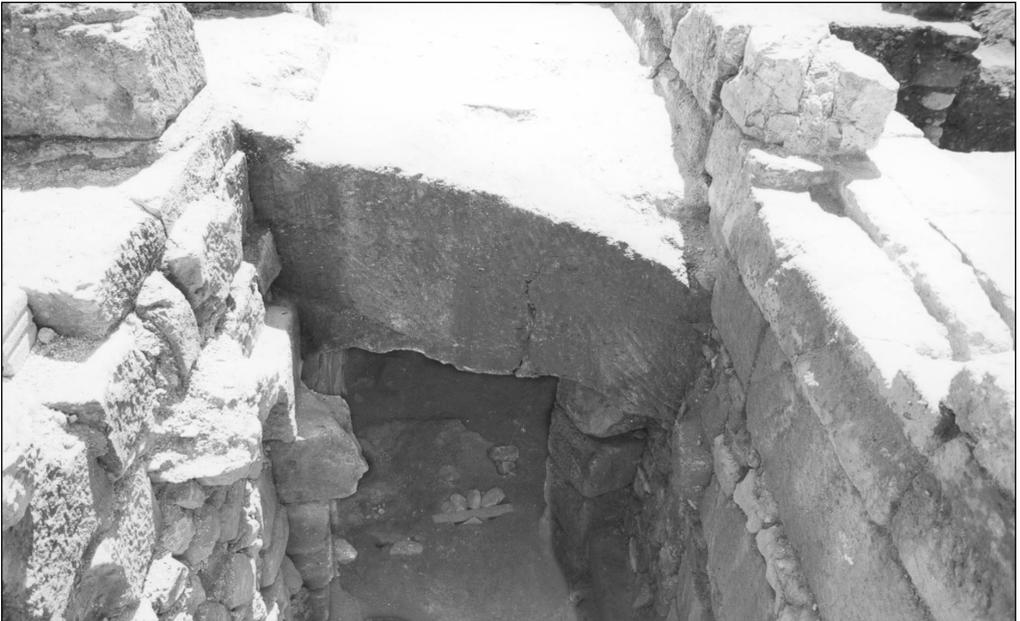
Fig. 2. The excavation under the south aisle of the church with the rock ceiling of the mithraeum where it had been cut away (Photo M. Gawlikowski)

The excavation of this part of the subterranean complex was particularly difficult because of the presence of later walls and foundations. Even after removing the modern structure and lifting a patch of mosaic underneath, we were dealing with an area of barely 2.50 m by 2.70 m, which

had to be excavated to a depth of about 4 m. It is surrounded on three sides by the foundations of the church, laid in two phases (about AD 400 and 483), while on the fourth side there is a vertical rock face with the opening to the part of the grotto that had served as the entrance (*Fig. 2*).

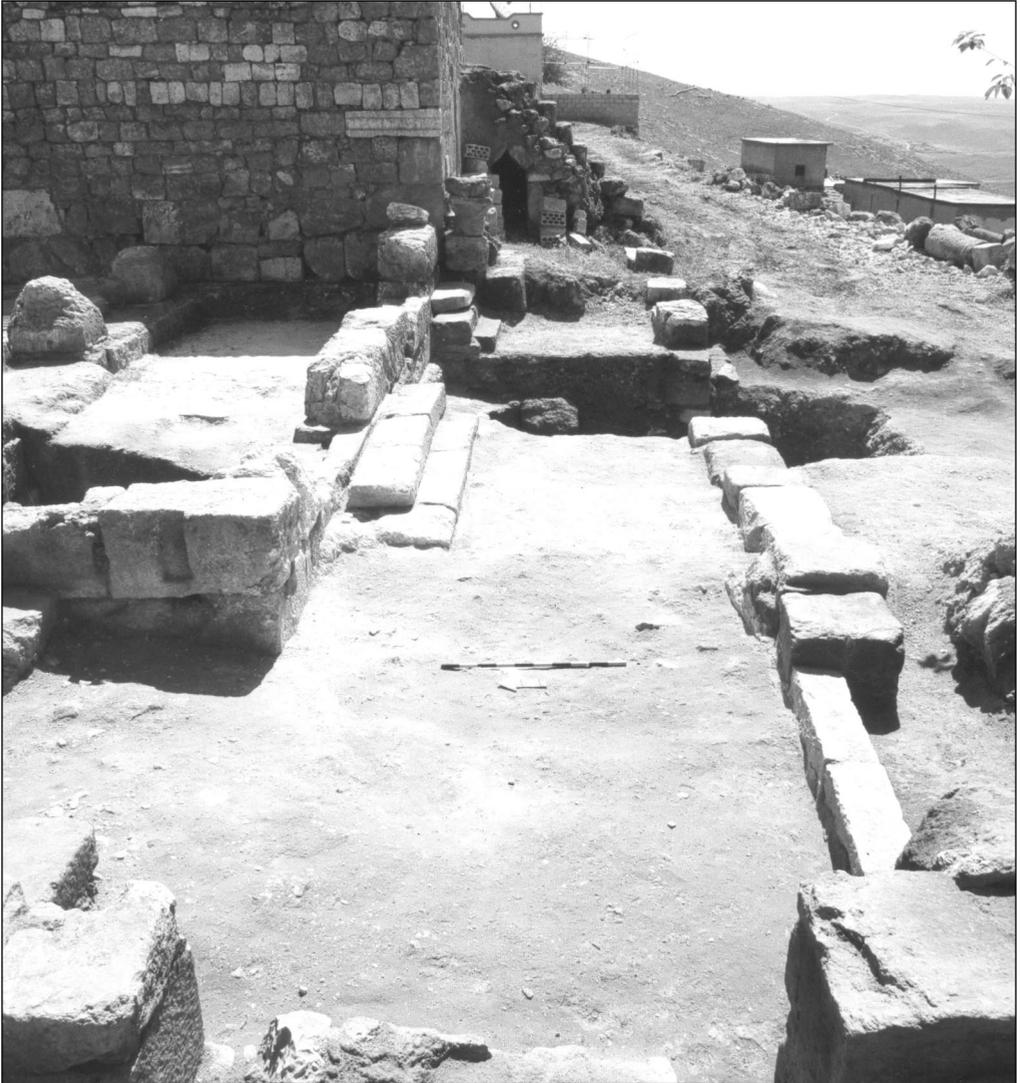
Fig. 3. The south portico as cleared during the present season, "Maison Khalil" in the background (Photo M. Gawlikowski)

church builders. Gradually, it appeared that the room opened southwards to the outside. This entrance was also filled with stones and soil and covered with a mosaic which paved the southern portico alongside the church (*Fig. 3*). The mosaic is plain white, so we did not hesitate to

lift a part of it, which was already repaired in antiquity and further damaged by the subsiding fill.

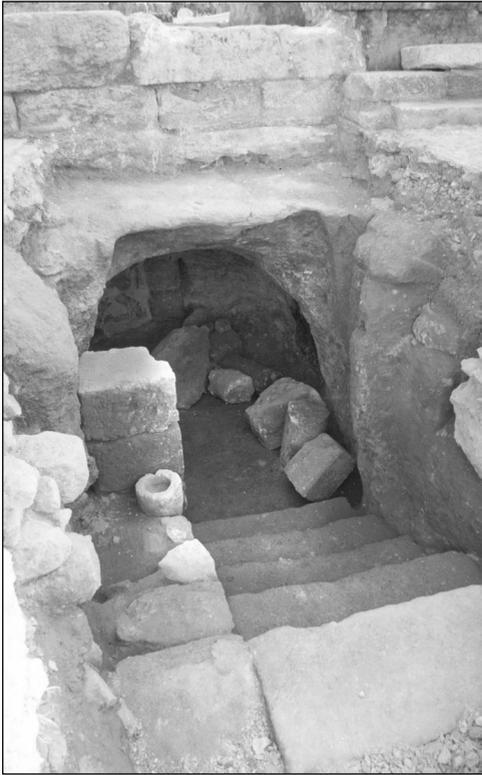
*Fig. 4. Steps and doorway to the mithraeum beneath the church wall
(Photo T. Szmagier)*

Underneath, a flight of five steps was found, 1.50 m wide (*Figs. 4-5*). The stone steps are set in a dromos cut in the rock and lead to a doorway preserving in place two jambs: the one to the right is rock-cut, the other built of stone blocks and secondary. The lintel is not preserved. The door itself was apparently fitted into a wooden frame. Elements of two columns that could have adorned the doorway have been found. Just behind the doorway, to the right, the rock wall is blackened with soot and displays a horizontal row of holes

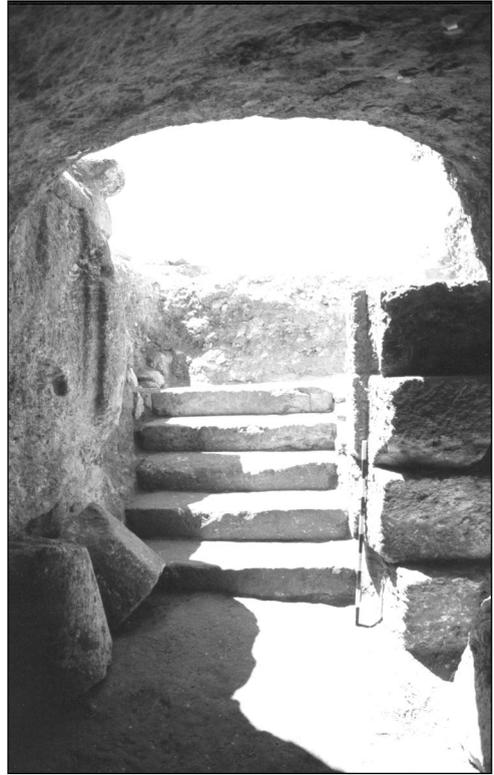
*Fig. 5. The steps seen from inside the mithraeum
(Photo T. Szmagier)*

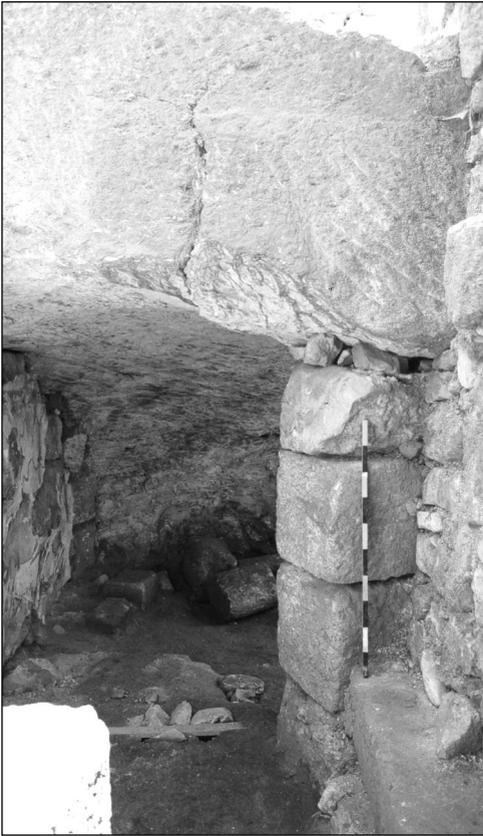
Fig. 6. The entrance room and the sheared-off rock ceiling supported by a pillar to the right (Photo T. Szmagier)

The collected evidence suggests that this part of the grotto suffered massive damage, possibly in an earthquake. There is a crack in the ceiling from side to side, apparently contemporary with the destruction of the left doorjamb. Moreover, the vertical cut of the rock further west means that a part of the cave had become roofless. This is best explained, if we assume that the natural roof had been damaged beyond repair and was replaced with a built cover, supported by the pillar surviving in the corner between the church foundations.

Another pillar still supports the remaining roof, which is cracked (Figs. 6–7). The bench that was formed between this pillar and the repaired doorway was filled with an abundant deposit of kitchen refuse: ashes, bones, and ceramic sherds. The pottery assemblage is particularly rich, consisting mainly of broken cooking pots, plates and drinking vessels. Most of the bones were of chicken, with some mutton and beef present as well. Apparently, an overall cleaning of the place had been ordered after the destruction and the trash swept into a corner. As the pottery is

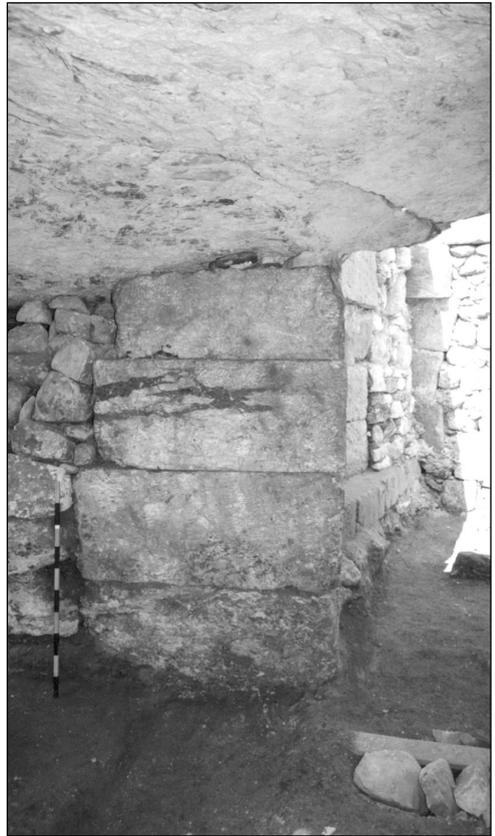
Fig. 7. The supporting pillar seen from inside, the covering of a pit in the foreground (Photo T. Szmagier)

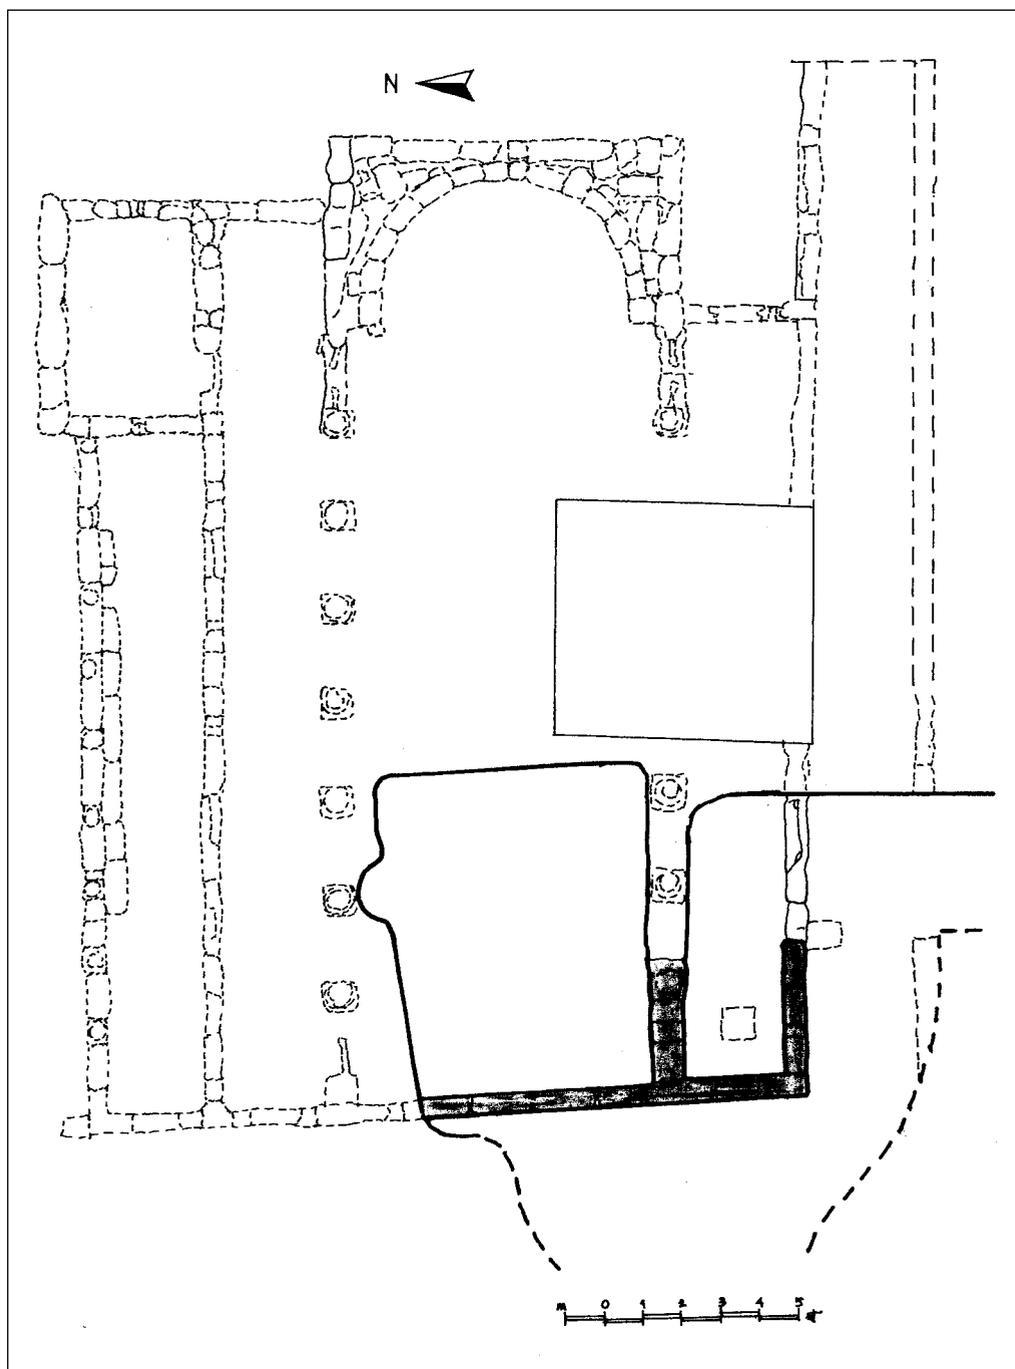
Fig. 8. Outline of the mithraeum under the church of Photios in its early phase
(Drawing W. Terlikowski)

The original western limit of the cave is not known. It is clear, however, that it reached well beyond the line of the church façade (Fig. 8). A test pit in the western portico of the church revealed yet another pillar that had supported the roof built after the rock ceiling had been damaged. In another test pit the top of a painted wall was revealed barely 40 cm from the church foundation, so close that it cannot be investigated any further.

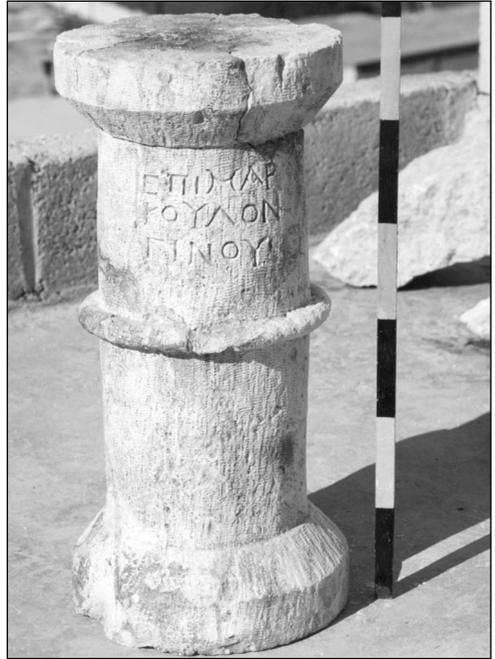
Fig. 9. Altar of Marcus Longinus
(Photo T. Szmagier)

Very few objects associated with the mithraeum were recovered. Of the several votive altars only one is inscribed, apparently in the course of the 2nd century (Fig. 9), bearing the name of one Marcus Longinus, in Greek. The feet of a statuette seem to have belonged to a Leontocephalus figure, well-known from Mithraic iconography (Fig. 10).

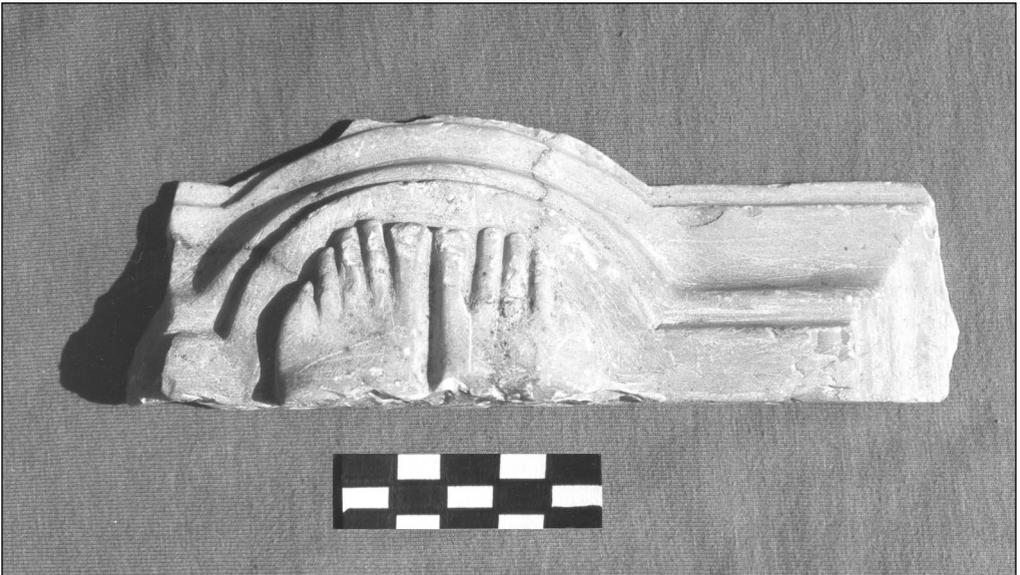
Fig. 10. Feet of a marble statuette
(Photo T. Szmagier)
