OLD DONGOLA

FIELDWORK IN 2002

Stefan Jakobielski

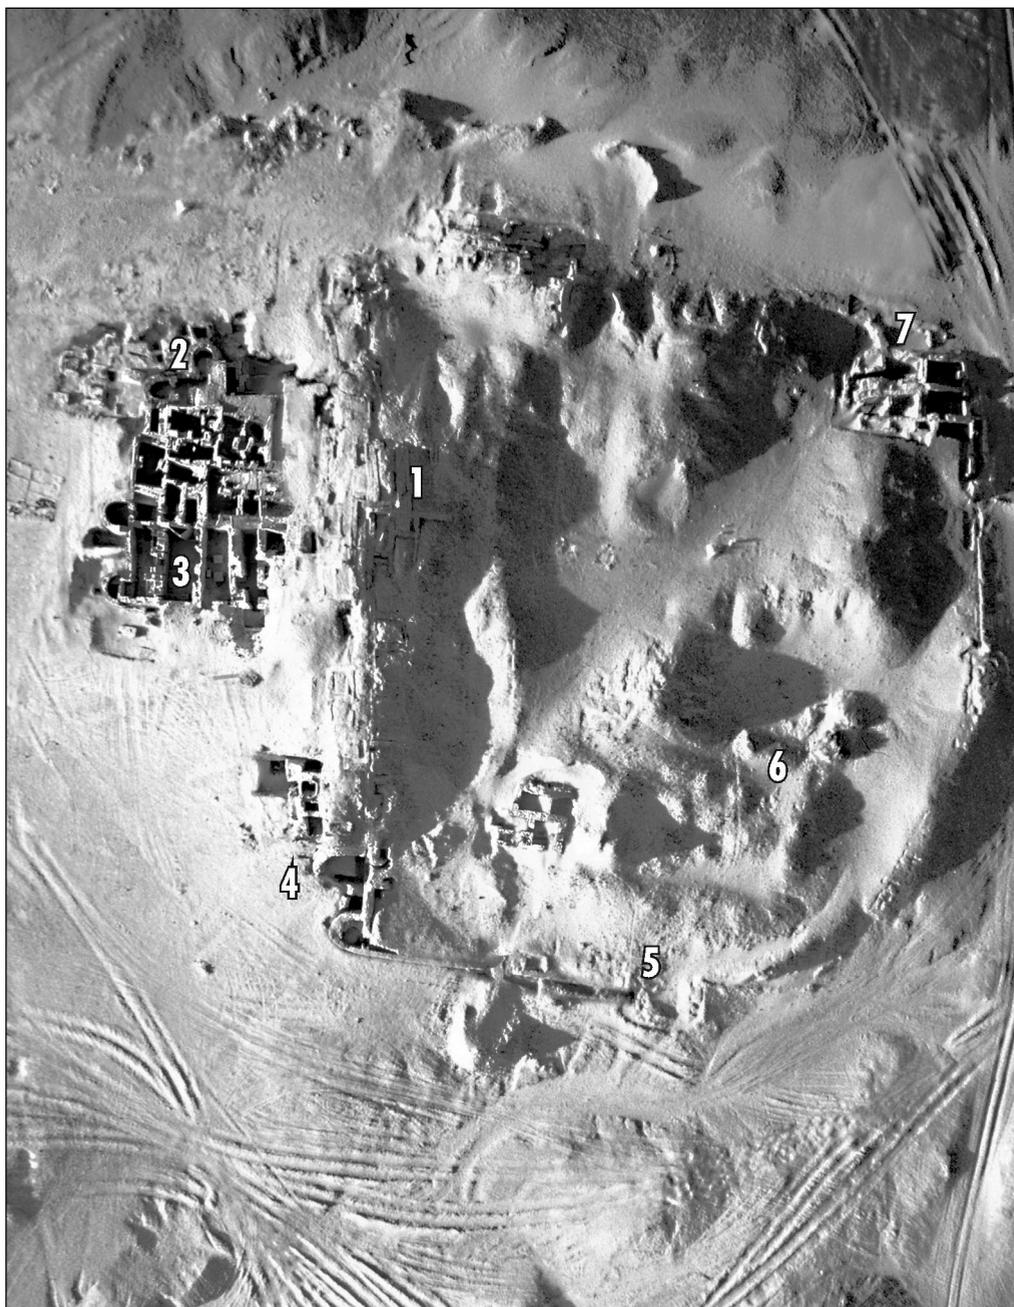
Fig. 1. Aerial view of the excavations on Kom H: 1 - Building NW-E; 2 - Northwestern Annex, northern end (NW-N); 3 - Northwestern Annex, southern end (NW-S); 4 - Southwestern Annex (SW); 5 - Unit S; 6 - Church (HC); 7 - service area NE; 8 - Building N (Photo B. Żurawski)

There were three objects of exploration within the area of the monastic compound on Kom H (*Fig. 1* and *Plan 1*):⁵⁾ the North-western Cemetery (TNWH) by the western facade of the Northwest Annex to

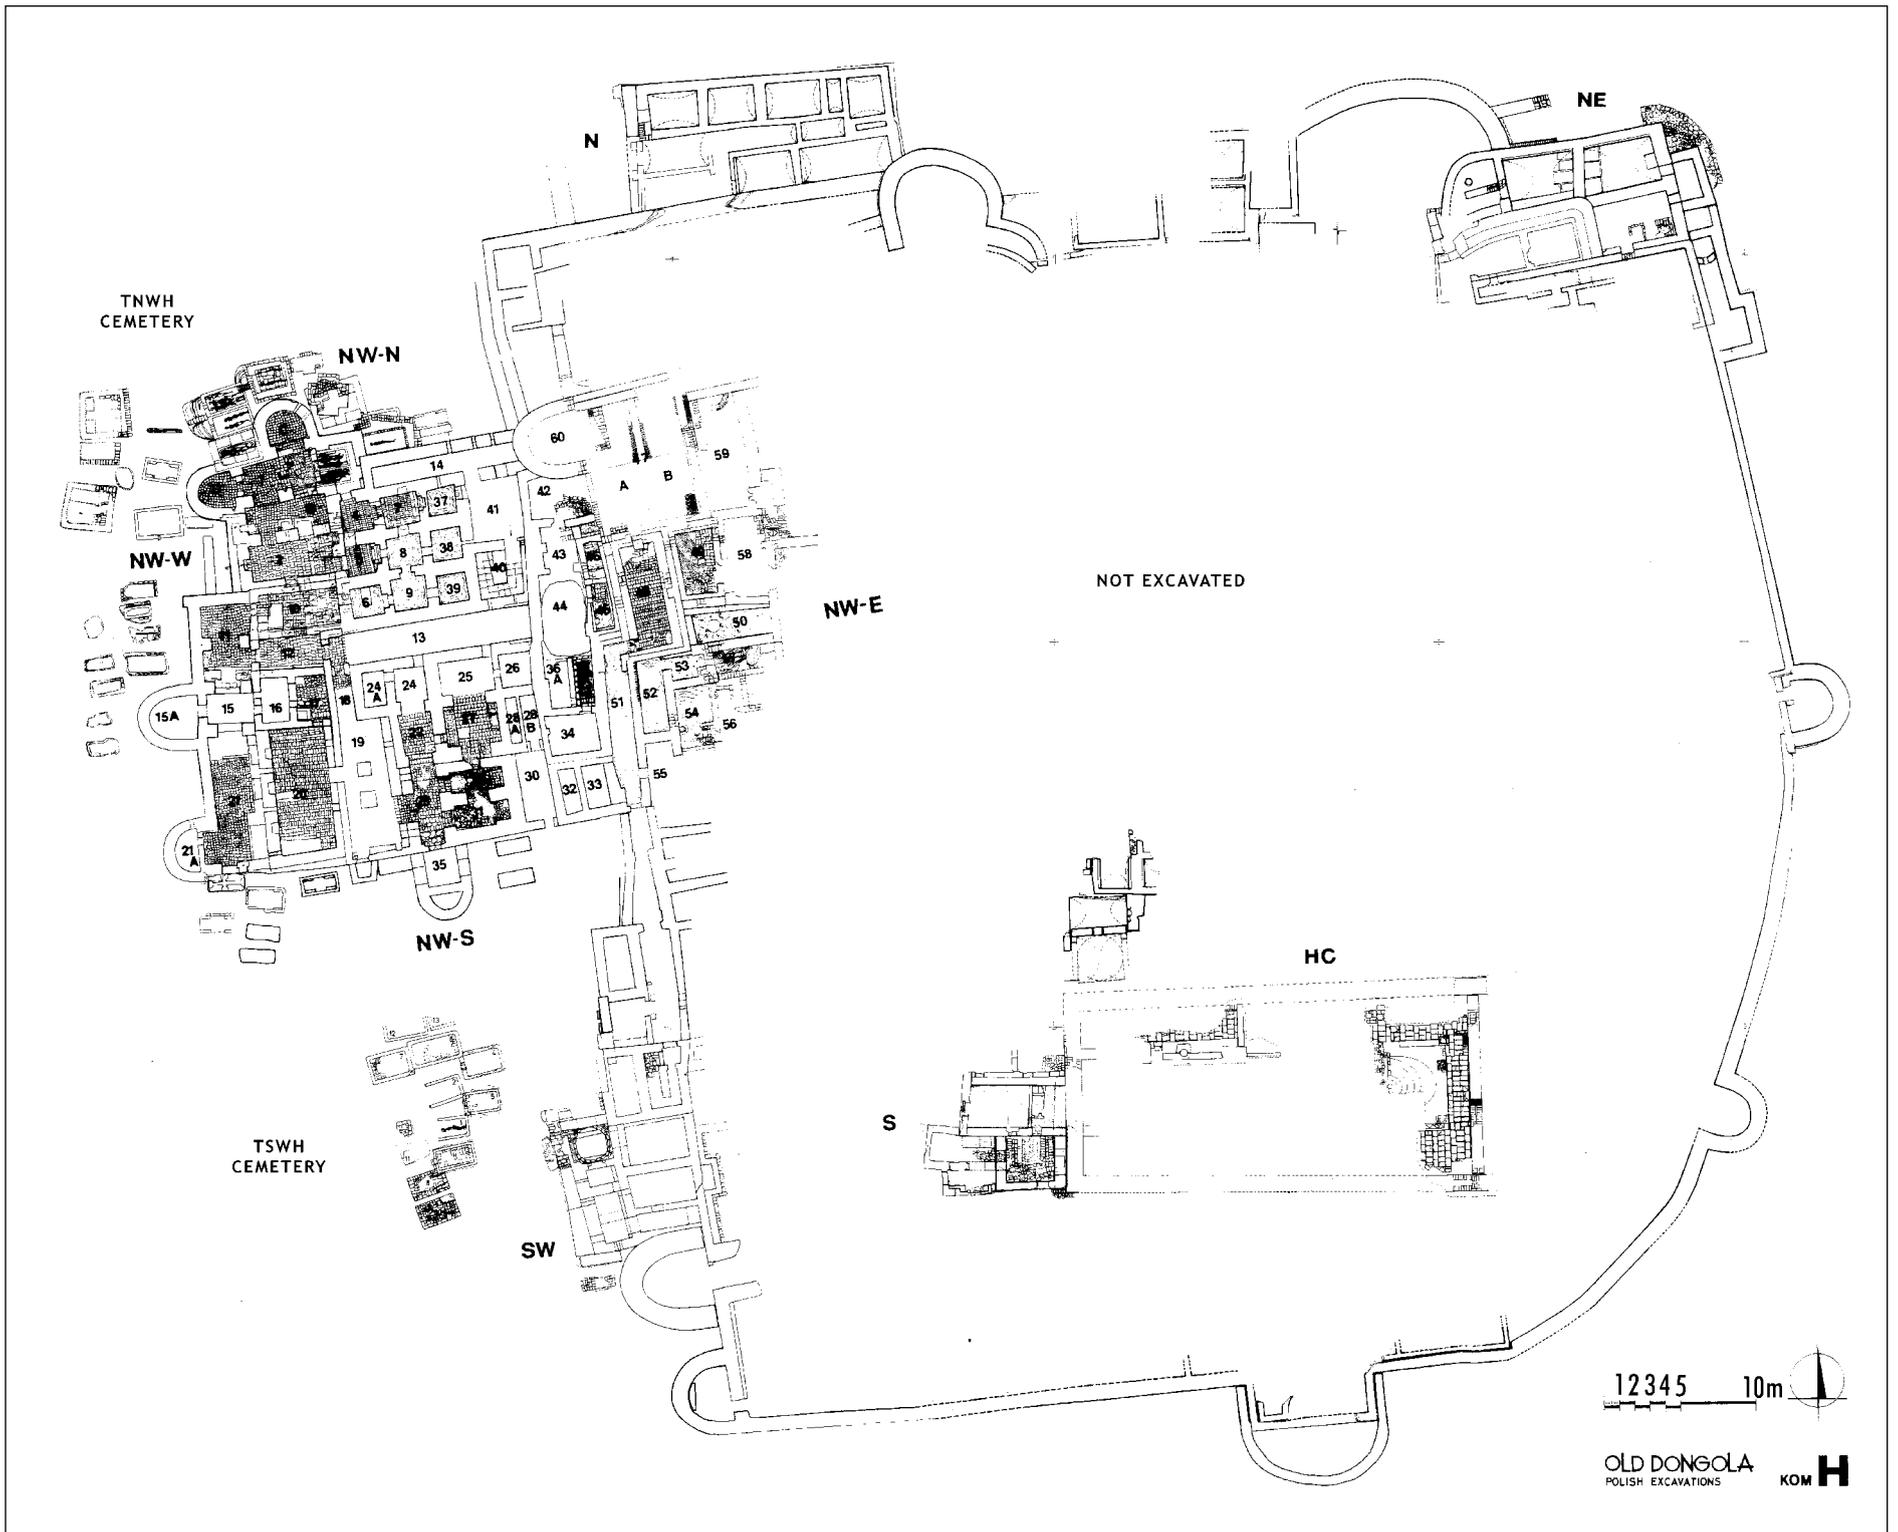
Plan I. General plan of the Monastery on Kom H (2002/3) (Drawing M. Wiewióra, based on earlier documentation)

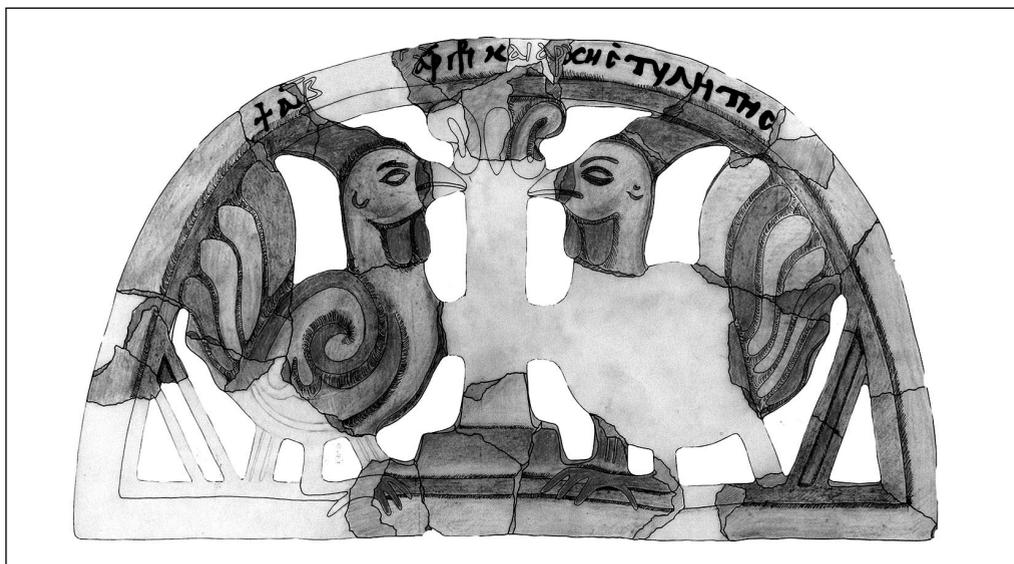
Fig. 2. Painted terracotta window grille from the Monastery, restored from fragments (Inv. No. D.36/02). Mid 11th century (Drawing W. Chmiel)

painted. Four such grilles or screens could be restored using also fragments found previously at the site. In one case (*Fig. 2*) two cocks are shown flanking a column and on the arched frame above them there is a painted dedicatory inscription of an archpresbyter and archistylites. The term ἀρχιστυλιτης⁸⁾ is attested here for the first time in full, having occurred before in texts from Dongola solely in abbreviated form. The proper name is missing, yet there is a good deal of likelihood, judging by the association of titles, that the person referred to in this inscription was Georgios (Γεωργιός), later bishop and archbishop of Dongola, the man who according to other evidence was responsible for an extensive rebuilding of the Annex in the second half of the 11th century.

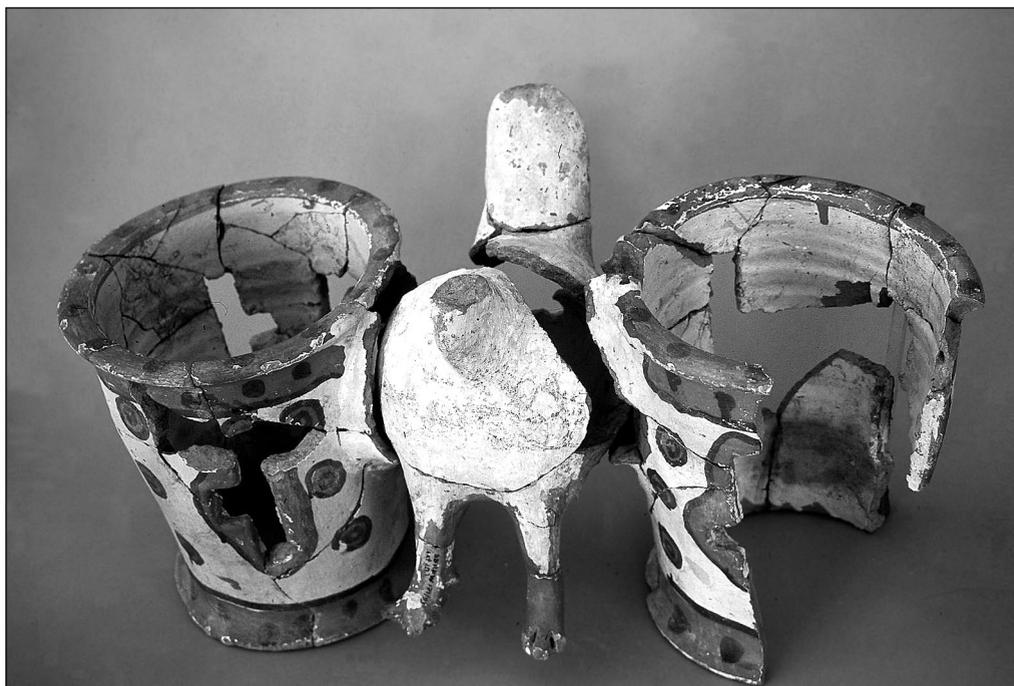
Fig. 3. Fragmentary double pot stand from the Monastery (Inv. No. D.24/02) (Photo K. Pluskota)

extremely numerous. One curious pottery object deserves special attention (*Fig. 3*). It may be a double-pot stand made up of two open-ended cylinders joined at the middle with a bird-shaped vessel. The object was slipped yellow and painted with red bands. It has no parallels in Nubian pottery.

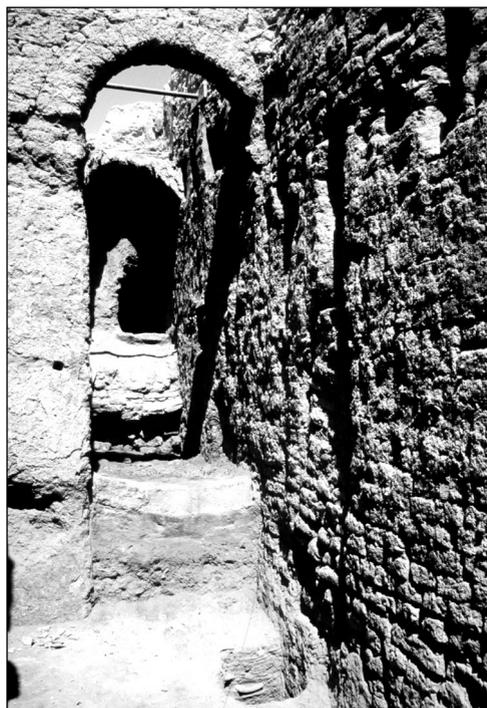
Fig. 4. Arched doorway between outer southeastern corner of annexed Building NW-S and the Main Monastery Building, leading to passageway 28B. View from the south (Photo S. Jakobielski)

Rooms 28B and 30 in the Annex area were also excavated to the original level, revealing in the process the original southwestern corner of the NW-E Building on the axis of the southern outer wall of the Annex complex. The earliest yard of the Annex had once been entered through an arched entrance comprising the full breadth of the later southern wall of room 30. Another arched doorway (*Fig. 4*) closed off the yard on the north, having been built between the outer southeastern corner of room 28A (which appears to be at the same time the outer southeastern corner of the NW-S Building in its earliest

phase) and the outer western wall of NW-E. It led to room 28B, which in this period formed an open corridor leading in

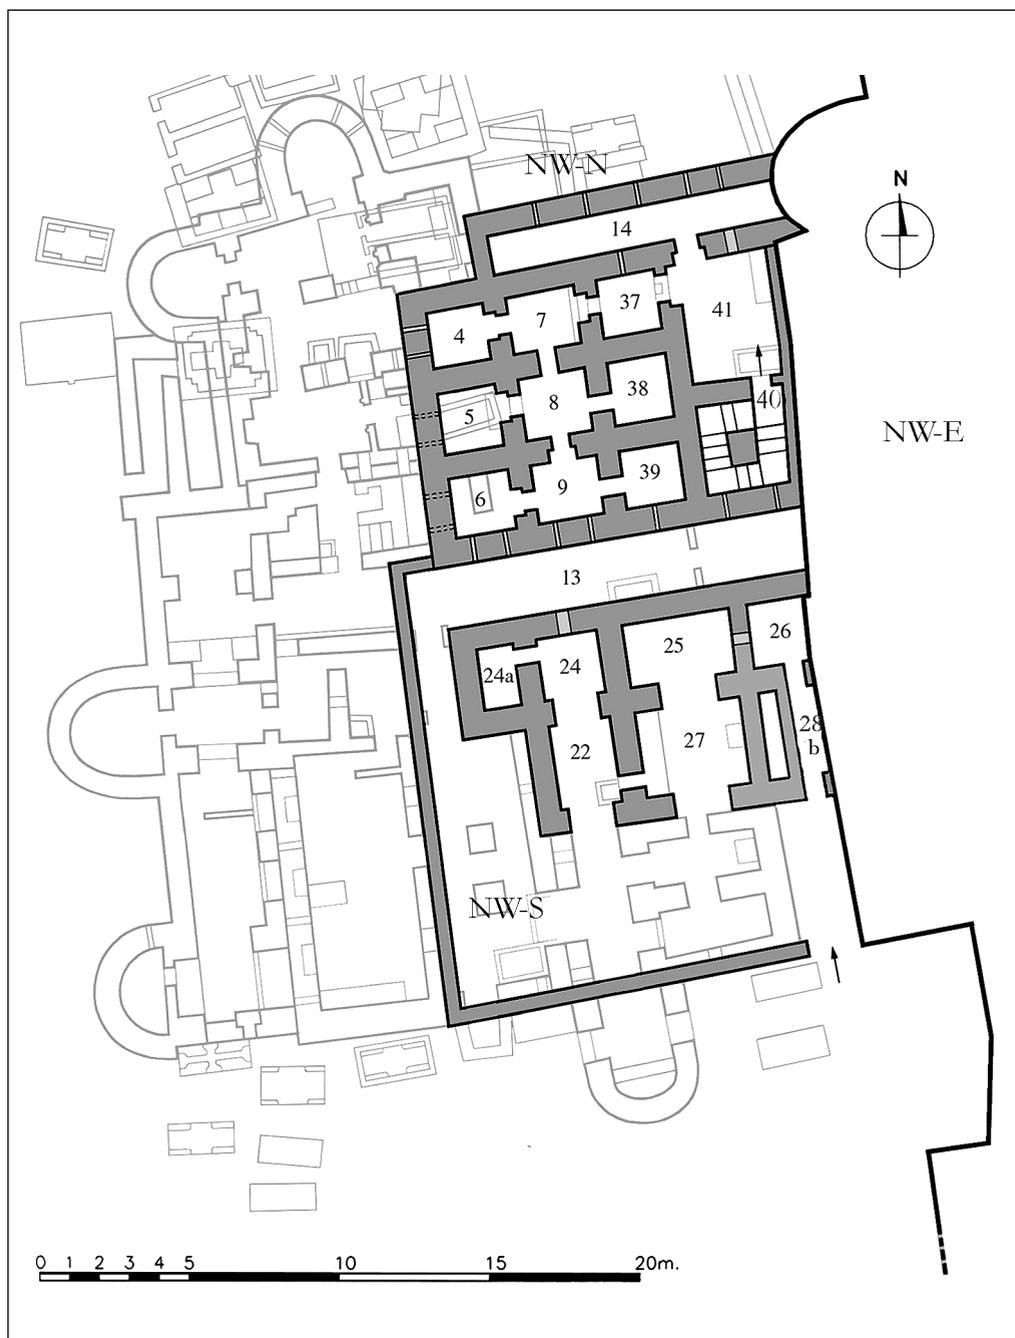
Fig. 5a. Sketch plan demonstrating the development of the Northwestern Annex: earliest phase from the 10th century (Drawing W. Chmiel and S. Jakobielski, based on documentation plans)

turn to the original (and only) door to room 26 (*Fig. 5a*).

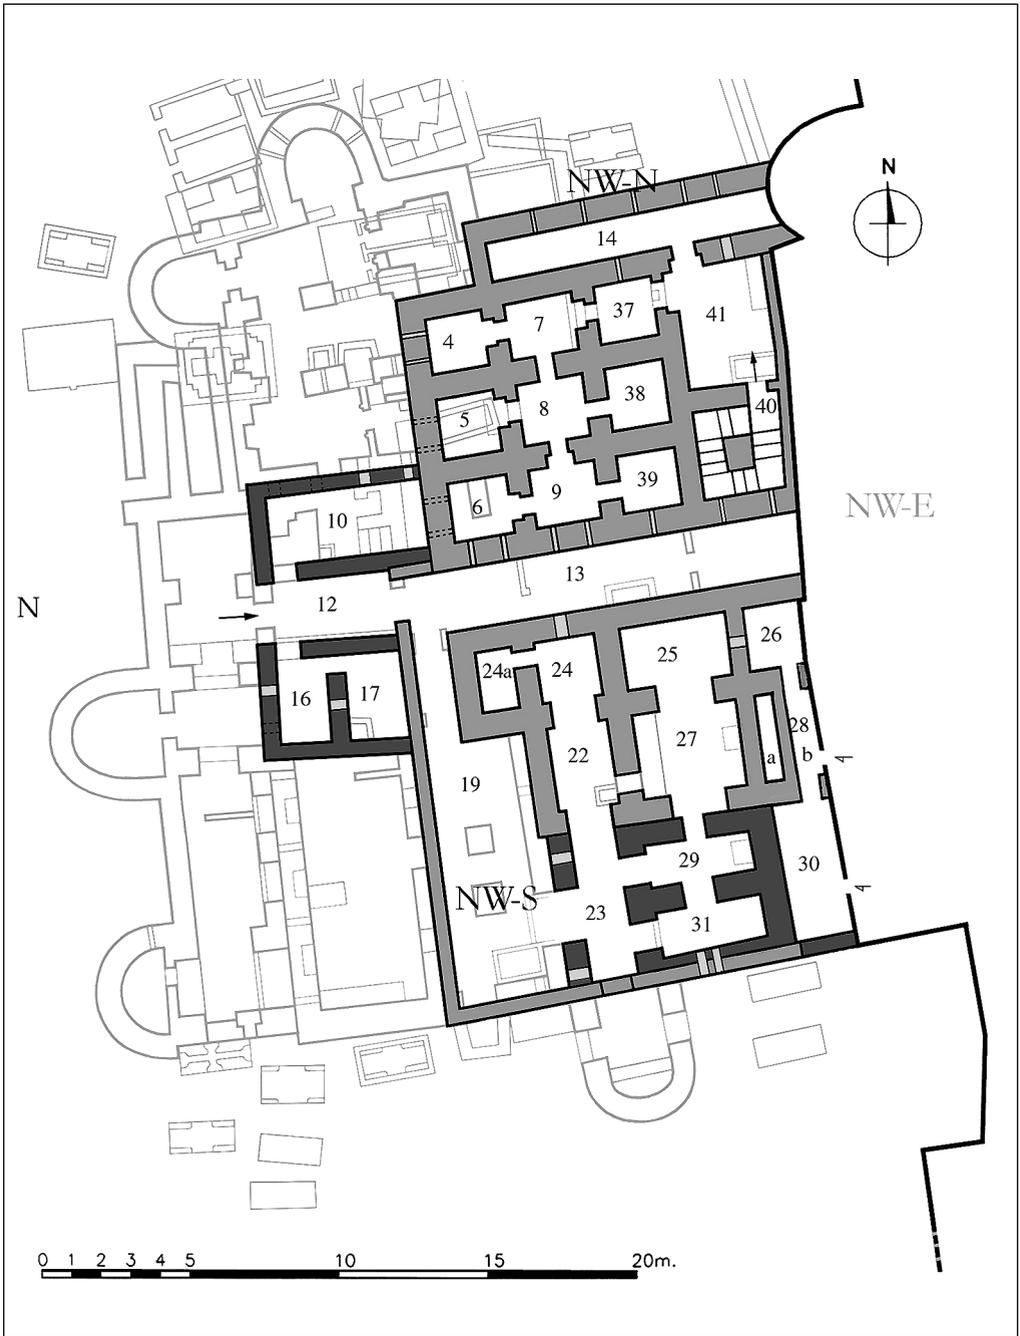
Fig. 5b. Sketch plan demonstrating the development of the Northwestern Annex: phase II, rebuilding carried out by Georgios in the mid 11th century (Drawing W. Chmiel and S. Jakobielski, based on documentation plans)

The rebuilding program executed by Georgios in the mid 11th century changed the spatial and functional layout of this part of the Annex (*Fig. 5b*). With the erecting of the eastern wall of rooms 31 and 29, the area east of it became room 30; the arched southern doorway was replaced with a wall, thus removing the room, together with neighboring rooms 28A and 26, from the Annex. Low doors, 1.50 m high, were cut in the western wall of Building NW-E in order to enter this space. In the next stage, a small vaulted corridor was built across room 28B along its northern wall, open into room 36 so as to provide a direct covered passageway between rooms 26 and 36. After the doors leading to it from rooms 32 and 34 were blocked, the rest of the space was most probably turned into a rubbish dump. At the time of the next rebuilding, when the upper story of the Annex and Building NW-E was re-arranged, vaults were introduced in rooms 28B and 28A (the latter likely being a chimney duct located in the outer southeastern corner of the oldest phase of Building NW-S). Both were made accessible but through trapdoors in the floor of the upper story (i.e., from room ¹28).¹¹⁾ Room 30, accessible through an opening in the south wall, was now used for household purpose.

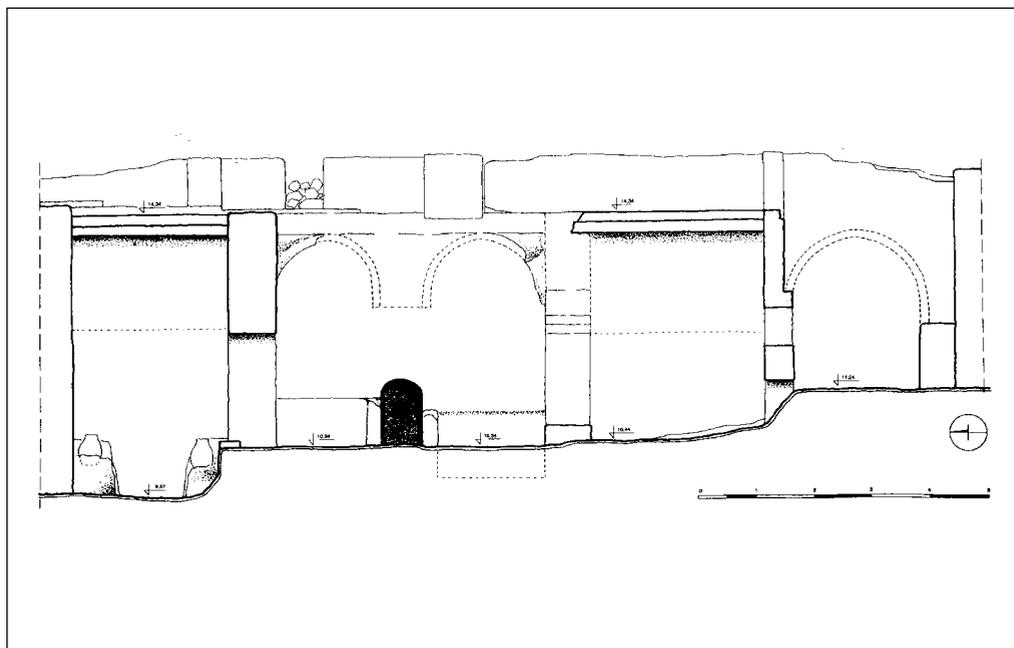
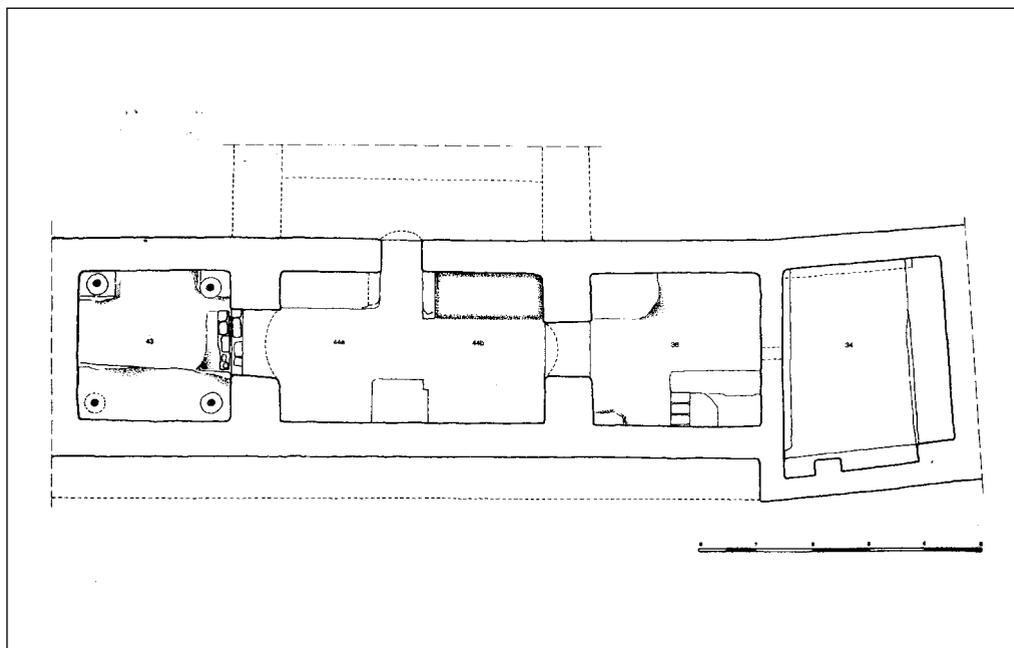
Fig. 6. Great hall in Building NW-E after 10th-century rebuilding into individual rooms 43, 44A, 44B, 36, and 34: a) N-S section looking east (top); b) plan of ground floor (Drawing T. Kelm-Krauze)

Three main phases of use were distinguished in Building NW-E. The first one should be associated with the beginning of the Classic Christian period, as suggested by the pottery evidence. At that time rooms 42, 43, 44, 36 and most of 34 formed one whole, measuring 17.80 m in

length and 3 m in width. This monumental hall was covered with a huge barrel-vault rising to a height of 4.20 m. The mud-brick walls were founded directly on the rock covered with a mud floor. There must have been a doorway to the southern part of the building, but no evidence of it survived the rebuilding. A passage to the northwestern tower (room 60) in the northern end, if it existed, will be uncovered once the ground-floor level is excavated here. The sole access attested to date was from the eastern part of the building. It was a low entrance leading to unit 45, which had apparently been rebuilt into a kind of vaulted narrow passage of obscure use. The passage, before being incorporated into the western extension of the building, ran alongside the earlier western girdle wall of the Monastery.

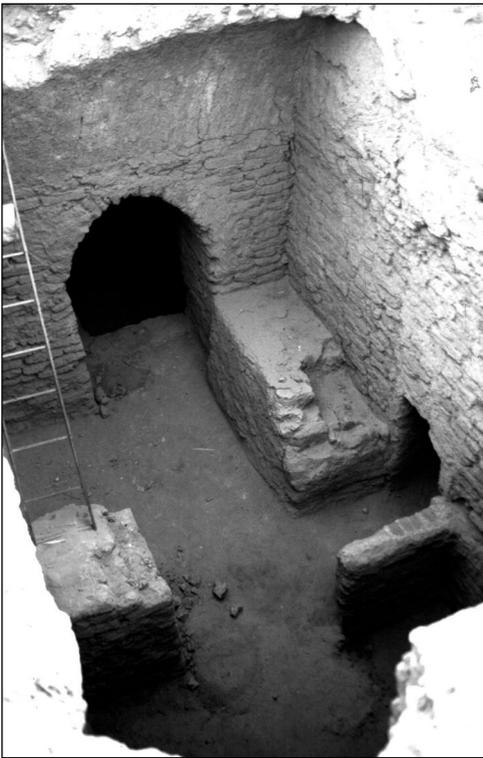
Fig. 7. Building NW-E. Interior of rooms 44A & 44B with entrance to passage 45. In the background, an archway leading to room 43 (Photo W. Chmiel)

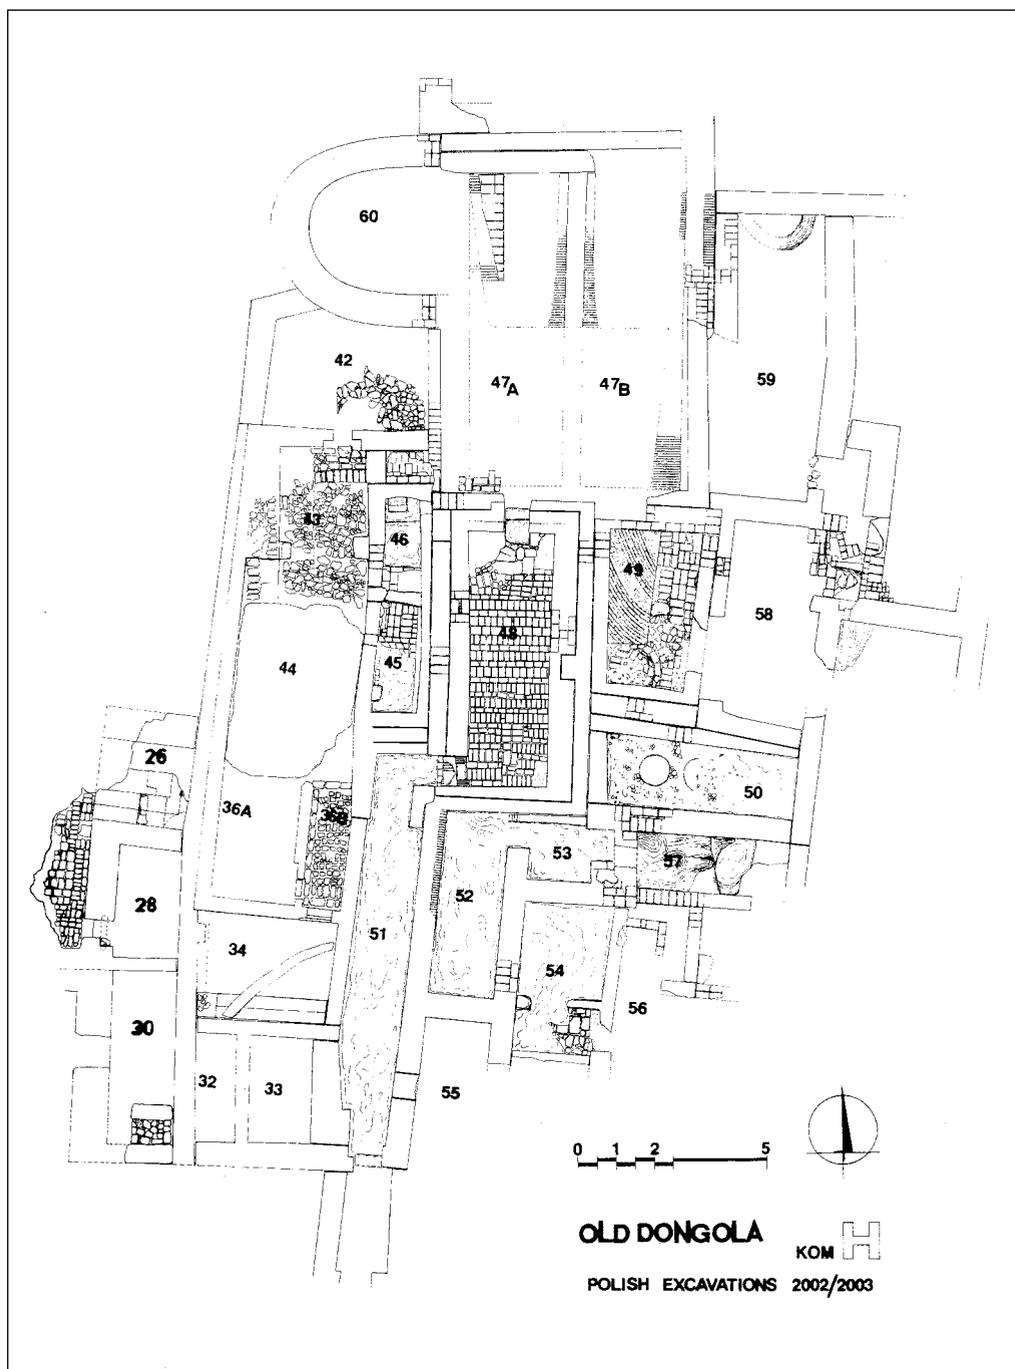
Fig. 8. Plan of the extant part of the upper floor of Building NWE and Annex (Drawing M. Wiewióra after plans by T. Kelm-Krauze and A. Wójcik)

On the upper floor (*Fig. 8*) a single room (later divided by a large arcade) existed at first over rooms 43 and 44; it was bordered on the south by two other rooms (36, 34) in a row, connected by narrow doors in the east wall. All the walls were plastered (2 layers of plaster and evidence of successive coats of whitewash were recorded), the floor was paved with irregular stone slabs. Room 44 was connected with 45 (and may have been one with it initially). Room 43 was obviously connected with staircase 40 in the Annex, but no traces of jambs or threshold were found because the wall in this place was preserved too low. Considering that the rubble fill underlying the final collapse of the vaults regularly contains Late Christian pottery, the rooms, on both the ground floor and the upper level appear to have been used for quite a long period of time.

The upper-floor rooms of the Main Monastery Building (NW-E) were evaluated in terms of essential safety measures required for the further methodic exploration of the structure. In effect, an area 15 by 20 m of the upper floor was cleared, comprising 15 rooms, which all appear to have been an adapted ruin, intended for temporary use (cf. *Fig. 8*).

This season another eleven rooms of the upper floor were cleared (cf. *Fig. 8*). The walls were all built of different-size mud brick (occasionally repaired with red brick) and were preserved to a height ranging from 1.70 m to as low as 0.25 m. Several periods of use are attested, with the currently uncovered one representing mostly the

One method that was applied in the reconstruction of the building was to double the walls, by inserting them into existing spaces (cf. *Fig. 8*); new barrel vaults could easily be introduced then (rooms ¹⁴⁸, ¹⁴⁹, ¹⁵⁰). In rooms ¹⁴⁵, ¹⁵⁰, ¹⁵⁸ and ¹⁵¹, it was sufficient to double one or two walls in order to cover them anew with a vault. Rooms ¹⁴⁸ and ¹⁴⁹ and probably ¹⁴⁷ and ¹⁴⁶ (as also a passage in room ¹³⁶, excavated in the previous season), received a new brick paving (*Fig. 12*).

16) A circular brick feature in the southwestern corner of room ¹⁴⁹ (cf. *Fig. 8*), strongly suggestive of the kind of round seat that was typical of refectories, turned out to be an attempt to repair a damaged vault.

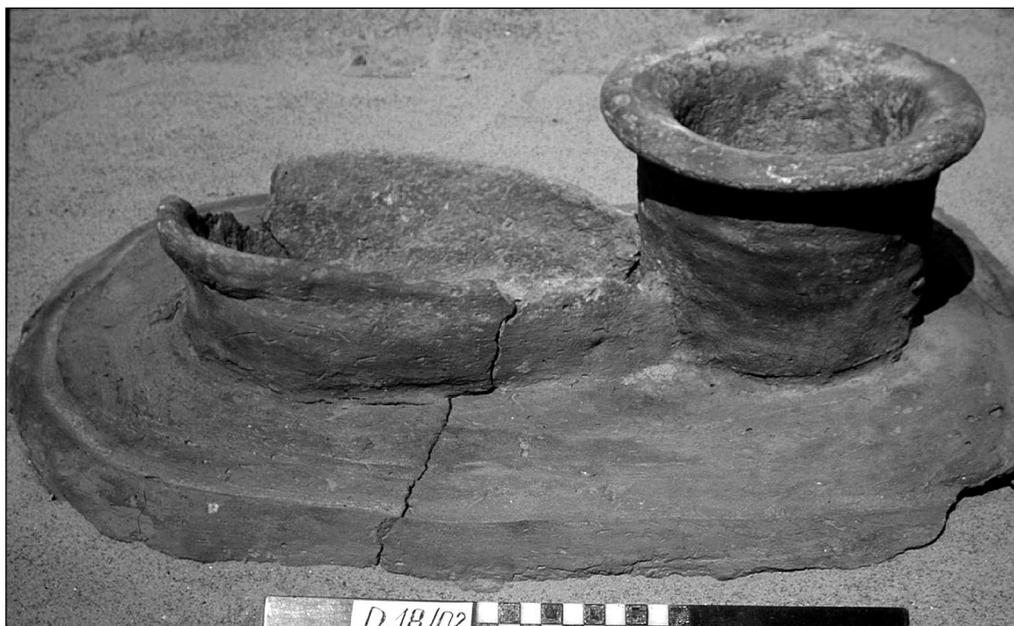
Fig. 9. Terracotta toilet seat with cylinder and basin on the front part of a flat rectangular base (Inv. No. D. 18/02) (Photo K. Pluskota)

Many fragments of hydraulic installations were discovered in the layers of the rubbish dump. Included here was a ceramic toilet seat with evidence of use (Fig. 9), two complete sinks of a form never encountered before (Fig. 10) and several different ceramic pipes, both square-sectioned and semicircular on a flat base.

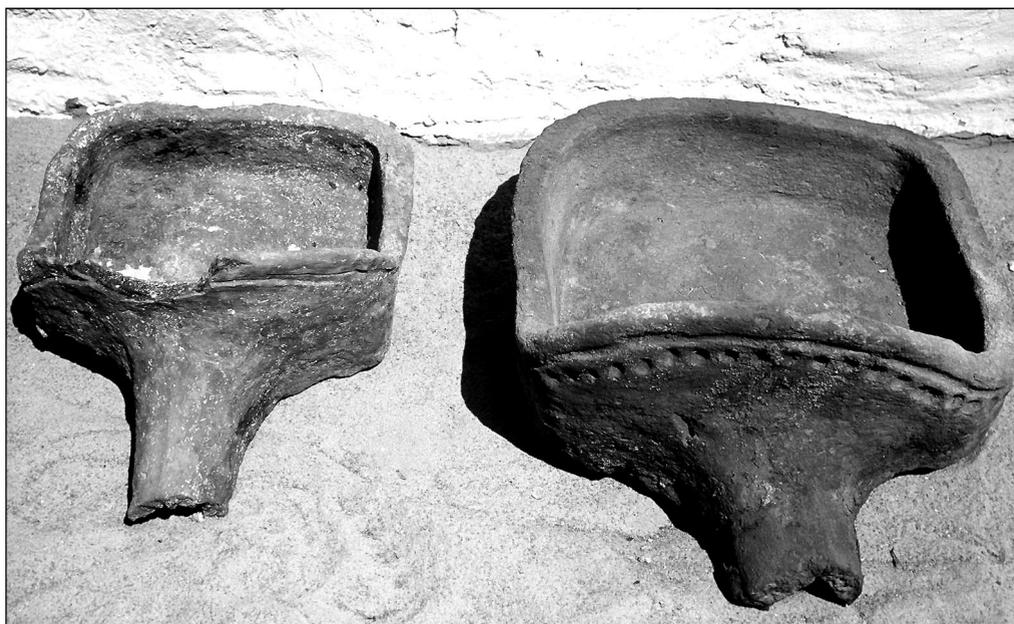
Fig. 10. Terracotta sinks (Inv. Nos. D.16/02 & D. 17/02) (Photo W. Chmiel)

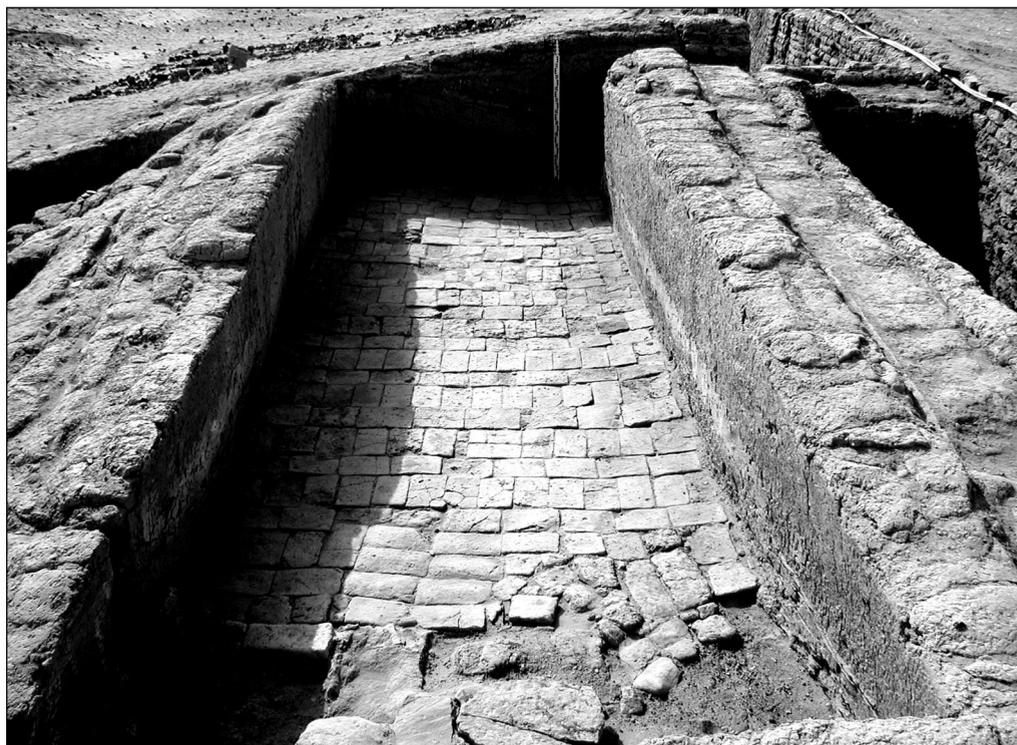
Fig. 12. Interior of room ¹⁴⁸ of Building NW-E, looking south, in the last phase of use (Photo M. Wiewióra)

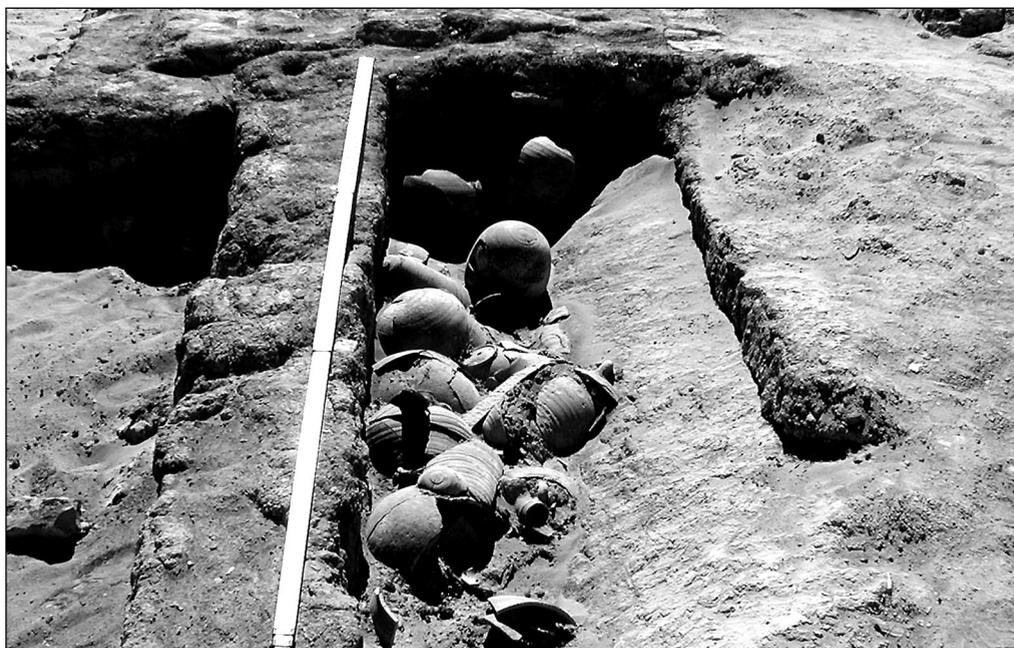
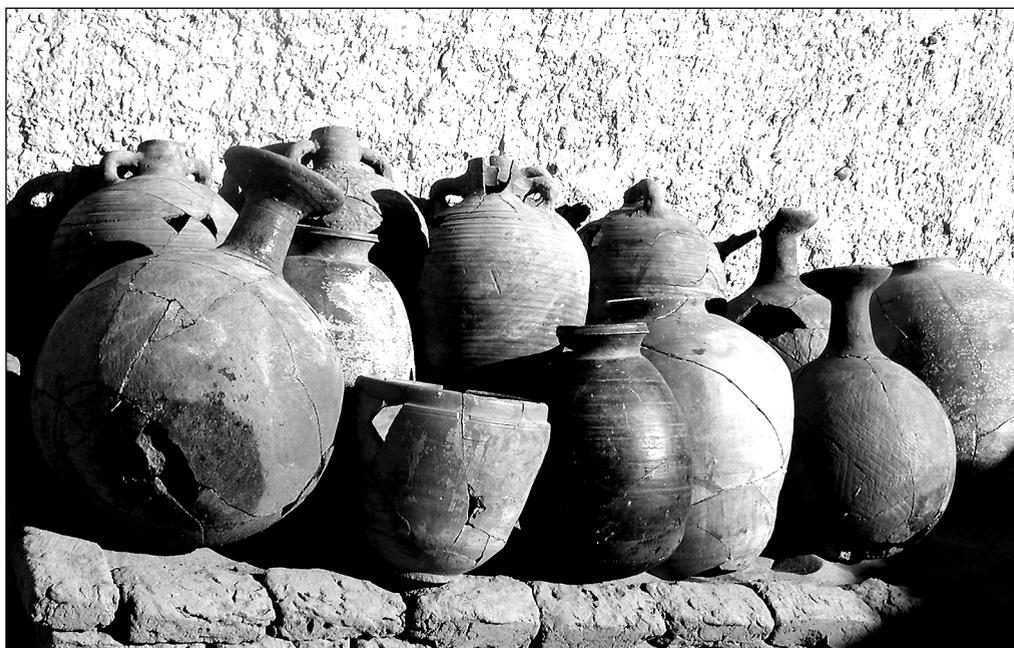
Fig. 13. Thirteen large Early Christian pottery vessels found as fill in the eastern haunch of a vault in room 47B of Building NW-E: a) in situ during exploration (top); b) displayed in the Expedition House (Photo M. Wiewióra)

The next to be constructed was likely the northern part adjacent to the northern section of the enclosure and the northwestern tower (room 60), but not actually adjoining the southern part of the building. Included here were rooms 47a, 47b, and 59, as well as several rooms further to the north (not plotted on the plan in *Fig. 8*), most probably filling completely the area up to the northern section of the enclosure wall. The mud brick used in the construction of this part of the building is much smaller (28 x 16 x 6.5 cm). As to the date, an important indication was given by a set of large Early Christian vessels, thirteen in number, which were found extraordinarily placed in the fill of the eastern haunch of the vault in room 47b (*Fig. 13a,b*). Three of these were so-called 'beer-jars' with elongated necks, another four were early amphorae of local production and a fifth most notably an import. The latter vessel had been provided with an apparently Coptic inscription in yellow paint on the upper part of the body: ΝΤΝ ΙΑΚΟΒ Ϡ ΑΡΧ, "from Iakob, archpresbyter". The ceramic evidence is thus in favor of a relatively early period of construction for the northern part of building as none of the vessels in this deposit was manufactured later than in the 8th century.
