Hawarte: Conservation of a Mural

Polish Archaeology in the Mediterranean 14, 295-299

HAWARTE

CONSERVATION OF A MURAL

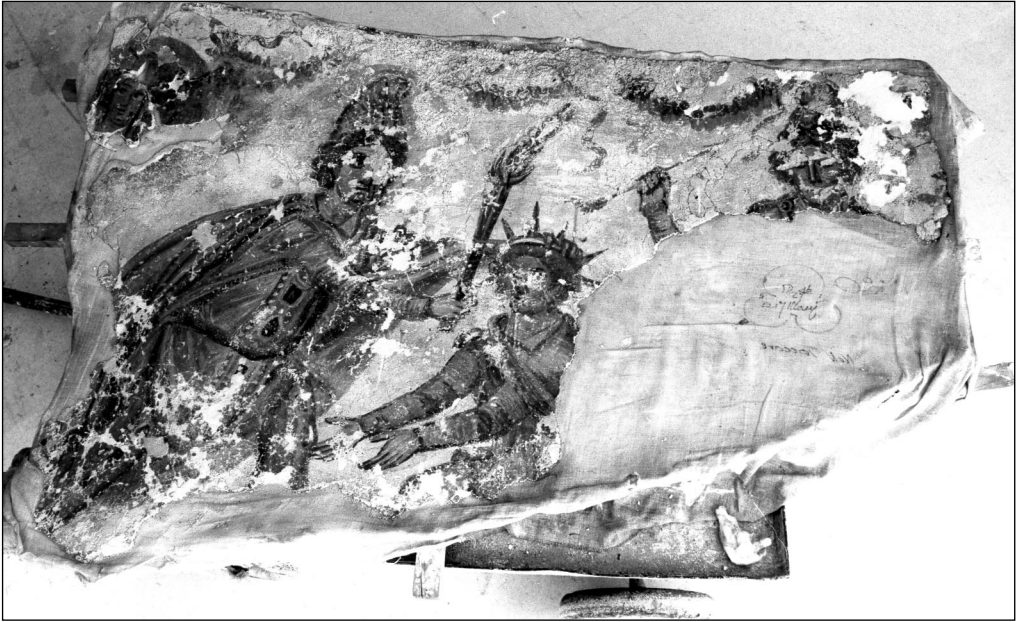
It had been cut from the wall before 1998 and separated from the earlier paint layer. Both layers, each about 0.2-0.5 cm thick, had been backed with gauze and transported on a plaster bedding that was profiled to correspond to the original curve of the wall in the mithraeum (Fig. 1a). The condition of the upper paint layer was evaluated as fairly good, while the surface of the lower one, covered with a thin coating of lime plaster, was full of cracks and gaps that made it generally illegible. After preliminary treatment involving cleaning and consolidation, it was possible to distinguish the colors and the composition of the painted scene.

Fig. 1a. Mithraic scene detached from the eastern wall of the mithraeum in Hawarte, state before treatment in 2002 (Photo E. Parandowska)

The first step was to dust the surface using natural brushes and *wishab* sponges. A 30% solution of ethanol in water was tamponed on to clean the painted surface chemically. A detached fragment of the mural representing the moon, found in one of the boxes, was fixed and glued to the rest of the scene. The cracks and empty spaces were filled with newly prepared stucco (1:1:1.5 parts of fine sand-calcium carbonate-PRIMAL AC-33).

In order to prepare the new background the entire painted surface was first protected with Japanese tissue, followed with two layers of gauze and canvas glued with polyvinyl alcohol in water. A polyethylene

sheet was used to isolate the facing from the wet gypsum applied on top as the new plaster bedding, reinforced with linen flocks and wooden bars. This was then turned upside down, opening the way to the preparation of a supporting construction composed of several layers.

The reverse side of the painting was impregnated with PLEXTOL B-500. A layer of cotton gauze and another of canvas were stuck with PRIMAL AC-33 (1:1 solution in water). This was followed by a layer of ground (calcium carbonate with 60% polyvinyl acetate), leveled with a thin layer (0.2 cm) of the same putty with sifted sand. A sheet of polystyrene foam (1 cm thick) was glued with polyvinyl acetate as an intervention layer, permitting the reinforced original painting to be detached easily, if need be, from the composite structure.

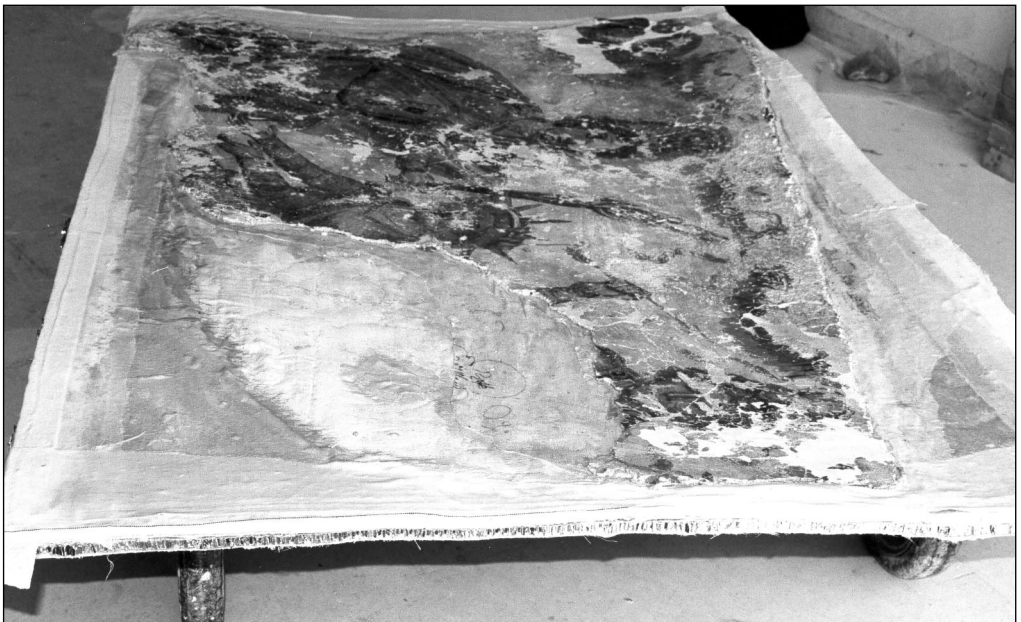
Fig. 1b. The same mural fragment glued on a new support (Photo E. Parandowska)

surface of the transfer were leveled with a layer of mortar (2:1:0.1 parts of sand-lime-PRIMAL AC-33). Small cracks were filled with a ground composed of calcium carbon-

ate, fine sand and PRIMAL AC-33 (*Fig. 1b*). The final aesthetic arrangement (color unification of the new plaster, wooden frame) will be completed during the next season.

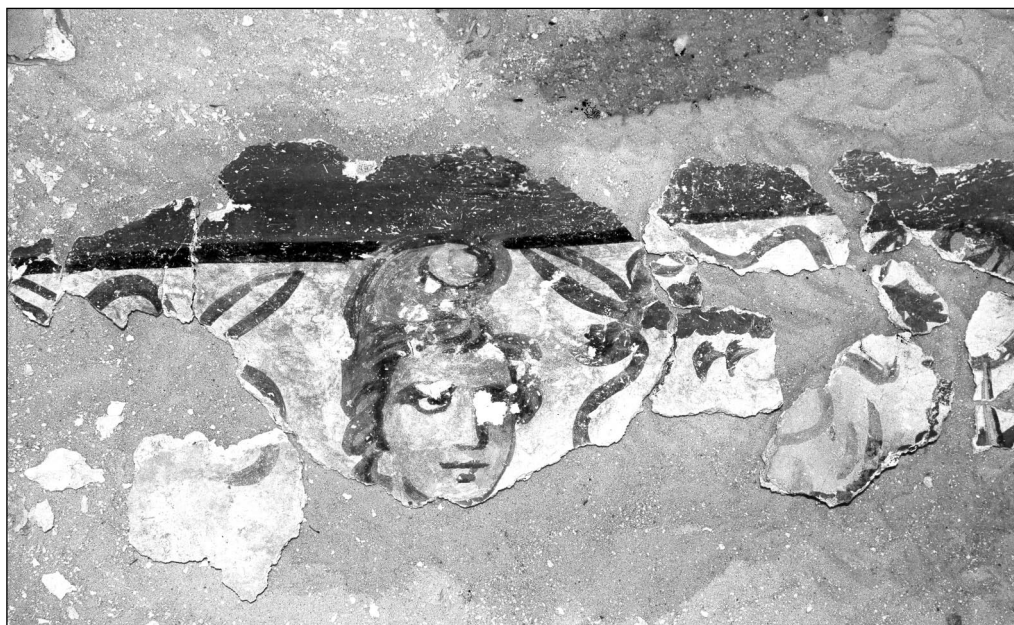
Fig. 2. Fragment of the fourth layer (lower one) of decoration found during the separation of layers carried out this season (Photo E. Parandowska)

of these fragments consisted of several superimposed painting layers. One of the objectives of the restoration work was to separate the layers of decoration and to detach them from the remaining stone support.

Detaching and restoration of the earlier layers of painting had to be preceded with careful cleaning, disinfecting (PREVENTOL, 20% solution in alcohol) and protecting of the surface with Japanese tissue stuck with polyvinyl alcohol. The reverses of thin and fragile separated fragments had to be reinforced with gauze and plaster (lime, sand and polyvinyl acetate). Once the facing had been removed with hot-water compresses, the fitting fragments were joined and glued (*Fig. 2*). Many new joining fragments were discovered during the present work (*Fig. 3*), but much work remains to be done. Selected larger fragments of particular painting layers can be prepared for display at the Museum in the same manner as the two transfers described (previously a part of the ceiling had been treated in Warsaw).

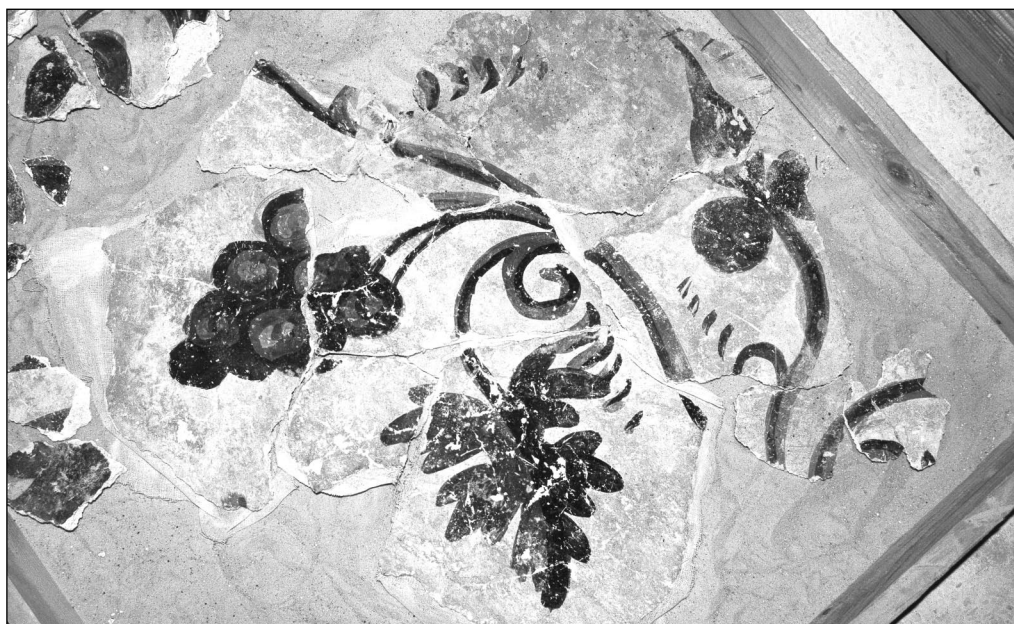
Fig. 3. Example of new joining fragments discovered this season (Photo E. Parandowska)
