Old Dongola: Fieldwork in 2004

OLD DONGOLA

FIELDWORK IN 2004

Stefan Jakobielski

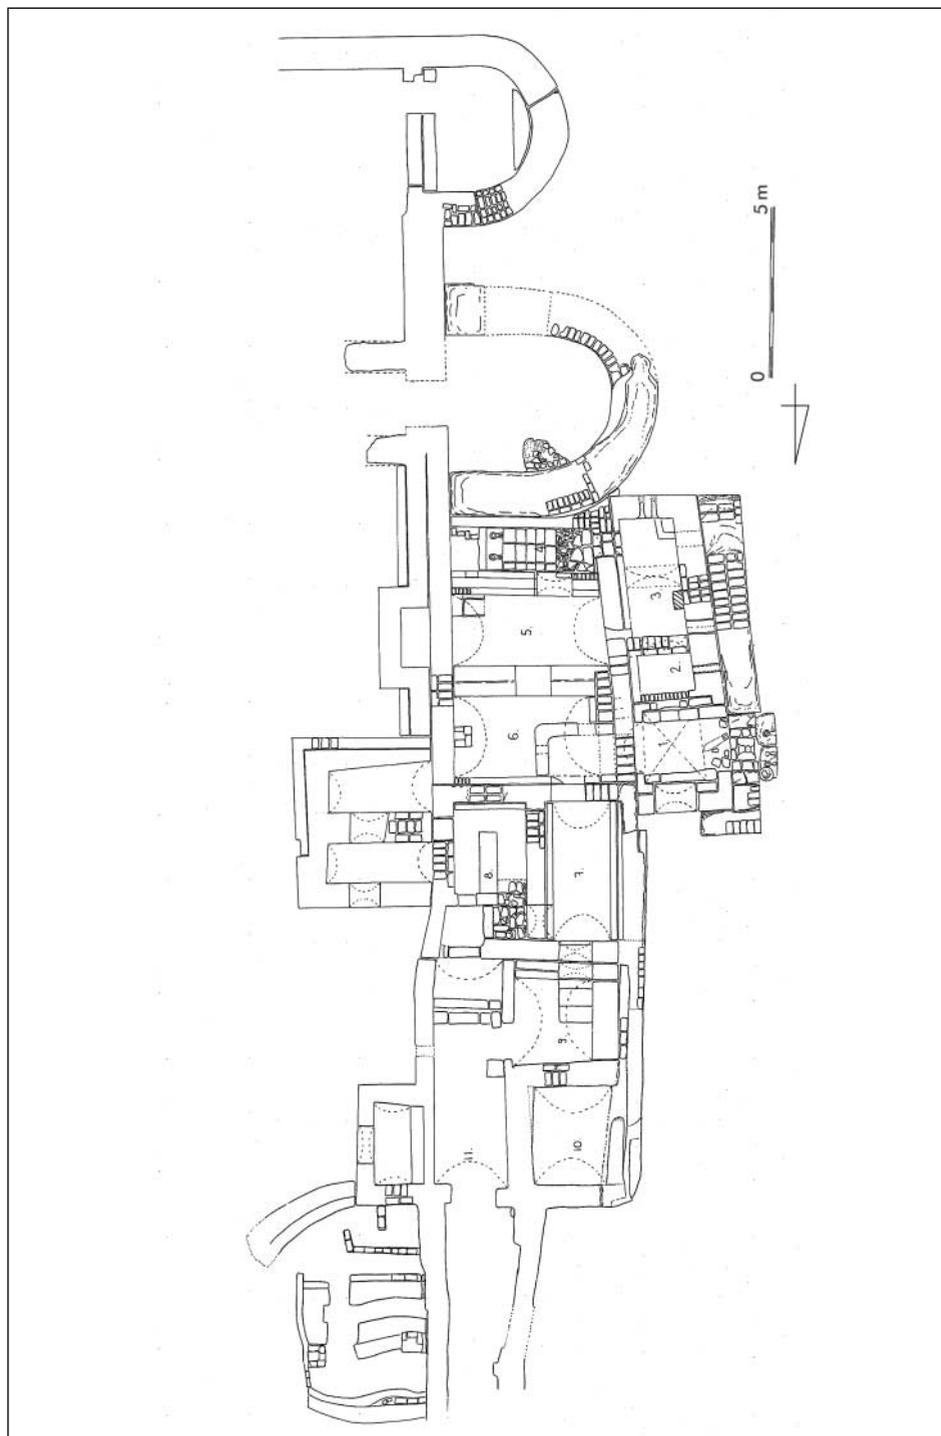
Fig. 1. Plan of the Southwestern Annex and Southwestern Building after fieldwork in 2004
(Drawing J. Swigicki, updating earlier documentation)

itself many times rebuilt, extending to the north and comprising at least seven rooms on the two floors joined by a monumental staircase. In the Late Christian period, both buildings were accessible from the west, through the same vestibule (room 1), but they evidently constituted distinct parts, perhaps due to a different function served at least through part of their existence. Therefore, for the sake of convenience, until the function of both units is identified, the southern part will be referred to as the Southwestern Annex and the northern one as the Southwestern Building [*Fig. 1*].

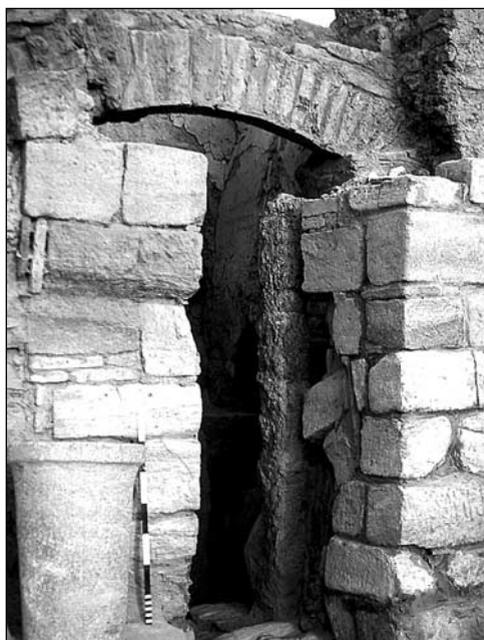
Fig. 2. Entrance gate to the Southwestern Annex, seen from the west (Photo B. Żurawski)

The Southwestern Annex, 7.85 by 8.50 m, was built alongside the western section of the girdle wall, attached to its outer face. It appears to have been wedged in between the Southwestern Building and a semicircular wall enclosing the entrance to the monastic compound situated near the southwestern corner tower. The Annex, which originally comprised only three rooms (4, 5, 6) set in a row, was apparently erected not earlier than in the 11th century. In the 12th century, it was extended to include a passage comprising a square domed vestibule and long corridor running alongside its western façade. This west wall was doubled later, at the same time that an imposing arched doorway was built, leading from the west into the vestibule. This gate had jambs constructed of reused ashlar sandstone blocks, and was provided with a massive door of wooden

beams, of which some traces were still found [Fig. 2]. Stone slabs with round holes, reused from some toilet facility, constituted the threshold.

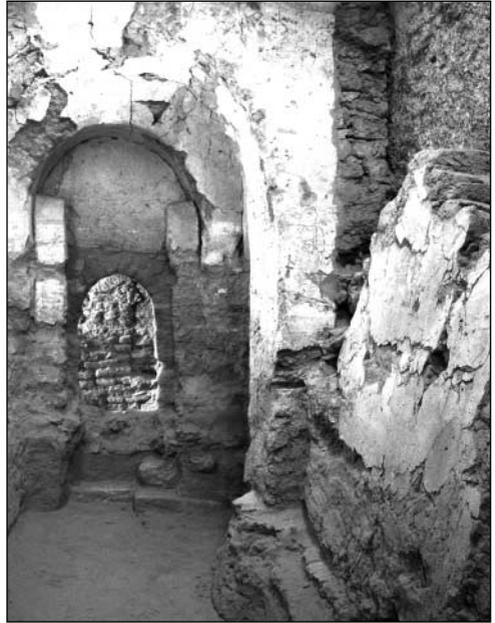
Fig. 3. Interior of passage in the SW Annex looking north (Photo W. Chmiel)

The passage was constructed entirely of mud-brick [Fig. 3]. Its eastern side was the west wall of the earlier structure; therefore, only the south and west walls (nearly 0.70 m thick) were built, enclosing a corridor 5.50 m long and nearly 3.20 m high. Arches subdivided this space into three parts (numbered 2, 2a, and 3), each nearly square in plan. The evidence is strongly in favor of individual domes covering each of these units, not the least the extra walls built against the eastern side of the passage, which would have been quite superfluous in the case of a barrel vault, this being easily supported on a ledge cut in the wall face. The arches, too, belie the presence of a barrel vault, although they could have been useful, if not necessary, to support a flat roof resting on wooden beams.

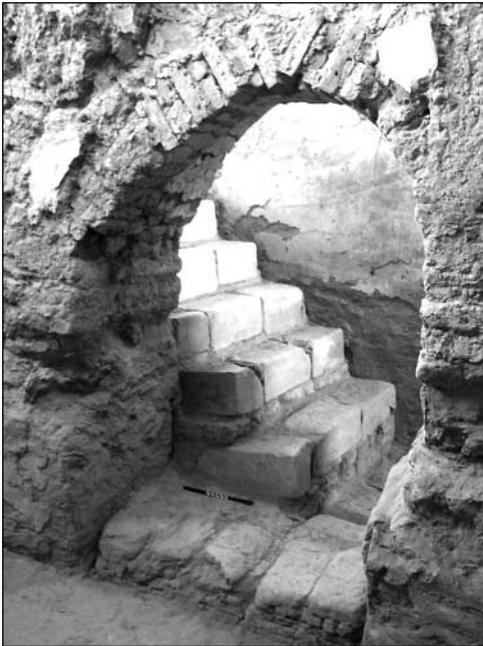
Fig. 4. Staircase filling room 4 in the SW Annex, seen from inside room 5 (Photo W. Chmiel)

steps [Fig. 4] indicating that the rebuilding included the addition of an upper story. At this time, the Annex was evidently regarded as an independent unit, not yet joined (at least on the upper story level) with the neighboring Southwestern Building, which had its own staircase [Fig. 5]. However, room 4 was not long enough for the staircase to attain the desired height; from the upper landing, one could get presumably only to the top of the semicircular wall where it met the old girdle wall of the monastery. This in turn was reinforced on the inside with a kind of platform of red brick, which made the wall thicker allowing passage along its top and, apparently up a few extra steps, to the upper story through an alleged entrance in the east wall of the space over Room 5. This complicated scheme would explain the curious structure of the

platform on the eastern side of the Annex. A simpler solution can be suggested as well: a westward path on top of the semicircular wall leading to the roof of the passage (3) and reaching the same room from the west through an alleged entrance in the west wall. Furthermore, by obtruding the connecting doorway, the staircase in room 4 quite obviously inconvenienced the passage between rooms 4 and 5 [cf. *Fig. 4*].

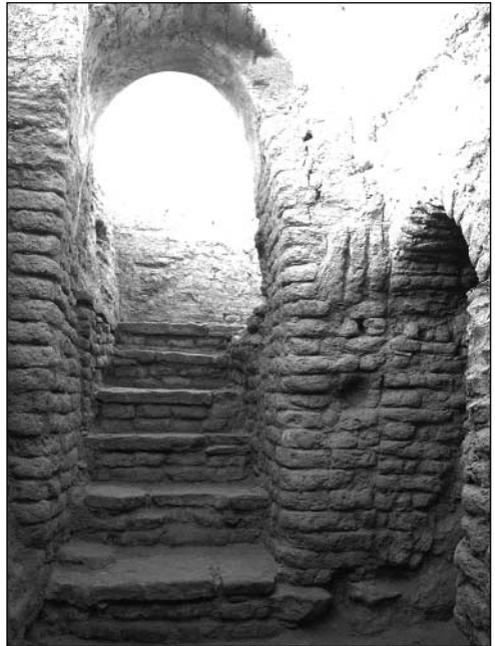
Fig. 5. Staircase leading up from corridor 7 to the SW Building (Photo W. Chmiel)

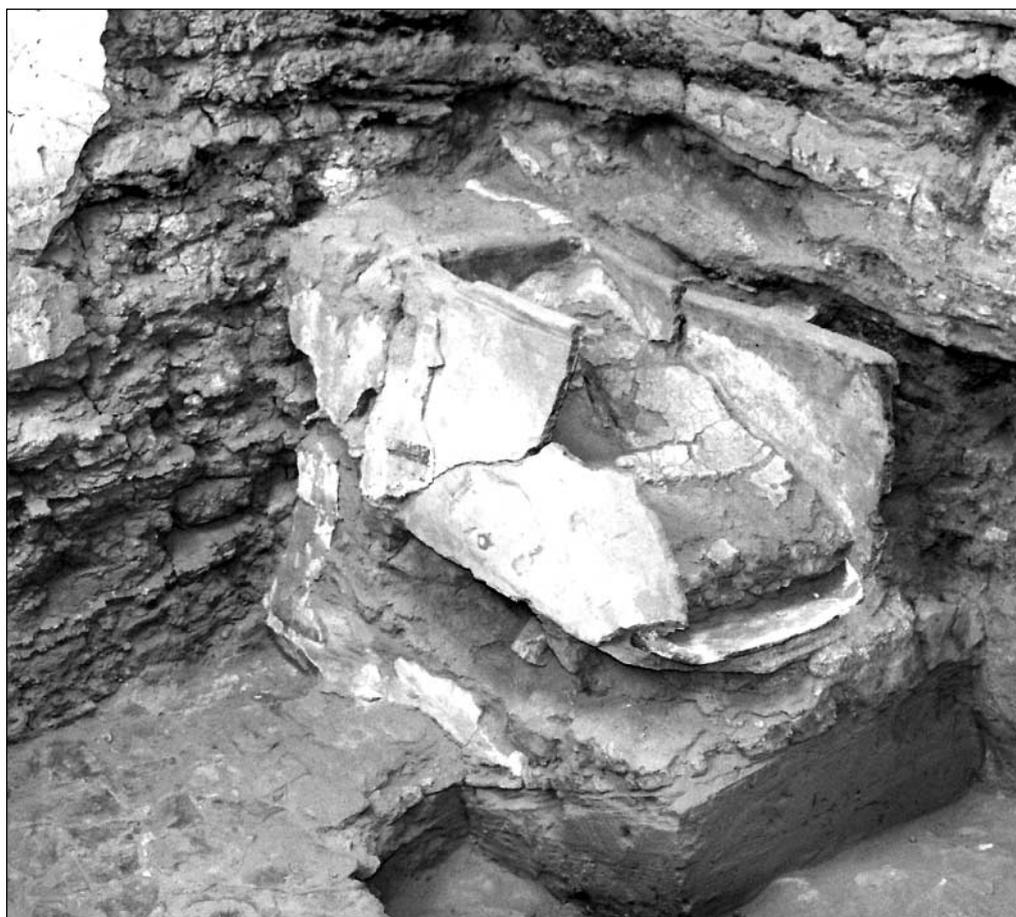
Fig. 7. Terracotta basin in the southeastern corner of room 5 in the SW Annex
(Photo J. Świącicki)

this space may have been too difficult to cover with a roof, it is possible that the extant vaulting was merely a stage in the original construction. Nothing but a deep terracotta basin (0.60 x 0.68 m, 0.30 m deep) was found in room 5, mounted in the southeastern corner obviously in the last period of use [Fig. 7]. In the sand underneath it, a massive marble-tray rim fragment was found, apparently used as a makeshift support for the basin.

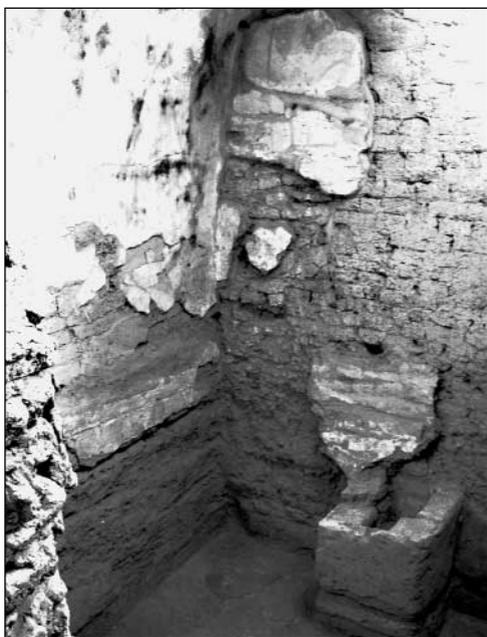
Fig. 8. *The interior of room 6 in the SW Annex, facing east (Photo W. Chmiel)*

Room 6 was evidently used as a chapel. There was a square structure found, built against the east wall, which could have served as an altar [Fig. 8]. It is preserved to some 0.50 m. Over it, on the east wall, there was once a huge mural representing the Archangel Michael; however, the plaster had all but been washed off the wall and lay in a crushed heap at its base. Recovered better-preserved fragments revealed an archangel's wing with the characteristic 'peacock feathers', as well as many fragments of inscribed plaster originating from the vicinity of the northeastern corner. Among these was a considerable part of Psalm 29, written in black ink in Old Nubian and Greek [Fig. 9]. The text is presented in a curious way, alternately in one of the two languages, verse after verse. Remnants of another four texts in Greek were also recorded but not yet identified; two of them, however, seem to be Greco-Nubian graffiti.

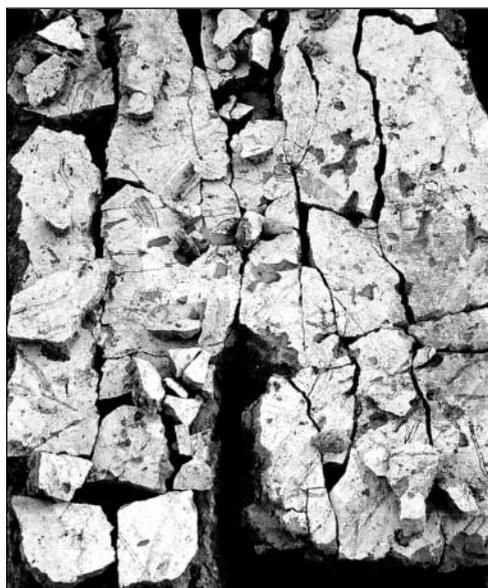
Fig. 10. Recomposition of fragments of the collapsed vault with a scene of the Massacre of the Innocents (Photo W. Chmiel)

As for the painted decoration of the chapel, the extant representations on the vaults seem peculiar at the very least. Beside a figure of the Archangel Gabriel(?) on the north wall, there is a still unidentified scene of two men sitting in an interior, seen through an unveiled curtain, apparently concluding a financial agreement (cf. *Fig. 8* on p. 280 in this volume). There are some other separate composition possibly connected with the story, including a mysterious praying monk, fastened by his hair to a rock. The large composition observed on the tumbled remains of the vault (to be recomposed in the coming season) could be identified as a scene of the Massacre of Innocents [*Fig. 10*].

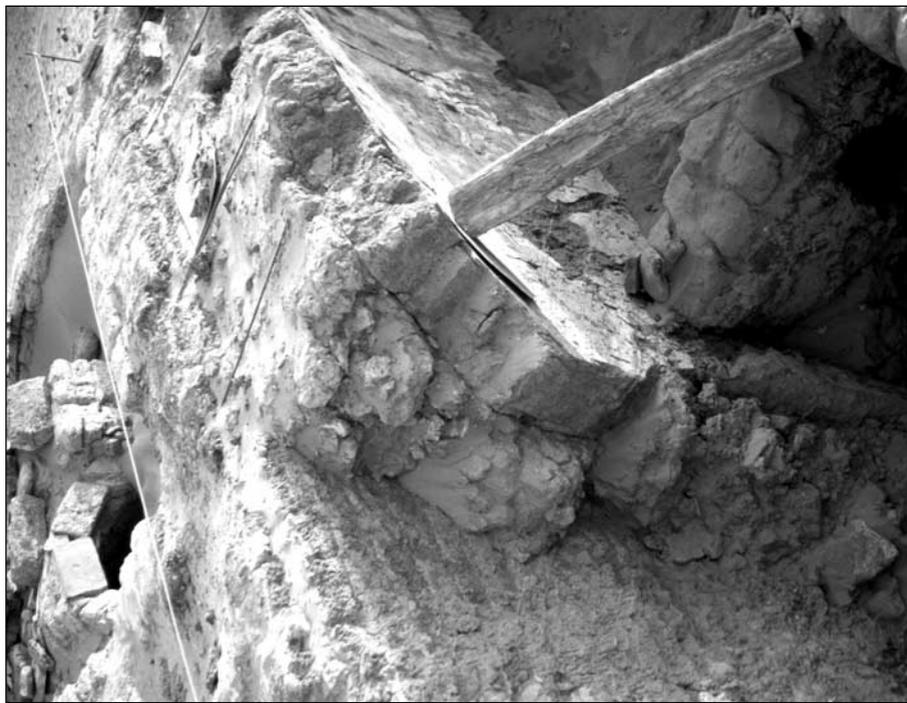
Fig. 13. Destroyed vault in room 6 over the entrance to room 7 and the Terminal Christian wall supporting the vault (Photo W. Chmiel)

There could have been another reason for the height of the screening wall. The rectangular (high) wall could have served as a natural support for the western part of the northern section of the vault above the entrance to corridor 7, which was threat-

ening to collapse (in similarity to what the excavators did during exploration) [Fig. 13]. The same is true of the arcade above the entrance from the west (with a fine realistic rendering of a palm grove [Fig. 15]). It had tumbled presumably and an effort was made to salvage the rest by buttressing the exterior of the wall and the southern part of the vault with an extra wall, *nota bene*, unsuccessfully.

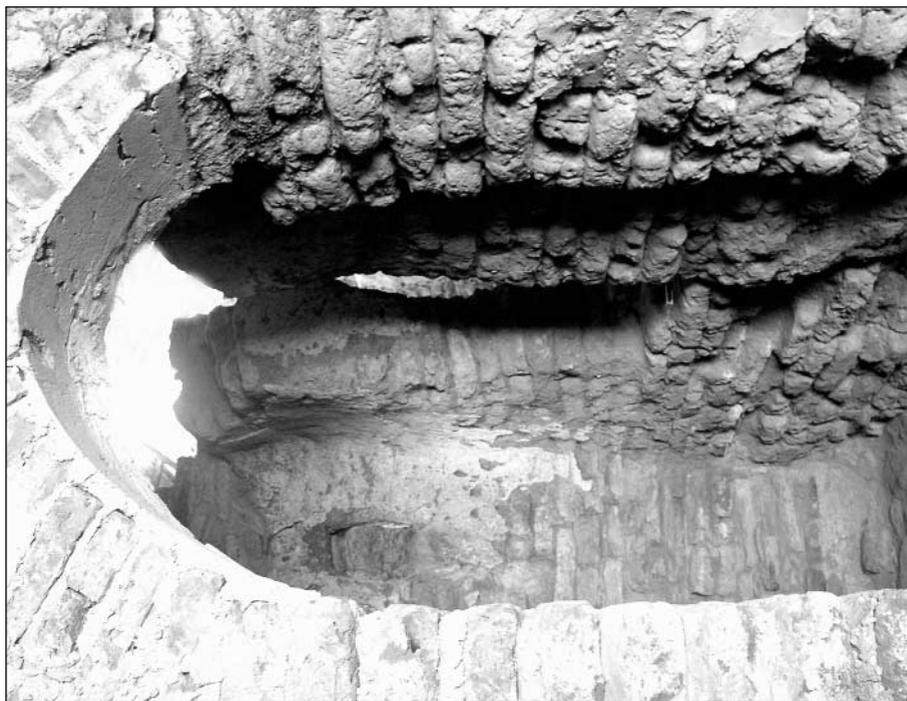
Fig. 12. Later vestibule in the northwestern corner of room 6, view through the entrance from the west; note small doorway on right, the latest doorway exiting the chapel in room 6 (Photo W. Chmiel)

as substitute lamps found in great abundance in successive deposits covering the floor [*Fig. 11*]. By that time, the north-western corner of the room had been screened off with a wall, creating a kind of rectangular anteroom bypassing room 6 *en route* from the entrance vestibule (room 1) to the corridor (7) leading directly into the Southwestern Building. The L-shaped wall screening off this passage was built in two, if not three stages, being increased in height concurrently with the rising occupation level [*Fig. 12*]. A narrow doorway in the western part of the wall was left as the chapel entrance in the last phase.

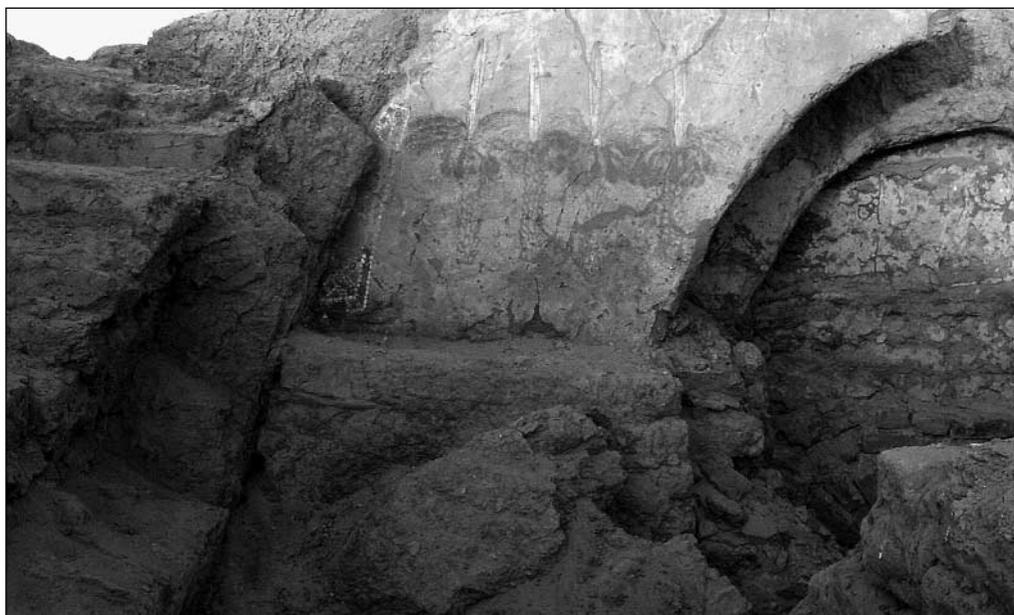
*Fig. 15. Arcade above the entrance from the west with a frieze of palms
(Photo W. Chmiel)*

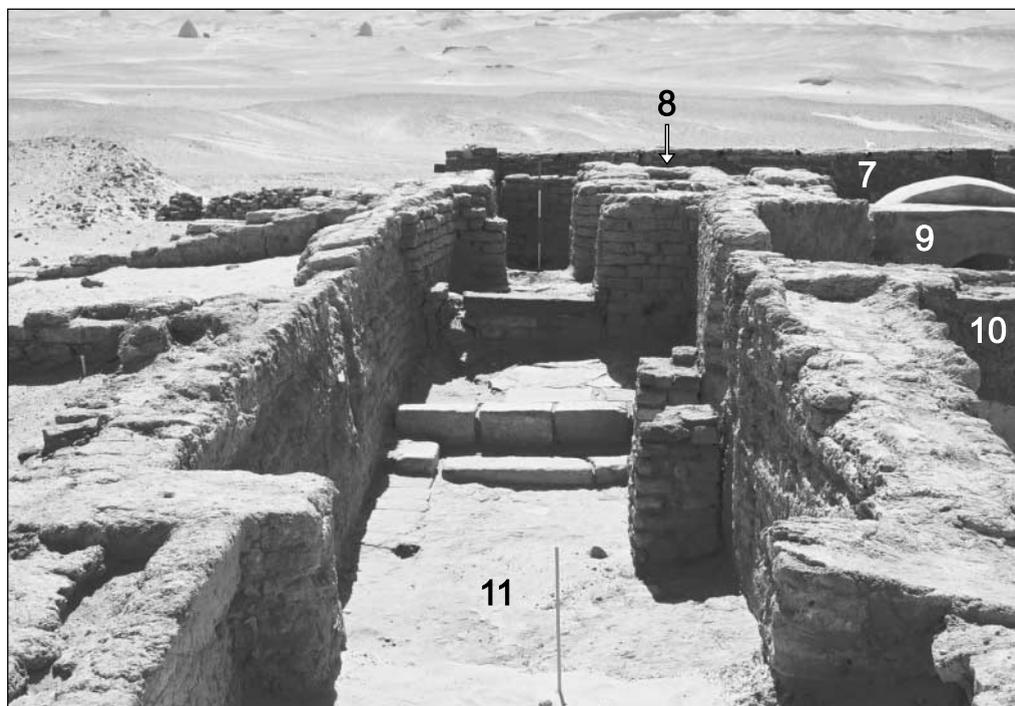
Fig. 17. General view of the upper story of the Southwestern Building, facing south. Numbers refer to the plan in Fig. 1 (Photo J. Świącicki)

in the initial phase. The flagging rising slightly to the north in a kind of ramp would stand in support of this theory. Still another staircase, made of reused stone blocks and red brick in room 8, introduced undoubtedly late in the occupation of the building when the upper story was converted thoroughly, led from the first-floor level presumably to the roof [Fig. 17]. A preliminary analysis of the walls is sufficient to indicate three major rebuilding phases, which are particularly well visible in the exterior bond of the west wall. It should be noted, too, that this wall, being the outer wall much at risk from the elements, must have undergone many local repairs over the centuries.
