The Lion of Allat in Palmyra : New Museum Display Project

Polish Archaeology in the Mediterranean 16, 470-474

THE LION OF ALLAT IN PALMYRA NEW MUSEUM DISPLAY PROJECT

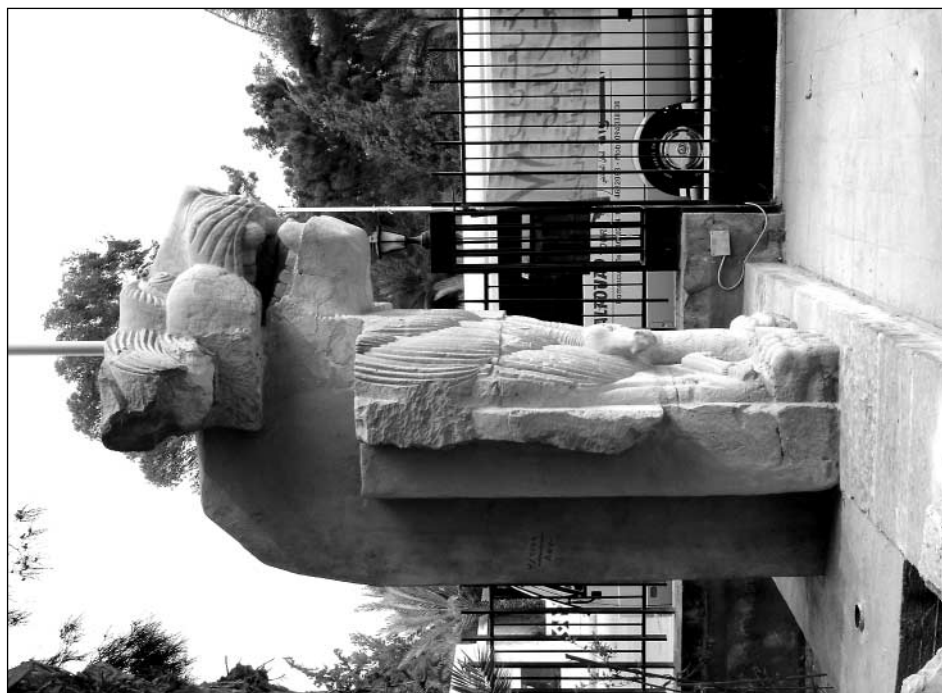
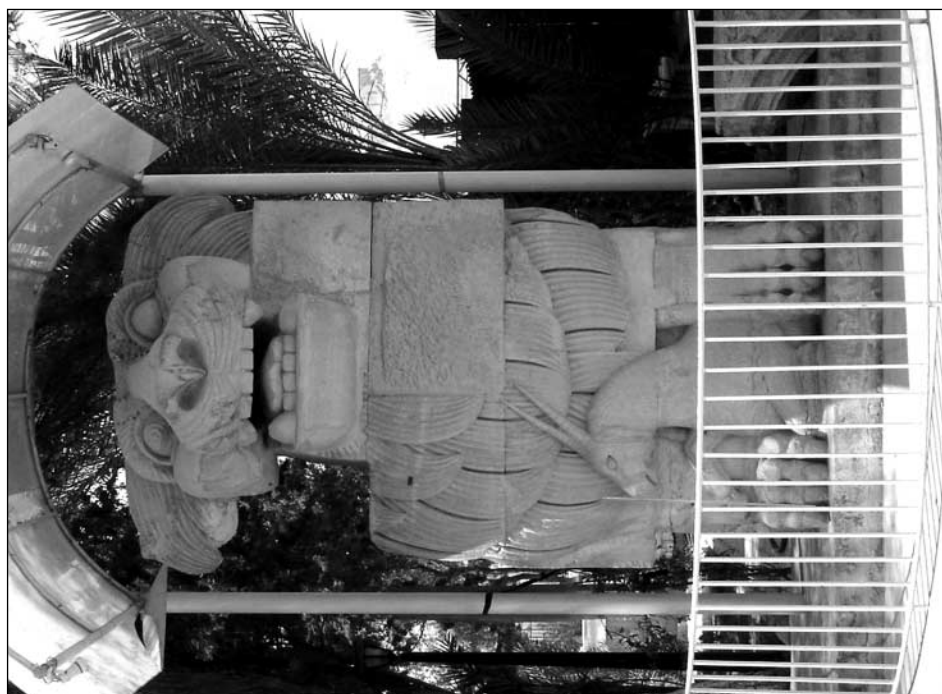
After 25 years, the display of the statue was found to be inadequate [*Fig. 1*]. Indeed, problems had appeared already during the remounting when the lion tilted forward dangerously, threatening to collapse. A concrete counterweight was added at the back of the statue to counter the tilt, giving the lion an unbecoming hump in effect. Recently, monitoring of the stone surface noted considerable cracking and disconnection of fragments, resulting from the statue's shaken equilibrium. The scaly cracking of the blocks under the lion's jaws seemed to be the most serious problem, suggesting that the head was pressing too heavily on the edges of the blocks.

*Fig. 1. Lion statue from the Allat temple now in the Museum of Palmyra, before conservation in 2005, front and lateral view
(Photo B. Markowski)*

In 2000, a project was presented for a new display of the statue. It addressed two issues, one of which was to recreate the ori-

ginal form of the lion as a relief representation. The other question was to design a supporting construction that would ensure proper statue balance, while satisfying accepted aesthetic standards of reconstruction. The statue had to be dismantled and remounted on a new foundation connected to a reinforced concrete wall backing the sculptured fragments and acting as a counterbalance for the forward tilting tendency. Stone blocks on either side of the lion were supposed to imitate the wall, against which the statue must have been displayed originally. The new restoration project also called for a reconstruction of the missing curls of the mane in order to improve the overall aesthetic effect. Two of these missing elements with carved curls had been replaced in the past with unworked blocks and the third had not been restored at all.

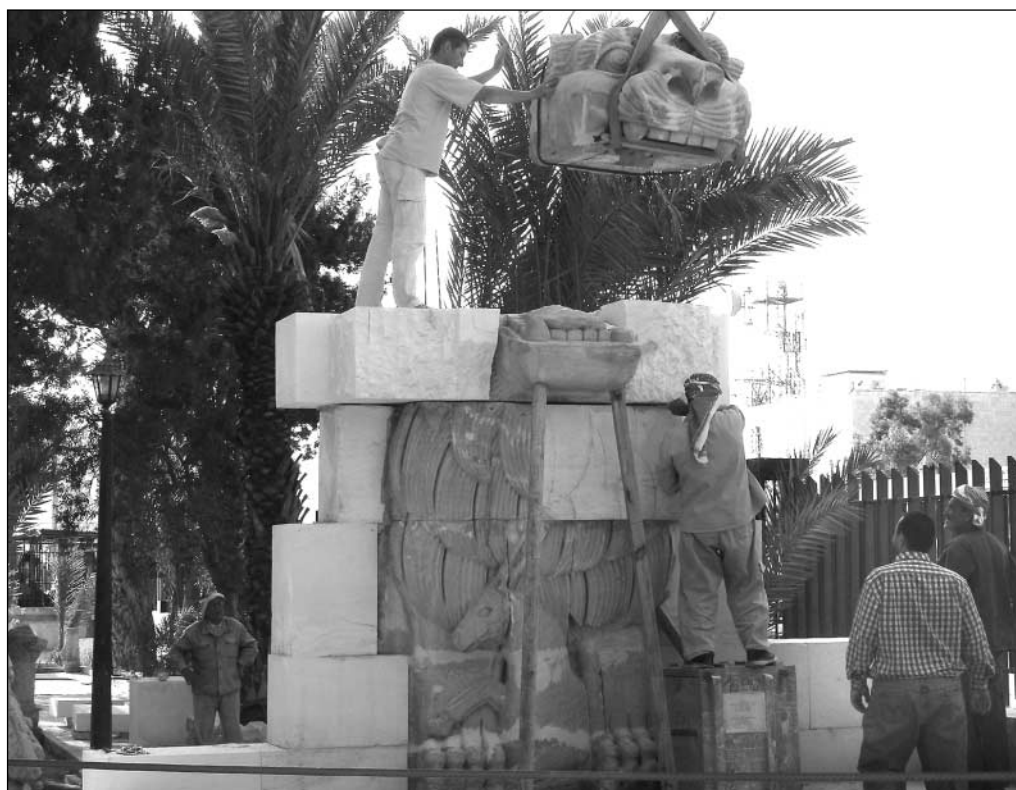
Fig. 2. *Lion statue from the Allat temple during refitting of the elements*
(Photo D. Wielgosz)

Once all the elements of the statue had been refitted [Fig. 2], sculptural work on the front progressed simultaneously with building the bearing construction at the back. Each block was fitted with from one to three stainless steel rods (ϕ 14 mm), inserted at an angle of 45° downward, which should reduce the thrust on particular joints. Each of the 24 rods was bent in copy of the 13 pieces of ribbed steel reinforcement in the wall (ϕ 12 mm). Wood scaffolding was then put up and the reinforcement poured with concrete. The contacting surface of the

limestone blocks was first impregnated with c. 10 l of 5% PARALOID B72 in toluene. The concrete wall was 1.30 m long, 3.10 m high and had an average thickness of 0.25 m. Wooden beams shored up the statue from the front until the concrete had set. Once the concrete had dried, the scaffolding was removed and the surface floated with a sand-and-white-cement mortar.

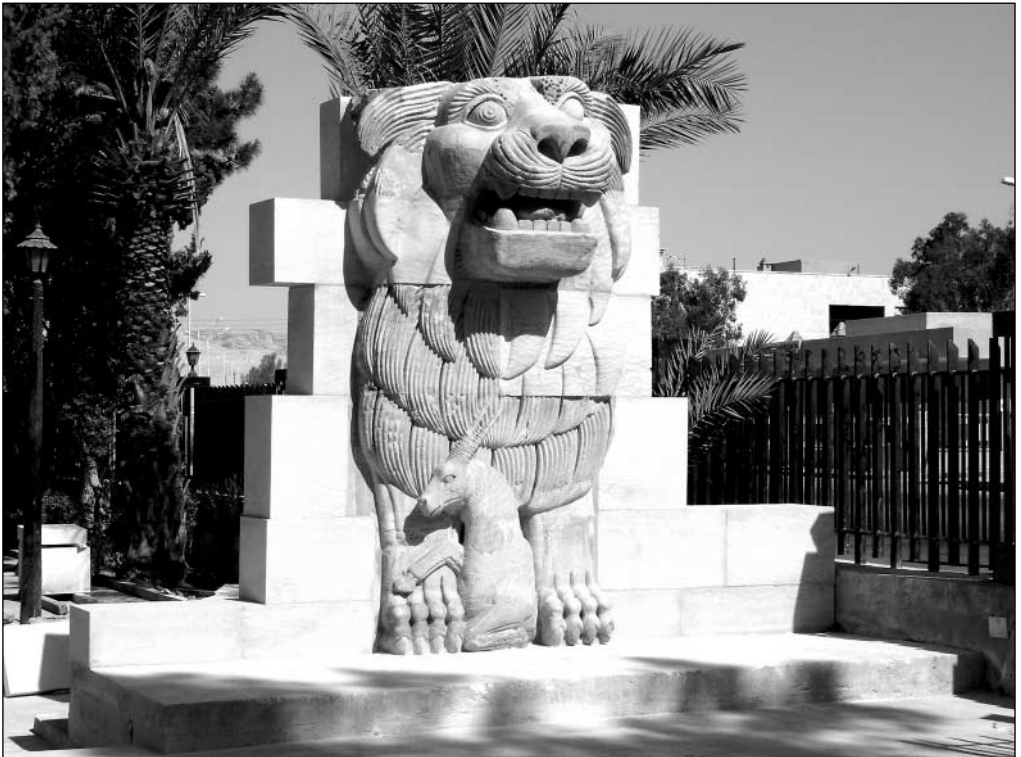
In the effect of the work, the Lion of Allat was restored in imitation of its original appearance [Fig. 3]. It is no longer a statue in the round removed from its building context, but fulfils the design of the ancient artist who wanted it to be a relief representation jumping out from a wall. Its

appearance in past years with the huge mass of concrete at back must have been misleading to visitors and clearly had nothing to do with the original lion. The new bearing construction of the statue fits into the thickness of a wall made of new limestone blocks, forming a uniform surface at back. The concrete wall to which all the stone blocks were anchored is connected integrally with stainless steel reinforcement with the foundation, thus

guaranteeing full and permanent stability of the structure. After color merging with the patinated yellow color of original blocks, this bearing wall attracts virtually no attention. The improvised wall, erected of new blocks, and the reconstruction of the missing curls of the mane ensure viewers' capability to appreciate the integrated and harmonious composition of an ancient sculpture and leave no doubt as to which elements were original.

*Fig. 3. The Lion of Allat after conservation
(Photo B. Markowski)*
