Marina El-Alamein: Conservation and Restoration Work in 2006

MARINA EL-ALAMEIN

CONSERVATION AND RESTORATION WORK IN 2006

Stanisław Medeksza *et alii*

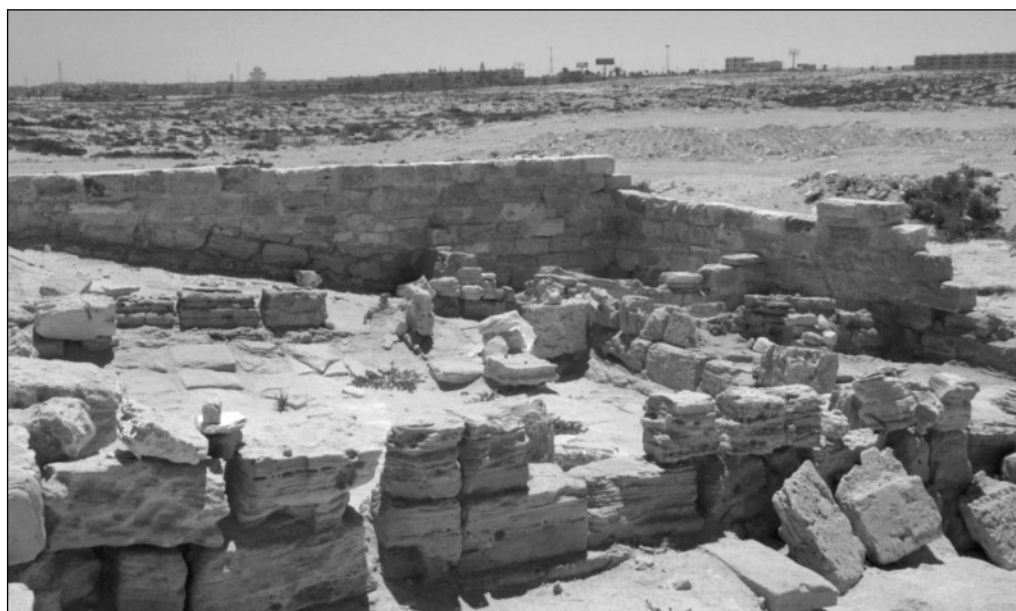
Fig. 2. House H1. Reconstructed perimeter wall in the southeastern part of the structure, state in 2006 (Photo S. Medeksza)

The southwestern course of the perimeter wall was investigated this year and found to be preserved as a foundation at best (at depths of 1.00-1.50 m), sufficiently

The building conservation work this season concerned the perimeter wall in the southeastern, southern, southwestern and western part of the house, i.e. Rooms 1, 2, 21 and will be continued [Fig. 3]. New parts of the walls are distinguished by their different thickness and the leveling of particular layers, which does not follow the collapsing courses of the preserved original [Fig. 3]. The new blocks are 0.30 m thick and are bonded lengthwise with the run of the wall. Walls were also reconstructed between Rooms 12, 11, 10, 10a, 5, 4, 6 and 27 in order to clarify the general plan of the house.

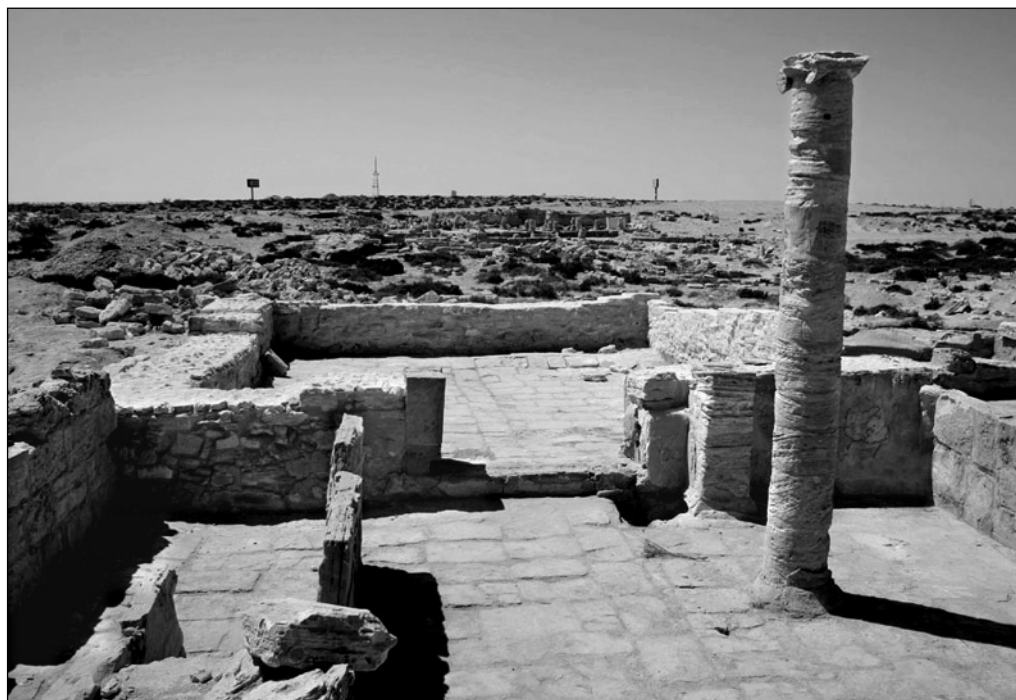
Fig. 4. House H2. Reconstructed column in courtyard, state in 2006
(Photo S. Medeksza)

The anastylosis of the one Ionic column in the courtyard was completed in 2006 [Fig. 5]. A wall of broken stone was completed around room 2, its top sealed with cement-lime mortar on top of an insulating layer of a harder cement-lime mortar. Peeling original plaster discovered in the northwestern corner of the room was consolidated and made to adhere to the wall with lime mortar. A block with

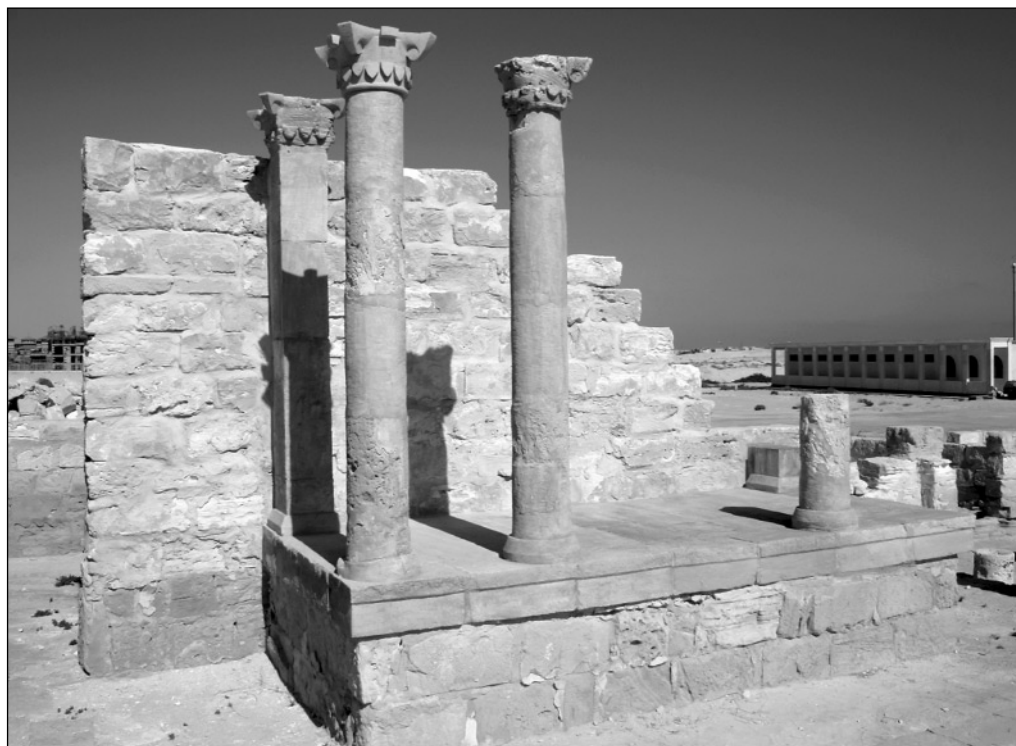
Fig. 6. Commemorative monument from House H21c, state in 2006 (Photo R. Czerner)

The anastylosis of the commemorative monument dedicated to Commodus in Room 2 of the building was continued, completing the engaged pilaster, the base and fragment of shaft of the second pillar. The wall constituting the backdrop of the monument was built up substantially, practically up to the architrave [Fig. 6]. The original capital was reinforced, and the missing corners of the abacus with

volutes reconstructed of limestone closely resembling the original (cut by P. Zambrzycki). The upper surfaces of the three capitals mark the level of the top of the monument, giving a good idea of its spatial form and size. The last stage, planned for the next season, will be to remount the original cornices.

The original top of the base of the monument had been made of red marble slabs between 4.3 and 5.0 cm thick. In the reconstruction, chamfered blocks, 0.30 cm thick, have been laid flat as a base under the columns, profiled and recessed by 0.5 cm from the face, thus achieving an edge projecting 0.07 m beyond the wall face and of a similar thickness as the original marble slab, which bore the dedicatory inscription to Commodus on the side edge. This band runs around the podium of the monument on three sides, on the south, east and north.

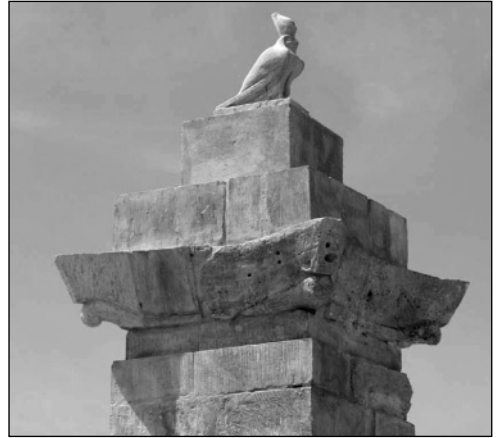
Fig. 7. Close-up of replica statue of Horus from the top of the sepulchral monument, mounted in 2006 (Photo P. Zambrzycki)

place by polyester-acrylic resin. Two crowning courses, receding in steps, were reconstructed of new blocks following the original theoretical reconstruction. A limestone statue of Horus, a replica of an original kept in storage on the site (carved by P. Zambrzycki) [Fig. 7], was replaced at the top of the monument. The replica was made using traditional techniques and photographic documentation. A cement-lime mortar was used for all the reconstruction work (sand to lime to white cement proportions being 6:3:1). Upon completing the anastylosis, the reconstructed elements were unified coloristically with the original (using natural pigments and acrylic resin binder) [Fig. 9].

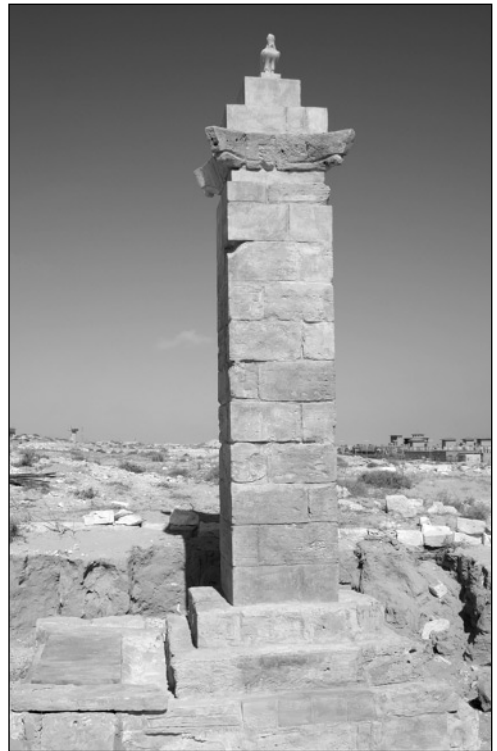
Fig. 9. Pillar tomb T12 after restoration, state in 2006 (Photo R. Czerner)

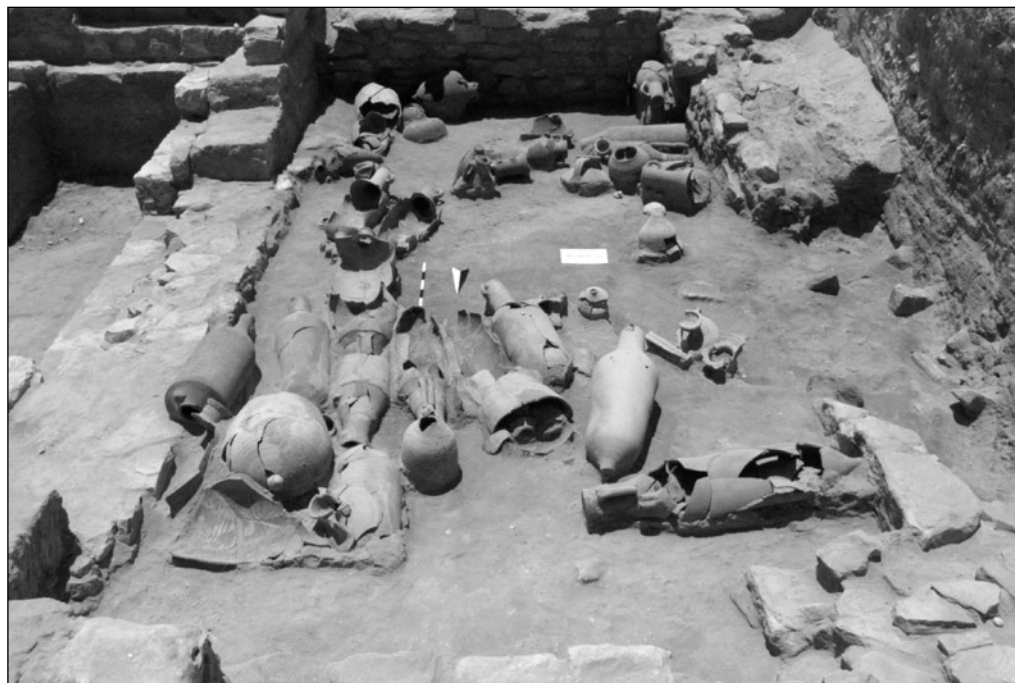
*Fig. 10. Room 26 of House H1, deposit of amphorae from the 1st–3rd century AD
(Photo S. Medeksza)*

walls of Room 26 were cut by the outer perimeter wall of the house from a later phase. The amphora dump in Room 26 proved to be an exceptionally rich assemblage comprising several dozen complete or almost complete vessels [Fig. 10]. Not only is the geographical distribution of forms extensive, but so is the chronological range, which covers a period from the 1st through the 3rd century AD. A more specific dating is not possible for lack of other well-dated finds.
